## Job Report

Client                    The ABC Company  
Site Address            Long Lane  
Job Number            **004567**  
Job Form                **Fire Door Survey**  
Operative  
Date  
Reference  
Report prepared by:

# OVERVIEW

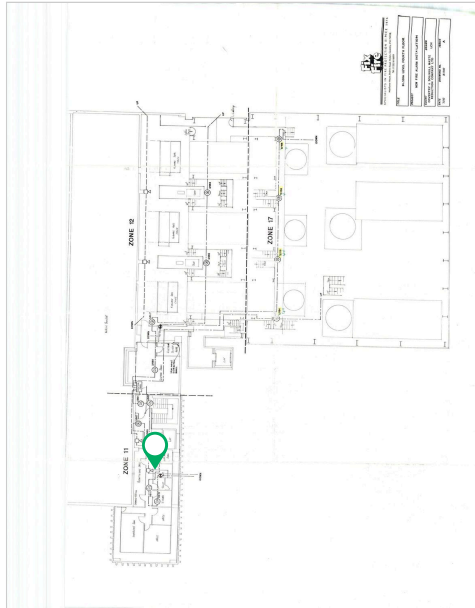
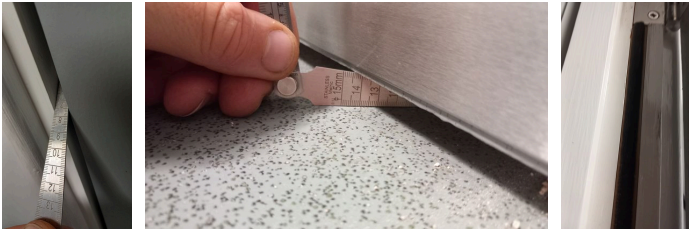
Job Sheet No.	00005-1
Form	Fire Door Survey

Door Name/Location	CS270 lift maintenance door
Floor Level	Forth
Door Configuration	Single leaf
Door Action	Single Action
Does the door have a third party scheme label / plug	Yes
Label / Plug reference photo

Fire door rating	30s
Door construction material	Wood / Timber
Door Leaf Condition	Leaf condition satisfactory
Door Gaps	Adjust the leaf and frame
Leaf gap max/min (mm)	8
Door Threshold	Install drop-down seal
Door Frame	Frame condition satisfactory

Fire Door Survey	
Intumescent Smoke seals (combined)	Replace - flattened brush
Door Hinges	Hinges satisfactory
Door handle	Satisfactory
Signage	Signage satisfactory
Door Closer	Door closer satisfactory
Door components checked	<ul style="list-style-type: none"> <li>• Door leaf</li> <li>• Door frame</li> <li>• Door gaps</li> <li>• Smoke seal</li> <li>• Door hardware</li> <li>• Signage</li> </ul>
Non-conformity components	<ul style="list-style-type: none"> <li>• Excessive gaps around door</li> <li>• Smoke seal damaged</li> </ul>
Photos of Non - Conformity components

Remedial action required	Yes
Remedial action recommendations	<ul style="list-style-type: none"> <li>• Ease and adjust door frame</li> <li>• Replace smoke seal</li> </ul>
Door Frame	Frame condition satisfactory
Intumescent Smoke seals (combined)	Replace-flattened brush
Door Threshold	<ul style="list-style-type: none"> <li>• Install drop-down seal</li> </ul>

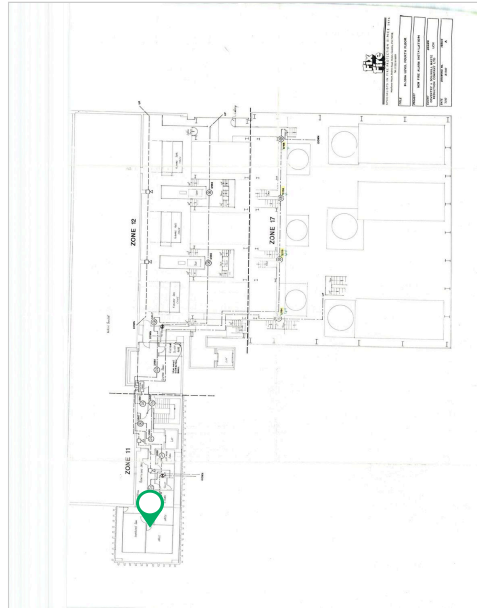
Job Sheet No.	00005-2
Form	Fire Door Survey

Door Name/Location	Shift managers' office near the showers
Floor Level	Forth
Door Configuration	Single leaf
Door Action	Single Action
Does the door have a third party scheme label / plug	Yes
Label / Plug reference photo

Fire door rating	30s
Door construction material	Wood / Timber
Door Leaf Condition	Leaf condition satisfactory
Door Gaps	Adjust the leaf and frame
Leaf gap max/min (mm)	7
Door Threshold	Install drop-down seal
Door Frame	Frame condition satisfactory

Fire Door Survey	
Intumescent Smoke seals (combined)	Replace - flattened brush
Door Hinges	Hinges satisfactory
Door handle	Handle loose, refit handle
Signage	Required FDKS
Door Closer	Adjustment/overhaul closer
Door components checked	<ul style="list-style-type: none"> <li>• Door leaf</li> <li>• Door frame</li> <li>• Door gaps</li> <li>• Intumescent strip</li> <li>• Smoke seal</li> <li>• Door hardware</li> <li>• Glazing</li> <li>• Signage</li> </ul>
Non-conformity components	<ul style="list-style-type: none"> <li>• Excessive gaps around door</li> <li>• Smoke seal damaged</li> <li>• Door signage missing</li> </ul>
Photos of Non - Conformity components	
Remedial action required	Yes
Remedial action recommendations	<ul style="list-style-type: none"> <li>• Ease and adjust door frame</li> <li>• Replace smoke seal</li> <li>• Install signage</li> </ul>
Door Frame	Frame condition satisfactory
Intumescent Smoke seals (combined)	Replace-flattened brush

Door Threshold	<ul style="list-style-type: none"> <li>• Install drop-down seal</li> </ul>
Operative	
Operative

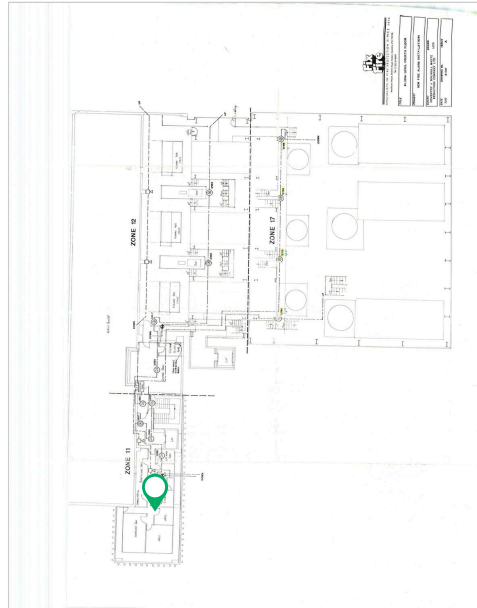
Job Sheet No.	00005-3
Form	Fire Door Survey

Door Name/Location	CS276 office
Floor Level	Forth
Door Configuration	Single leaf
Door Action	Single Action
Does the door have a third party scheme label / plug	Yes
Label / Plug reference photo	
Fire door rating	30s
Door construction material	Wood / Timber
Door Leaf Condition	Leaf twisted, bowed or cupped-repair possible
Door Gaps	Adjust the leaf and frame
Leaf gap max/min (mm)	7
Door Threshold	Install drop-down seal
Door Frame	Frame condition satisfactory

Fire Door Survey	
Intumescent Smoke seals (combined)	Replace - flattened brush
Door Hinges	Replace - hinges worn
Door handle	Handle loose, refit handle
Signage	Required FDKS
Door Closer	Adjustment/overhaul closer
Door components checked	<ul style="list-style-type: none"> <li>• Door leaf</li> <li>• Door frame</li> <li>• Door gaps</li> <li>• Intumescent strip</li> <li>• Smoke seal</li> <li>• Door hardware</li> <li>• Glazing</li> <li>• Signage</li> </ul>
Non-conformity components	<ul style="list-style-type: none"> <li>• Door leaf damaged</li> <li>• Excessive gaps around door</li> <li>• Smoke seal damaged</li> <li>• Door signage missing</li> </ul>
Photos of Non - Conformity components	
Remedial action required	Yes
Remedial action recommendations	<ul style="list-style-type: none"> <li>• Repair door leaf</li> <li>• Ease and adjust door frame</li> <li>• Replace smoke seal</li> <li>• Install new hinges</li> <li>• Install signage</li> </ul>

Door Frame	Frame condition satisfactory
Intumescent Smoke seals (combined)	Replace-flattened brush
Door Threshold	<ul style="list-style-type: none"> <li>• Install drop-down seal</li> </ul>
Operative	
Operative

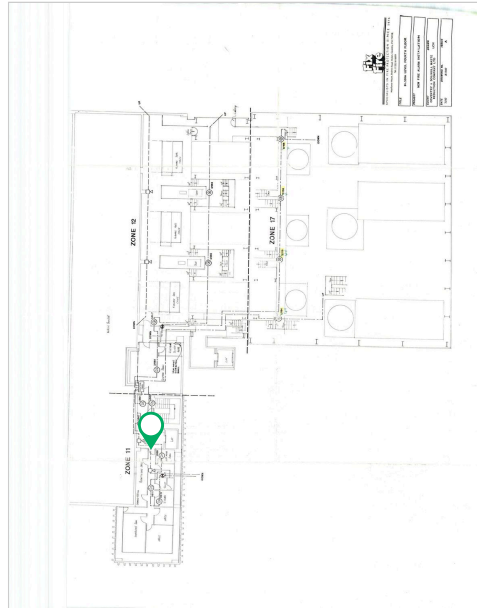
Job Sheet No.	00005-4
Form	Fire Door Survey

Door Name/Location	Wing entrance door next to CS270
Floor Level	Forth
Door Configuration	Single leaf
Door Action	Single Action
Does the door have a third party scheme label / plug	No
Label / Plug reference photo

Fire door rating	30s
Door construction material	Wood / Timber
Door Leaf Condition	Excessively twisted, bowed or cupped, repair not possible
Door Gaps	Adjust the leaf and frame
Leaf gap max/min (mm)	7
Door Threshold	Install drop-down seal
Door Frame	Excessive damage, replace door set

Fire Door Survey	
Intumescent Smoke seals (combined)	Replace - flattened brush
Door Hinges	Replace - hinges worn
Door handle	Satisfactory
Signage	Required FDKS
Door Closer	Adjustment/overhaul closer
Door components checked	<ul style="list-style-type: none"> <li>• Door leaf</li> <li>• Door frame</li> <li>• Door gaps</li> <li>• Intumescent strip</li> <li>• Smoke seal</li> <li>• Door hardware</li> <li>• Glazing</li> <li>• Signage</li> </ul>
Non-conformity components	<ul style="list-style-type: none"> <li>• Door leaf damaged</li> <li>• Door frame damaged</li> <li>• Excessive gaps around door</li> <li>• Smoke seal damaged</li> <li>• Hardware Non - Compliant</li> <li>• Door signage missing</li> </ul>
Photos of Non - Conformity components	
Remedial action required	Yes
Remedial action recommendations	<ul style="list-style-type: none"> <li>• Install new door set</li> </ul>
Door Frame	Excessive damage, replace door set

Intumescent Smoke seals (combined)	Replace-flattened brush
Door Threshold	<ul style="list-style-type: none"> <li>• Install drop-down seal</li> </ul>
<b>Operative</b>	
Operative

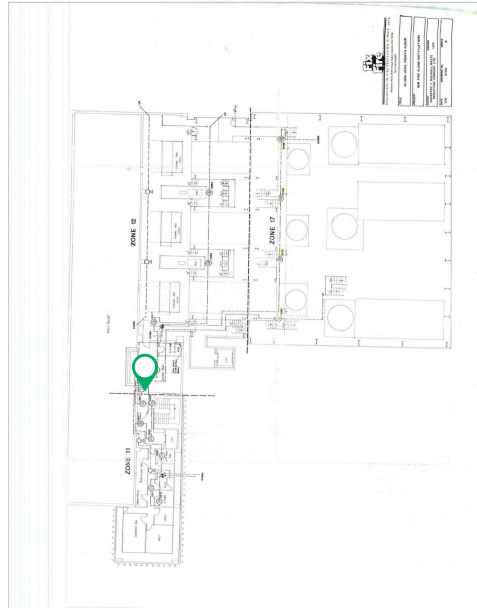
Job Sheet No.	00005-5
Form	Fire Door Survey

Door Name/Location	CS261 control room. 50mm thickness door, unknown rating. Replace recommended
Floor Level	Forth
Door Configuration	Single leaf
Door Action	Single Action
Does the door have a third party scheme label / plug	No
Label / Plug reference photo

Fire door rating	60
Door construction material	Wood / Timber
Door Leaf Condition	Excessively twisted, bowed or cupped, repair not possible
Door Gaps	Adjust the leaf and frame
Leaf gap max/min (mm)	8
Door Threshold	Install drop-down seal
Door Frame	Frame condition satisfactory

Fire Door Survey	
Intumescent Smoke seals (combined)	Replace - painted brush/fin
Door Hinges	Replace - hinges worn
Door handle	Satisfactory
Signage	Required FDKS
Door Closer	Adjustment/overhaul closer
Door components checked	<ul style="list-style-type: none"> <li>• Door leaf</li> <li>• Door frame</li> <li>• Door gaps</li> <li>• Intumescent strip</li> <li>• Smoke seal</li> <li>• Door hardware</li> <li>• Glazing</li> <li>• Signage</li> </ul>
Non-conformity components	<ul style="list-style-type: none"> <li>• Door leaf damaged</li> <li>• Excessive gaps around door</li> <li>• Smoke seal damaged</li> <li>• Hardware Non - Compliant</li> <li>• Door signage missing</li> </ul>
Photos of Non - Conformity components	<p>The photographs show various issues with fire doors: <ul style="list-style-type: none"> <li>Top row: A door with a damaged smoke seal, a door with a large gap at the top, a close-up of a worn hinge, a door with a missing sign, and a door with a damaged frame.</li> <li>Middle row: A close-up of a damaged seal, a door with a large gap at the bottom, a close-up of a damaged seal, and a close-up of a worn hinge.</li> <li>Bottom row: A close-up of a damaged seal, and a door with a large gap at the bottom.</li> </ul> </p>

Remedial action required	Yes
Remedial action recommendations	<ul style="list-style-type: none"> <li>• Install new door set</li> </ul>
Door Frame	Frame condition satisfactory
Intumescent Smoke seals (combined)	Replace-flattened brush
Door Threshold	<ul style="list-style-type: none"> <li>• Install drop-down seal</li> </ul>
Operative	
Operative
