FINAL REPORT

GTI Service Request No.: 525
GTI Project No.: 22480.1.54

Evaluation of Boretrace™

Report Issued: June 18, 2021

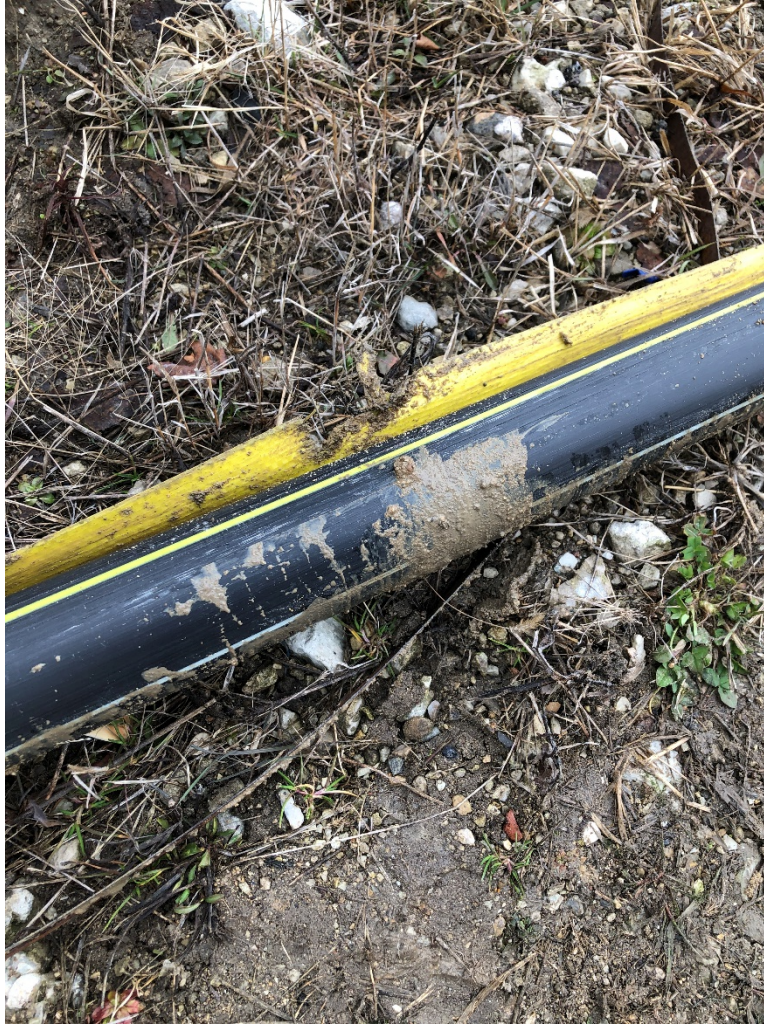
Figure 6. Field observed abrasion and material removal

Both the 12 AWG tracer wire and Boretrace™ tracer wire were attached to the bore head as shown in Figure 3 below. Some abrasions were observed after removal from the bore

hole (Figure 6). However, no visible disconnections or catastrophic damage to either the traditional tracer wire or Boretrace™ product was visible. Upon laboratory inspection by DPS, some abrasions were observed on the Boretrace™ product and a single opening in the PE film exposed the tracer wire jacket, but the bare wire was not exposed. Tracer wire continuity was maintained, as described in **Marker System Evaluation**.

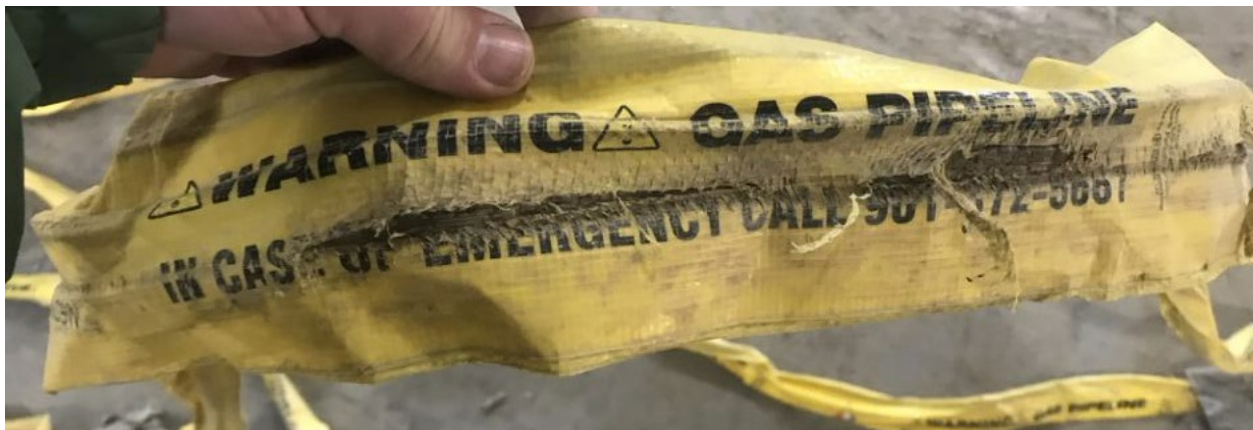
Figure 7. Abrasion Point (1)

- 1) Three (3) visible film abrasion points were observed (see Figure 7 and Figure 8)
 - One (1) abrasion point where the tracer wire jacket was exposed (Figure 9)
- 2) No visible damage to tracer wire or abrasion to wire jacket
 - Resistance checks across length of tracer wire confirmed no open line
 - Continuity was confirmed
