Roof Solutions

Roof - Solar Panel - Thermal Inspection

Job Number: 21-0923

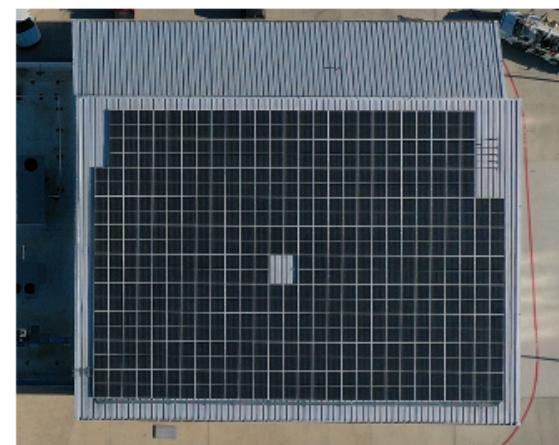
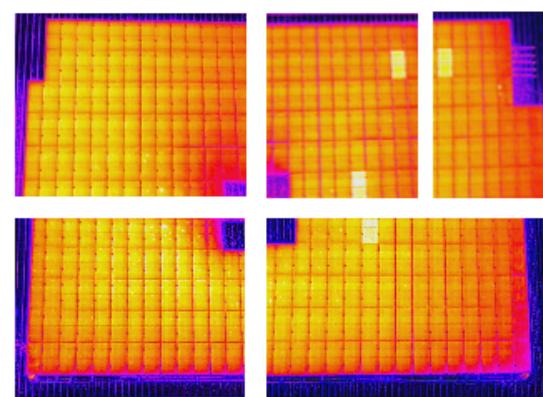
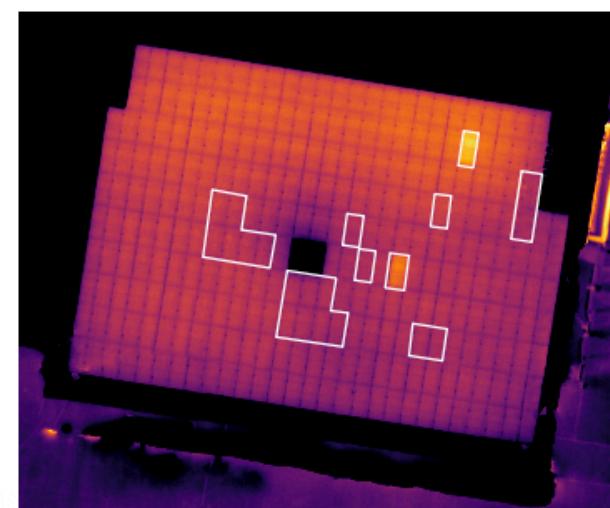
Image #: 1 **Job #:** 21-0923 **Date:** 09/23/2021 **Time:** 9:30am – 1:00pm

Array 1 (image set 1)
Number of Modules: 270 Modules
Faulting Modules: 2 Modules
Modules w/ Faulting Cells: 20

Comments: Multiple thermal anomalies were observed on this solar panel array. 2 panels and multiple individual cells are overheating as compared with other panels in the array.

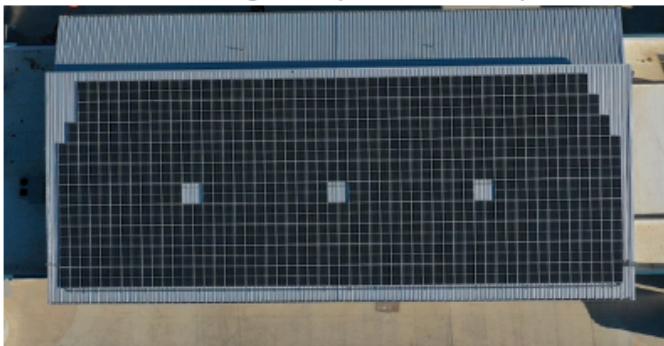
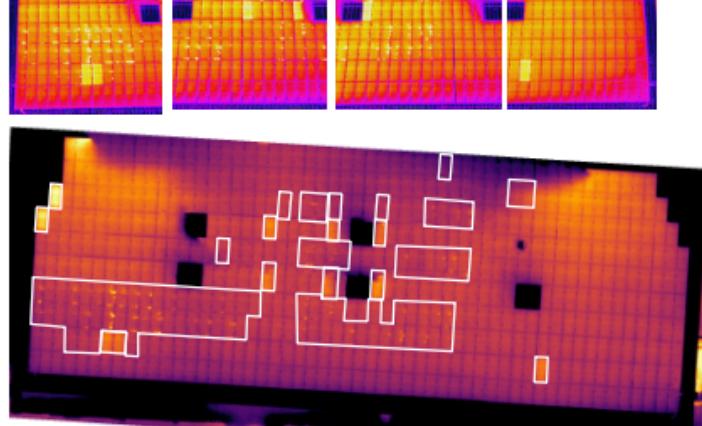
Image #: 2 **Job #:** 21-0923 **Date:** 09/23/2021 **Time:** 9:30am – 1:00pm

Array 2 (image set 2)
Number of Modules: 523 Modules
Faulting Modules: 11 Modules
Modules w/ Faulting Cells: 87

Comments: Multiple thermal anomalies were observed on this solar panel array. 11 panels and multiple individual cells are overheating as compared with other panels in the array.

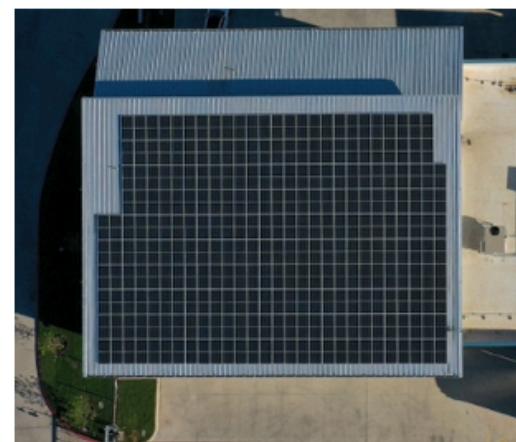
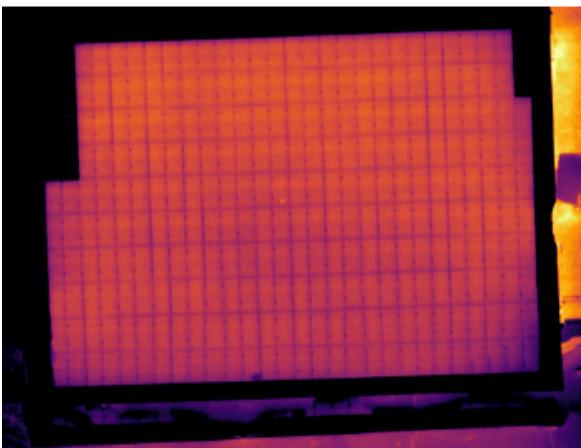
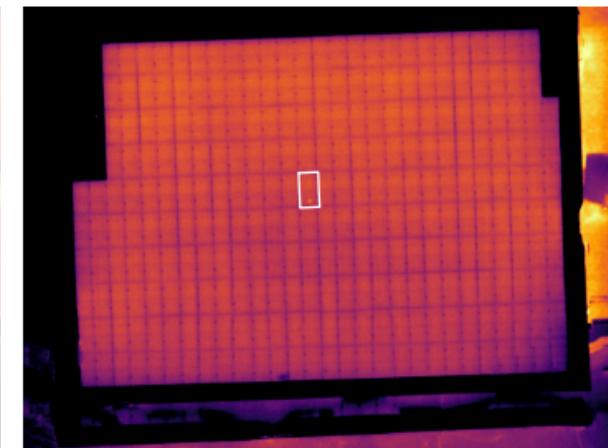
Image #: 3 **Job #:** 21-0923 **Date:** 09/23/2021 **Time:** 9:30am – 1:00pm

Array 3 (image set 3)
Number of Modules: 270 Modules
Faulting Modules: 0 Modules
Modules w/ Faulting Cells: 1

Comments: Two thermal anomalies were observed on this solar panel array. 2 individual cells are overheating as compared with other cells and panels in the array.

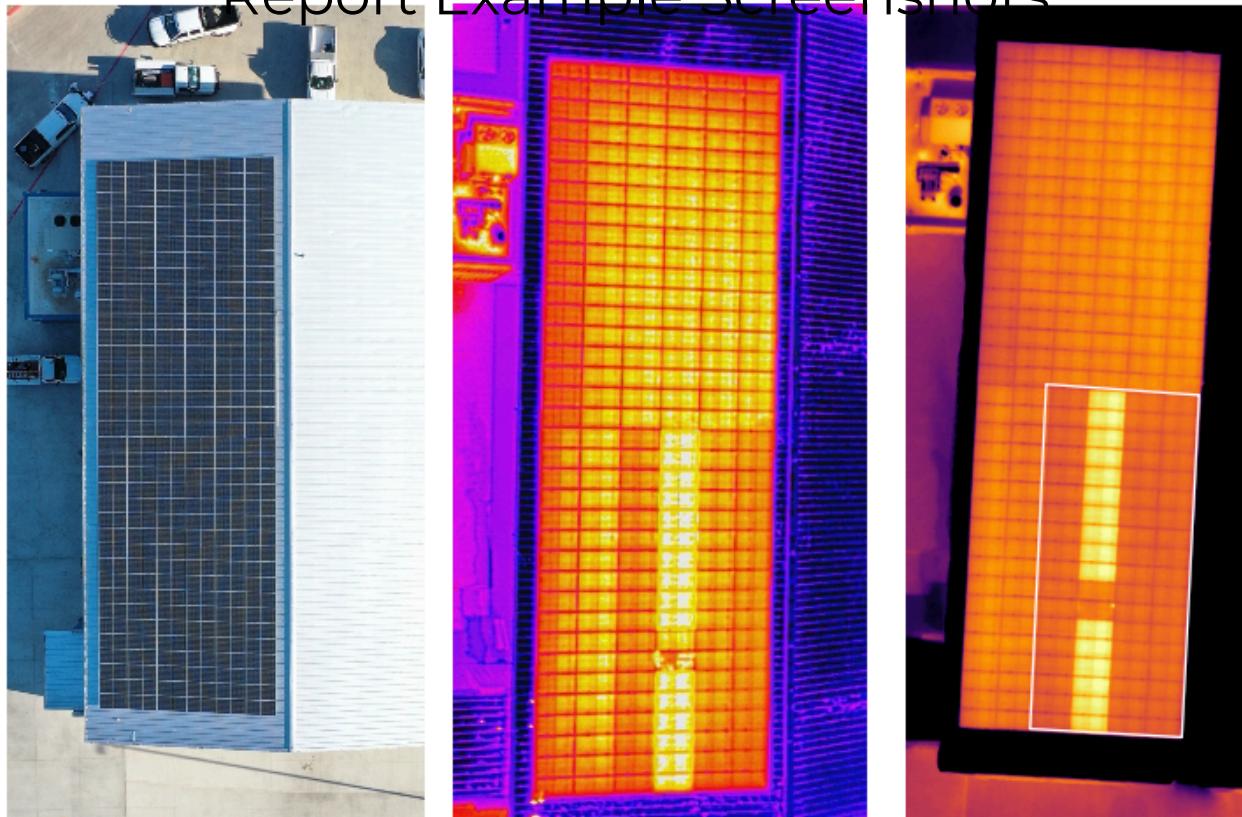
Image #: 4 **Job #:** 21-0923 **Date:** 09/23/2021 **Time:** 9:30am – 1:00pm

Array 4 (image set 4)
Number of Modules: 216 Modules
Faulting Modules: 70 Modules (16 hotter and 54 cooler)
Modules w/ Faulting Cells: 2

Comments: Multiple thermal anomalies were observed on this solar panel array. 1 string of panels are overheating and 3 strings of panels reflect a lower temperature as compared with other panels in the array. 2 panels in the string that are overheating reflect a different signature.
