# Facade Solutions

## Facades - Building - Thermal Inspection

North Façade, Windows, and Thermal

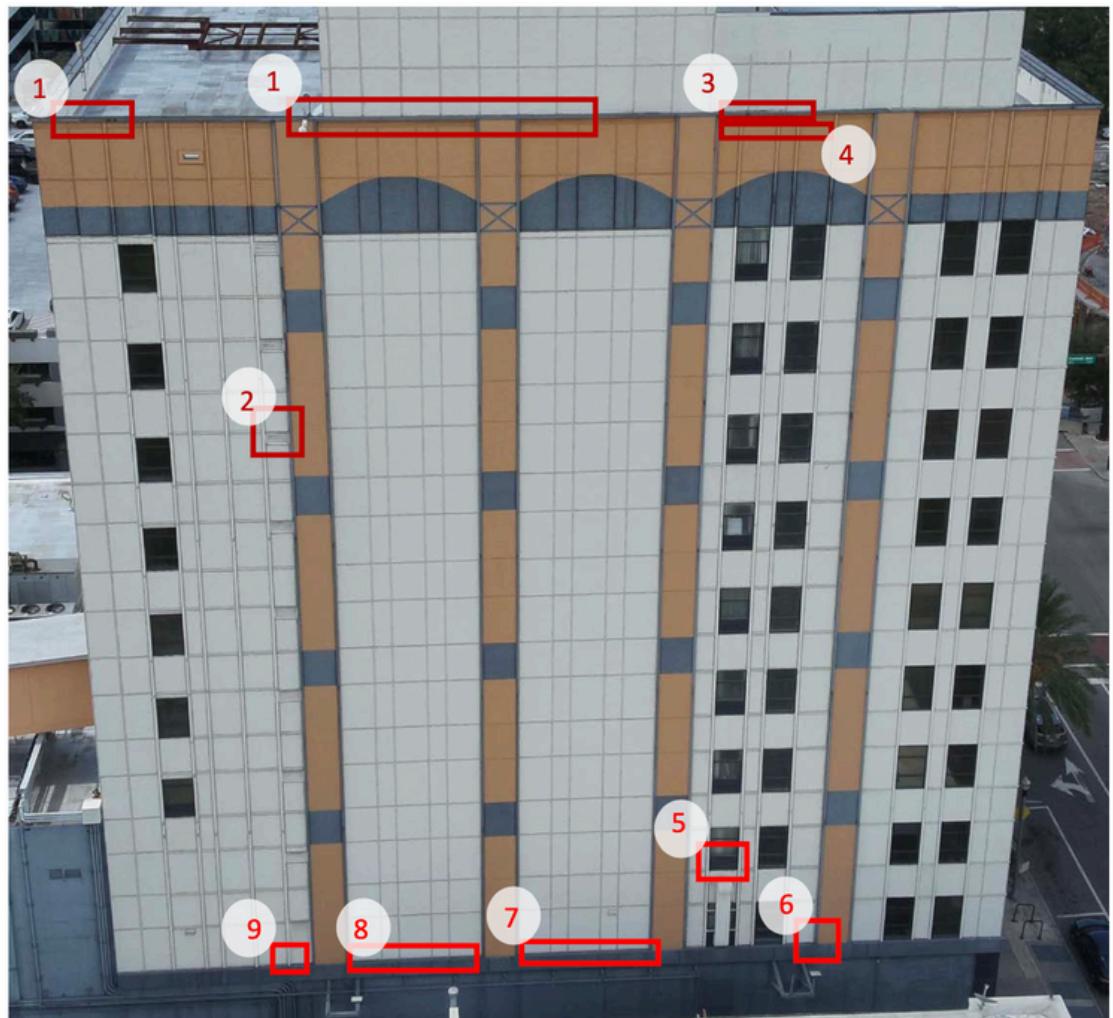
Location: North Façade, Quadrants 1–4

Comments: This image index shows the locations of the visually observed failures on the north facade.

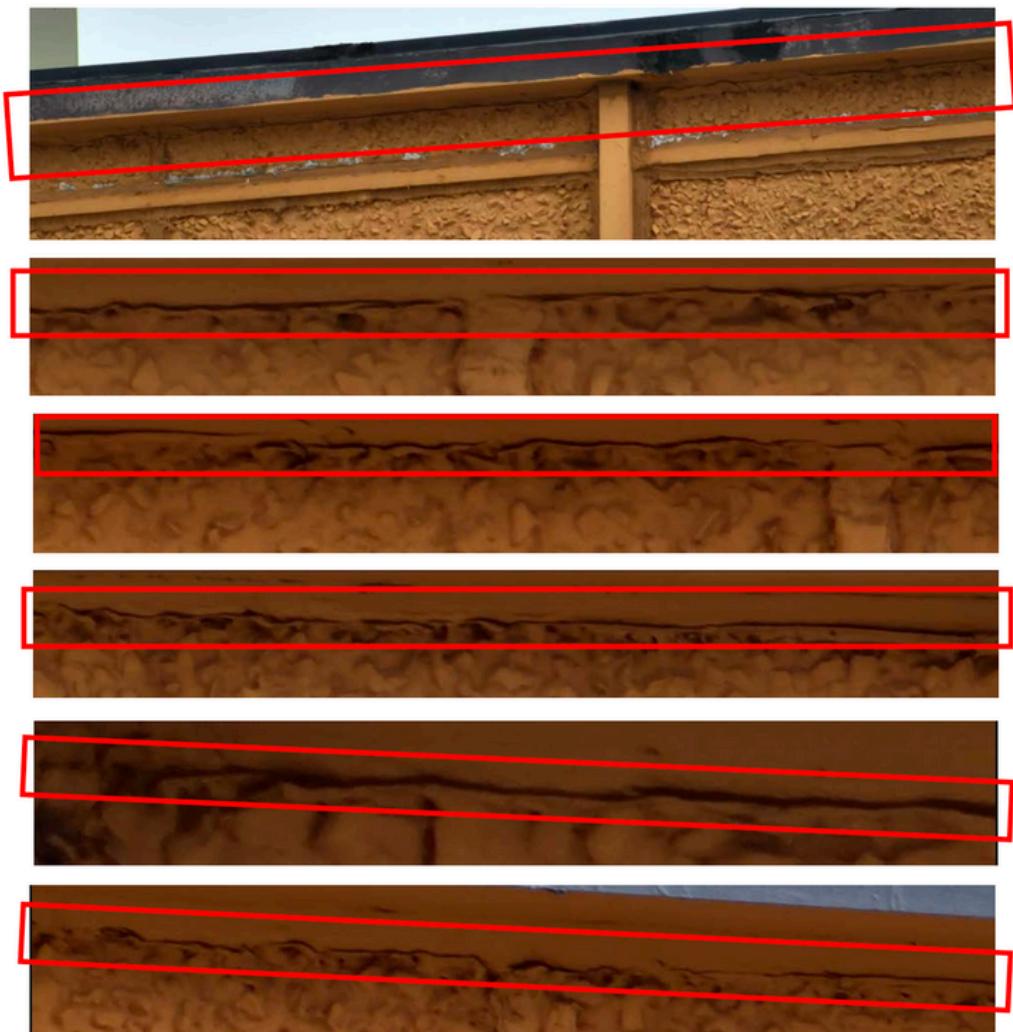
**Image #:** 1 **Date:** 00/00/0000  
**Location:** North Facade  
**Folder:** Quadrant 1 Zoom  
**File:** DJI\_20230717163022\_0023\_SUPR, DJI\_20230717163016\_0019\_SUPR, DJI\_20230717163015\_0018\_SUPR, DJI\_20230717163015\_0017\_SUPR, DJI\_20230717163014\_0016\_SUPR, DJI\_20230717163013\_0015\_SUPR  
**Comments:** Suspected separation of sealant. There is so much sealant present that some of it could be overlap in sealant, but is highlighted for further review.

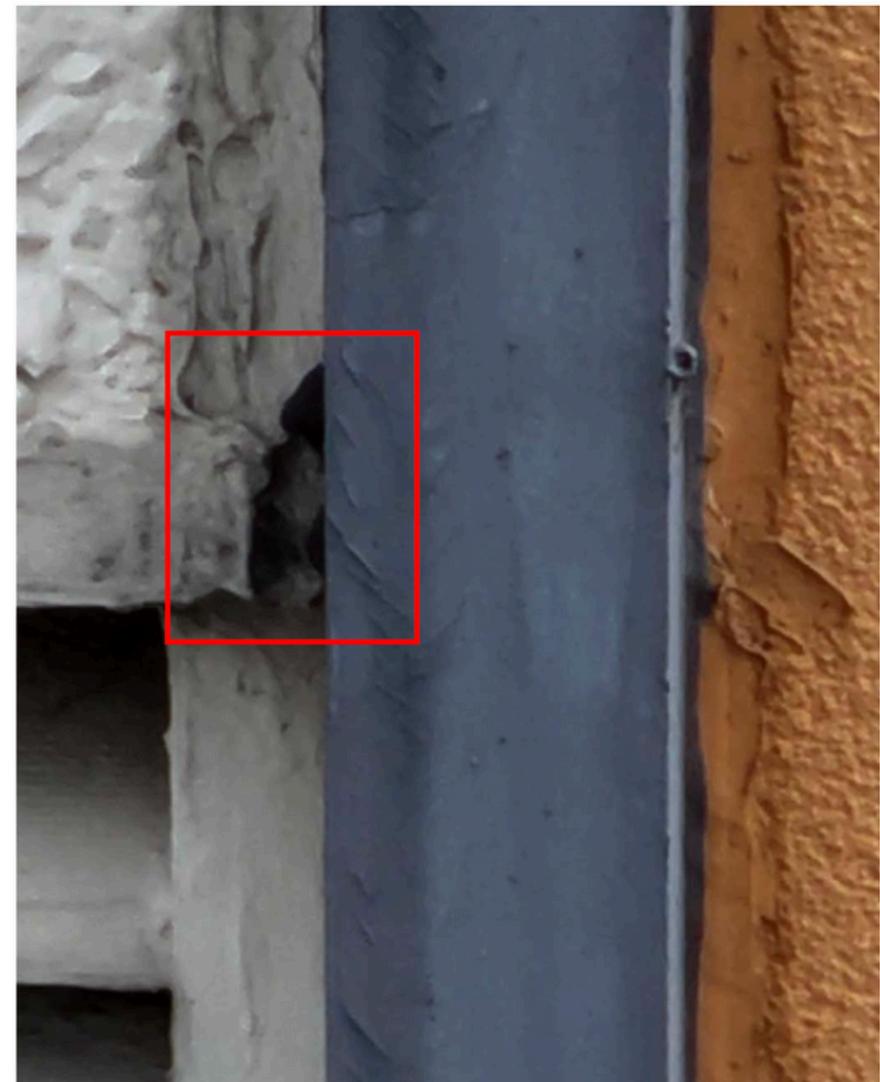
**Image #:** 2 **Date:** 00/00/0000  
**Location:** North Facade  
**Folder:** Quadrant 1 Zoom  
**File:** DJI\_20230717163150\_0116\_SUPR  
**Comments:** Missing sealant at vent corner

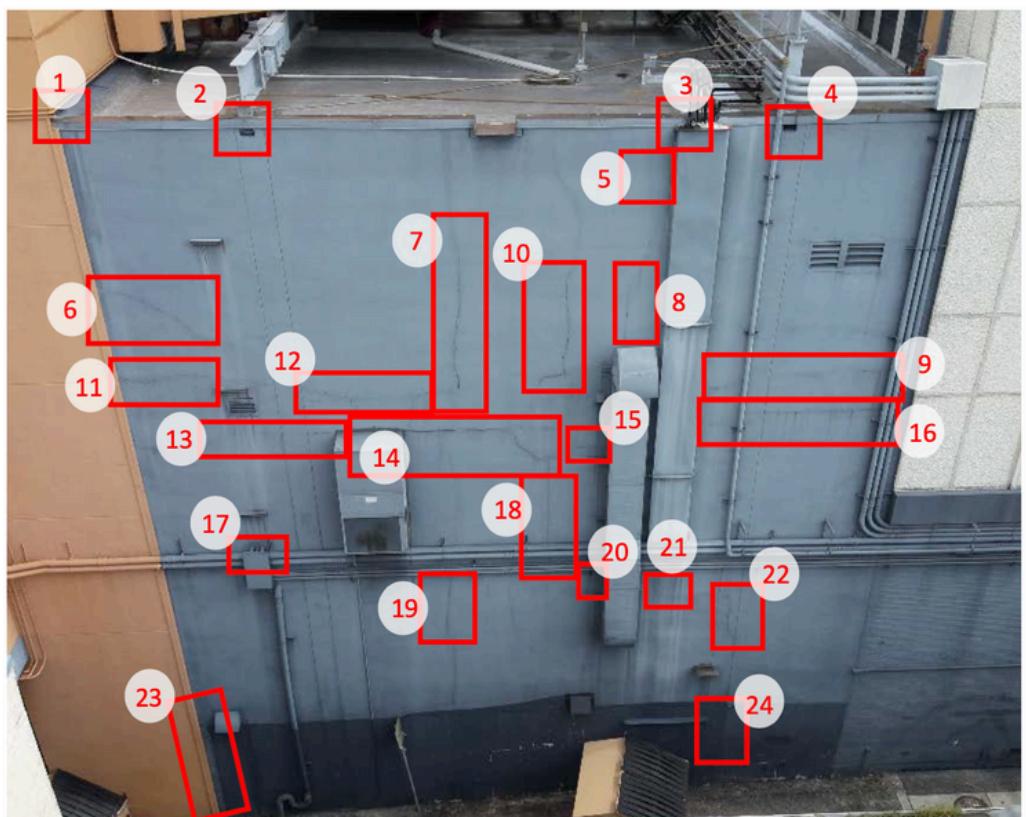
**Location:** North Façade, Gray Section Anomalies      **Date:** 00/00/0000  
**Comments:** Cracking observed throughout this section.

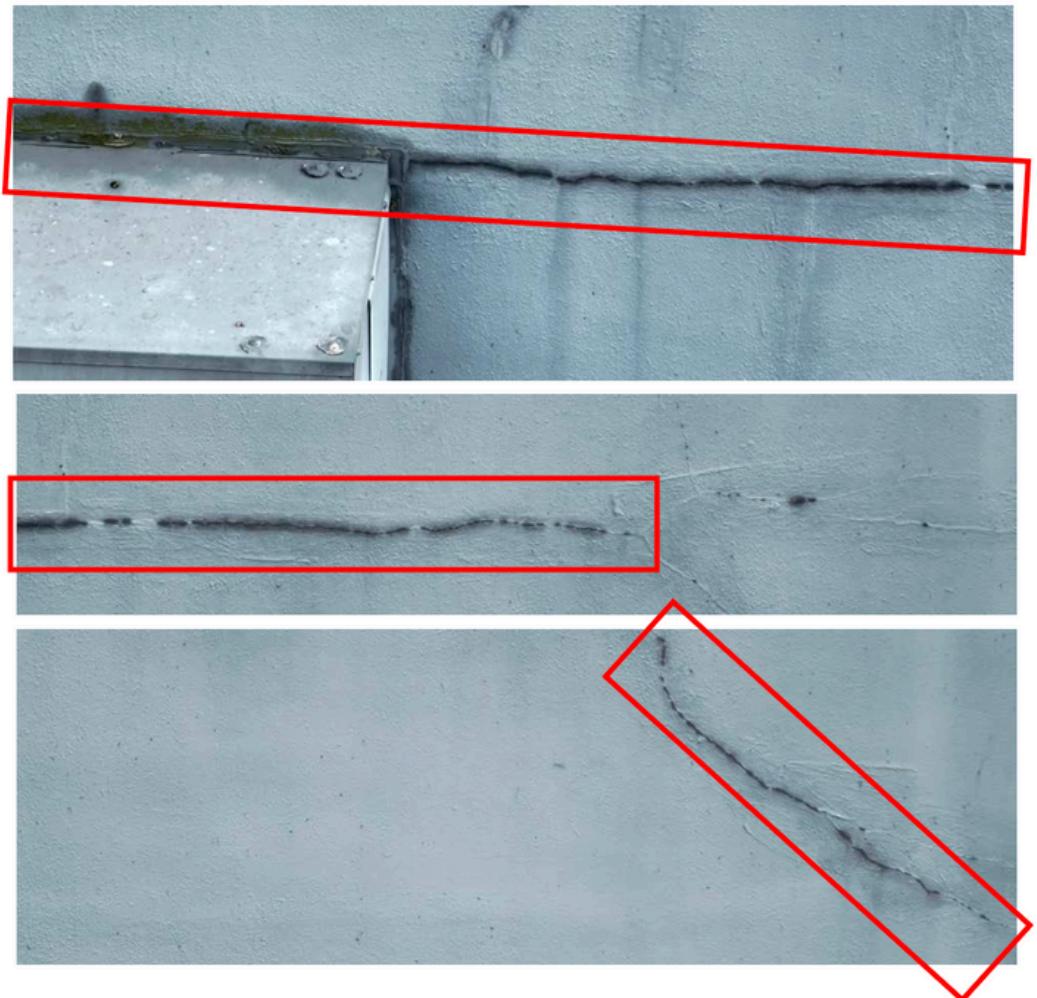
**Image #:** 14 **Date:** 00/00/0000  
**Location:** North Facade  
**Folder:** Gray Section Zoomed  
**File:** DJI\_20230717162313\_0093\_SUPR, DJI\_20230717162313\_0092\_SUPR,  
DJI\_20230717162322\_0101\_SUPR  
**Comments:** Cracks, Organic Matter

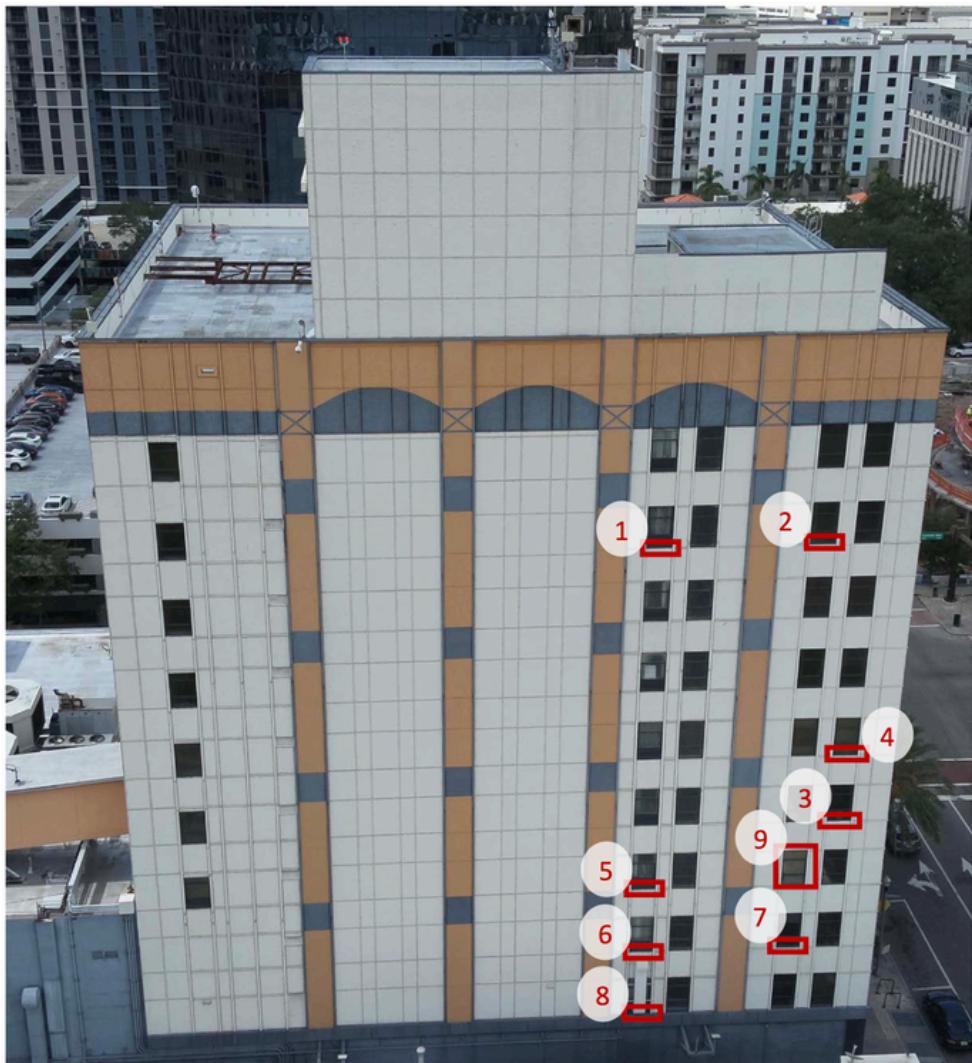
**Location:** North Façade, Window Overview      **Date:** 00/00/0000  
**Comments:** This image index shows the locations of visually observed defects correlated with the windows.

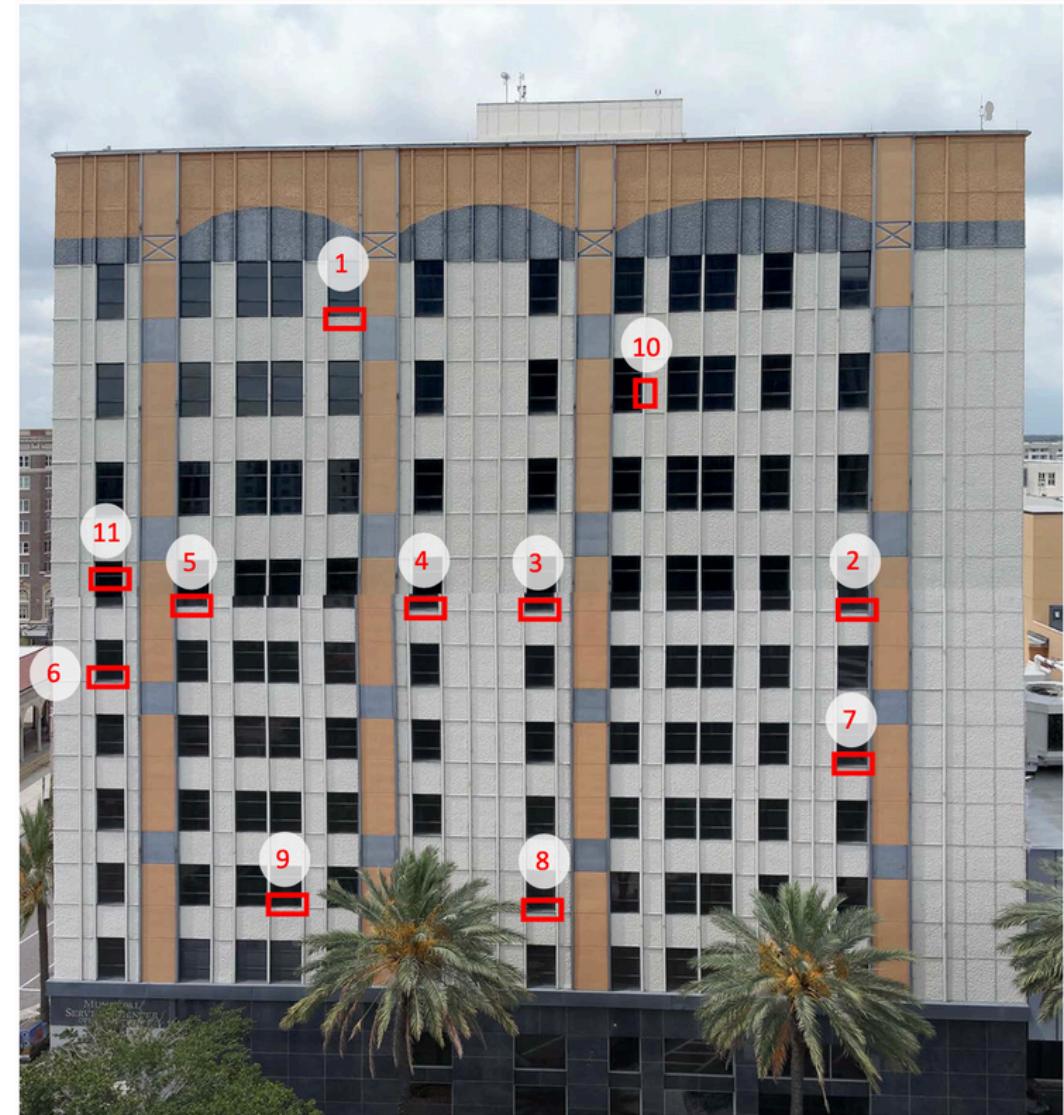
**Location:** South Façade, Window Overview      **Date:** 00/00/0000  
**Comments:** This image index shows the locations of visually observed defects correlated with the windows.

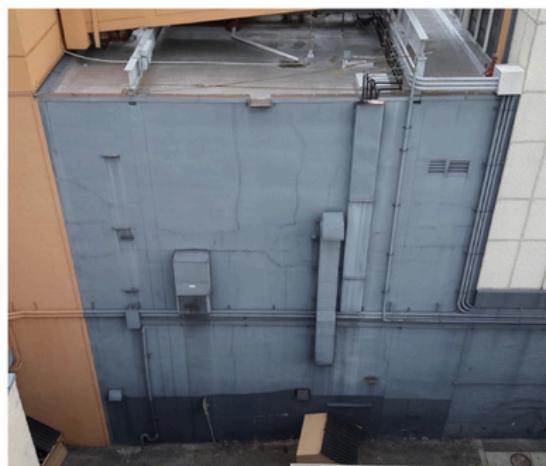
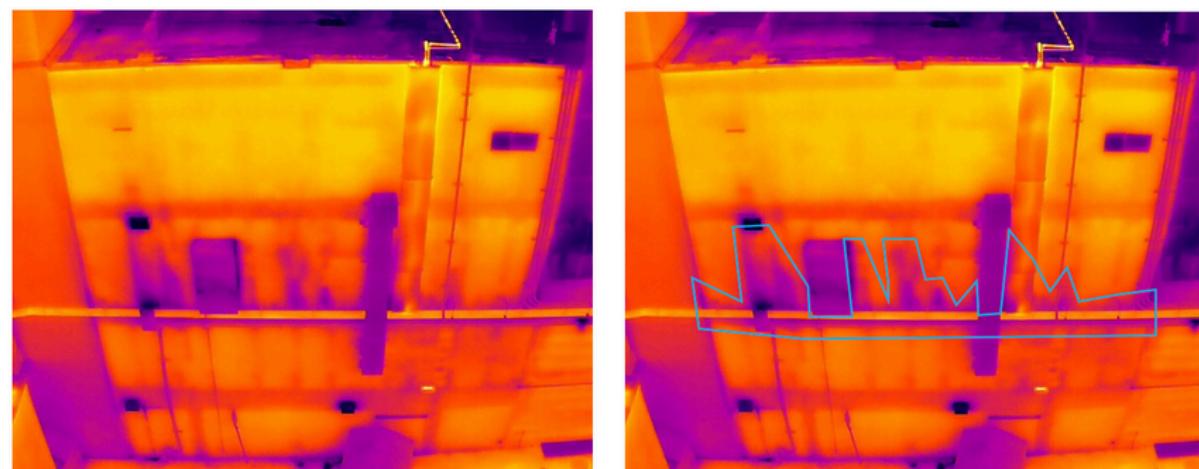
**Image #:** 3      **Job #:** 23-0717      **Date:** 00/00/0000      **Time:** 7:00pm – 7:45pm

**Subject Priority:** 2      **Location:** Grey Section, 1<sup>st</sup> Floor

**Comments:** Suspected moisture.
