Inspection Report for Mr & Mrs Happy Buyers

The structure at 123 Dream Home Ln., Wonderland, SC is a three-story house with Brick Veneer Siding and Stucco Siding .. It is built on a slab. It has an attached garage with three cars capacity. The house faces east, is approximately 14 years old and has approximately 4100 sqft.. It has 3 bedrooms 3 full baths and a half bath.

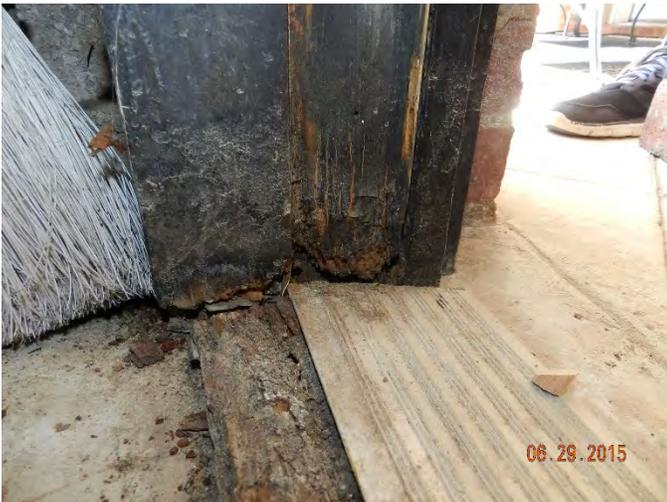
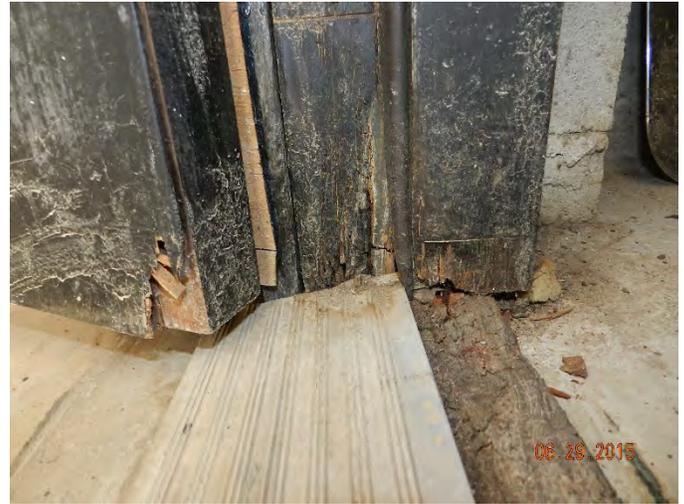
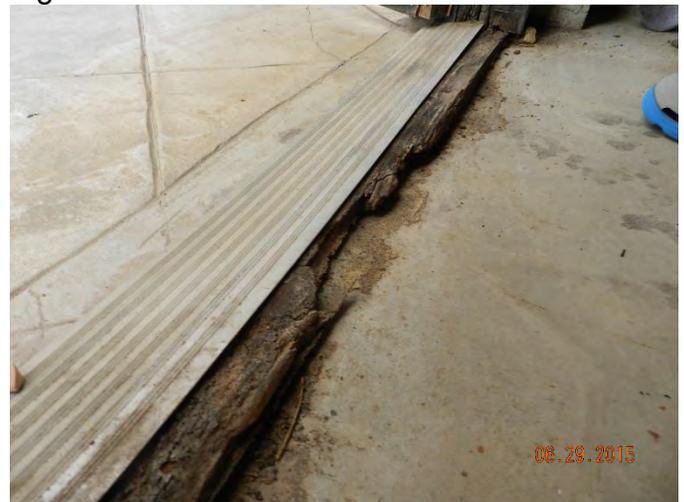
2. THE UNDER THE STAIRWELL EXTERIOR CLOSET DOOR, JAMB AND THRESHOLD HAVE ROT AND DAMAGE. THE THRESHOLD AND DOOR FRAME ARE LOOSE. THE METAL ABOVE THE DOOR IS RUSTING AND THERE ARE SIGNS OF REPEATED WATER INTRUSION. SEE FIGURES 3-5.

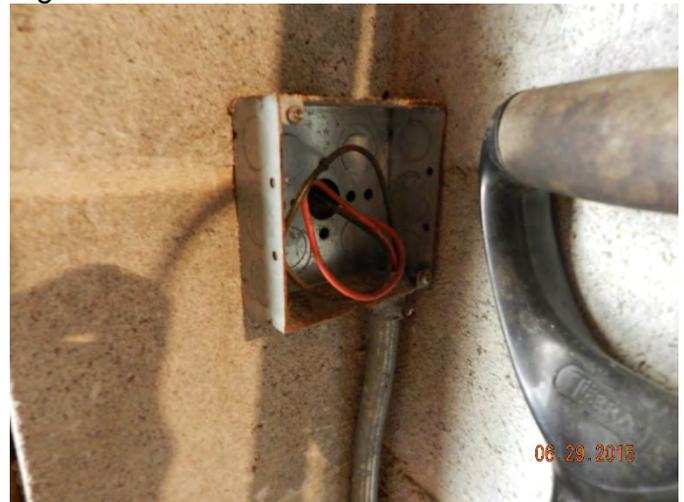
Figure 6

2. IN THE UNDER THE STAIRWELL EXTERIOR CLOSET, THERE IS A WIRING JUNCTION BOX MISSING A COVER. SEE FIGURE 6.
3. IN THE KITCHEN, THE RANGE HOOD DOWNDRAFT EXHAUST VENT BUTTON IS DAMAGED.

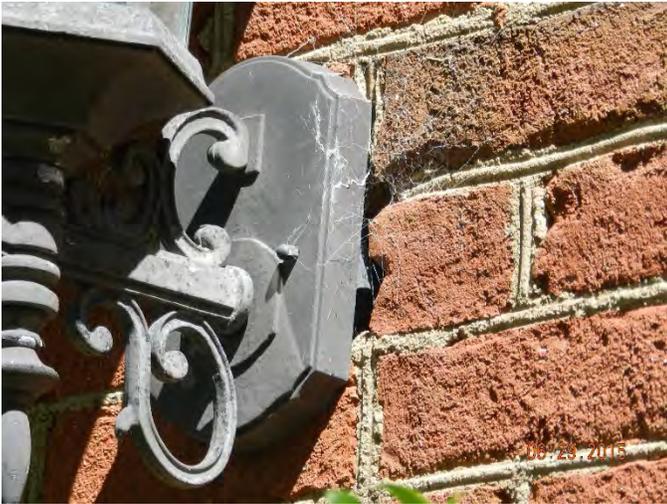
Figure 7

4. THERE ARE GAPS AROUND SEVERAL OF THE EXTERIOR WALLS LIGHTS THAT SHOULD BE SEALED AND A COUPLE OF THE FIXTURES ARE LOOSE AT THE WALLS. SEE FIGURE 7.
5. THE FRONT PORCH MIDDLE FAN IS NOT WORKING AND IS RUSTING.

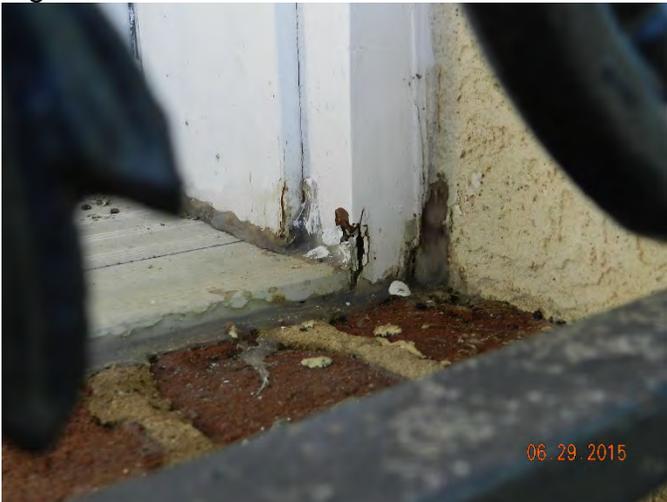
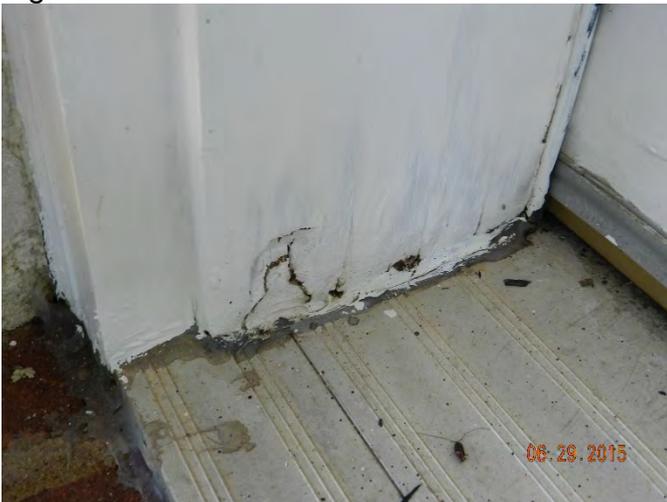
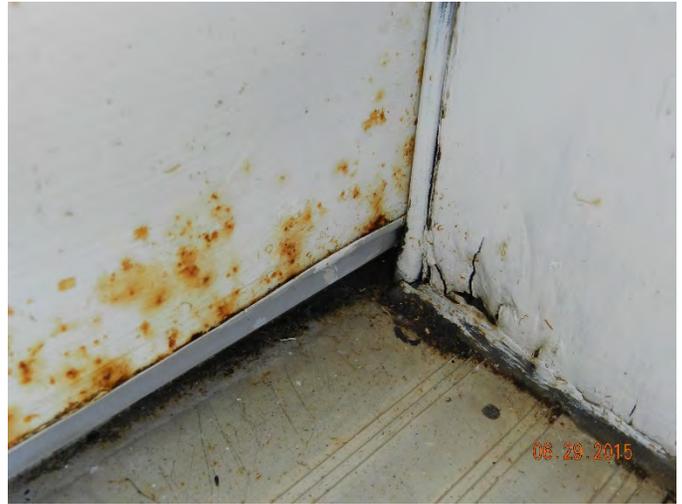
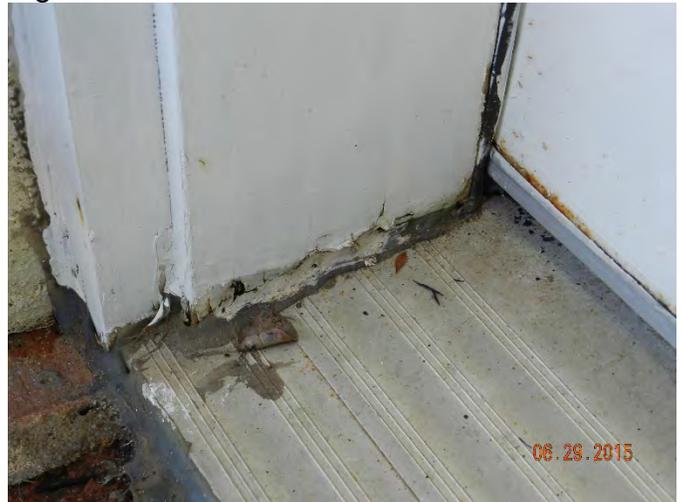
5. THERE IS ROT AND DAMAGE TO BOTH LOWER LEVEL LEFT SIDE DOOR JAMBS. SEE FIGURES 8-11.

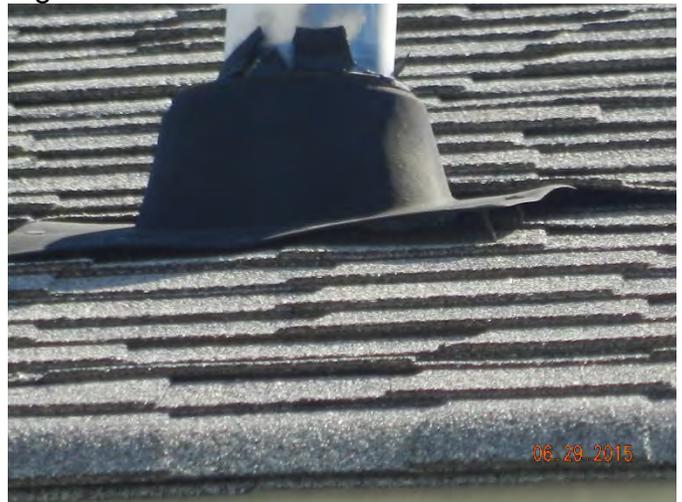
Figure 12

1. THE SHINGLES APPEAR TO BE ORIGINAL AT 17 YEARS OLD AND HAVE NORMAL WEATHERING FOR THIS AGE. TYPICAL LIFE EXPECTANCY IS 20-25 YEARS.
2. THE MAIN LEVEL RIGHT REAR CORNER SHINGLE CAP IS DAMAGED. SEE FIGURE 12 .

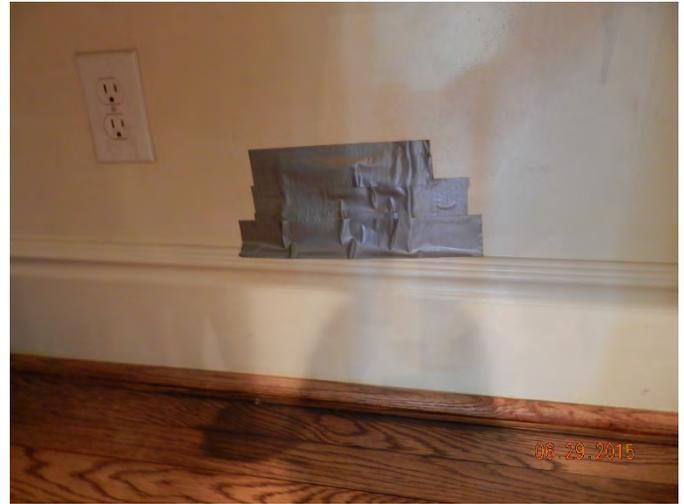
Figure 16

1. THERE IS A HOLE IN THE KITCHEN PANTRY RIGHT WALL THAT IS DUCT TAPED OVER. SEE FIGURE 16.
2. SEVERAL DOORS DO NOT HAVE DOORSTOPS OR THEY ARE DAMAGED..

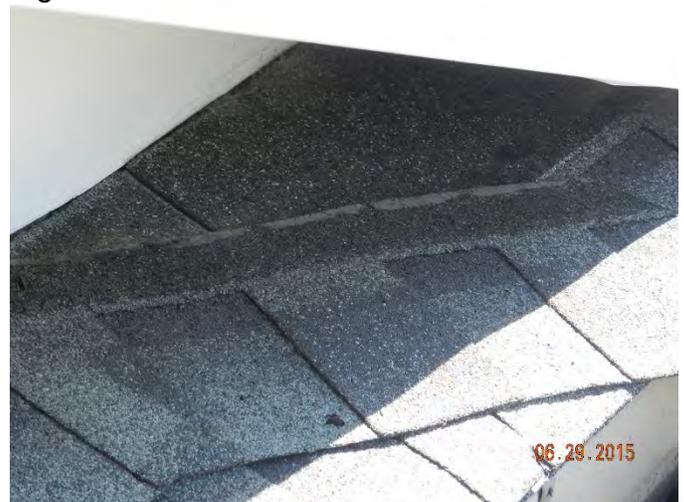
Figure 17

10. THE FLASHING IS LOOSE AND SEPARATED FROM THE HOUSE AT THE FRONT LEFT CORNER OF THE MASTER BEDROOM. SEE FIGURE 18.
11. THERE IS A LOOSE SHINGLE TAB OVER THE FLASHING OF THE SKIRT ROOF AT THE LEFT END OF THE FRONT PORCH ROOF AS VISIBLE FROM THE MASTER BEDROOM BALCONY. SEE FIGURE 17.

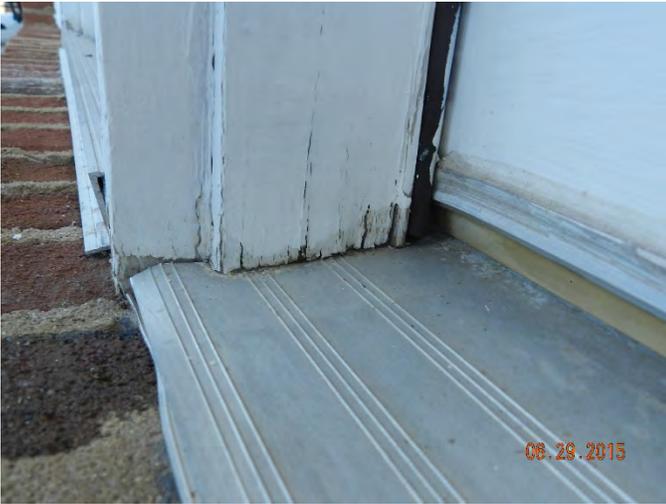
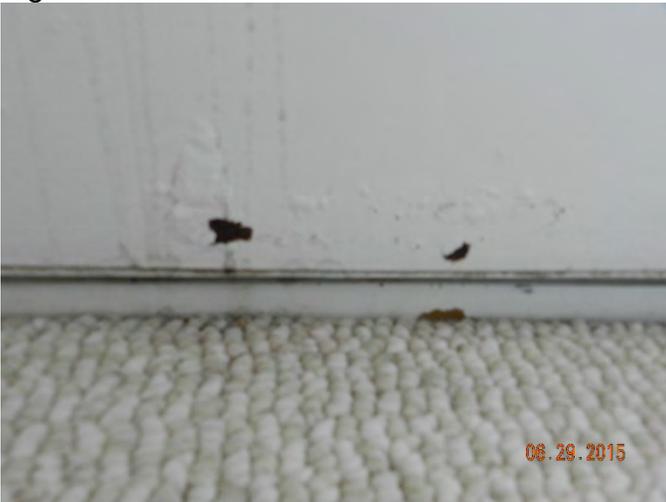
7. THERE IS ROT AND DAMAGE TO THE DOOR JAMB OF THE FRONT DOOR OF THE MASTER BEDROOM BALCONY AND THE 3<sup>RD</sup> BALCONY DOOR IS RUSTING. SEE FIGURES 19 & 20.

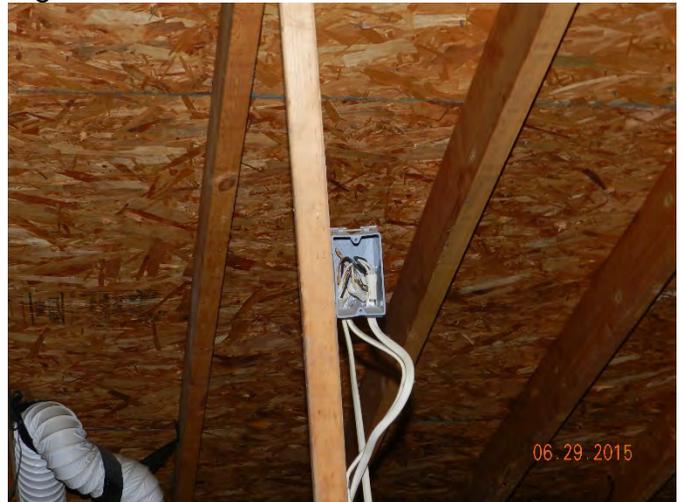
Figure 23

6. IN THE ATTIC, THERE IS A WIRING JUNCTION BOX MISSING A COVER. SEE FIGURE 23.
7. THE UPSTAIRS LINEN CLOSET BY THE ELEVATOR HAS A LIGHT, BUT NO LIGHT SWITCH WAS LOCATED TO OPERATE IT.

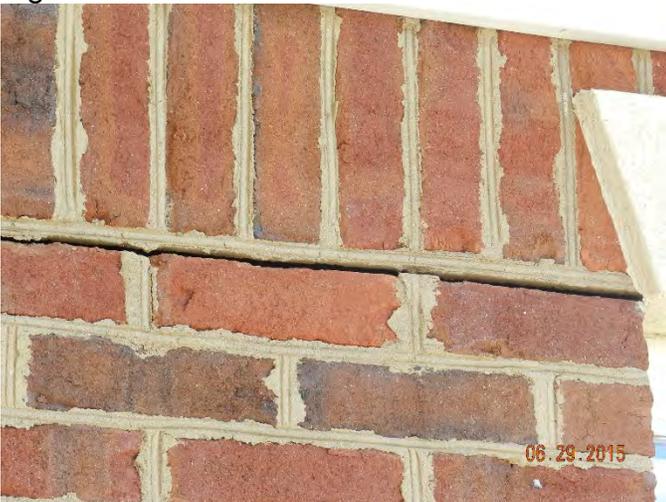
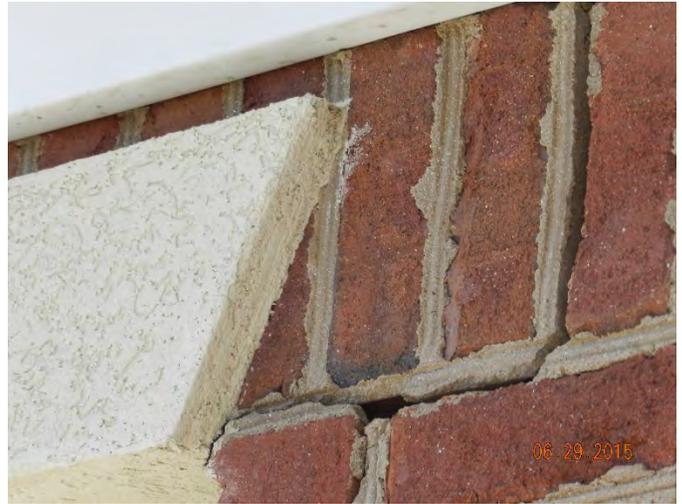
8. THERE ARE A COUPLE OF LARGE SETTLING CRACKS OVER THE UPSTAIRS HALL BATHROOM WINDOW AND THE UPSTAIRS HALL WINDOW. THE CORNER APPEARS TO HAVE DROPPED DOWN BETWEEN THESE 2 AREAS. SEE FIGURES 21 & 22.

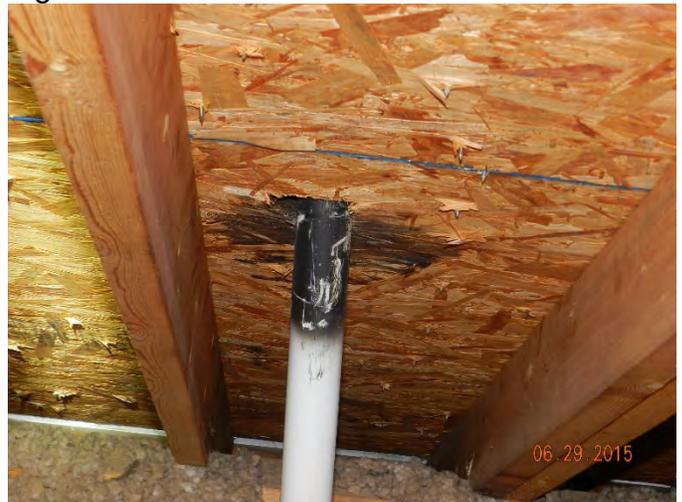
Figure 24

6. ALL OF THE REAR ROOF VENT PIPE BOOTS ARE SPLIT AND ONE IS RAISED AT THE SHINGLES. THIS IS A LEAK ISSUE. IN THE ATTIC, THERE IS STAINING AND MINOR DAMAGE AROUND THE VENT PIPE BOOTS. SEE FIGURE 24.

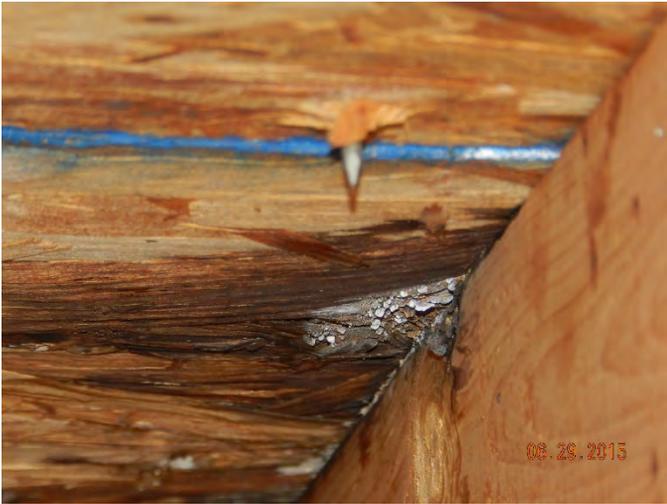
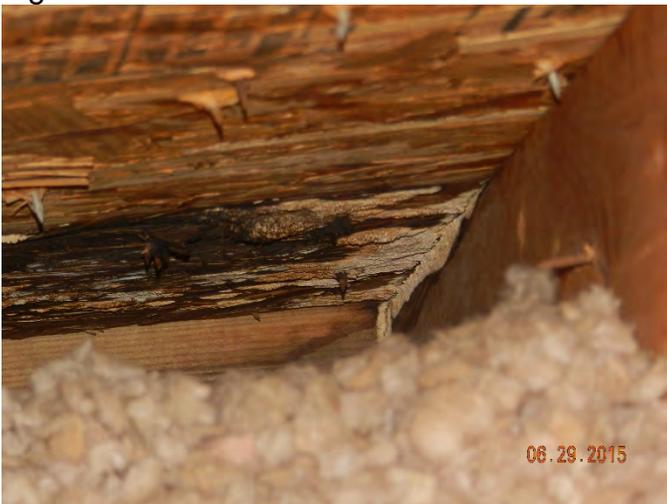
9. IN THE LEFT FRONT OF THE ATTIC, THERE IS STAINING AND DAMAGE IN A COUPLE AREAS. SEE FIGURES 25 & 26.
10. IN THE ATTIC, THE ELEVATOR SHAFT IS NOT ENCLOSED PROPERLY AT THE TOP. THIS IS A FIRE CHASE SAFETY ISSUE. SEE FIGURE 27.

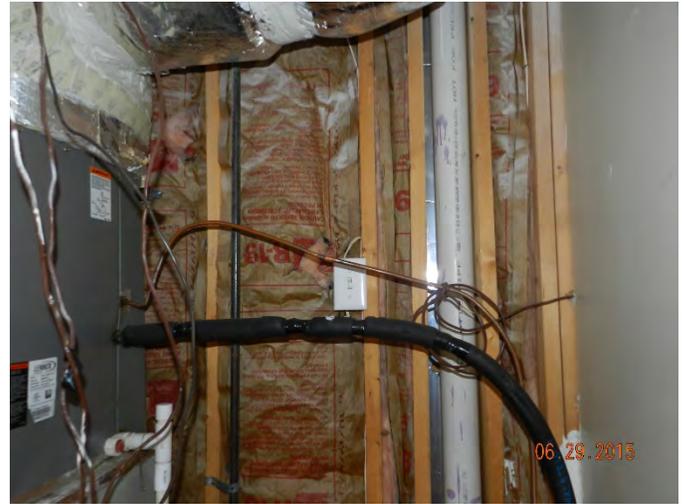
Figure 28

11. IN THE BASEMENT UTILITY ROOM, THERE ARE INSULATION BATTS INSTALLED WITH THE PAPER FACING EXPOSED. THIS IS A FIRE SAFETY ISSUE. SEE FIGURE 28.
12. IN THE BASEMENT UTILITY ROOM IN THE MAIN ELECTRICAL PANELS, THERE ARE GAPS MISSING KNOCKOUTS, AND GAPS AROUND INCOMING WIRING MISSING GROMMETS. SEE FIGURES 29 & 30.

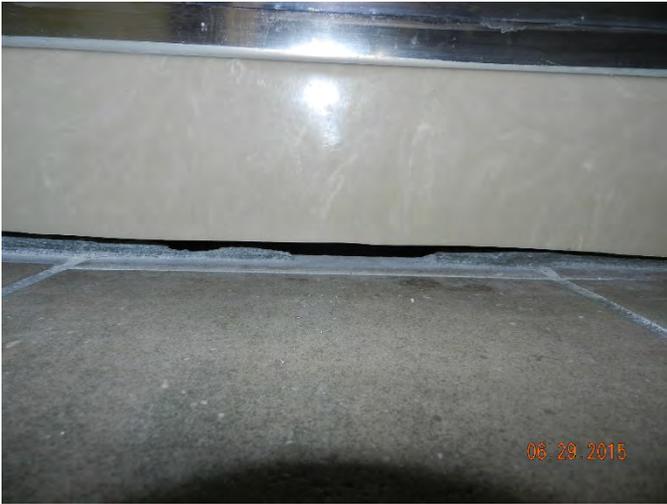
Figure 31

5. IN THE UPSTAIRS HALL BATHROOM, THE CAULKING IS MISSING / DETERIORATED AROUND THE SINK COUNTERTOP AT THE BACK SPLASH PANEL AND AT THE WALL.
6. IN THE DOWNSTAIRS BATHROOM, THE SINK STOPPER IS DISCONNECTED, THE CAULKING IS DETERIORATED AROUND THE SINK AT THE COUNTERTOP, THE SINK COUNTERTOP SHOULD BE SEALED WHERE IT MEETS THAT WALL AND AT THE COUNTERTOP, AND THERE IS AN EXCESSIVE GAP BETWEEN THE SHOWER THRESHOLD AND THE FLOOR. SEE FIGURE 31.
