**PRIYA BLUE**  
Trusted Globally. Recycling Sustainably

# **INCIDENT INVESTIGATION & ENVIRONMENTAL RESPONSE REPORT**

ESCAPE OF HYDROCARBONS FOLLOWING CONTACT OF A VESSEL  
WITH AN ADJACENT BARGE-CRANE STRUCTURE

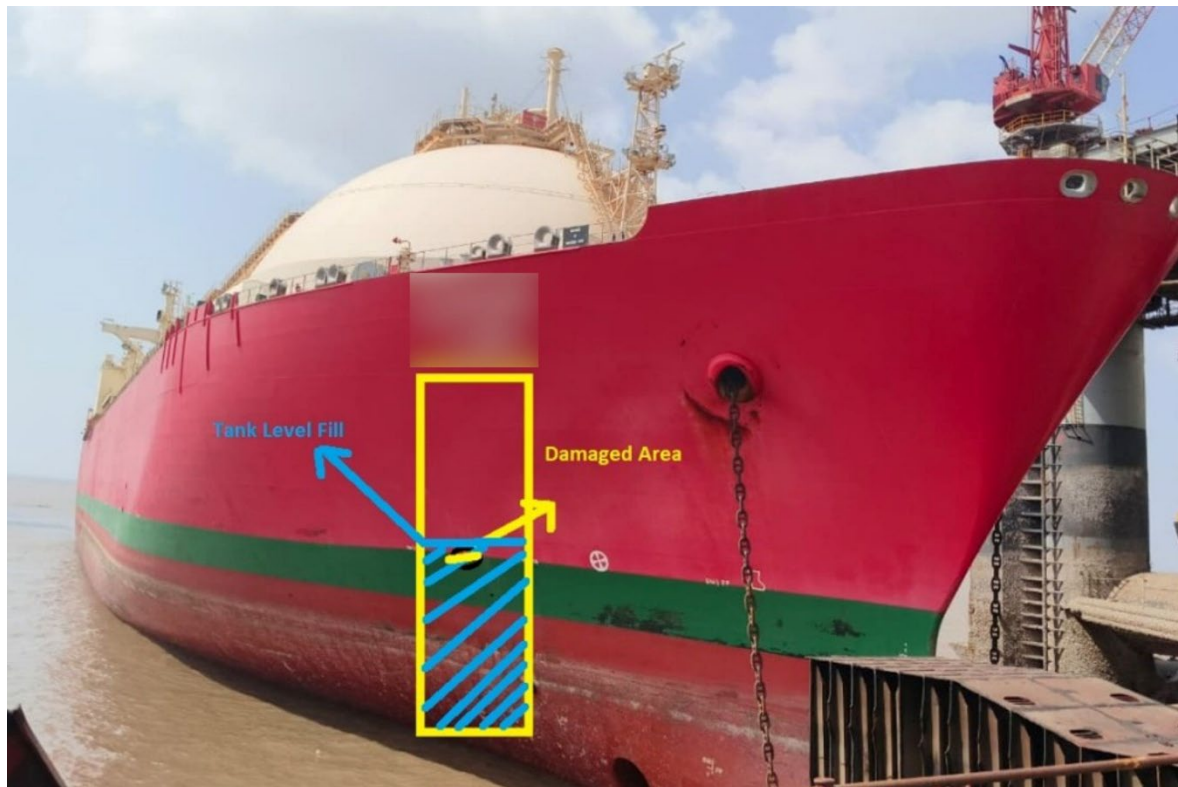
Localized structural damage to the forward starboard fuel oil tank, with a horizontal crack developing in the tank plating;

*Vessel at the Alang facility, with the affected forward section identified during the third-party survey.*

The immediate cause was contact between the forward starboard section of the vessel and the structure of an adjacent barge crane, in the way of the fuel oil tank forward of the collision bulkhead, so in the area of single skinned hull, during a period of exceptionally strong (new moon spring) tidal movement.

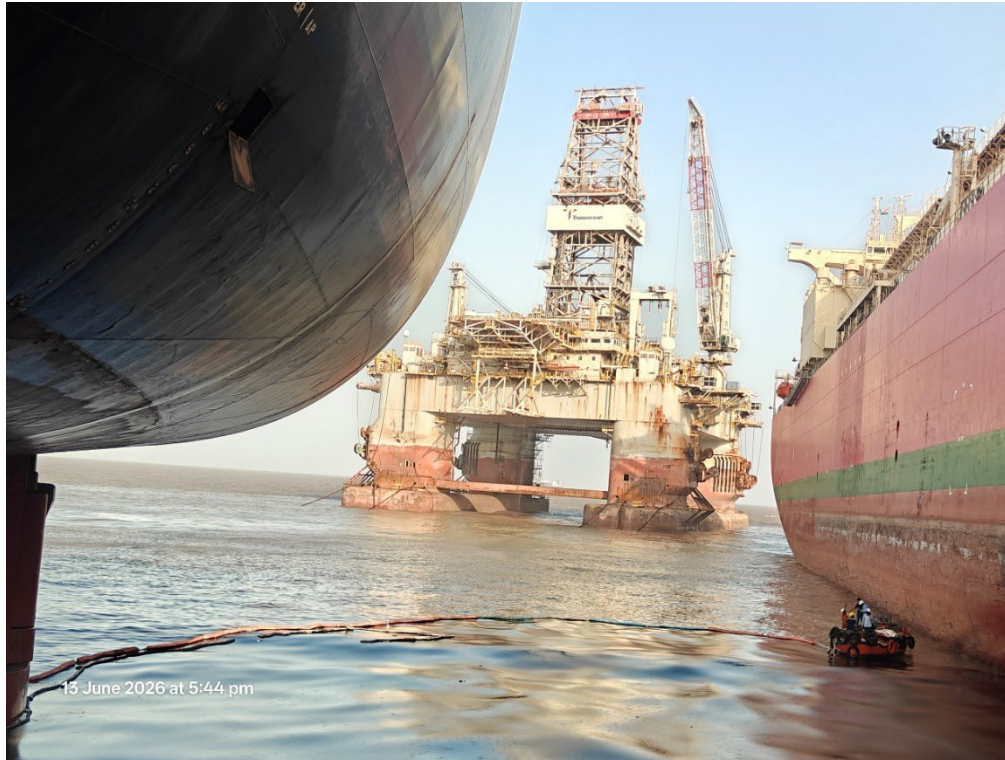
Image description: Deployment of the oil boom in the sea with the help of boats at the aft side of the spillage.

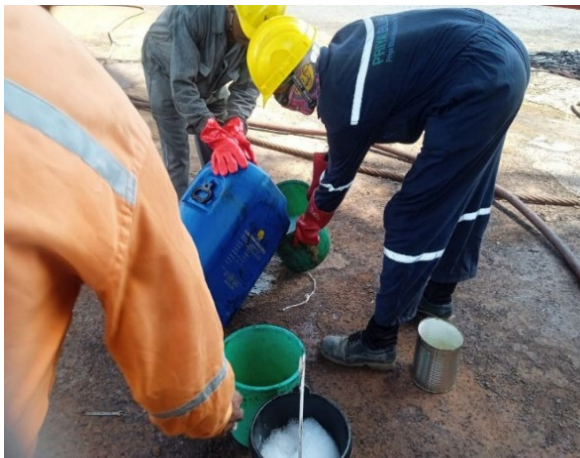
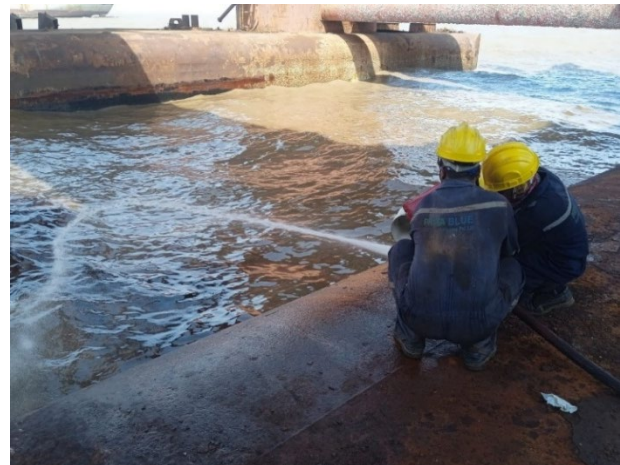
Image description: Foam sprayed on the spillage nearby the ship to prevent any fire

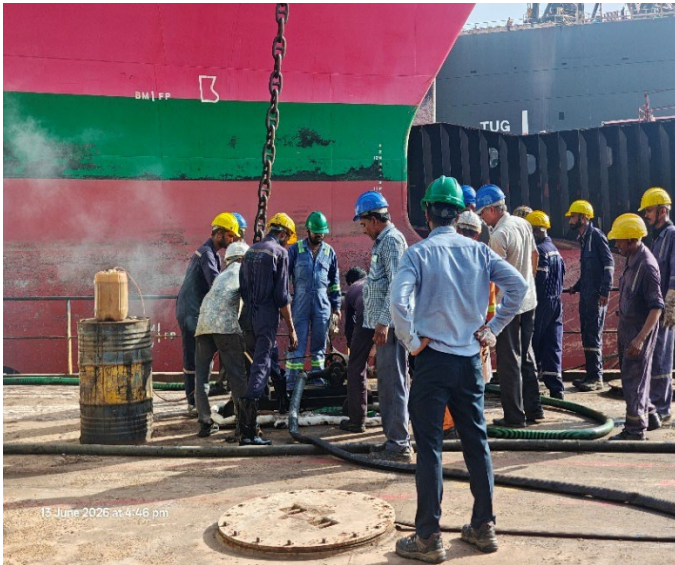
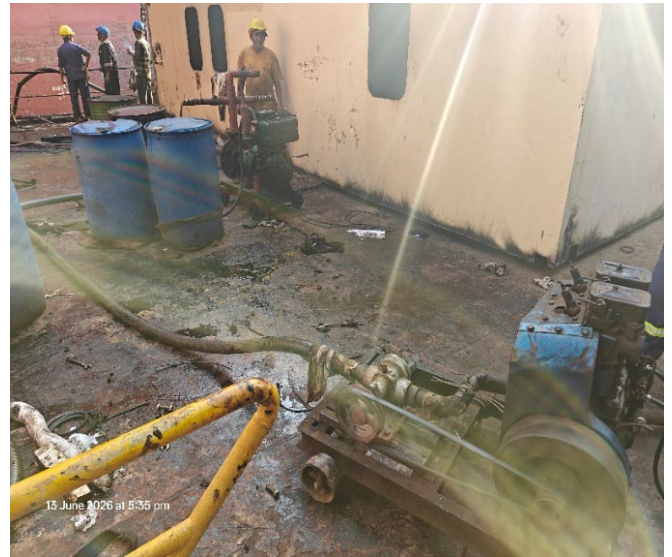
Setting up oil removal pumps and started transferring oil from the pontoon to the barge's empty tanks.

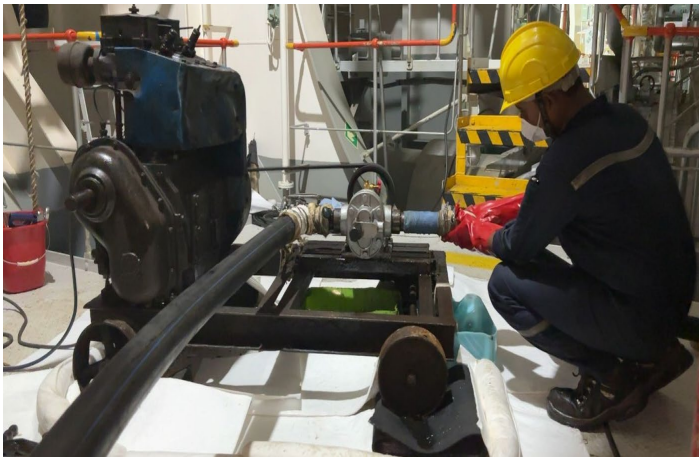
Deploying oil transfer engine pumps on a vessel to transfer oil from damaged tank to tankers directly

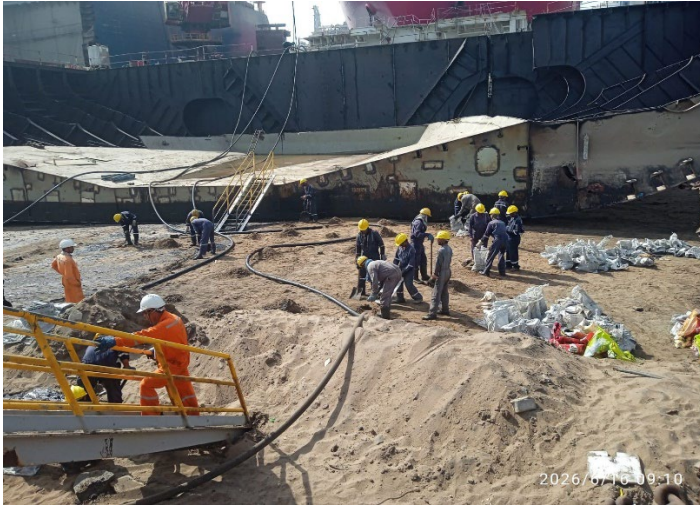
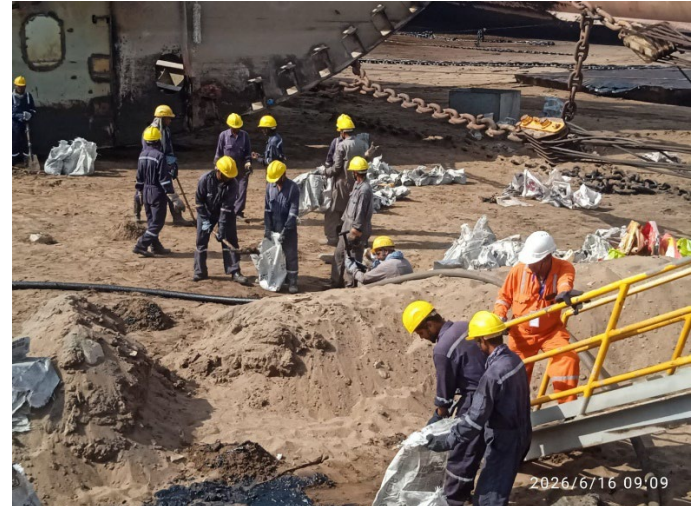
During low tide, collection of contaminated sand from the affected areas of the intertidal zone.

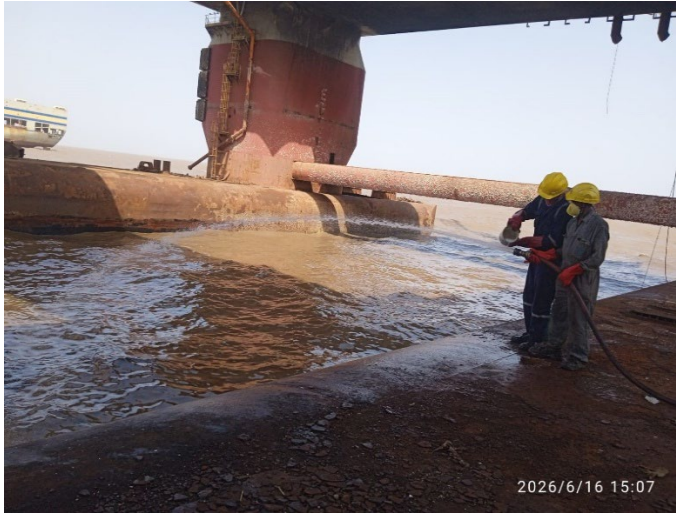
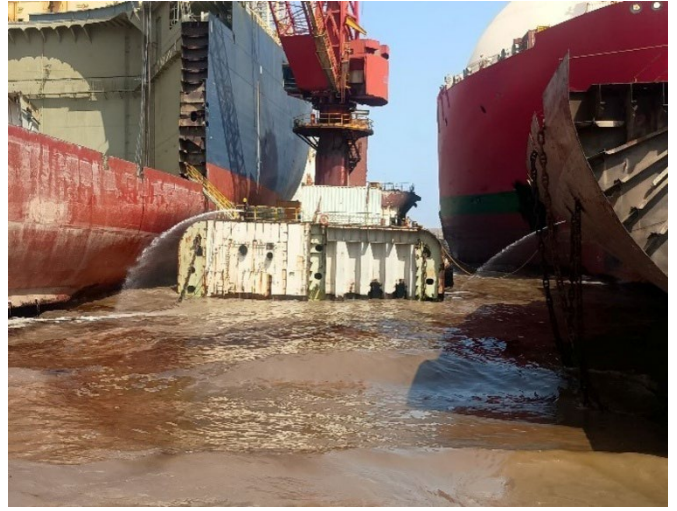
Spraying Oil Spill Dispersant Type III/II for efficiently combating oil spills during high tide

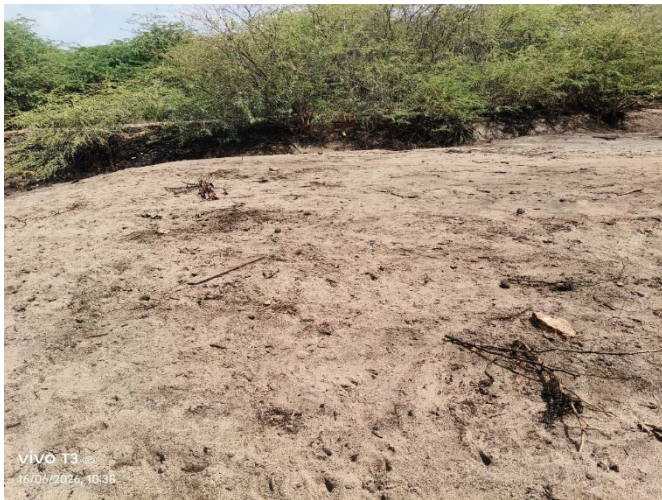
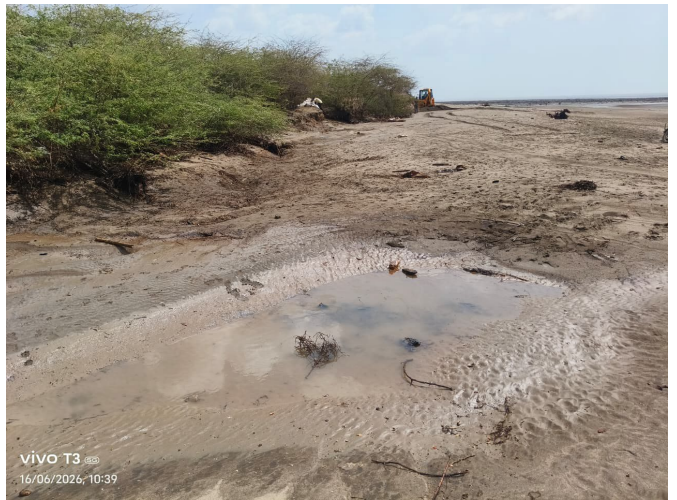
Cleaning of nearby affected areas.

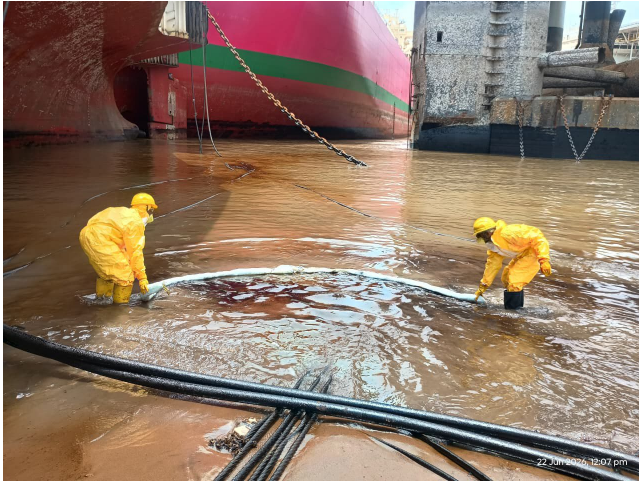
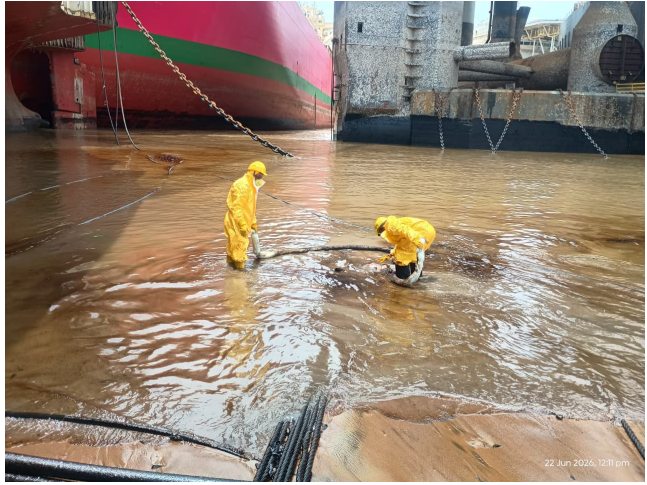
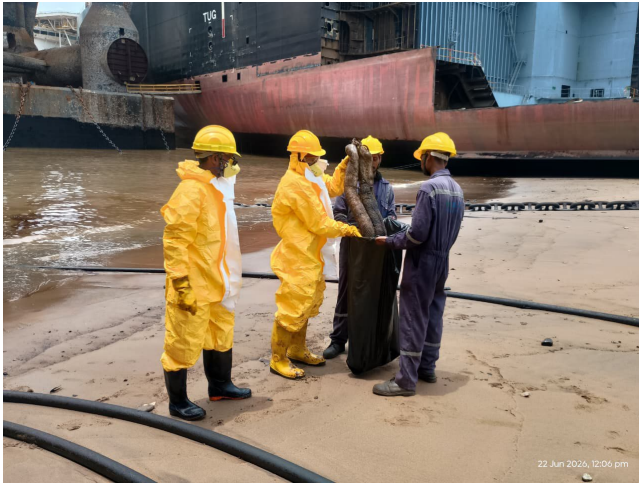
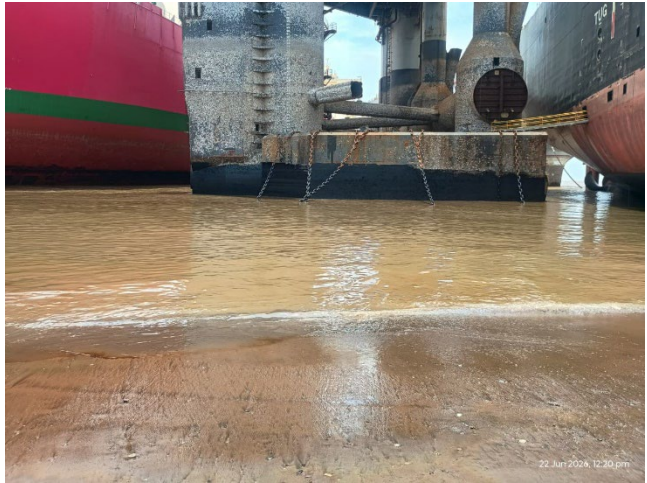
Cleaning with Pads and Booms.
