MRUT SIZING AXIAL: DEFECT DETECTION AND MEASUREMENT OF REMAINING WALL THICKNESS ON PIPES WITH GENERALIZED CORROSION

Arix Technologies sought to evaluate the MRUT SIZING application using VOLTA 2 for their inspection operations. To assess the application's performance, they provided a pipe sample containing conditions commonly encountered in the field, along with four artificial defects designed to challenge remaining wall thickness estimation. The Arix team aimed to confirm that Innerspec's solution could accurately detect and differentiate all four defects while providing a reliable estimate of the remaining wall.

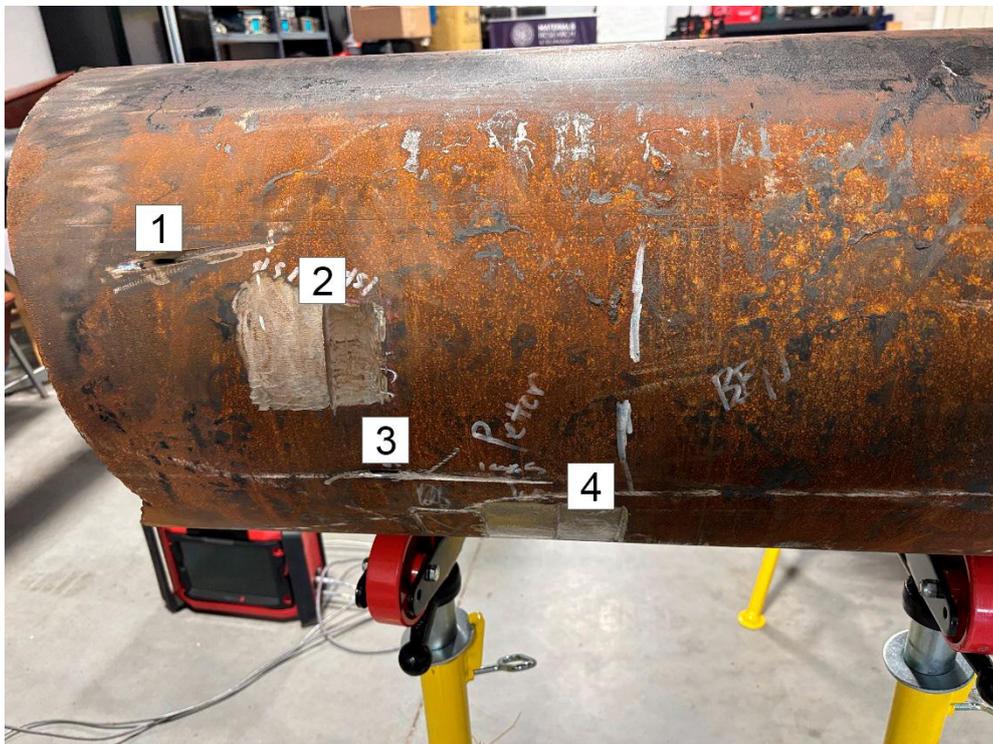
Figure 1. Pipe Sample. Induced Defects.

The sample was a 16-inch OD carbon steel pipe with a 0.250-inch WT and four artificial defects. These defects overlapped both axially and circumferentially, presenting an additional challenge for estimating the remaining wall thickness. The four defects, as shown in Figure 1, consisted of:

- Through-wall hole (1)
- Two-step smooth wall reduction (2)
- Through wall scratch (3)
- Two-step smooth wall reduction (4)

The sample presented general ID corrosion along the full part. This corrosion impeded the propagation of the SH1 (dispersive) mode used for the cutoff-frequency technique. The team hadn't been able to inspect this sample with an instrument that used only the cutoff-frequency technique.

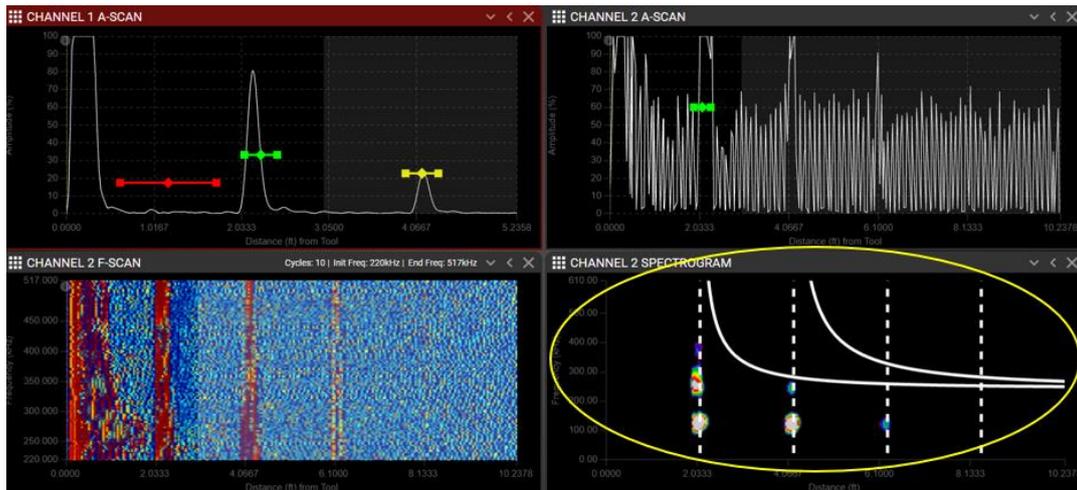
Figure 6. Calibration Screen

At the same 'clean' location, it was observed that the Channel 2 calibration (frequency sweep) had a negligible or non-existent response. Additionally, the baseline of the signal around the pipe was rough, resulting in a grainy B-Scan. This lack of frequency signal indicates that the SH1 wave mode cannot propagate around the pipe, which is a strong sign of internal corrosion. This is a known limitation of the

frequency-cutoff technique, which relies on the dispersive SH1 mode to calculate the remaining wall thickness.

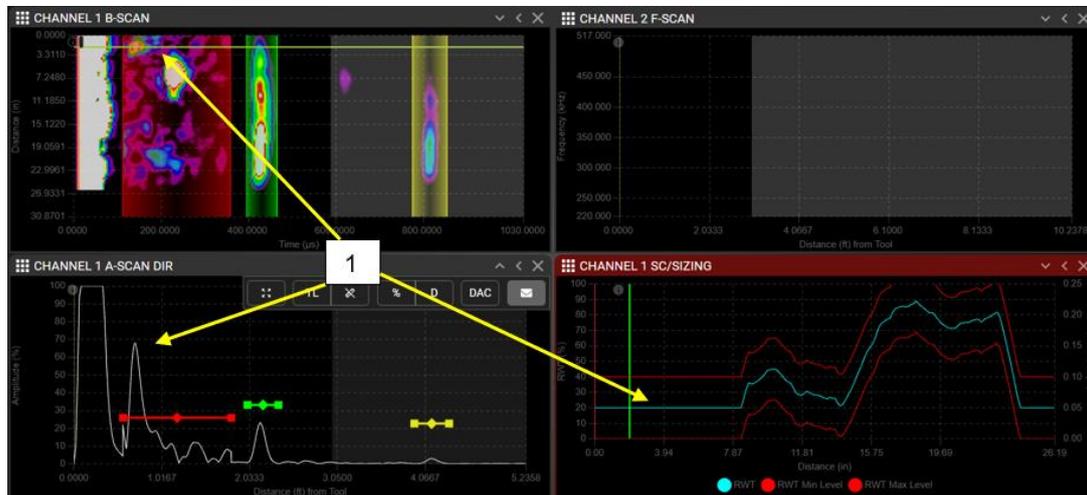
Figure 7. Location of Defect 1 on the Scan.

- Defect 1:
 - Axial location: 1.5" from the beginning of the scan.
 - Circumferential location: 7.2" from the strip location.

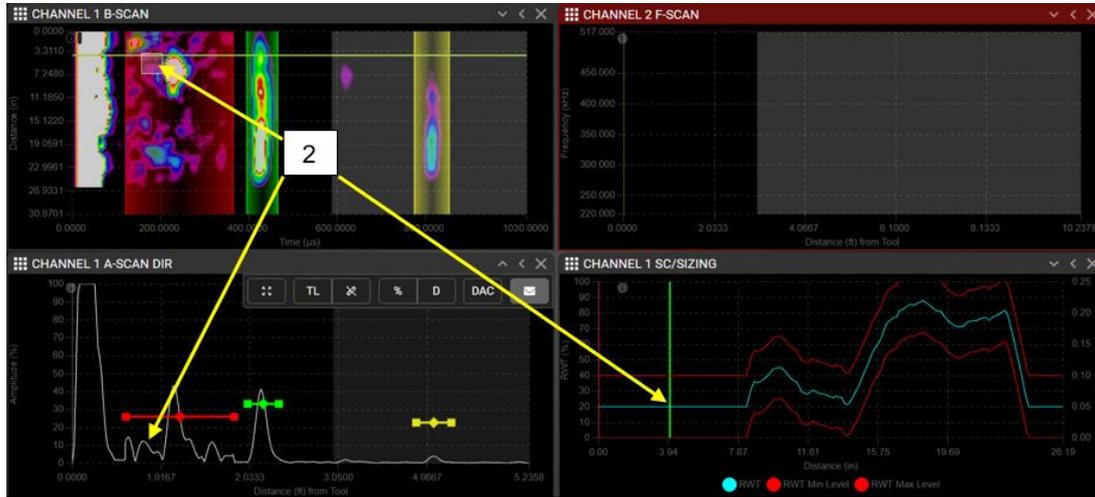
Figure 8. Location of Defect 2 on the Scan.

- Defect 2:
 - Axial location = between 3.6" to 6.6".
 - Circumferential location: 9.5".

This defect is in very close proximity to the larger defects (1 and 3), which partially masks the results; however, it remains clearly visible in both the A-scan and B-scans.

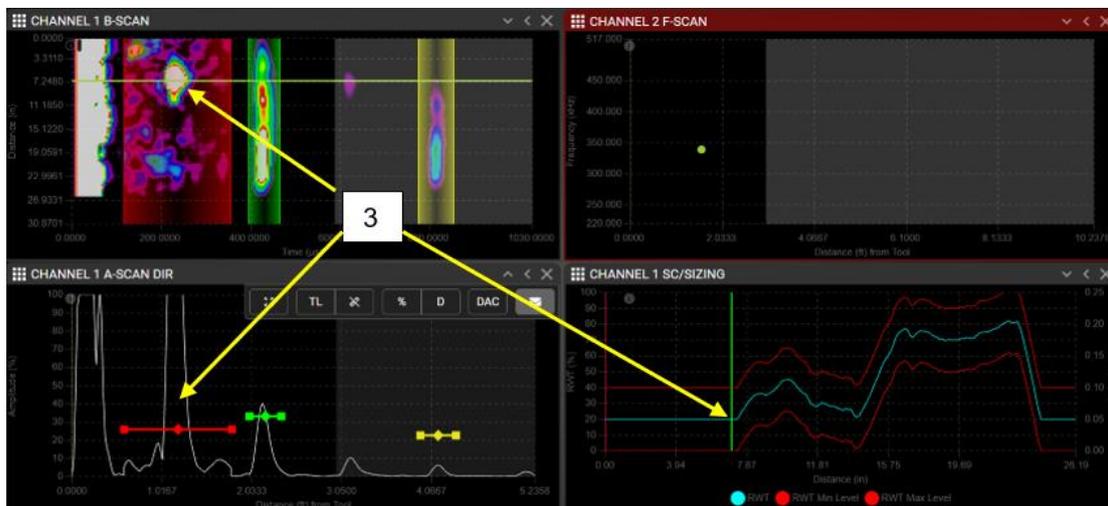
Figure 9. Location of Defect 3 on the Scan.

- Defect 3:
 - Axial location: 7".
 - Circumferential location: 12".
 - Between the 7.4" and 13.5" axial positions, Defect 3 begins to decrease, overlapping Defect 4 until approximately the 10" position. From 10" to 13.5", a reduction in the amplitude of the wrap-around indications is observed. The algorithm estimates the remaining wall in this area to be 30%–40%.
