**SERVICE BULLETIN No. Harmony LSA-044a**

**SAFETY ALERT**

- 1. CONCERNING:** All Harmony LSA aircraft up to S/N 2025 2307 inclusive.
- 2. REASON:** Foot control pedal assembly without a weld reinforcement on countershaft may have been installed in some of the Harmony LSA aircraft.

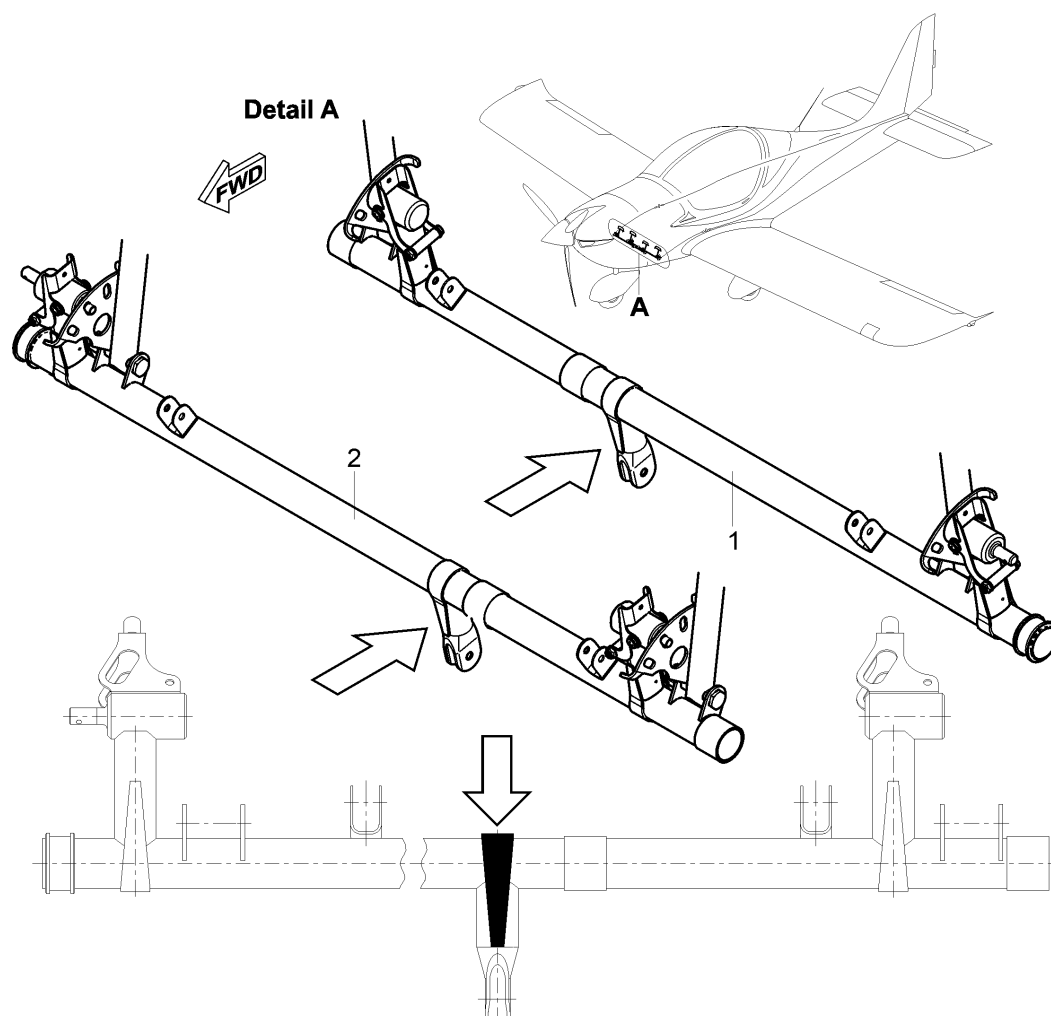
**Fig. 1** Locations of pedal assembly welded reinforcements

- 3.1.1 Examine whether both foot pedal control assemblies (P/N S4 72-01 01/02 or S4 70-02 01/02, if installed) include the weld reinforcement on the welded connection of countershaft tube (1, 2, Fig. 1) and lever. See Fig. 1 and Fig. 2 for welded reinforcement locations.
- 3.1.2 If the weld reinforcements are missing, take a photo of affected part(s) and report the inspection results to the manufacturer by submitting an Aircraft Occurrence Technical Report, including the photos of the affected part(s).
- 3.1.3 If the weld reinforcements are missing, replace the original countershafts of the foot control pedal assembly with the new countershafts with the weld reinforcement (P/N S4 72-01 01/02 or S4 70-02 01/02) in accordance with Work procedure para. 3.2 and 3.3.

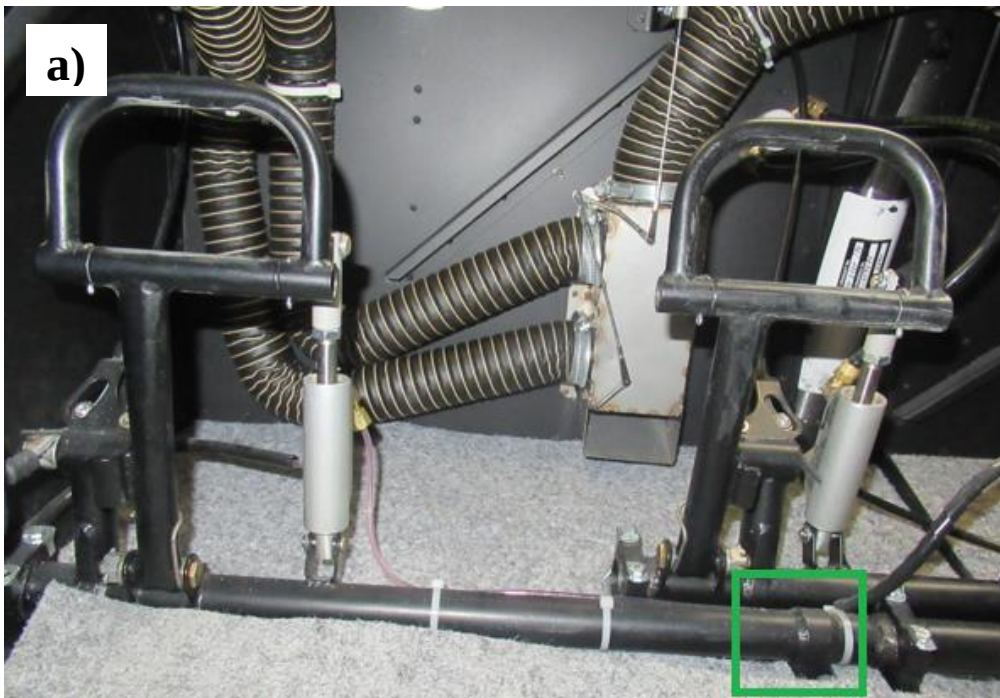
**Fig. 2 (a+b)** Detail of Countershaft Left with/without the weld reinforcement

**a)** Countershaft tube and lever welded connection with the weld reinforcement (green square)

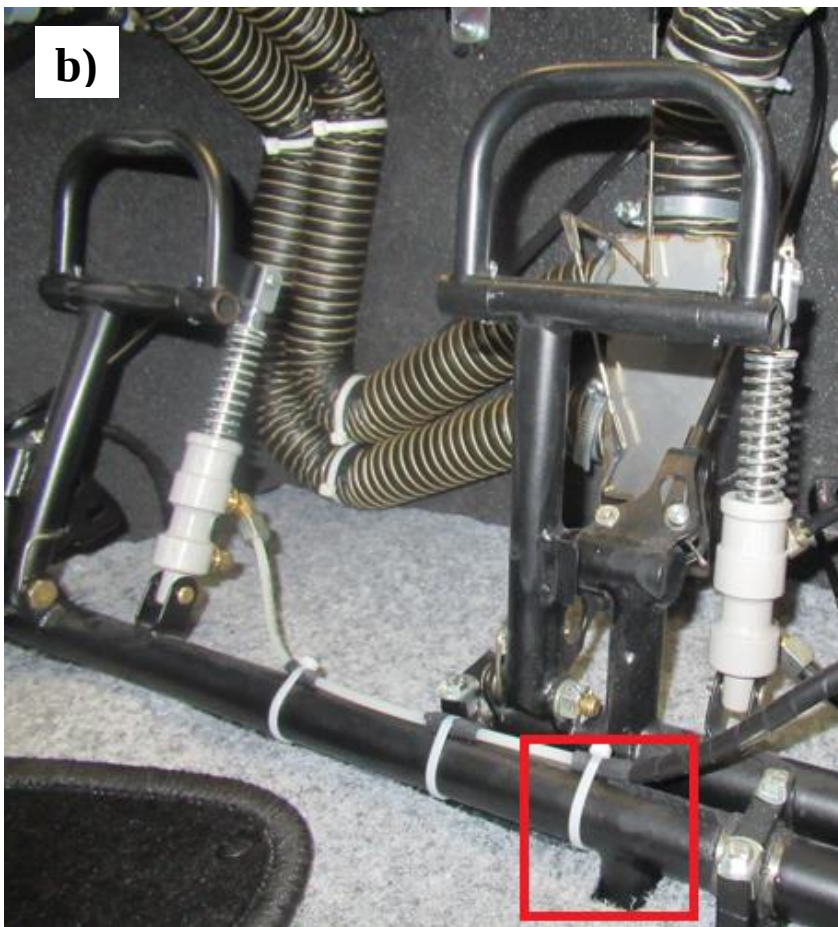
2. If the weld reinforcement is missing, examine the welded connection of the countershaft tube and the lever for cracks.
  3. If the weld reinforcement is missing, replace the original countershaft (P/N S4 72-01 01/02 or S4 70-02 01/02, if installed) with the new countershaft with the weld reinforcement, in accordance with the work procedure of this bulletin.

**b)** Countershaft tube and lever welded connection without the weld reinforcement (red square)

Make sure you use the correct countershaft as replacement. Identify the P/N of the original countershaft without the weld reinforcement and use the new countershaft with the weld reinforcement, and with the same P/N as the original countershaft, as replacement:
