*issues***MANDATORY BULLETIN No. Harmony-006a**

- 1. CONCERNING:** All Harmony aircraft up to S/N 2025 2252 inclusive.
- 2. REASON:** Foot control pedal assembly without a weld reinforcement on countershaft may have been installed in some of the Harmony aircraft.

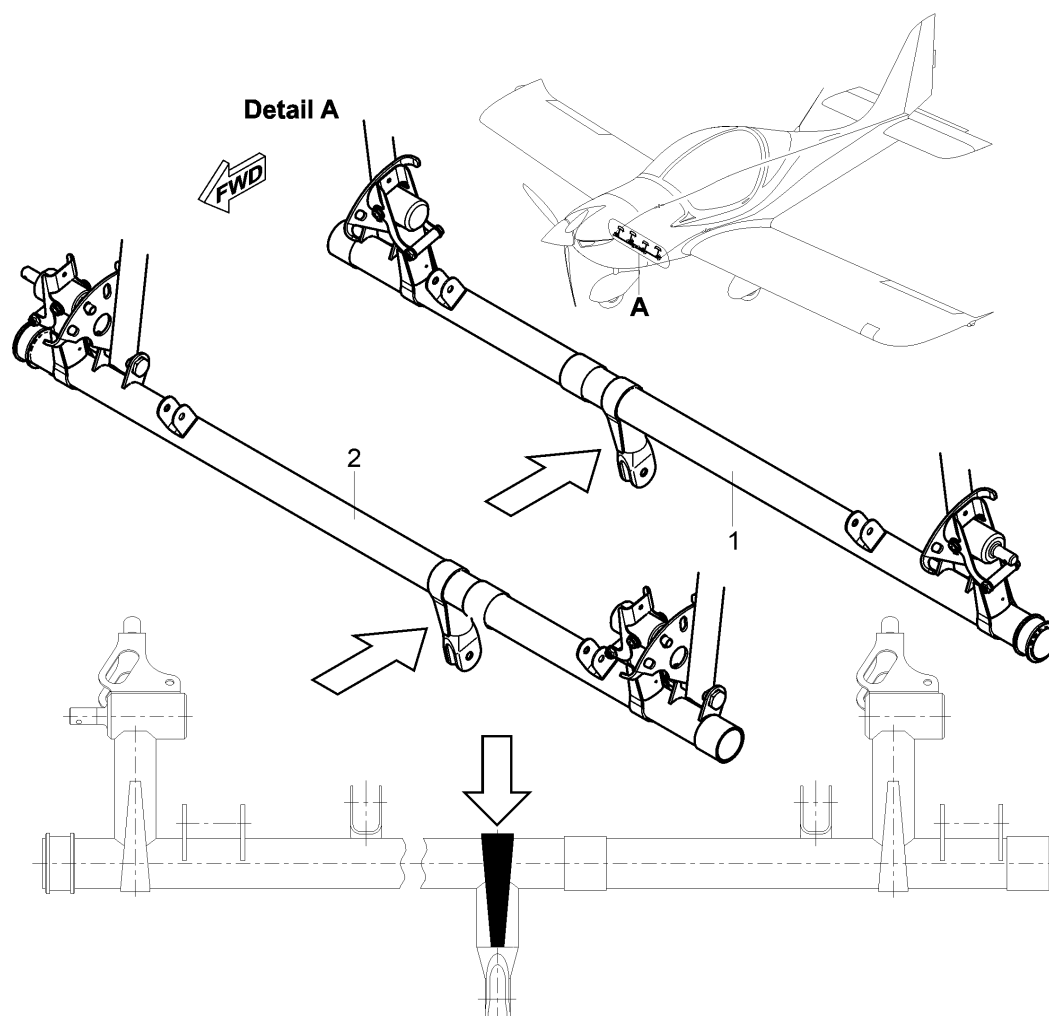
- 3.1.1 Examine whether both foot pedal control assemblies (P/N S4 72-01 01/02 or S4 70-02 01/02, if installed) include the weld reinforcement on the welded connection of countershaft tube (1, 2, Fig. 1) and lever. See Fig. 1 and Fig. 2 for welded reinforcement locations.
- 3.1.2 If the weld reinforcements are missing, take a photo of affected part(s) and report the inspection results to the manufacturer by submitting an Aircraft Occurrence Technical Report, including the photos of the affected part(s).
- 3.1.3 If the weld reinforcements are missing, replace the original countershafts of the foot control pedal assembly with the new countershafts with the weld reinforcement (P/N S4 72-01 01/02 or S4 70-02 01/02) in accordance with Work procedure para. 3.2 and 3.3.

Fig. 1 Locations of pedal assembly welded reinforcements

2. If the weld reinforcement is missing, examine the welded connection of the countershaft tube and the lever for cracks.
 3. If the weld reinforcement is missing, replace the original countershaft (P/N S4 72-01 01/02 or S4 70-02 01/02, if installed) with the new countershaft with the weld reinforcement, in accordance with the work procedure of this bulletin.

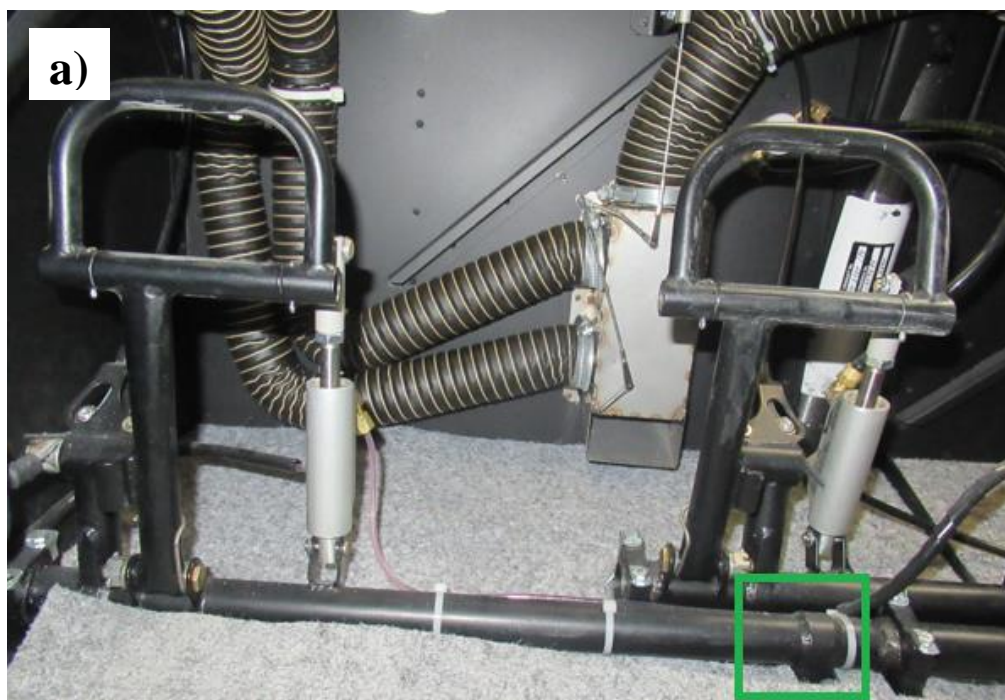
a) Countershaft tube and lever welded connection with the weld reinforcement (green square)

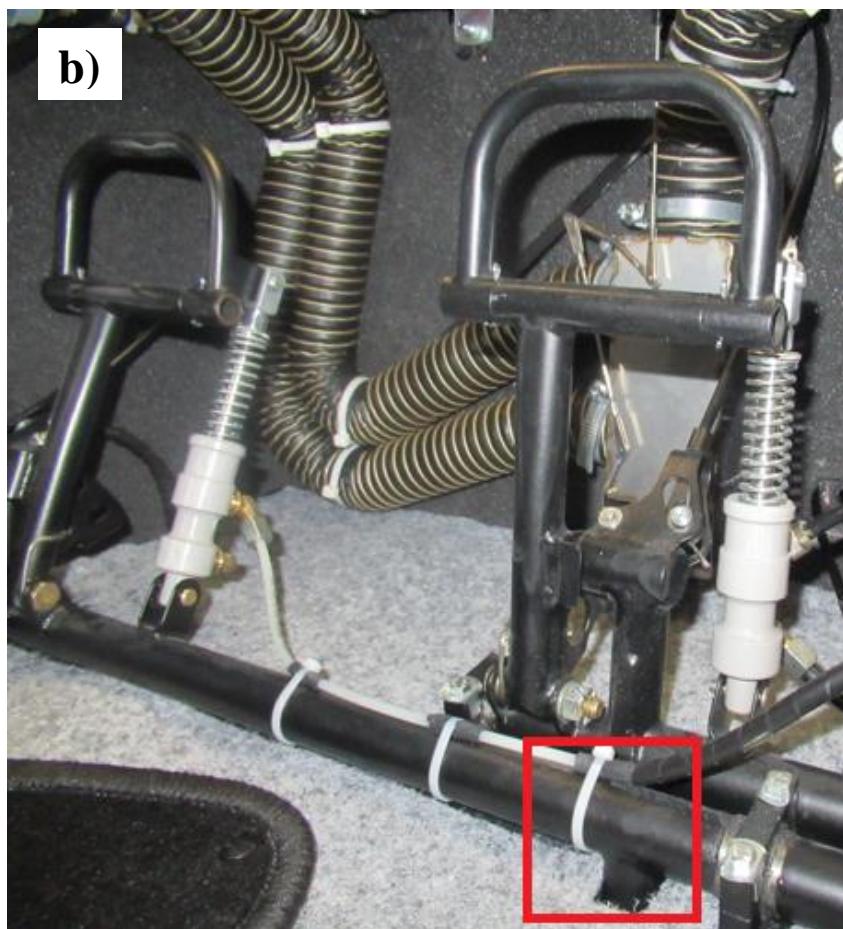
- 3. REQUIRED ACTIONS:**
1. Visually inspect the foot control pedal assembly. Examine whether the countershaft (left/right) includes the weld reinforcement (Affected Part: P/N S4 72-01 01/02 or S4 70-02 01/02, if installed).

b) Countershaft tube and lever welded connection without the weld reinforcement (red square)

Fig. 2 (a+b) Detail of Countershaft Left with/without the weld reinforcement

- If the weld reinforcement is missing and the cracks occurred on the welded connection of the countershaft tube and the lever, replace the countershaft immediately upon issue of this bulletin.
