MANDATORY BULLETIN No. RTC-080a – R1 - SR SAFETY RELATED

1. CONCERNING TO: All Sport Star RTC aircraft

2. REASON: Consistently performing a pre-flight inspection in the engine

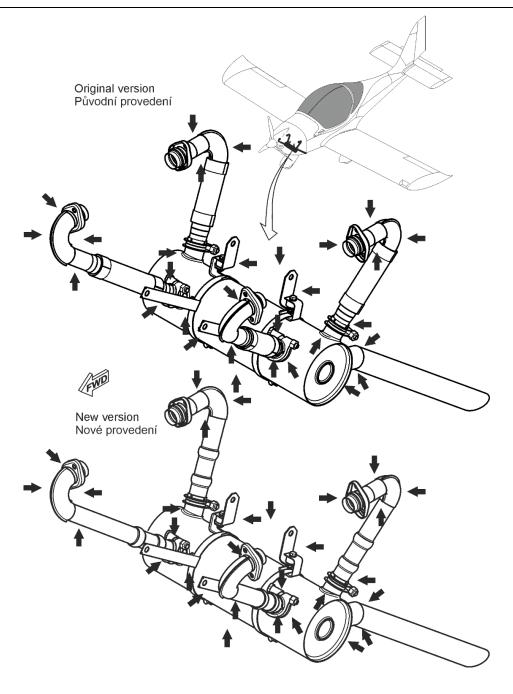
Fig. 1 Checked exhaust system locations.

- 1.3.1 As part of pre-flight preparation, dismantle the upper and lower engine cowlings according to MM Sport Star RTC Chapter 71, paragraph 71-10.
- 1.3.2 Inspect the entire exhaust system, focusing on the formation of cracks on the individual exhaust manifolds, the outer surface of the muffler and the exhaust outlet pipe see Fig.1.

Next, inspect the exhaust mounting brackets and brackets – see Fig.1.

- a) Cracks in exhaust elbows
- b) Cracks in exhaust manifolds to muffler
- c) Cracks in muffler manifold inlets
- d) Cracks in muffler cylindrical casing and side circular walls
- e) Cracks in muffler exhaust outlet pipe
- f) Cracks in exhaust brackets and brackets (front and rear)

If damage is found to any part of the exhaust system, immediately inform the aircraft manufacturer and replace the defective part of the exhaust system.

- 1.3.3 When replacing a defective part of the exhaust system, follow the instructions in MM Sport Star RTC, Chapter 78, paragraph 78-20.
- 1.3.4 Install the lower and upper engine covers according to MM SportStar RTC Chapter 71, Paragraph 71-10.
- 1.3.5 The requirement to implement this bulletin is not required if the installed or replaced exhaust system specified in Section 3. Measures of this bulletin for:
- Muffler
- E6 18-10 01 index C or higher
- Exhaust manifolds
- E6 18-23 01 index C or higher
- E6 18-24 01 index C or higher
- E6 18-25 01 index B or higher
- E6 18-26 01 index B or higher
