MANDATORY BULLETIN No. RTC-080a – R2 - SR
SAFETY RELATED

- 1. CONCERNING TO:** All SportStar RTC aircraft.
- 2. REASON:** Consistently performing a pre-flight inspection in the engine compartment can eliminate the recurring occurrence of cracks in the exhaust system of SportStar RTC aircraft in service.

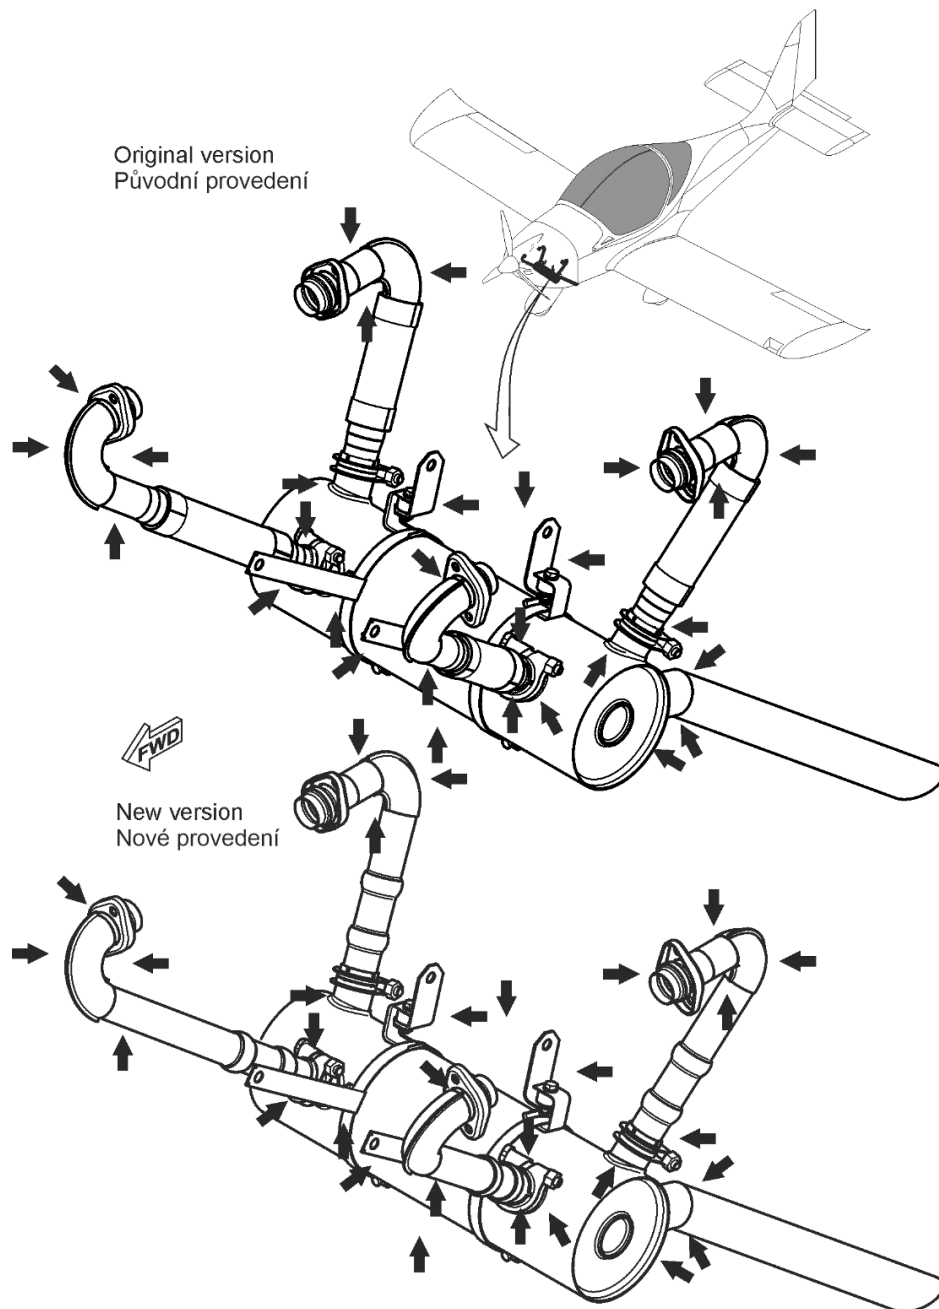
Fig. 1 Checked exhaust system locations

1.3.2 Inspect the entire exhaust system, focusing on the formation of cracks on the individual exhaust manifolds, the outer surface of the muffler and the exhaust outlet pipe – see Fig.1.

Next, inspect the exhaust mounting brackets and consoles – see Fig.1.

- a) Cracks in exhaust elbows
- b) Cracks in exhaust manifolds to muffer
- c) Cracks in muffer manifold inlets
- d) Cracks in muffer cylindrical casing and side circular walls
- e) Cracks in muffer exhaust outlet pipe
- f) Cracks in exhaust brackets and consoles (front and rear)

If damage is found to any part of the exhaust system, immediately inform the aircraft manufacturer and replace the defective part of the exhaust system.

1.3.3 When replacing a defective part of the exhaust system, follow the instructions in MM SportStar RTC, Chapter 78, paragraph 78-20.
