**MANDATORY BULLETIN No. RTC-082a-R1-SR
SAFETY RELATED**

- 1. CONCERNING TO:** All SportStar RTC aircraft manufactured up to 2017 (inclusive), i.e. S/N 2017 XXXX.
- 2. REASON:** In the operation of another type of aircraft which has identical pull rod end with adjustable eye installed, cases of bearing clearance were detected. The clearance occurs due to inadequate securing (swaging) of the bearing in the body of the eye.

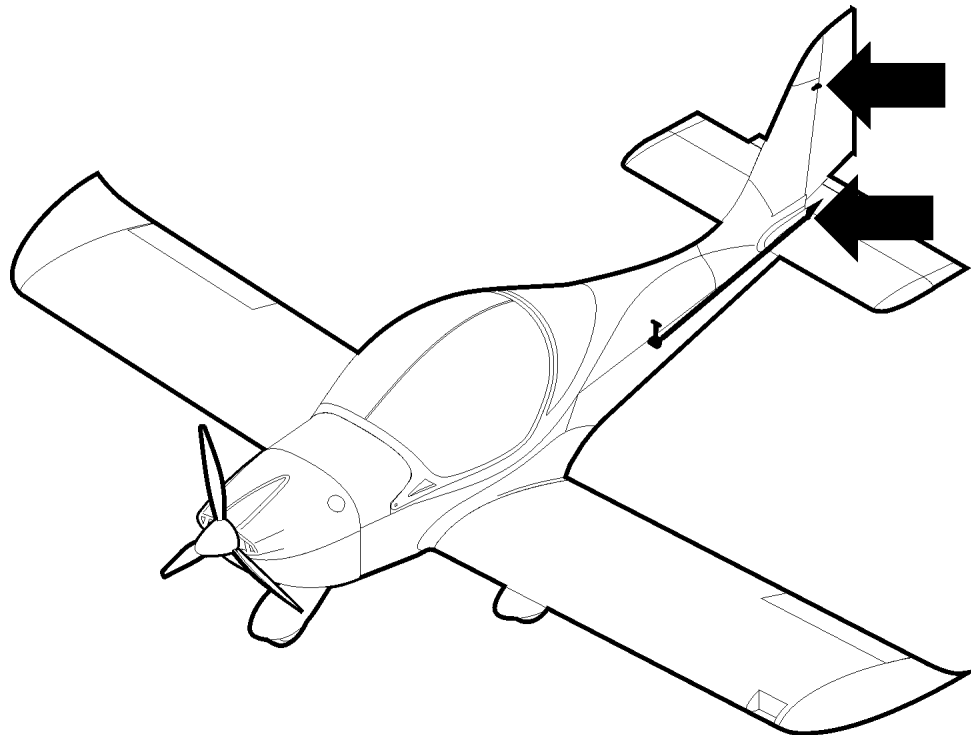
Fig. 1 Bearing inspection locations

Perform an inspection of the bearing swaging. The area where the bearing must be inspected are shown in Fig. 1. A groove is manufactured in the eye around the bearing housing. The groove is designed for the swaging out of the material around the pressed bearing and the curving the material over the edge of the bearing. This process results in axial securing of the bearing.

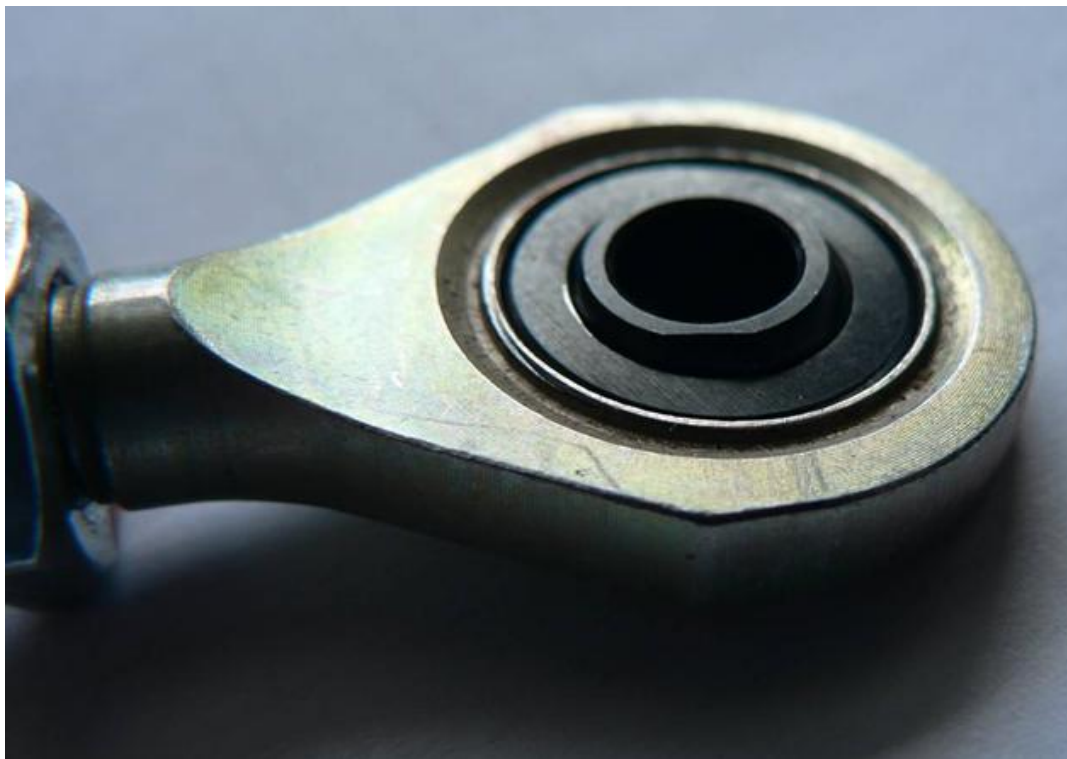
Manually check if the bearing in the eye is without clearance. If clearance is detected, remove the eye from the rod and inspect the swaging (groove) around the bearing housing. It is recommended to use a magnifying glass for unambiguous inspection of the swaging. An eye with an unswaged bearing has a clearly visible groove prepared for swaging, the surface treatment (cadmium plating) is visible even if the groove and there is no trace of swaging. In an eye with a swaged bearing, the surface treatment is rubbed off by the swaging process, the material is curved over the edge of the bearing and a polished trace left by the balls of the swaging tool is visible.

Fig. 2 Unsatisfactory method of securing the bearing in the eye

2. In case clearance is found, remove the eye from the pull rod and inspect the groove around the bearing housing.
 3. If the grooves look like the example in Fig. 2 and clearance is detected, replace the adjustable eye with a new one 8x14x6 AEN 3779.1 (nomencl. 079563).

If the inspected grooves look like in the example in Fig. 2, replace the adjustable eye with a new one 8x14x6 AEN 3779.1 (nom. 079563). The correct performance of bearing swaging, including a detailed view of the curved material, is shown in Fig. 3.

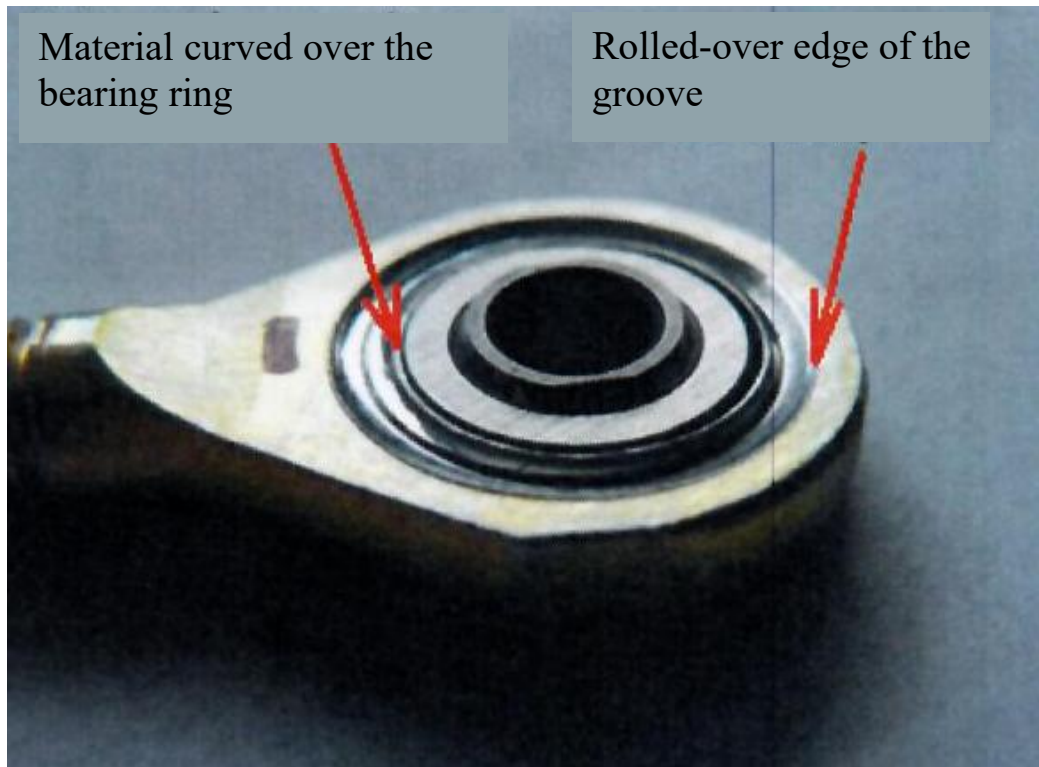
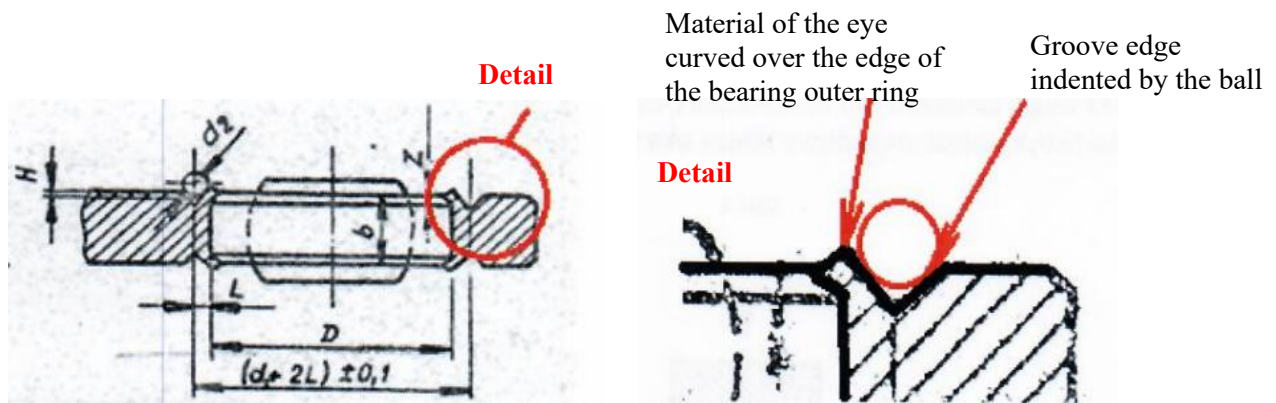
Replacement of the eye is not necessary if the bearing is without clearance, even if the curved material does not rest against the entire circumference of the bearing's chamfered edge. This tolerance is permissible according to the ONL 1331 standard.

Fig. 3 Correct method of securing the bearing in the eye with detail
