MANDATORY BULLETIN No. HARMONY LSA-046a SR

- 1. CONCERNING TO:** *ALL HARMONY LSA, HARMONY ELSA AIRCRAFT
MANUFACTURED UP TO 2017 (INCLUSIVE), I.E. S/N 2017
XXXX.*

- 2. REASON:** *Loosening of the bearing in the adjustable rod eye ONL 3797.1
(nom. 079575).*

- 3. REQUIRED ACTIONS:** *Inspection of the bearing swaging of the adjustable rod eyes
ONL 3779.1.*

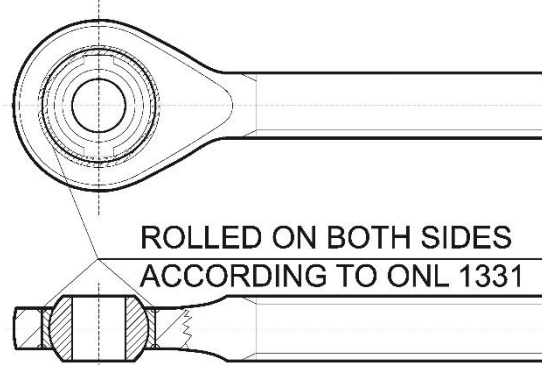
Fig. 1 Adjustable rod eye ONL 3779.1

Due to a reported case of bearing loosening in the adjustable rod eye ONL 3779.1 (Fig. 1) in service, perform an inspection of all aircraft that may be equipped with eyes with insufficiently staked (swaged) bearings. The cause is that during manufacturing, the bearing in the rod eye was not secured by rolling over groove material onto the chamfered edge of the bearing outer ring, as shown in Fig. 2.

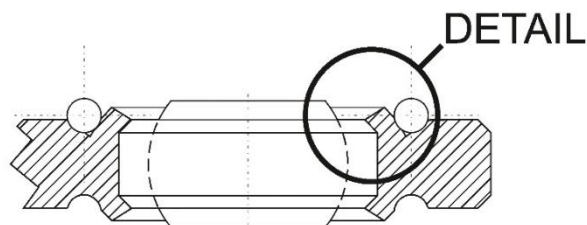
Fig. 2 Groove profile before swaging and properly swaged bearing

The bottom detail in Fig. 2 shows the proper bearing swaging in accordance with standard ONL 1331.2, where the bearing is secured by rolling over groove material onto the edge of the outer ring.

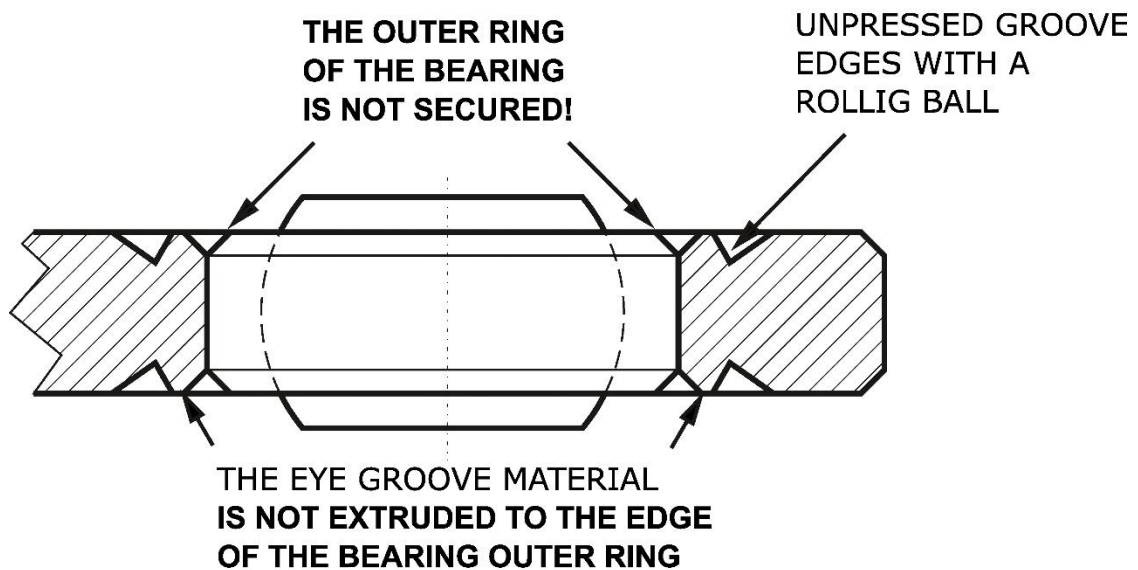
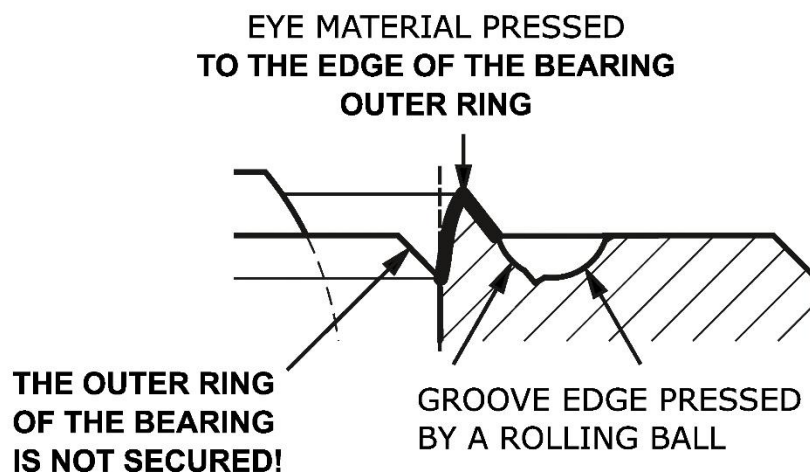
Fig 3. Incorrectly swaged bearing

Fig. 3 illustrates incorrect bearing swaging, where the bearing is insufficiently secured in the rod eye or not swaged at all.

Visually inspect (preferably using a magnifying glass) the condition of the swaging grooves and the bearing securing in the eye. If you find conditions similar or the same as in Fig. 3, replace the adjustable eye with a new one, 8x14x6 AEN 3779.1, nomenclature 079563, supplied by the aircraft manufacturer.

Visually inspect (preferably using a magnifying glass) the condition of the swaging grooves and the bearing securing in the rod eye of the rudder upper hinge. If you find conditions similar or the same as in Fig. 3, replace the adjustable eye with a new one, 8x14x6 AEN 3779.1, nomenclature 079563, supplied by the aircraft manufacturer.,

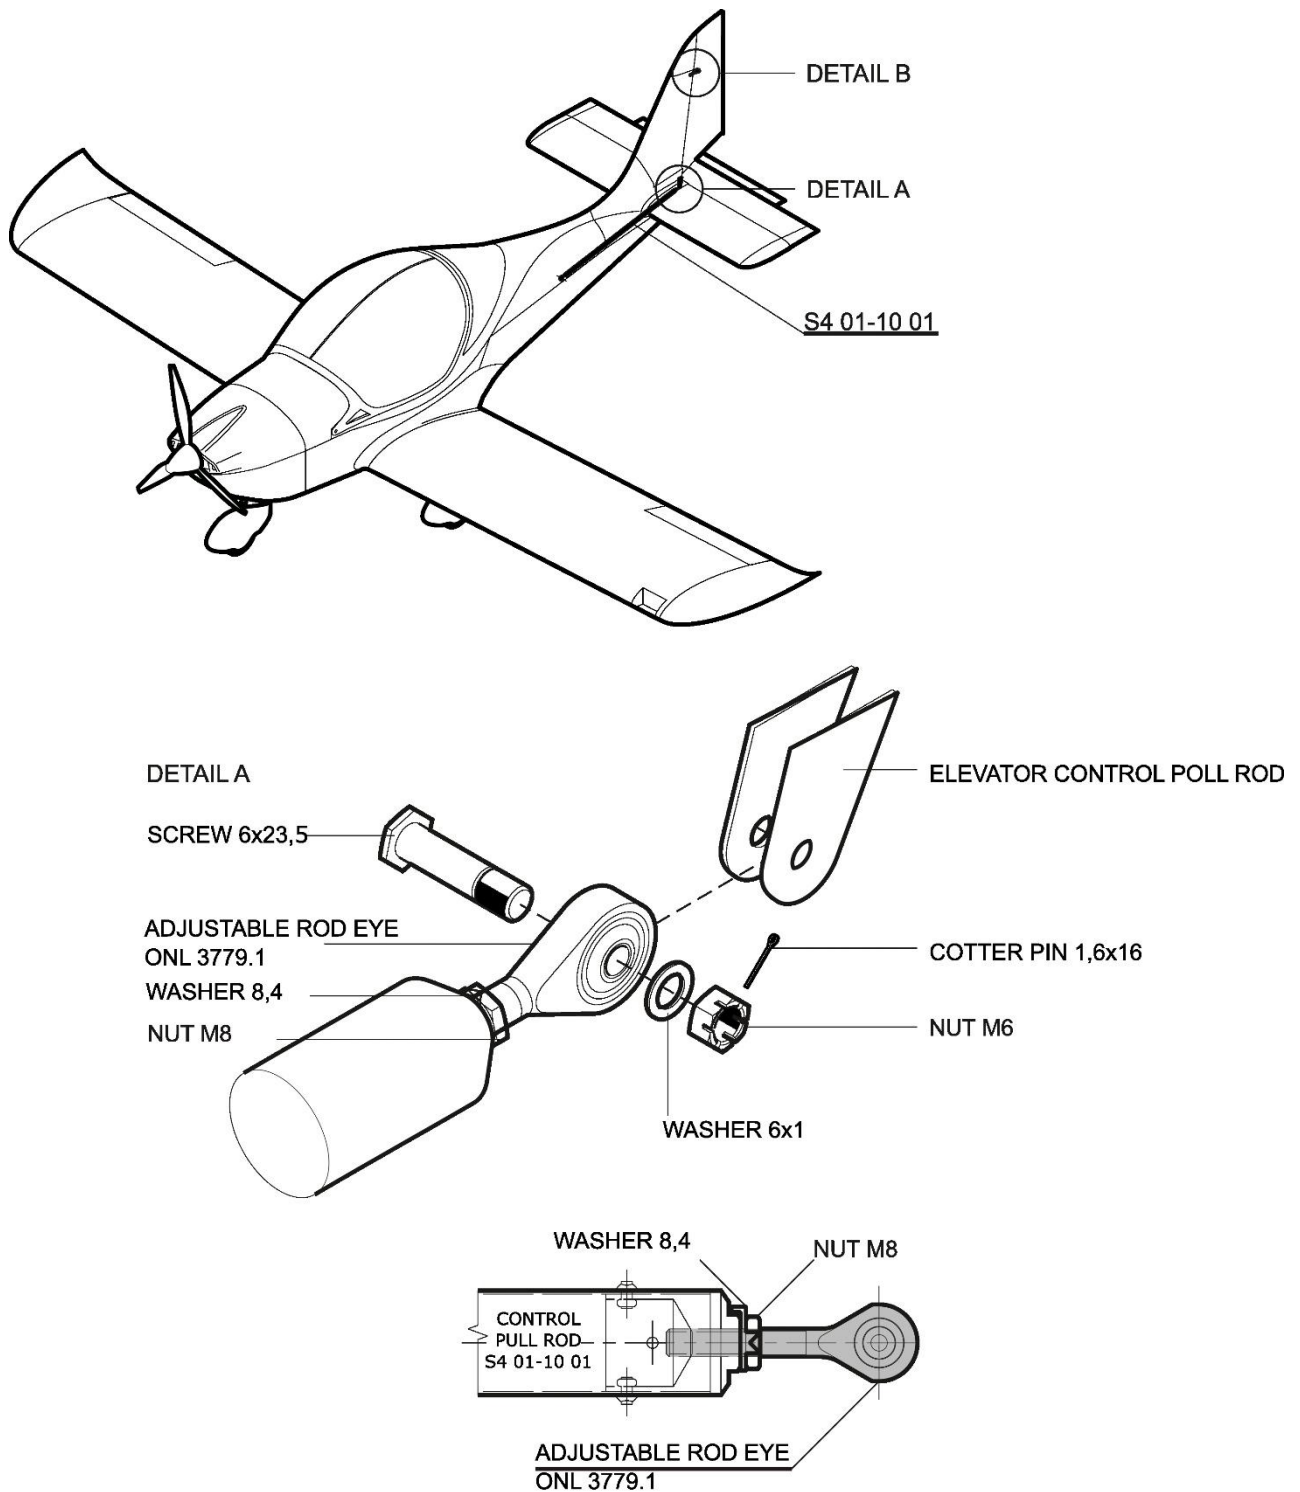
Fig. 4 Inspected connections – detaila A and B

If, during the pre-flight inspection, no excessive clearance in the controls or rudder mounting is found, stiffness in the control system, or any other abnormal condition is detected, perform a visual inspection of the rod eye S4 01-10 01 in the elevator control system (Fig. 4, Detail A) and the rod eye of the upper rudder hinge (Fig. 4, Detail B) at the next annual or 100-hour inspection.

If abnormal clearance or stiffness is observed in the joint, perform the inspection immediately.

Disconnect the connection between the rod and the lever on the elevator.

Remove the 1,6x12 cotter pin (Fig. 4) and the M6 nut.

Remove the 6x1 washer and the 6x23,5 bolt.

Check the bearing swaging in the rod eye for clearance by hand.

If clearance is detected, unlock the washer and remove the rod eye.

Connect the control rod to the elevator lever using a 6x23,5 bolt, 6x1 washer and M6 nut (Fig. 4).
