**MANDATORY BULLETIN No. EV97-045a SR**

- 1. CONCERNING TO:** *All EV97 Eurostar SL; SLW; SL+; EV97 Eurostar mod. 97; 99; 2000; 2000R aircraft, manufactured up to 2017 (inclusive), i.e. S/N 2017 XXXX.*

- 2. REASON:** *Loosening of the bearing in the adjustable rod eye ONL 3797.1 (nom. 079575).*

- 3. REQUIRED ACTIONS:** *Inspection of the bearing swaging of the adjustable rod eyes ONL 3779.1.*

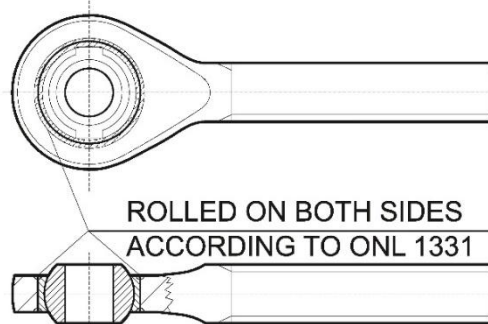
Fig. 1 Adjustable rod eye ONL 3779.1

Due to a reported case of bearing loosening in the adjustable rod eye ONL 3779.1 (Fig. 1) in service, perform an inspection of all aircraft that may be equipped with eyes with insufficiently staked (swaged) bearings. The cause is that during manufacturing, the bearing in the rod eye was not secured by rolling over groove material onto the chamfered edge of the bearing outer ring (Fig. 3 bottom).

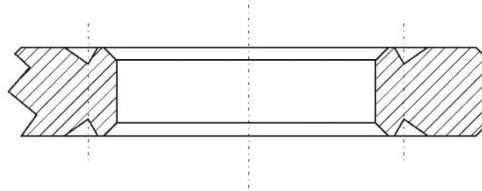
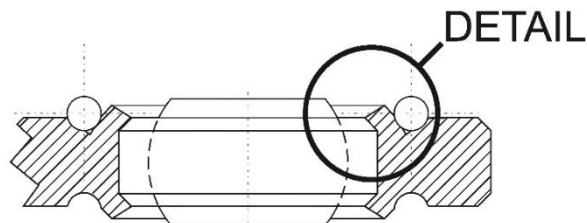
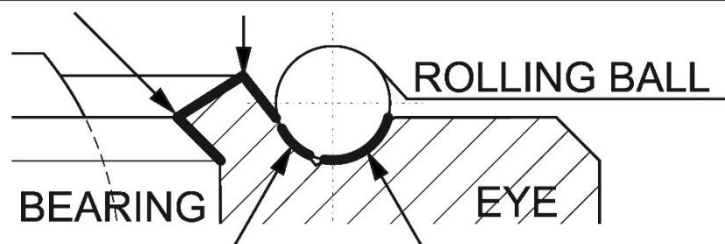
Fig. 2 Groove profile before swaging and properly swaged bearing

Fig. 2 shows the proper bearing swaging in accordance with standard ONL 1331.2, where the bearing is secured by rolling over groove material onto the edge of the outer ring.

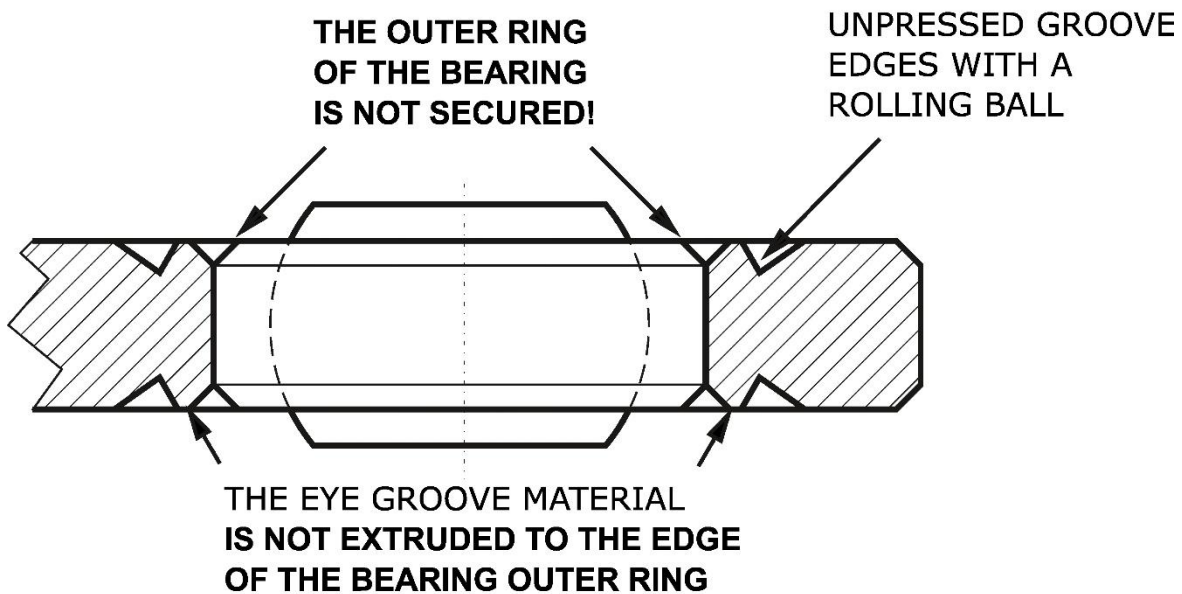
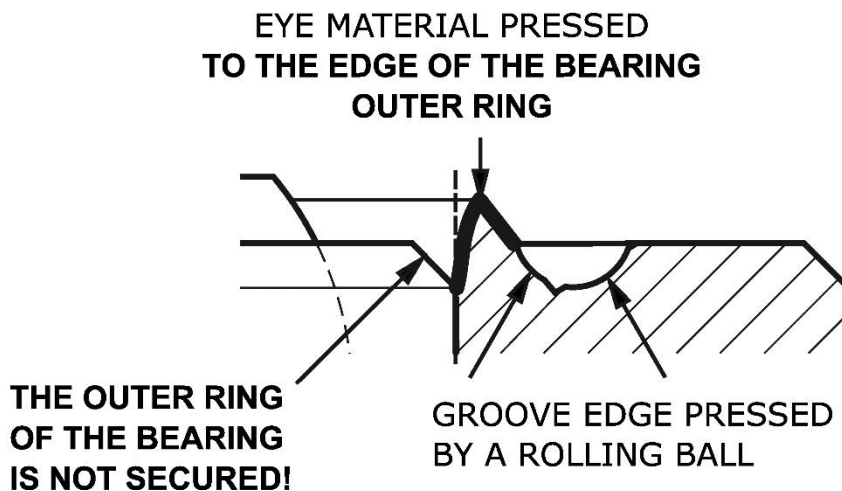
Fig 3. Incorrectly swaged bearing

Fig. 3 shows incorrect bearing swaging, where the bearing is not secured against falling out of the rod eye. Such condition can be critical, especially in the lateral control rod joints (Fig. 4, detail A; B), where a disconnection of the lateral control rods may occur.

Visually inspect (preferably using a magnifying glass) the condition of the swaging grooves and the bearing securing in the eye. If you find conditions similar or the same as in Fig. 3, replace the adjustable eye with a new one, 8x14x6 AEN 3779.1, nomenclature 079563, supplied by the aircraft manufacturer (a rod eye with a shortened threaded part is used for the E4 01-13 01 rods).

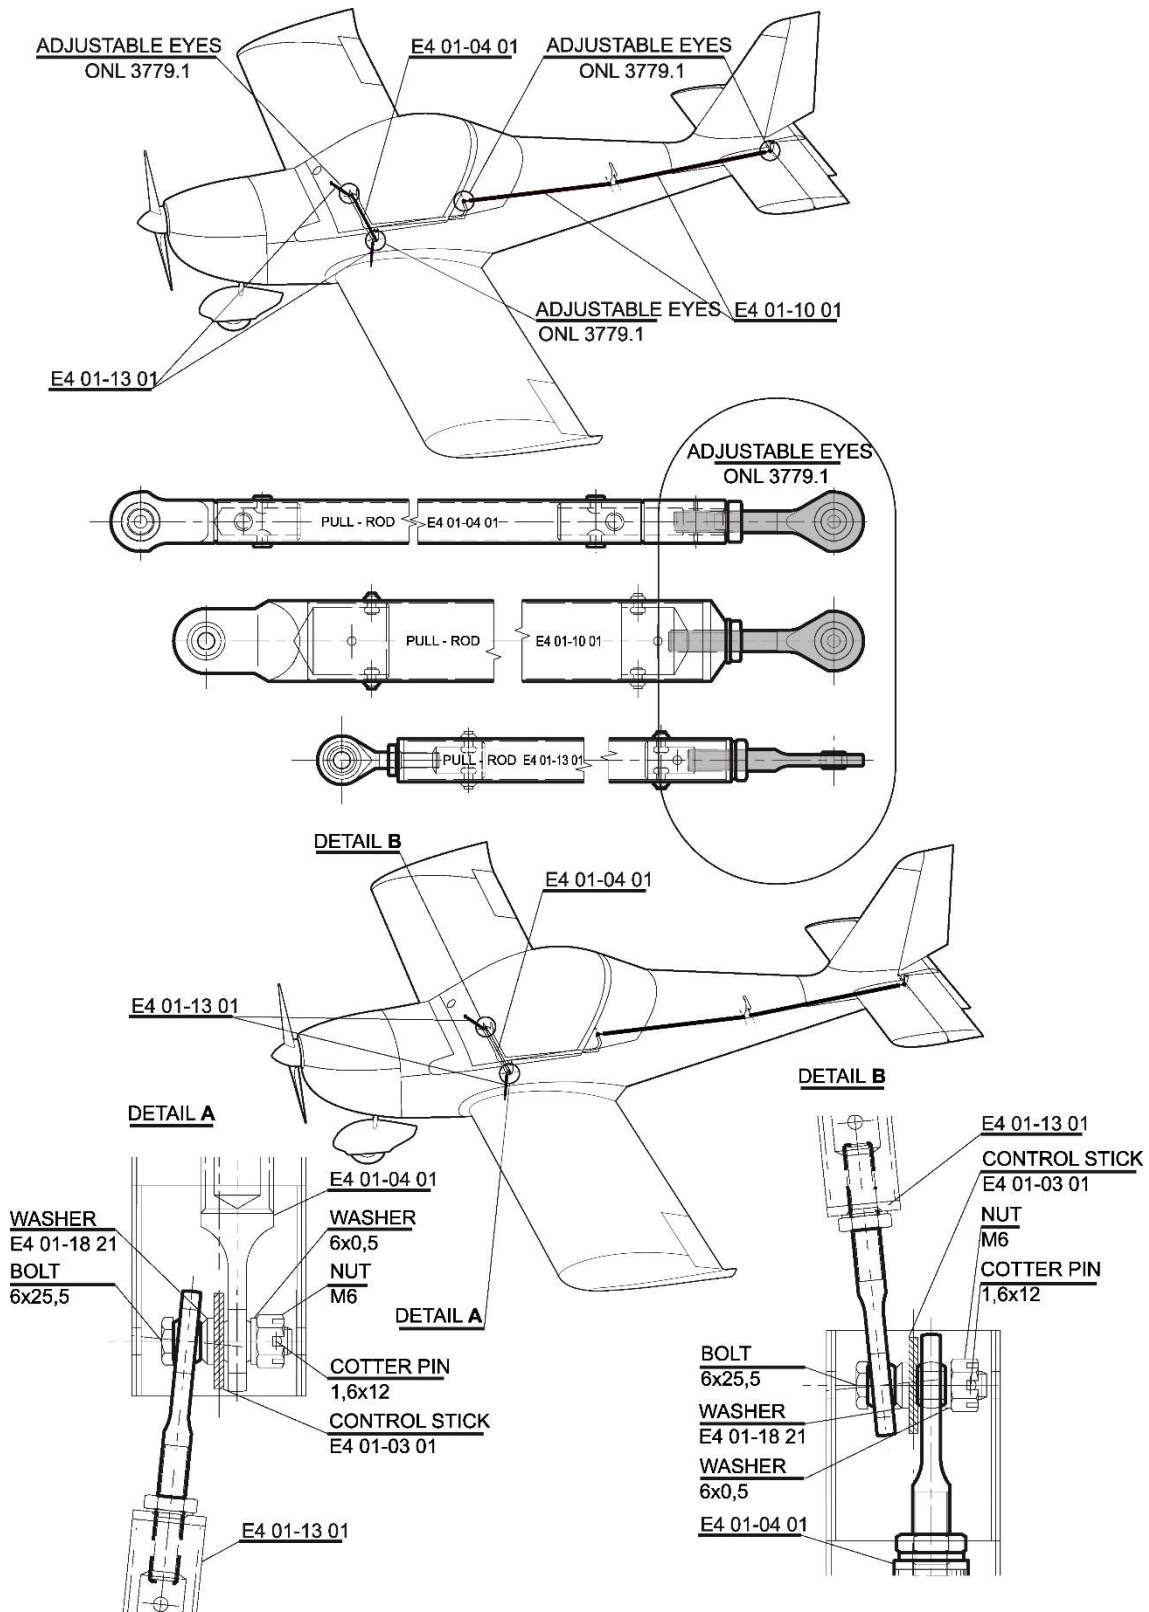
Fig. 4 Inspected manual control rod joints

Check the condition of the bearing swaging in the E4 01-04 01 adjustable rod eye and in the E4 01-13-01 aileron control rods.

To perform the bearing swaging inspection, remove the 1,6x12 cotter pins (Fig. 4, detail A; B) and remove the M6 nuts.

Check the bearing swaging in the rod eye for clearance by hand.

If clearance is detected, unlock the washer and remove the rod eye.

In case of replacement, install the new rod eye including a washer.

Check aileron deflections and adjust as necessary. After checking and adjusting the deflections, secure the washer.

Insert the 6x25 bolts into the bearing of the E4 01-13 01 rods (Fig. 4, detail A; B) and slide on the E4 01- 18 21 washers.

Further insert the bolts into the holes in the control levers and into the bearing in the E4 01-04 01 control rod.

Slide on the 6x0,5 washers and install the M6 nuts.

Secure the nuts with 1,6x12 cotter pins.

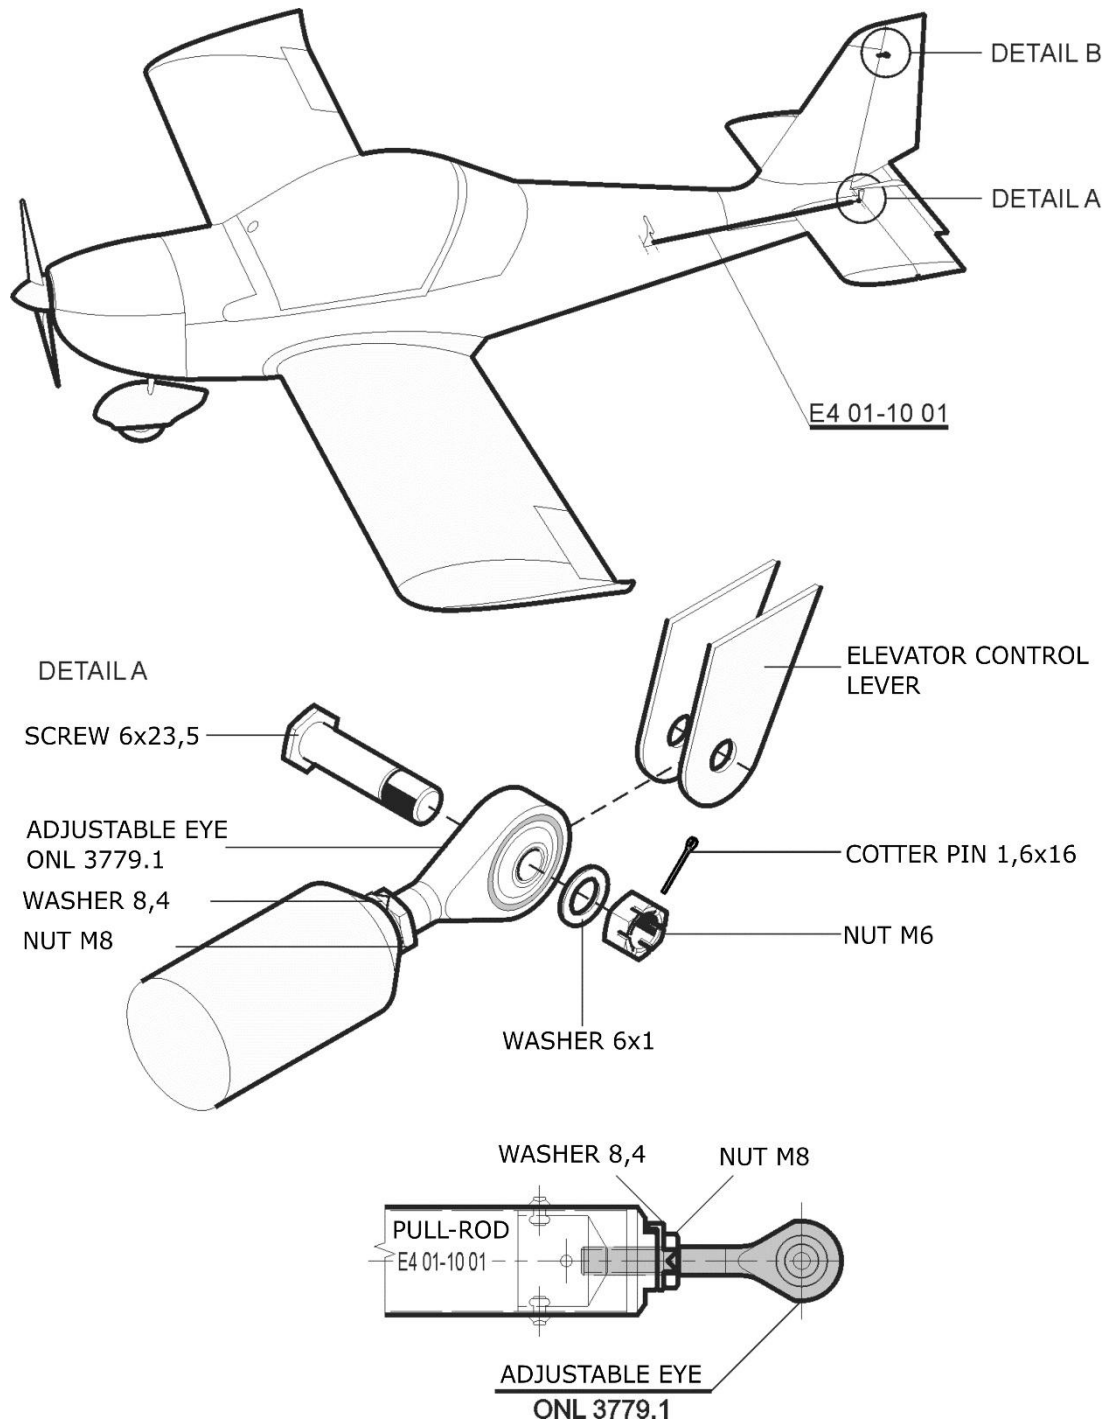
Fig. 5 Elevator control rod removal

If, during the pre-flight inspection, no excessive clearance in the manual control system or rudder mounting is found, stiffness in the control system, or any other abnormal condition is detected, perform a visual inspection of the rod eye E4 01-10 01 in the elevator control system (Fig. 5, Detail A) and the rod eye of the upper rudder hinge (Fig. 5, Detail B) at the next annual or 100-hour inspection.

If abnormal clearance or stiffness is observed in the joint, perform the inspection immediately.

In these joints, the rod eye may slip over the bolt head, leading to a disconnection of the control circuit.

Remove the 1,6x12 cotter pin (Fig. 5) and the M6 nut.

Check the bearing swaging in the rod eye for clearance by hand.

If clearance is detected, unlock the washer and remove the rod eye.

Visually inspect (preferably using a magnifying glass) the condition of the swaging grooves and the bearing securing in the eye. If you find conditions similar or the same as in Fig. 3, replace the adjustable eye with a new one, 8x14x6 AEN 3779.1, nomenclature 079563, supplied by the aircraft manufacturer.

In case of replacement, install the new rod eye including a new washer.

Connect the control rod to the elevator lever using a 6x23,5 bolt, 6x1 washer and M6 nut (Fig. 5).

Check the elevator deflection and adjust as necessary. After checking and adjusting the deflections, secure the washer.

Secure the M6 nut with a 1,6x12 cotter pin.
