# RIOS: LOS ANGELES

# Corona City Park:

# Tree Assessment Report

OCTOBER 30, 2025

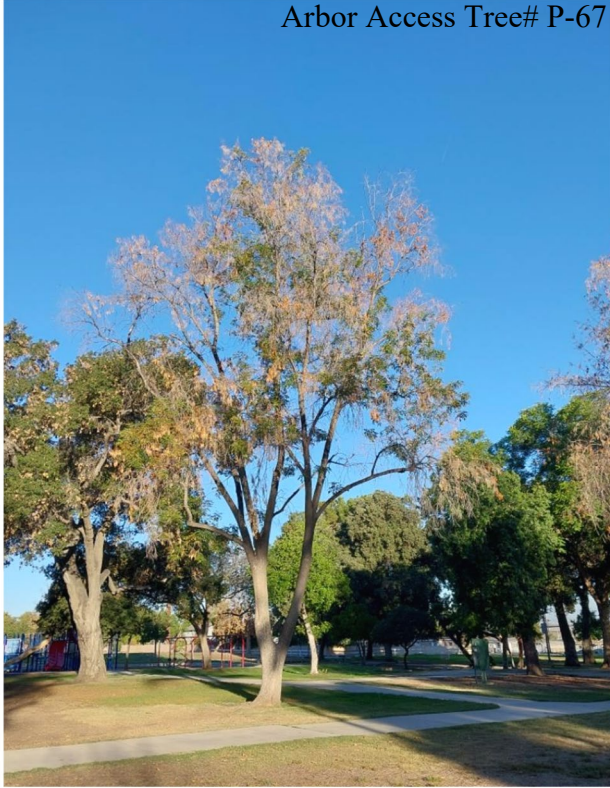
Arbor Access Tree# P-67

*Images 1-4 show examples of trees that are dead or have poor health and overall condition, making them unsuitable for site retention or relocation.*

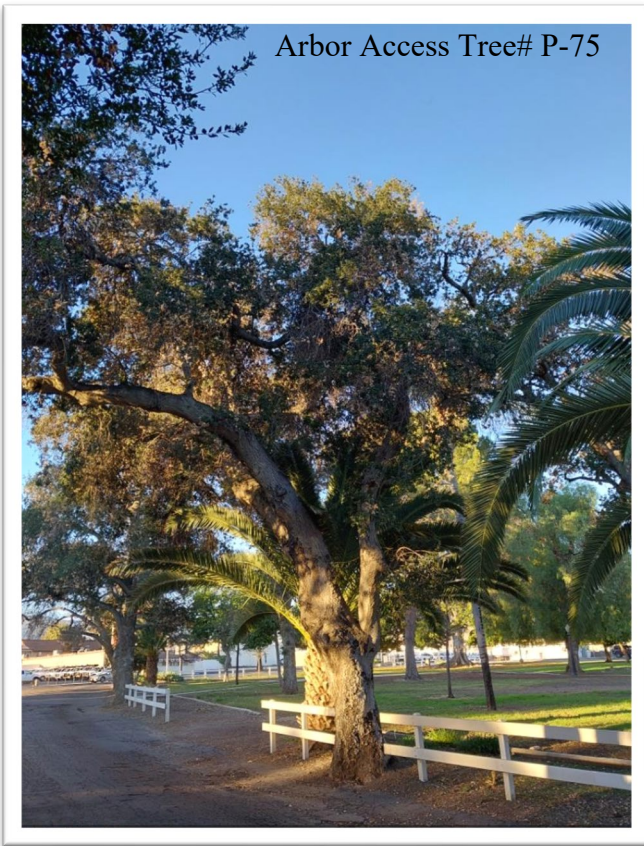
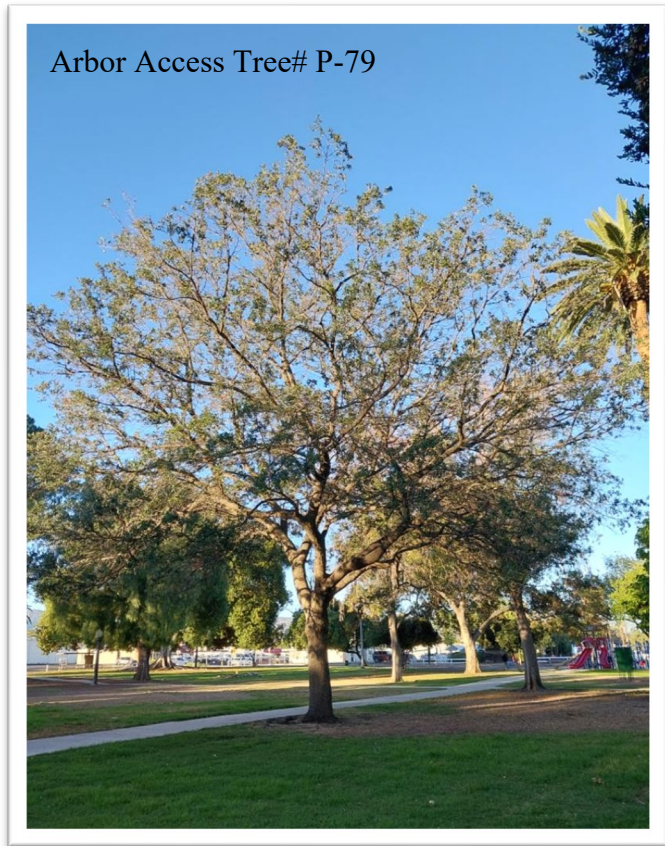
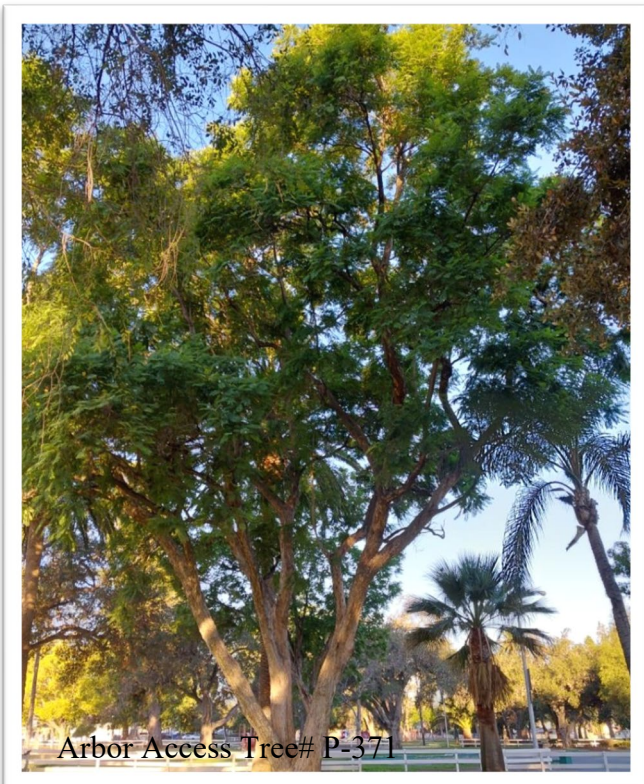
*Images 5-7 show examples of trees that are in fair or declining health and/or have poor structural condition, and are therefore not considered suitable for relocation.*

*Park-75, a declining Coast Live Oak, has numerous cavities on two of its main lateral branches and an active beehive in one of them.*

*Park-371 is a very large, multi-stemmed Jacaranda. This structure is not consistent with normal species characteristics; therefore, boxing and moving this tree is not recommended. The combined trunk diameter is greater than 40 inches, which would require a minimum of a 30-foot TPZ and an equal or larger box (this is not highly feasible).*

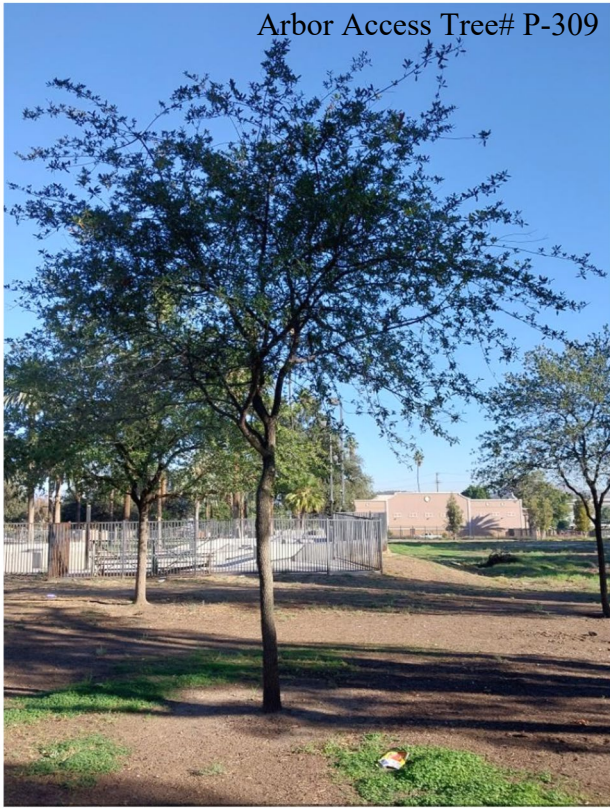
Arbor Access Tree# P-309

*Images 8-10 show examples of trees in good or fair health and suitable for relocation.*

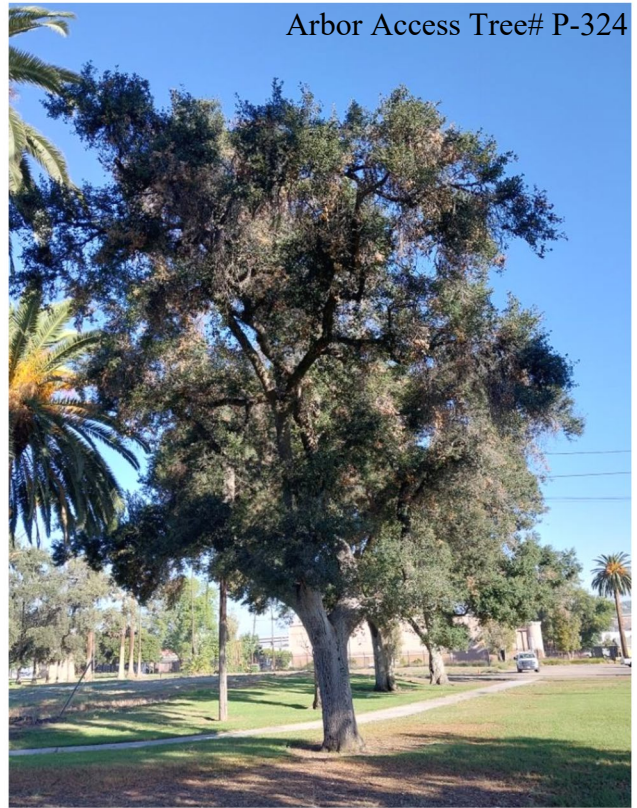
Arbor Access Tree# P-324

*Park-324 is a semi-mature Coast Live Oak that has some dieback within its canopy and a very small cavity at its base. However, with proper pre- and post-transplant care, the tree may reestablish well.*

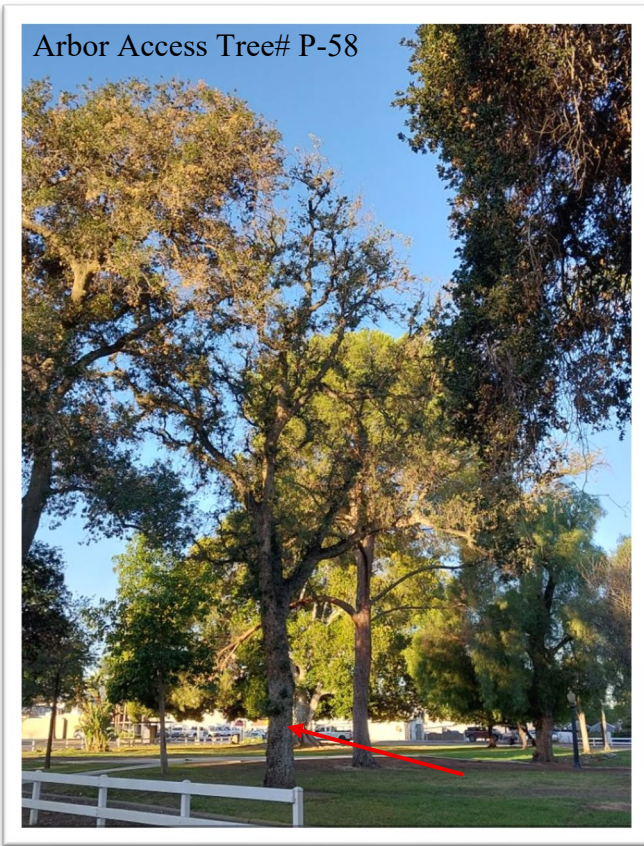
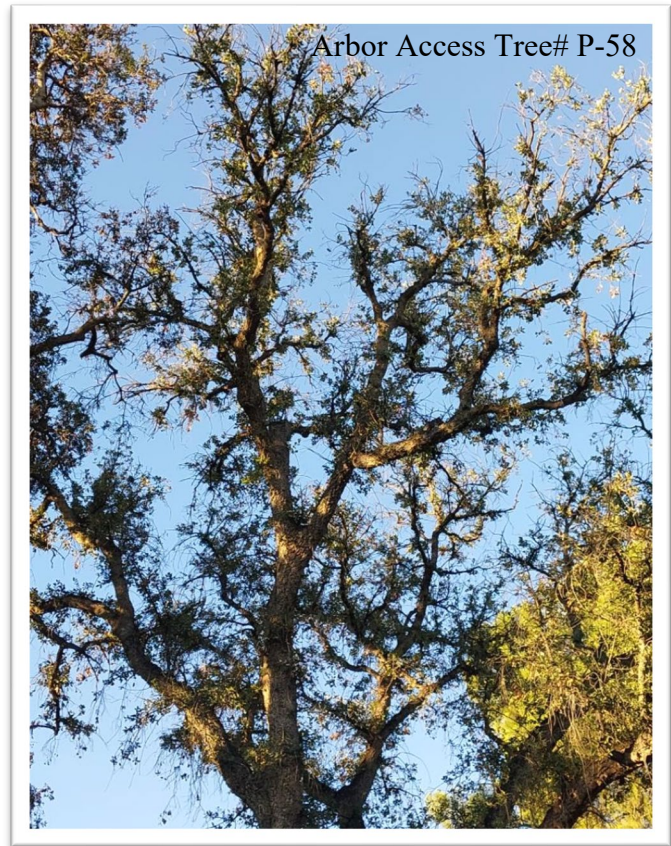
- One of these trees, a declining Cork Oak (P-58) is not considered a good candidate for retention due to its degree of dieback. This tree has poor canopy density and a high degree of dieback, and its removal is recommended. Park-69, a young Southern Live Oak, appears to have died and been removed, as we were unable to locate this tree in the field.

*Images 11 & 12 (top) show P-58, a Cork Oak with poor health that is proposed for site retention. Based on its poor and declining health, this tree is not considered a good candidate to retain on its site.*

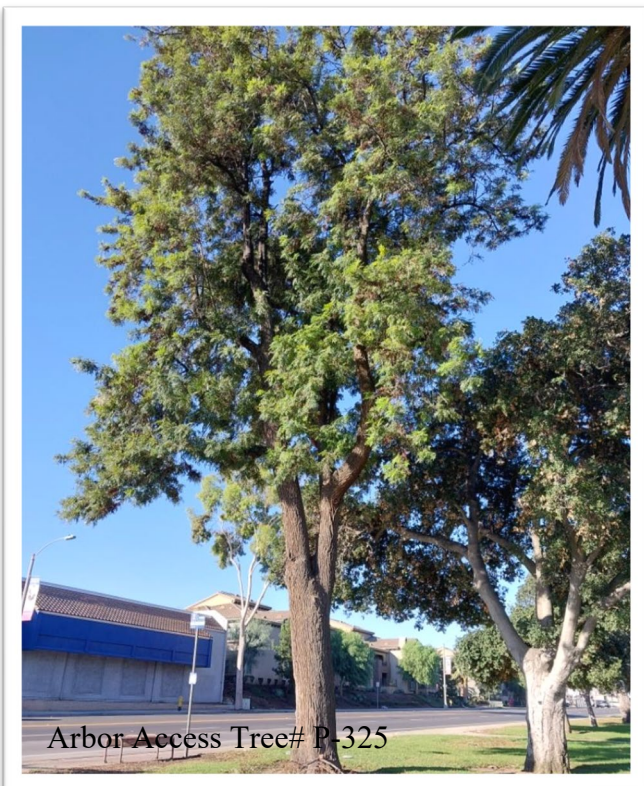
*Image 13 (at left), on the contrary, shows P-325, a healthy Silk Oak that should do well both before and after construction.*

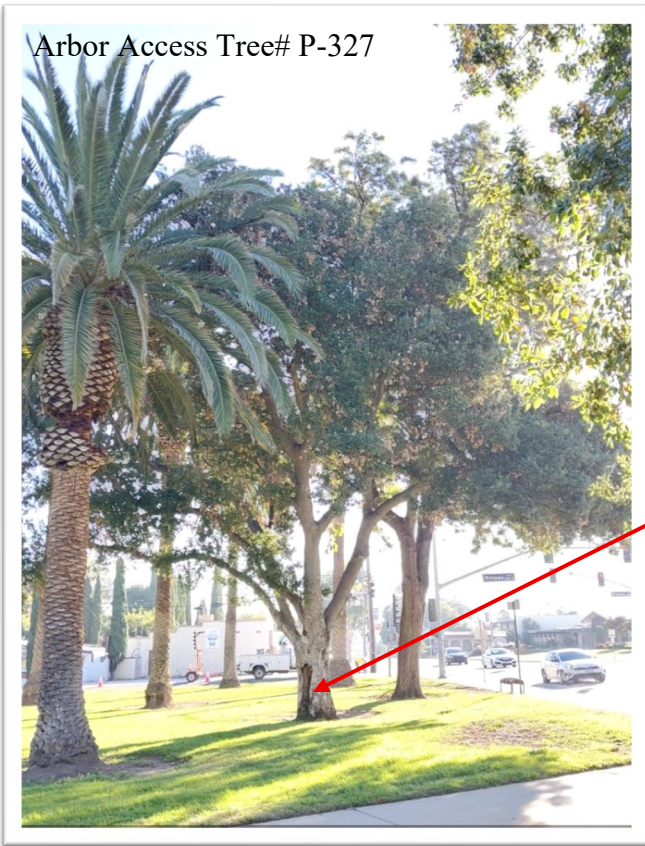
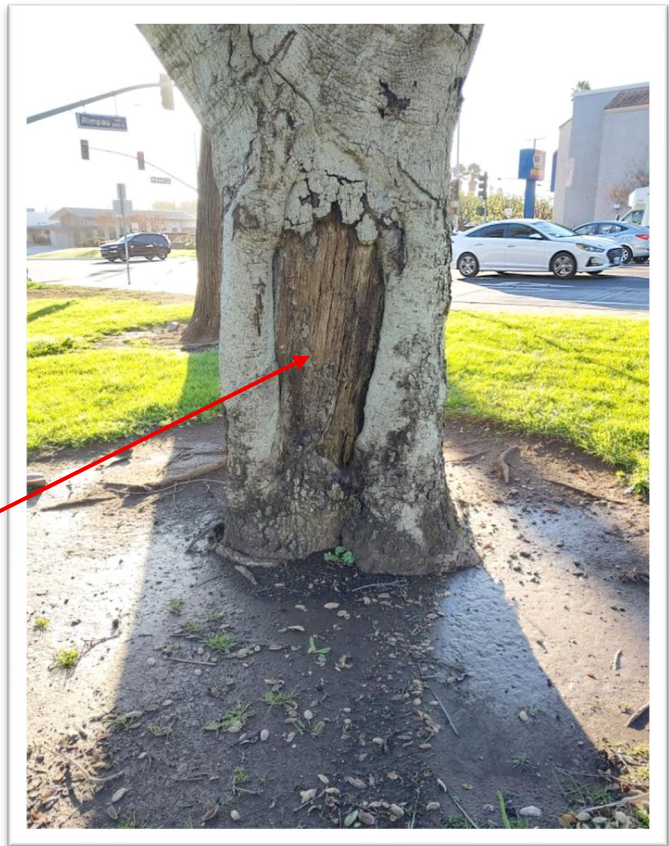
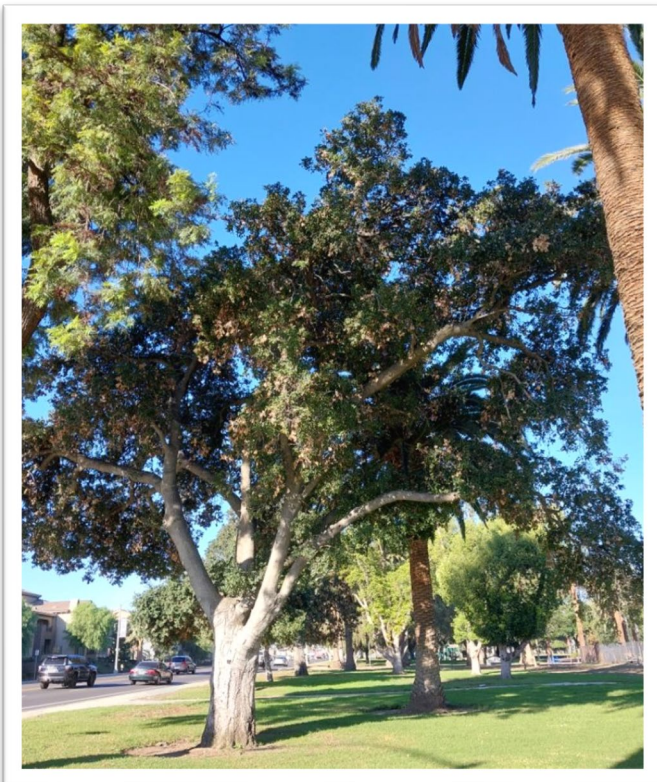
- Park-327 has a large injury on the west-facing side of the trunk. At this time, there appears to be good reaction wood along the margins; however, over time, this decay may jeopardize the plant's structure to the point that failure could occur. Plant vigor is good, with a healthy appearing crown. If retained, this tree will need to be monitored annually for any change in its overall health or structural condition.

*Images 14-16 show P-327. This tree has good healthy, with a full vigorous crown. However, the trunk injury will need to be monitored over the years for decay development and spread.*
