# Brick Veneer Stabilization After Partial Façade Collapse

30 Kimberly Road | East Brunswick, New Jersey

Project No. 2400\_47

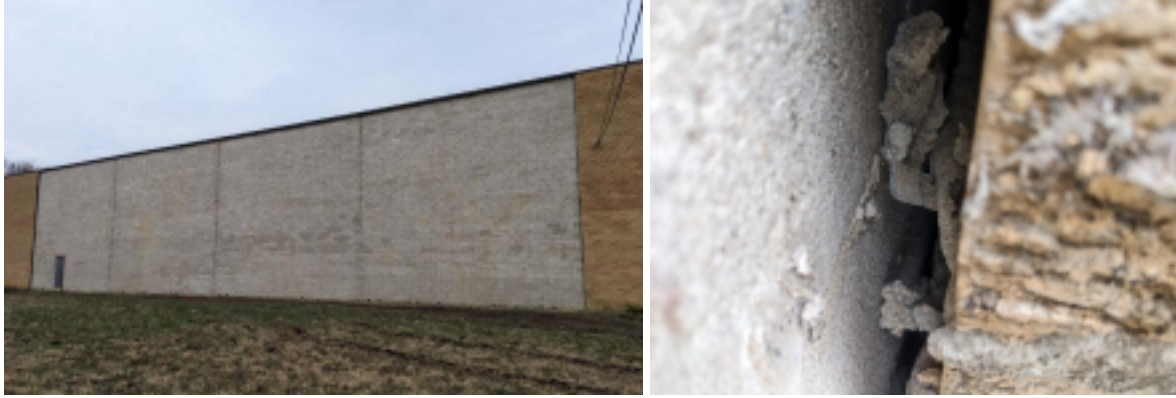
KSI inspected the property on April 10, 2024 after a high-wind storm event. Approximately 120 feet of the nominal 4-inch brick veneer had separated from the east wall for the full height of the warehouse, exposing the 8-inch CMU backup wall.

Collapsed veneer removed, exposing the CMU backup wall. Deteriorated and broken corrugated steel masonry tie visible in the cavity.

- Most visible original corrugated steel ties were deteriorated or broken; the few intact ties extended about 4 inches from the CMU.
- The cavity gap measured approximately 7/8 inch to 1-5/8 inches at the edges of the failed area.
- The remaining veneer adjacent to the collapse was visibly bulged outward; localized bulging was also observed near a control joint at the south end of the east wall.
- No waterproofing coating or membrane was observed between the CMU and brick veneer.
- Grade along much of the east wall covered the lowest brick course and likely blocked the weep holes.
- Interior efflorescence and water staining supported a history of moisture within the wall system.

KSI presented two principal approaches: remove and replace the brick façade, or strengthen the existing veneer in place with small-diameter stainless-steel helical ties drilled through the brick and anchored into the CMU backup wall. The in-place strengthening approach was selected for retained wall areas.

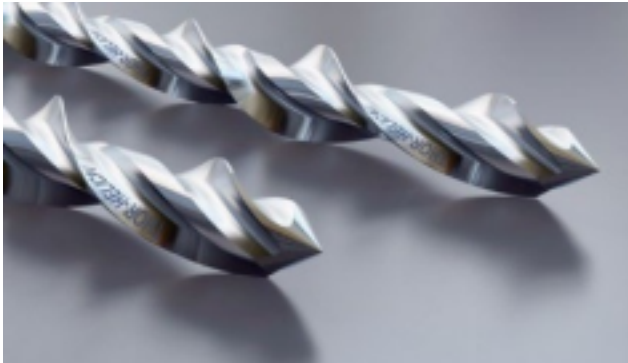
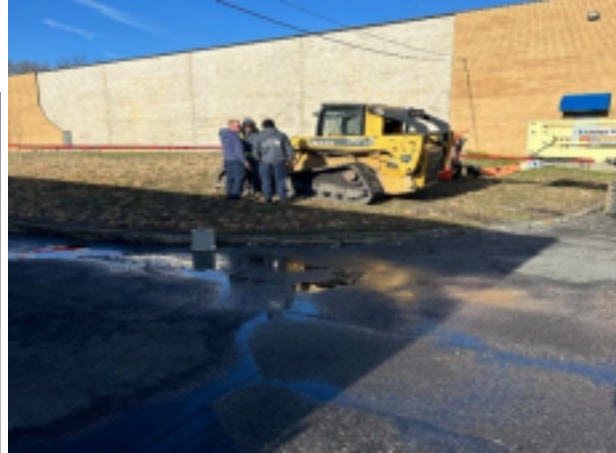
Field work at the east elevation. Stainless-steel helical wall ties used to reconnect the veneer to the backup wall.

- Install stainless-steel helical retrofit ties through the existing brick veneer into the CMU backup to restore out-of-plane restraint.
- Lay out and install ties in accordance with the engineer's repair design and verified field conditions.
- Complete targeted masonry repairs and repointing where needed around distressed areas. •

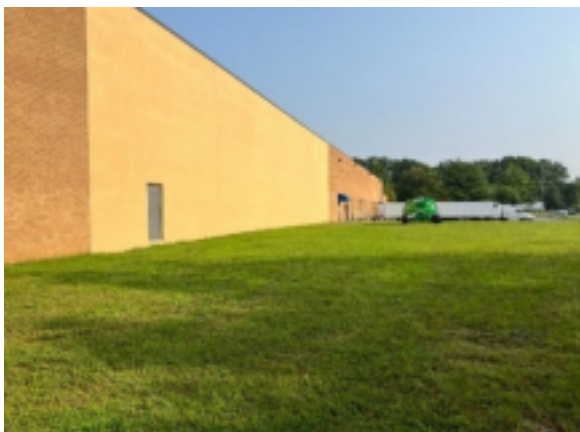
## Stabilized retained veneer

The retrofit tie program restored a direct mechanical connection between the retained brick veneer and the structurally stable CMU backup wall, avoiding wholesale removal of serviceable masonry in treated areas.
