GT2026-176262

## DESTRUCTIVE AXIAL VIBRATIONS ON IGC THRUST COLLARS: RCA

Andrea Fusi<sup>1</sup>, Andrea Betti<sup>1</sup>, Giovanni Karahoxha<sup>1</sup>

<sup>1</sup>Compression Service Technology S.r.l., Florence, Italy

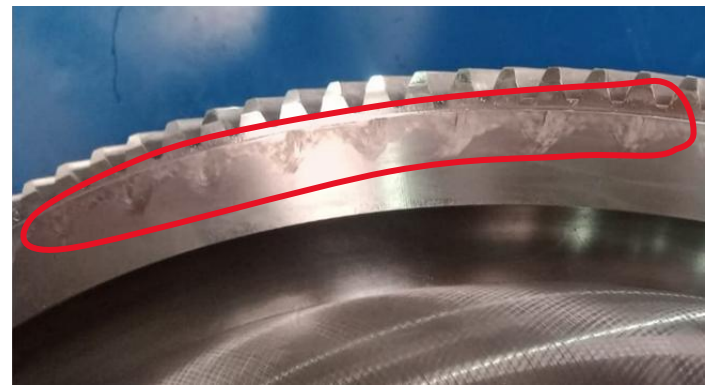
In addition, **92 imprints** were observed on the conical surface of the bull gear (MAC A in Fig. 4 and MAC B in Fig. 5). These marks showed variable radial extensions (from about 30% up to 90% of the theoretical contact track) and were clearly caused by direct metal-to-metal rubbing between the bull gear and the thrust collar.

FIGURE 4: 92 IMPRINTS ON MAC A BULL GEAR.

To explain the periodicity of the imprints, it is important to consider the tooth counts of the bull gear and the first pinion: 184 and 38 teeth, respectively. The marks could not have been generated by a forcing frequency at 92x (2280 Hz), as no such component was detected in the field. Instead, the imprints were

where  $Z_B$  and  $Z_P$  are the tooth counts of the bull gear and the first pinion, respectively, and  $\gcd(Z_B, Z_P)$  denotes the greatest common divisor of  $Z_B$  and  $Z_P$ . Since  $\gcd(Z_B, Z_P) = 2$ , Eq. (1) provides the predicted number of repeatable contact locations, that is  $N = 92$ , in agreement with the observed imprint count.

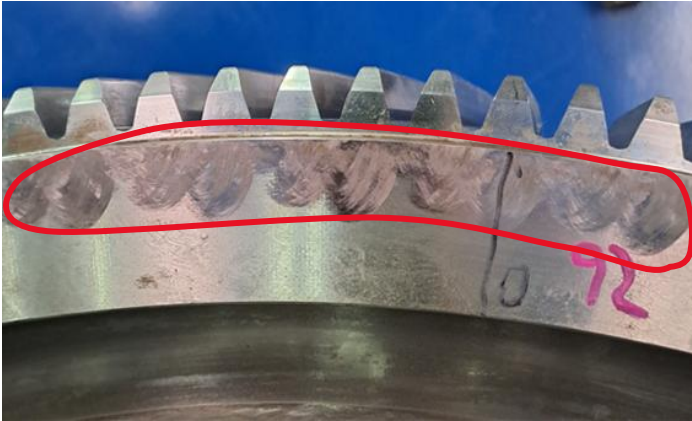
Moreover, MAC B exhibited the same imprint periodicity observed in MAC A, with 92 traces on the bull gear surface. However, in MAC B the imprinting pattern appeared as two distinct, overlapping sets: a first set of 92 traces and a second set, still consisting of 92 traces, circumferentially shifted by approximately one bull-gear tooth pitch (Fig. 5). This behavior indicates that the pinion collar experienced a loss of interference during operation, resulting in collar slippage and a corresponding phase shift of the imprinting locations.

**FIGURE 5: 2 SETS OF 92 IMPRINTS ON MAC B BULL GEAR.**

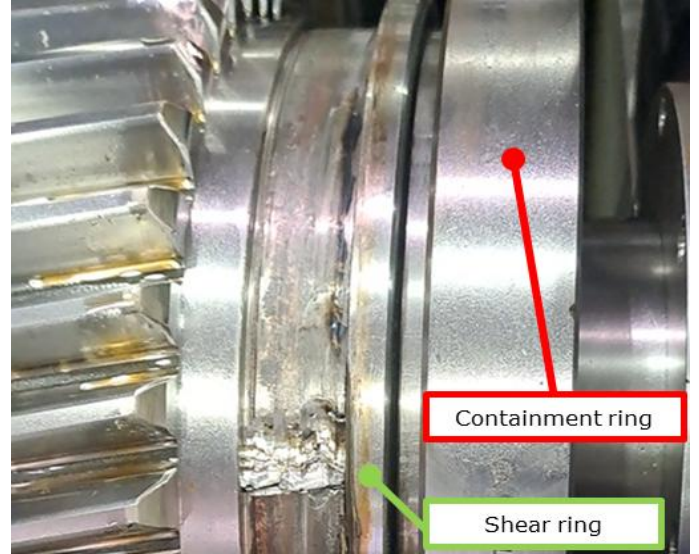
In MAC B, the shear rings remained in place (Fig. 6), even though the containment ring had slipped approximately 15 mm toward the drive-end side, dragged by the already fractured collar. This slippage was likely caused by a loss of interference in the containment ring.

**FIGURE 6: MAC B FIRST PINION AS FOUND AFTER ESD.**

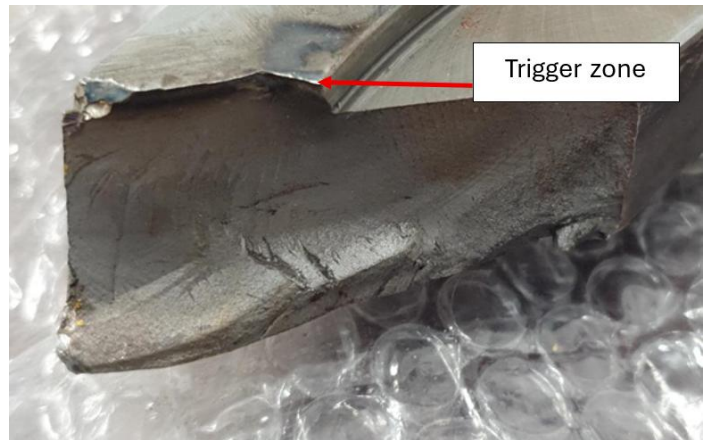
The fractographic examination of the broken thrust collars from both MAC A and B, performed by an accredited laboratory, revealed multiple fatigue cracks originating from the worn surface where the imprints were located (Fig. 7 and Fig. 8).

**FIGURE 7: MAC A BROKEN RING FRACTURE.**

The fractures showed all the typical features of fatigue failure—radial marks, beach lines, and a final overload zone—starting a few millimeters from the inner edge of the contact track. The fracture surface also displayed the following characteristics:

- An initial propagation along a radial plane, later transitioning to a surface inclined  $\approx 30^\circ$ .
- Evidence of local heating caused by friction during operation.
- A superficial intergranular fracture zone with deeper transgranular propagation.

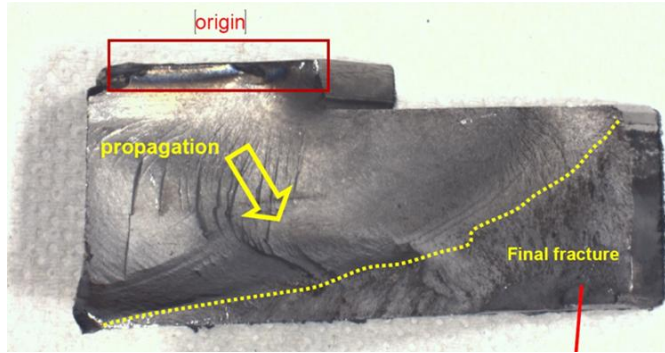
**FIGURE 8: MAC A PICTURE FROM FRACTOGRAPHIC EXAMINATION.**

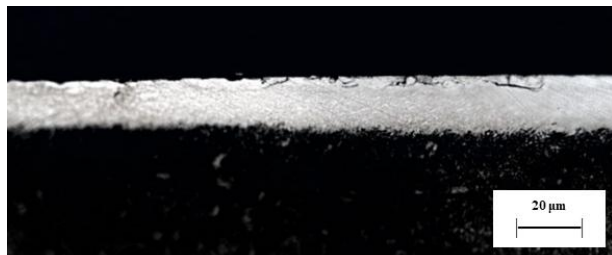
(a) 200X

Micrographic analysis (Fig. 9) additionally showed alterations in the carburized layer, including the formation of “fresh” martensite ( $4\text{--}5\ \mu\text{m}$ , white layer) and a tempered underlayer (approximately  $15\ \mu\text{m}$ , grey layer) with micro-defects. These alterations were attributed to improper grinding during manufacturing; however, they were not considered the root cause of the rapid failure observed in service.

**FIGURE 9: MAC A THRUST COLLAR, PICTURE FROM MICROGRAPHIC EXAMINATION.**

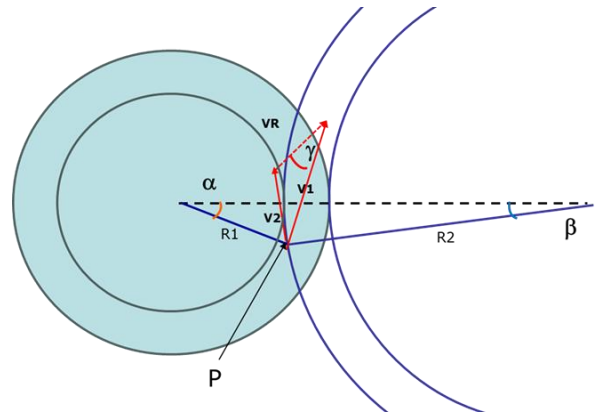
A closer analysis of the thrust collar operation shows that the theoretical contact on the cone generator does not occur in practice. The deformation of the ring during operation increases the real contact surface beyond the ideal geometric line. The initiation point of the failure (P in Fig. 10) is located a few millimeters from the inner edge of the ring, where the effective contact pressure becomes concentrated due to this deformation.

**FIGURE 10: THRUST COLLAR CONTACT GEOMETRY.**

Considering a location 5 mm from the inner edge, the calculated velocities are:  $V_1 = 99\ \text{m/s}$  on the pinion,  $V_2 = 86\ \text{m/s}$  on the bull gear, and a relative velocity  $VR = 31\ \text{m/s}$ . This high relative speed, combined with the contact inclination, explains both the presence and the direction of the striations observed on the ring surface. The strong and intermittent nature of the contact stress, together with its orientation, also supports the formation of defects perpendicular to the surface. This behavior is consistent with fretting-type damage mechanisms identified during the fractographic analysis.

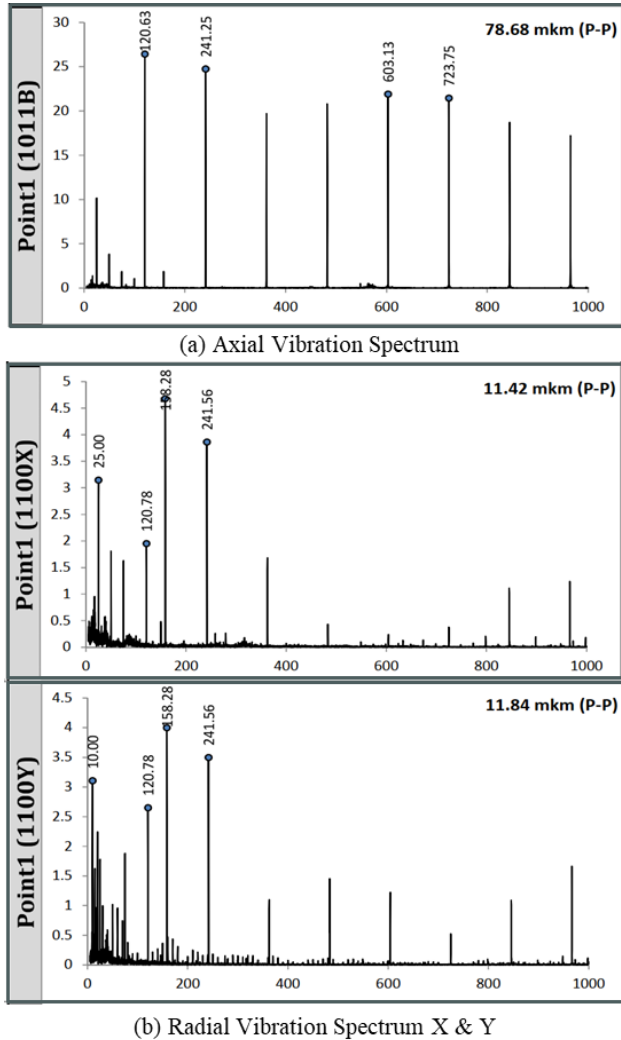
first pinion to investigate the phenomenon and quantify the axial vibration response under operating conditions. The subsequent analysis showed low radial vibration at the expected frequencies, but **very high axial vibration at multiples of the pinion synchronous frequency—approximately 25 harmonics**. Such spectrums can be seen in Fig. 11, in which only the first 8 harmonics are shown for the sake of visualization.

**FIGURE 11: MAC B AXIAL AND RADIAL VIBRATION SPECTRUMS.**

To resolve the issue on site (given the constraints of the installed machines and the lack of space for collar stiffening) the original pinions were replaced and the thrust collar arrangement was removed. The new pinions were redesigned to accommodate an external thrust bearing mounted outside the casing, including a dedicated locating shoulder and an integral thrust face obtained directly from the pinion forging. After this modification, the issue did not reoccur.
