Nantucket Regional Transit Authority 10-12 Washington Street

Existing Conditions assessment

Project number: 60767467

December 2025

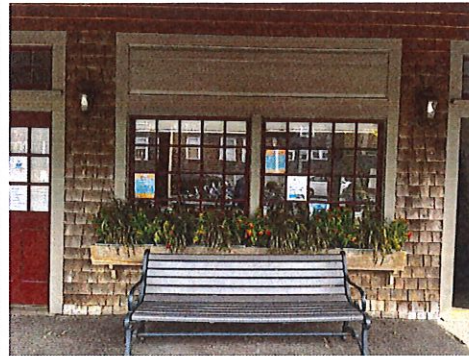
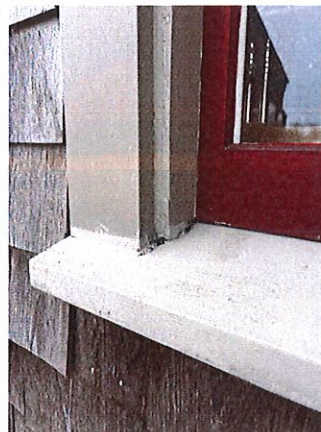
Exterior Window

Exterior windows are wood framed with single pane glazing. All windows have divided lites to meet the architectural aesthetic. Conditions of the wood sashes and frames are fair, with some signs of water intrusion.

Recommend planning to replace the windows within the next ten years with insulated, multi-pane type windows.

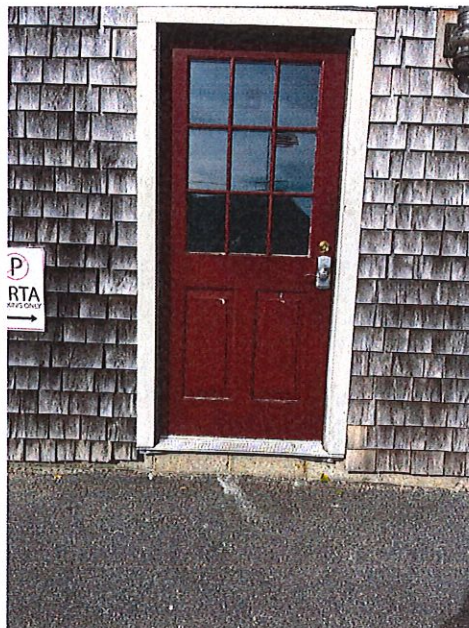
Exterior Door

Exterior doors are wood with wood frames. Three of the exterior doors have divided lights to meet the architectural aesthetic. The glazing is single pane glazing. The fourth exterior door has no glazing and serves as the primary entrance to the food pantry area.

Recommend planning to replace the exterior doors that have glazing within the next ten years with insulated type doors with insulated glazing for energy efficiency.

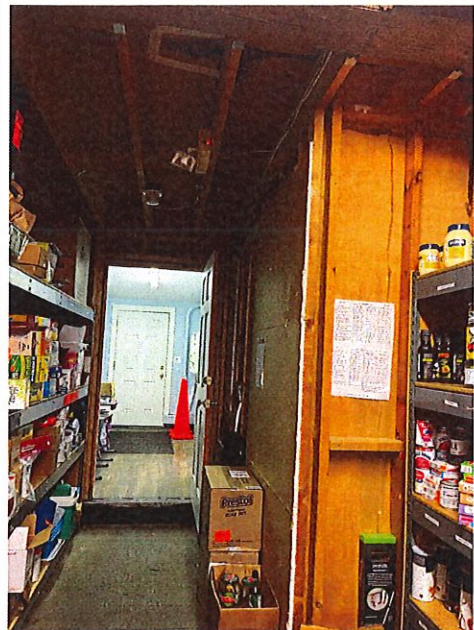
Interior Finish – Storage (note floor level)

The food pantry areas have some spaces that are finished, with painted walls and ceilings, and a storage room that has no finish. The floor in the food pantry area has multiple elevation changes, this condition should be investigated further. All the floors at the food pantry are down +4" from the NRTA offices, with some areas being lower.

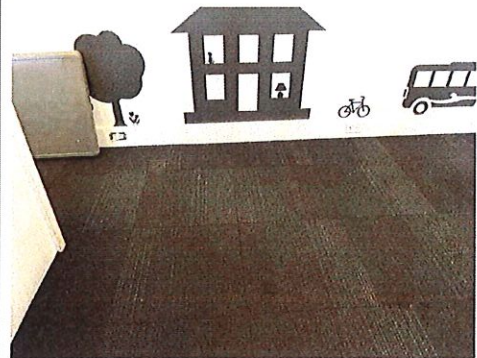
Interior Finishes – Lobby Carpet

The NRTA lobby has commercial grade carpeting tiles that are in fair condition with many stains and raised seams. The seams between tiles could be a maintenance concern.

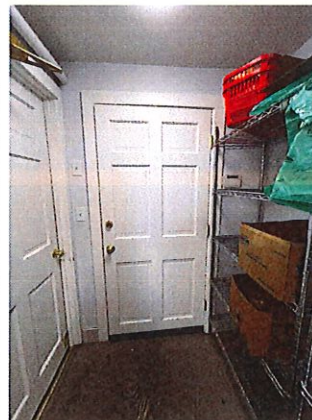
Interior door - typical

Interior doors are wood raised panel type with wood frames. The door sizes vary, both in width and height.

Hardware for the interior doors appears to be residential grade. Additionally, the hardware is knob type (non-levered) that is not accessible.

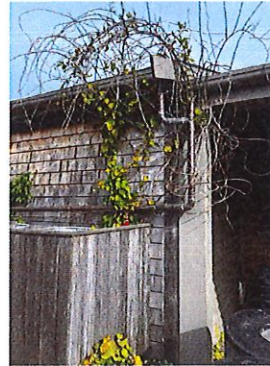
Gutters and Downspouts

The gutters and downspouts were in average condition at the time of the survey, showing only expected wear for the system's age. Useful life remains. There were vines climbing up the downspouts on the west elevation and areas where vegetation is growing within the gutters, which should be cleaned and removed before they cause damage to the gutter and roofing system.

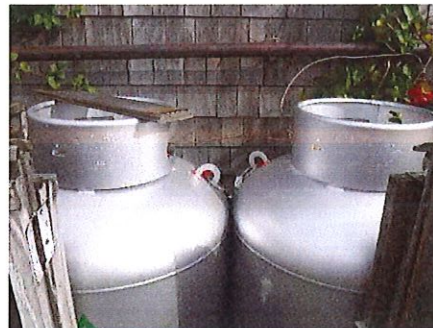
Propane Tanks

The propane system, piping and regulator are all in good condition at the time of the survey based on the visual inspection, showing only typical wear for the age of the system. No system deficiencies were observed.

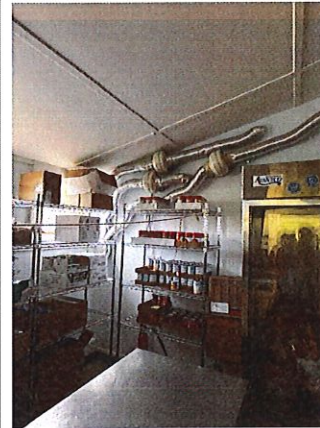
Toilet Room Exhaust Fans

Three wall mounted inline exhaust fans have been found in the pantry. These fans serve public bathrooms. The status of these fans is not functional. These fans are vented to the exterior through a 4" wall vent. All ducting for these fans if flexible duct.

1. A new HVAC system is recommended to replace the existing HVAC systems and meet new space configuration and requirements. A heat pump multi-zone system can be used to have multiple control points based on the layout and occupancy of future space. This new system would eliminate the propane system including tanks and piping.
2. The area of operable openings needs to be checked to check if it provides the required natural ventilation (4% of floor area). There were no other sources of fresh air observed.
3. Further investigate exhaust fans and restore code required exhaust for the toilet rooms.

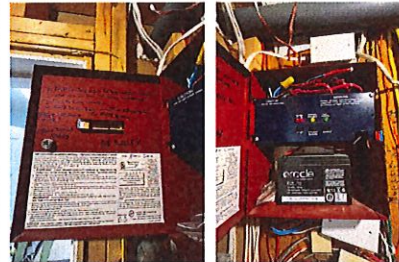
A fire alarm, fire detection, and notification system is provided for 10 Washington Street. One Fire Alarm Control Panel (FACP), a Fire-Lite Model MP-12 likely installed in the 1990s, is located adjacent to the attic stairway. The electrical panel adjacent to the Fire Alarm panel has a 15-amp circuit breaker labeled 'fire alarm system' in circuit 17. FACP indicators show one of the two red LEDs lit, indicating an active alarm condition; the yellow LED lit, indicating a trouble condition; and the green LED lit, confirming system power is present.

- Attain or perform full fire alarm system inspection and testing as required by code.
- Clear the alarm and trouble showing at the FACP.
- Confirm date and capacity of batteries, handwritten date of "8/17" was observed. Replace if expired.
- Restore monitoring service or confirm master box connection.
- Relocate / add notification devices per NFPA 72 spacing requirements.
- Add manual pull station devices per NFPA 72 requirements.
- Add carbon monoxide detectors where fuel-burning appliances exist.
- Two 120-gallon propane tanks are installed adjacent to combustible construction; per NFPA 58 and 527 CMR 1.00, the minimum required clearance is 10 feet for containers up to 500 gallons.

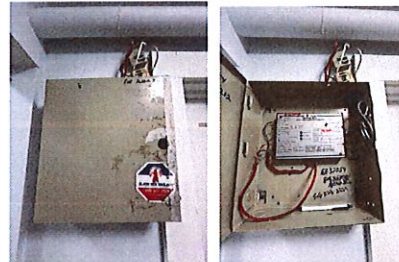
Fire Alarm Dialer

The fire alarm dialer, a Fire-Lite Model 411UD located down the hall from the FACP, shows no active LEDs, indicating it is not operational. A fire alarm master box is located on the rear exterior wall of 8 Washington Street; however, it is unknown whether the FACP is connected to this master box.

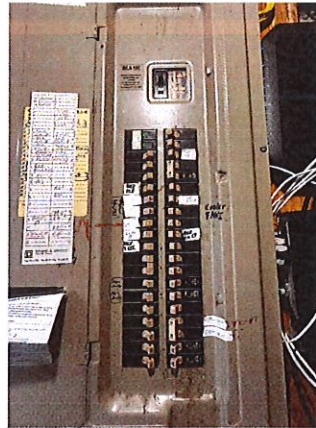
Electrical Panel

The building's electrical service is 200A, 120/240 single phase with a single 42 circuit panelboard located within the Food Pantry Area. The panel is past its useful life, recommended that it be replaced.

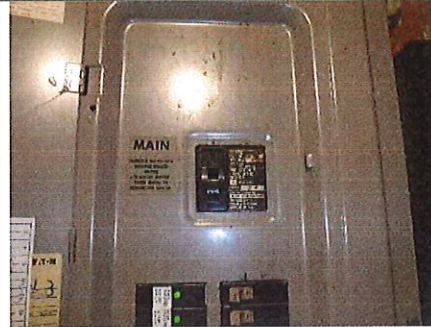
Electrical Panel

1. The electrical service should be replaced in its entirety due to age and condition.
2. Above the existing 200 amp panelboard, there are numerous romex cables installed in two large PVC conduits. The National Electrical Code does not allow for Romex cables to be installed in conduits. Also conduits by code are only allowed to have a 40% fill and based on the number of cables presently installed, the fill % appears to considerably past the 40% limit.

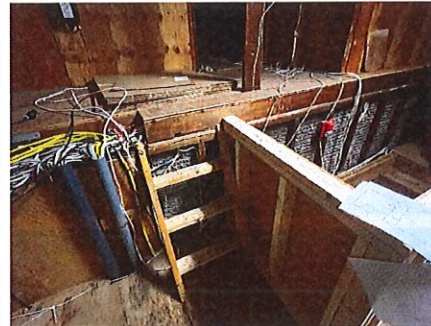
PVC Conduit / Un-supported Cabling

3. At several locations inside the facility, there are PVC conduits installed. PVC when burned gives off poisonous gas and is not recommended to be installed indoors.

4. There are numerous locations within the facility where Romex cables are improperly installed. One example is an installation in the attic where the Romex cable is secured by wrapping it around pipes. This cable also has a splice that is not contained by a required splice box.

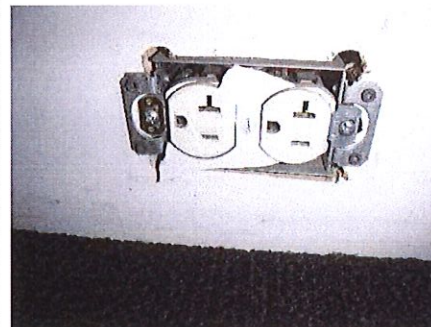
Damaged Outlet

7. There are several receptacles with missing or broken receptacle plates. Some receptacles are aged and appear to exceed their useful life expectancy.

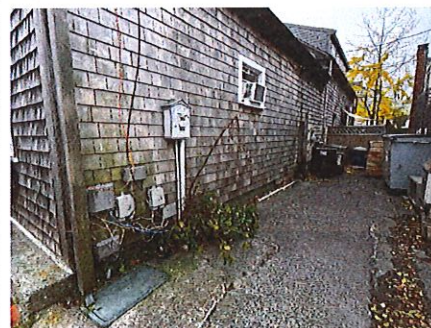
Rain Leader over Pull Box

9. There are several light fixtures that appear to not be working and will need to be replaced.
10. At the northeast corner of 8 Washington Street, where the Fire Alarm Master Box is, there is a rain leader discharging above a pull box. Unconfirmed what that pull box is for, but if it's for any electrical distribution, the drain should be re-routed.

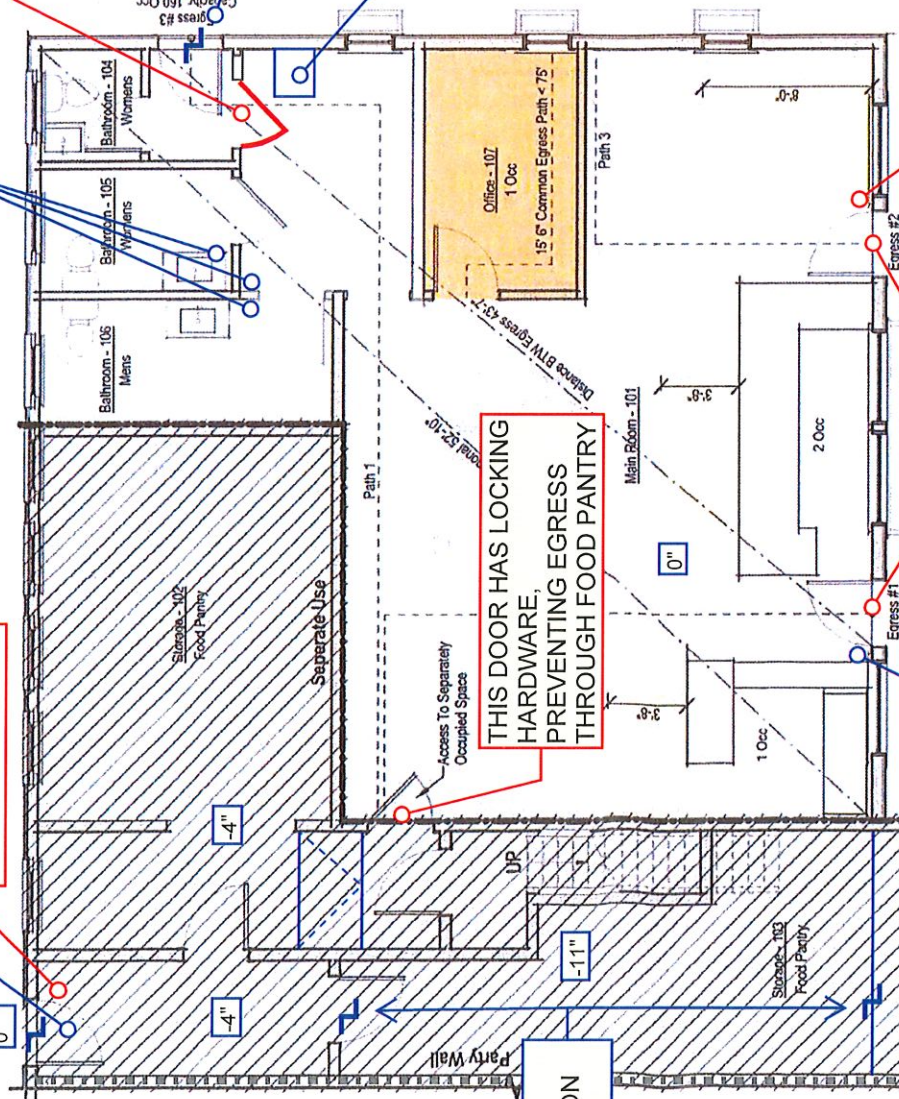
A.2

A LEVEL LANDING IS REQUIRED AT EGRESS DOORS

MISSING FIRE PULL

CONFIRM FIRE ALARM SYSTEM IS FUNCTIONAL / TESTED

EXISTING DOOR'S HAVE KNOB TYPE LOCKSETS WHICH IS NOT ACCESSIBLE, LEVER TYPE IS REQUIRED PER 521 CMR

FLOOR ELEVATION CHANGE
