Independently certified audit of the long term on-site
performance of batch anodised aluminium
extrusions and panels on exterior architectural
applications in the UK

**UNITED
ANODISERS**

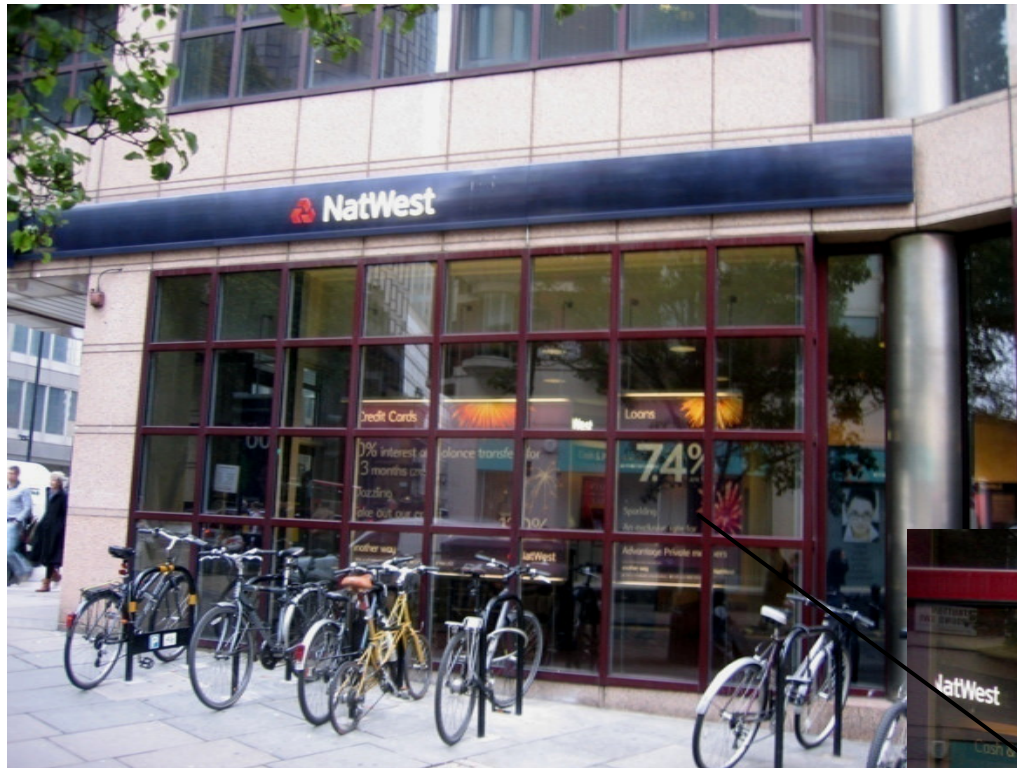
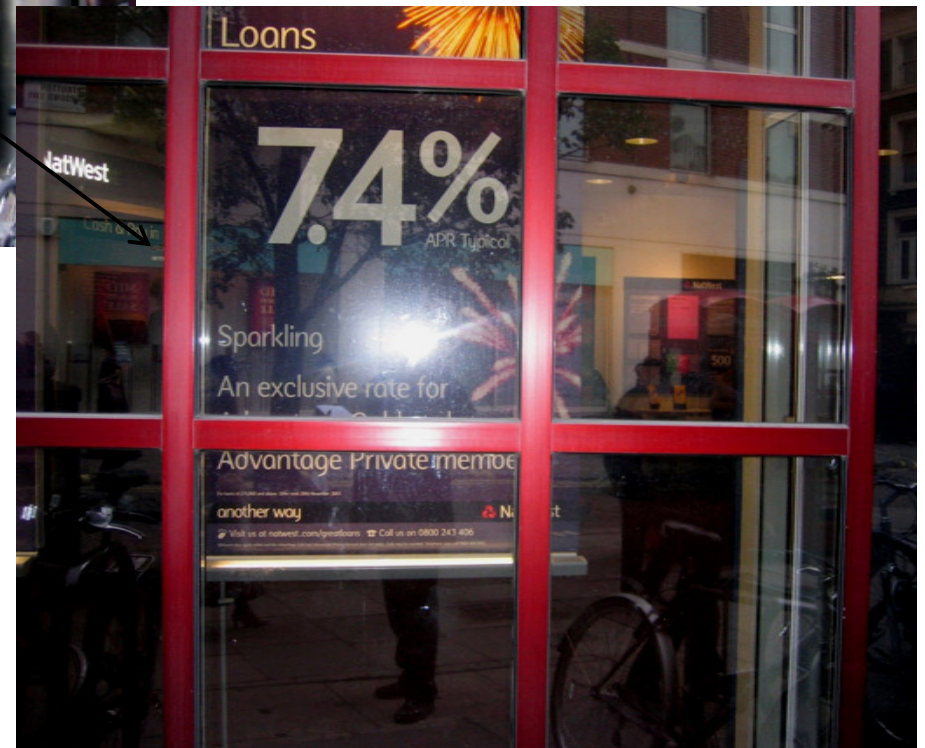
Address of building	NatWest Bank 55 Victoria Street London SW1
Date of independent inspection	October 2007
Use of building	Bank commercial offices
Date of construction	1987
Environment	High traffic density – centre of London
Evidence of regular cleaning or maintenance	No
External parts of building which were anodised	Window frames
Type of anodising	Batch
Anodiser	United Anodisers: LHT Anodisers, Uxbridge
Description of anodic colour and treatment	Sandalor Red C62/3
Original anodic film layer on anodised parts (microns)	Class 25 μm (AASC specifications)
Anodic film layer on date of independent inspection (microns)	25.5 μm
Visible signs of corrosion or surface degradation	None
Conclusion	No deterioration in anodic film protection after 20 years service life. No visible evidence of corrosion notwithstanding high density polluted urban environment. No discernable colour change

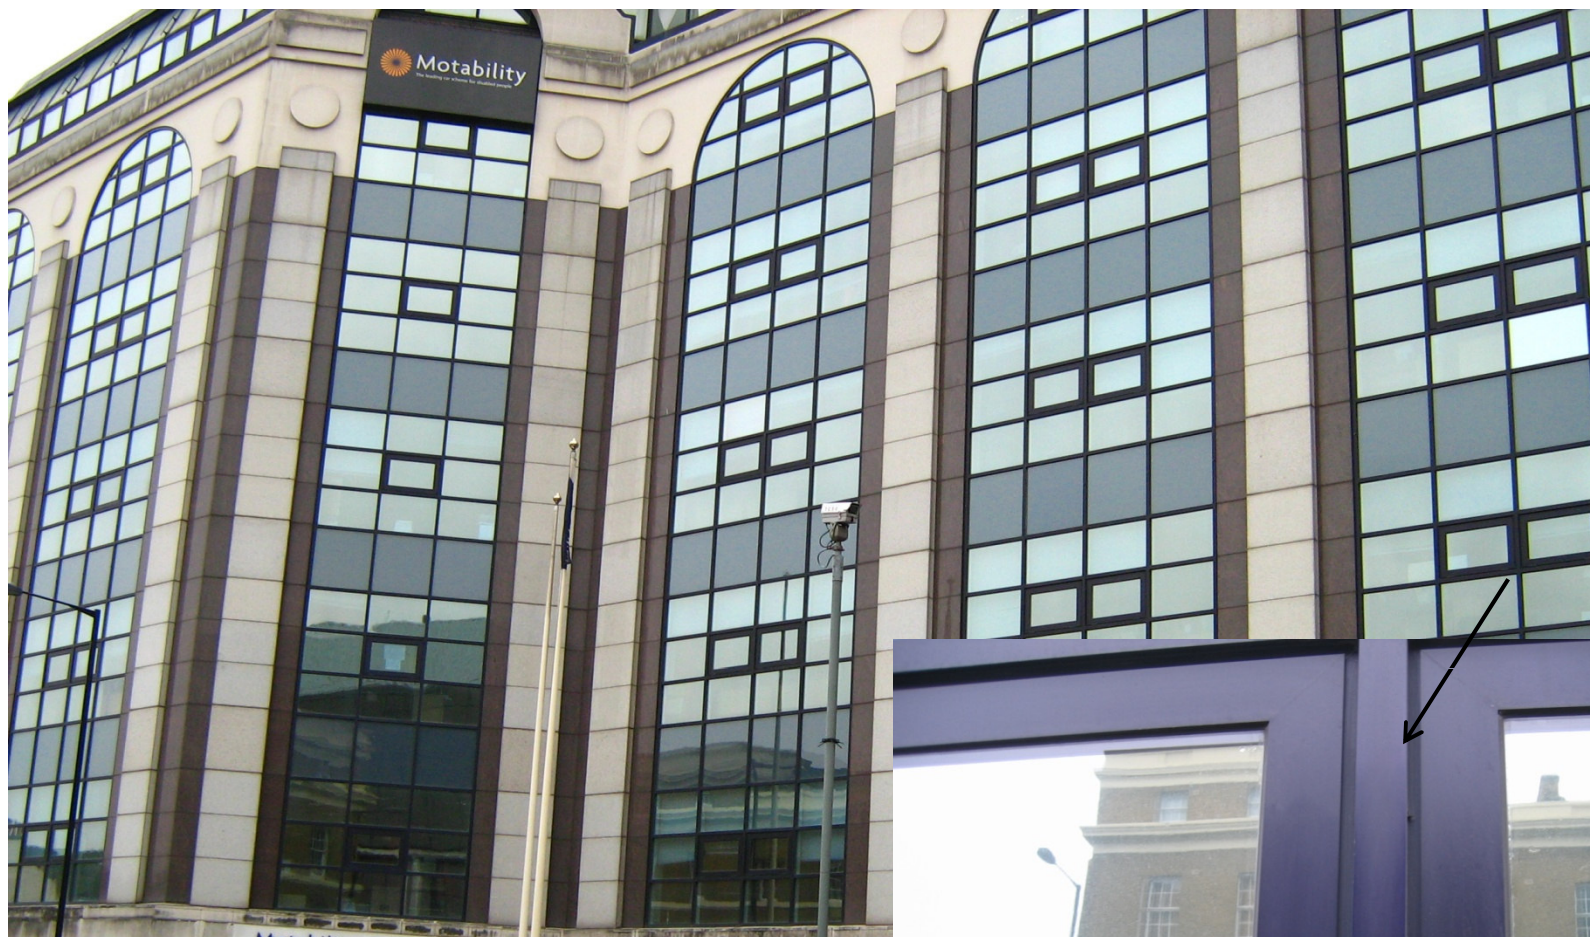
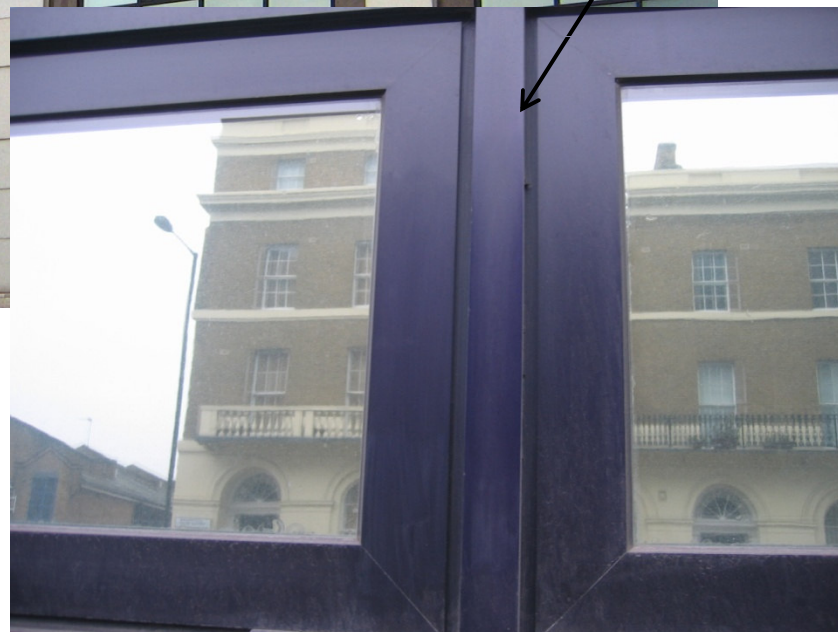
Address of building	City Gate House 22 Southwark Bridge Road London SE1
Date of independent inspection	October 2007
Use of building	Offices
Date of construction	1987
Environment	High traffic density – Centre of London – Close to the Thames river
Evidence of regular cleaning or maintenance	No
External parts of building which were anodised	Window frames
Type of anodising	Batch
Anodiser	United Anodisers: LHT Anodisers, Uxbridge
Description of anodic colour and treatment	Sandalor blue C 64/3
Original anodic film layer on anodised parts (microns)	Class 25 µm (AASC specifications)
Anodic film layer on date of independent inspection (microns)	27.6 µm
Visible signs of corrosion or surface degradation	None
Conclusion	No deterioration in anodic film protection after 20 years service life. No visible evidence of corrosion notwithstanding high density polluted urban environment. No discernable colour change.

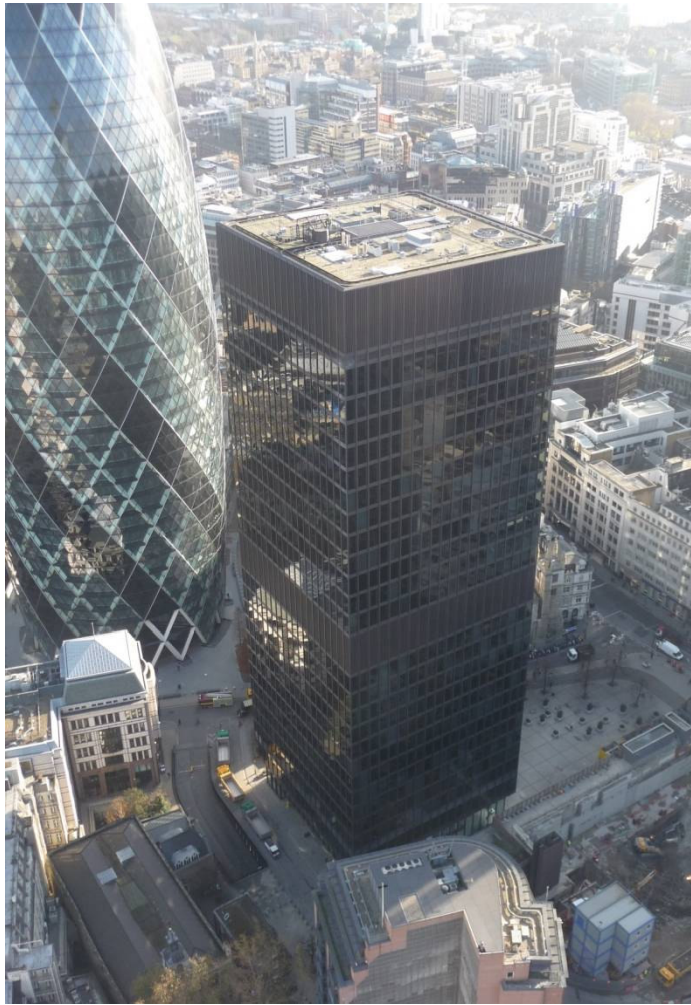
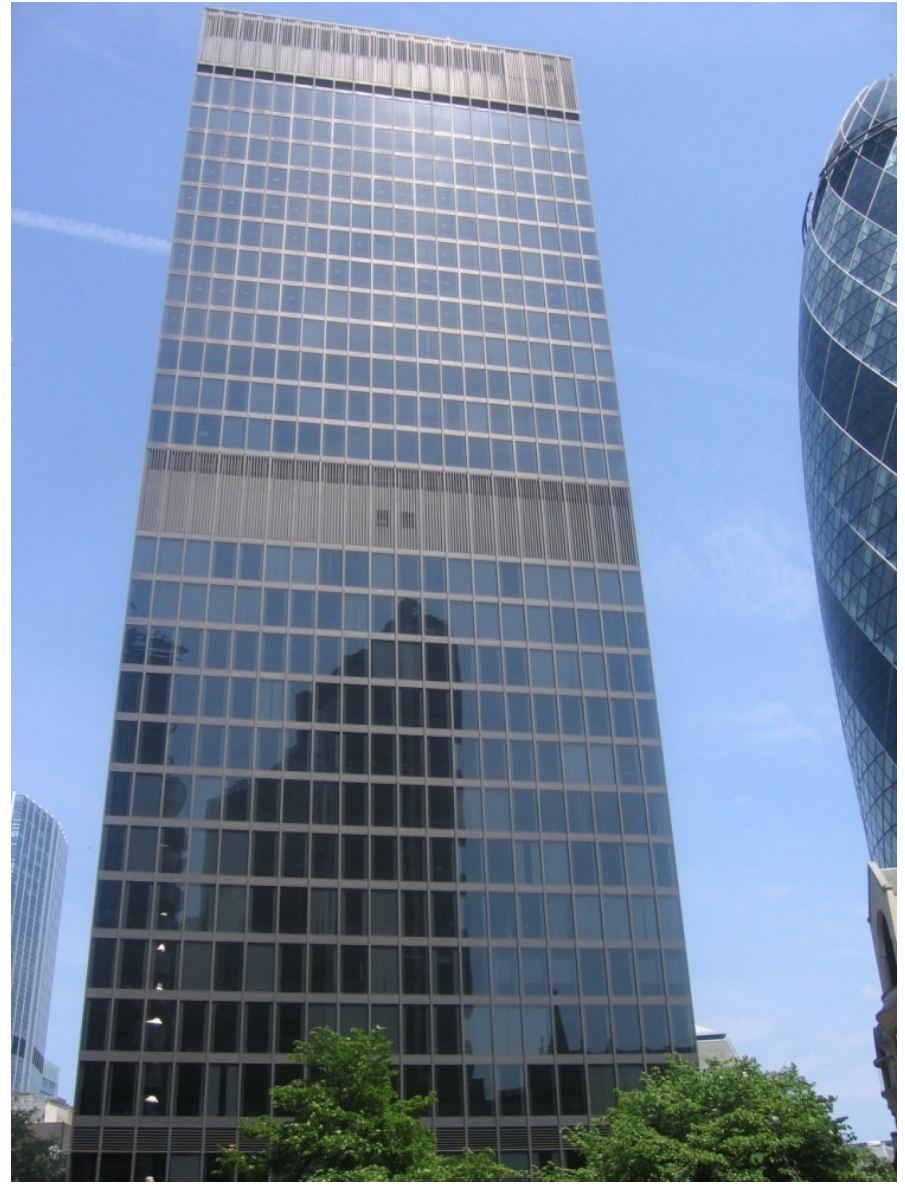
**Commercial Union HQ
St Helens, 1 Undershaft
London EC3**

Address of building	Commercial Union HQ St Helens, 1, Undershaft London EC3
Date of independent inspection	October 2007
Use of building	Offices
Date of construction	1993 (revamping after bomb attack)
Environment	High traffic density – financial district of London
Evidence of regular cleaning or maintenance	No
External parts of building which were anodised	Window frames
Type of anodising	Batch
Anodiser	United Anodisers: LHT Anodisers, Uxbridge
Description of anodic colour and treatment	Anolok II Dark blue-grey – B 717
Original anodic film layer on anodised parts (microns)	Class 25 μm (AASC specifications)
Anodic film layer on date of independent inspection (microns)	26.4 μm
Visible signs of corrosion or surface degradation	None
Conclusion	No deterioration in anodic film protection after 14 years service life. No visible evidence of corrosion notwithstanding high density polluted urban environment. No discernable colour change.

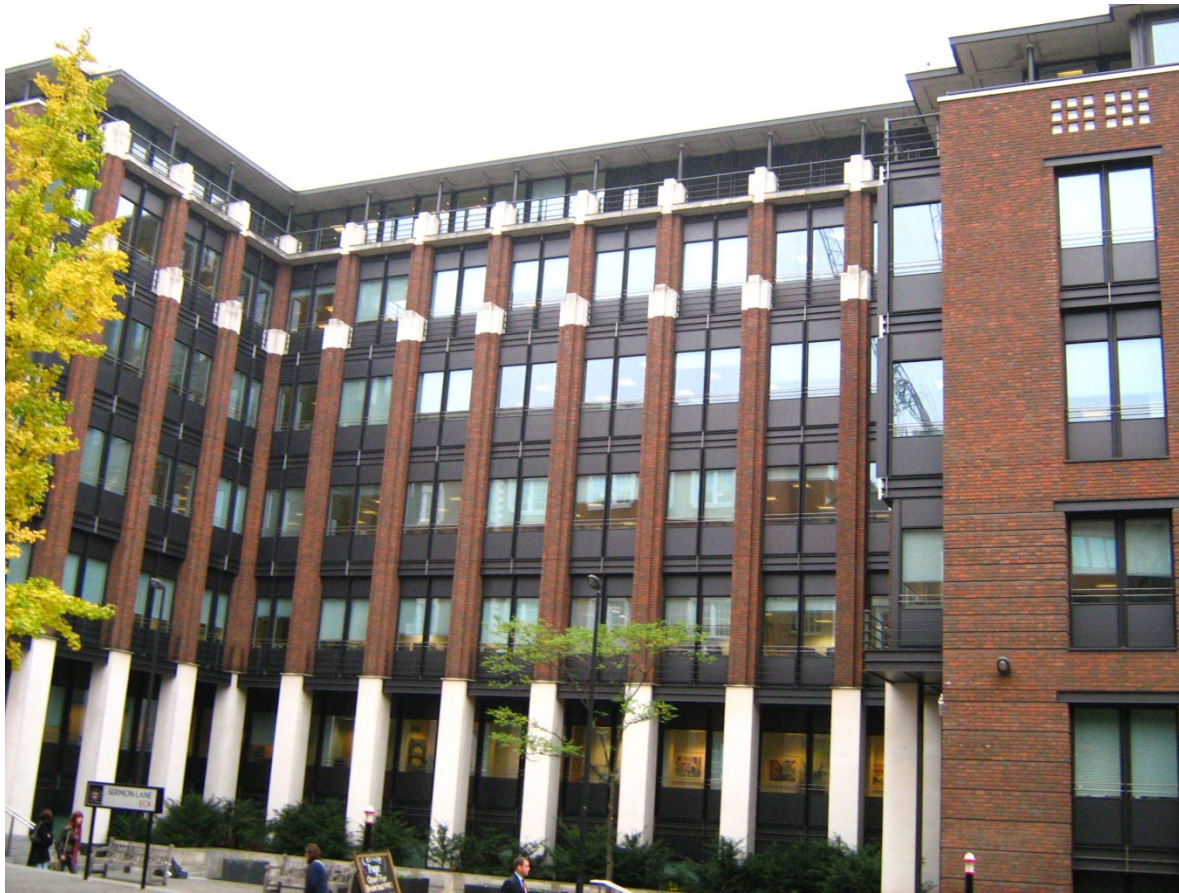
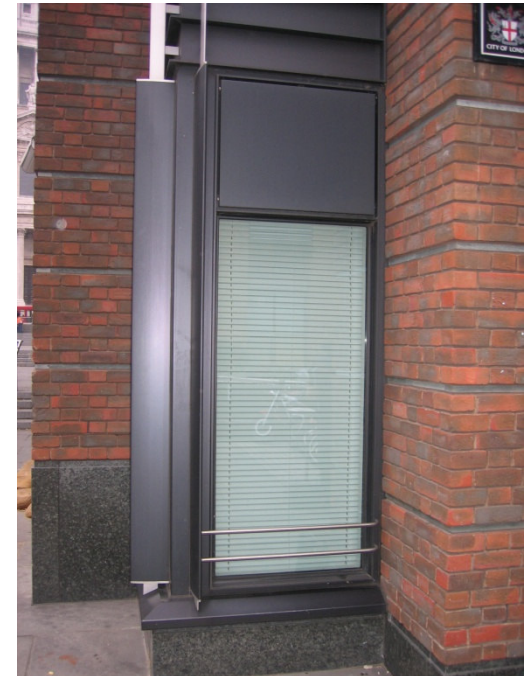
Peter's Hill House
1 Carter Lane
London EC4

Address of building	Peter's Hill House 1, Carter Lane London EC4
Date of independent inspection	October 2007
Use of building	Offices
Date of construction	1996
Environment	Urban – Quiet location – Adjacent to River Thames
Evidence of regular cleaning or maintenance	No
External parts of building which were anodised	Window frames – Window sills – Solid panels
Type of anodising	Batch
Anodiser	United Anodisers: LHT Anodisers, Uxbridge
Description of anodic colour and treatment	Anolok II Dark blue-grey B 717
Original anodic film layer on anodised parts (microns)	Class 25 µm (AASC specifications)
Anodic film layer on date of independent inspection (microns)	24.4 µm
Visible signs of corrosion or surface degradation	None
Conclusion	The very minor variation between the original treatment specification and the test result could either be due to: (1) a very limited erosion of the anodic film or (2) a variance in the anodic film layer in production. In either case, the surface protection is intact after 11 years service life. No visible evidence of corrosion. No discernable colour change.

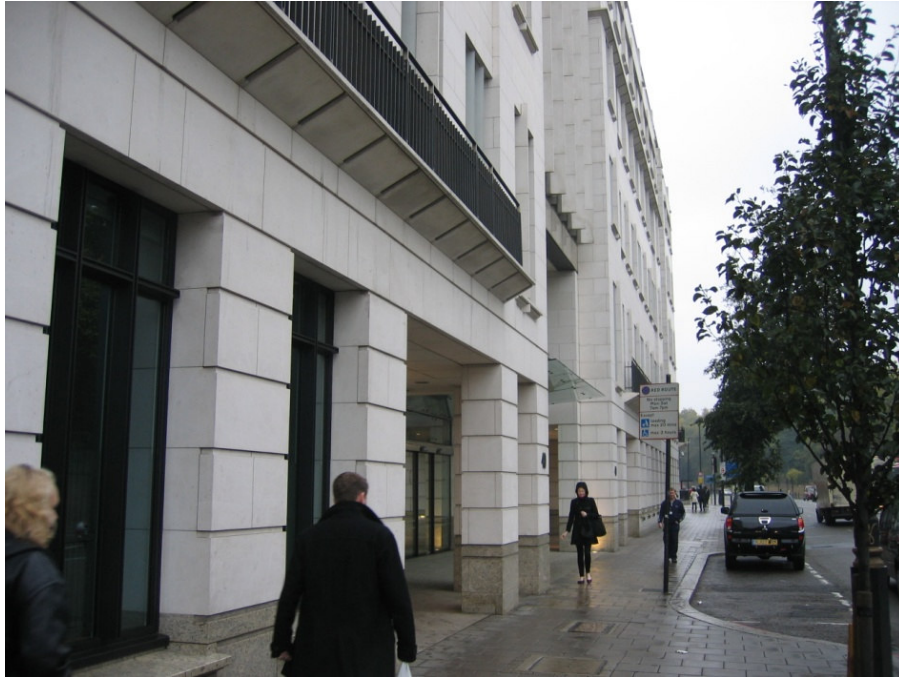
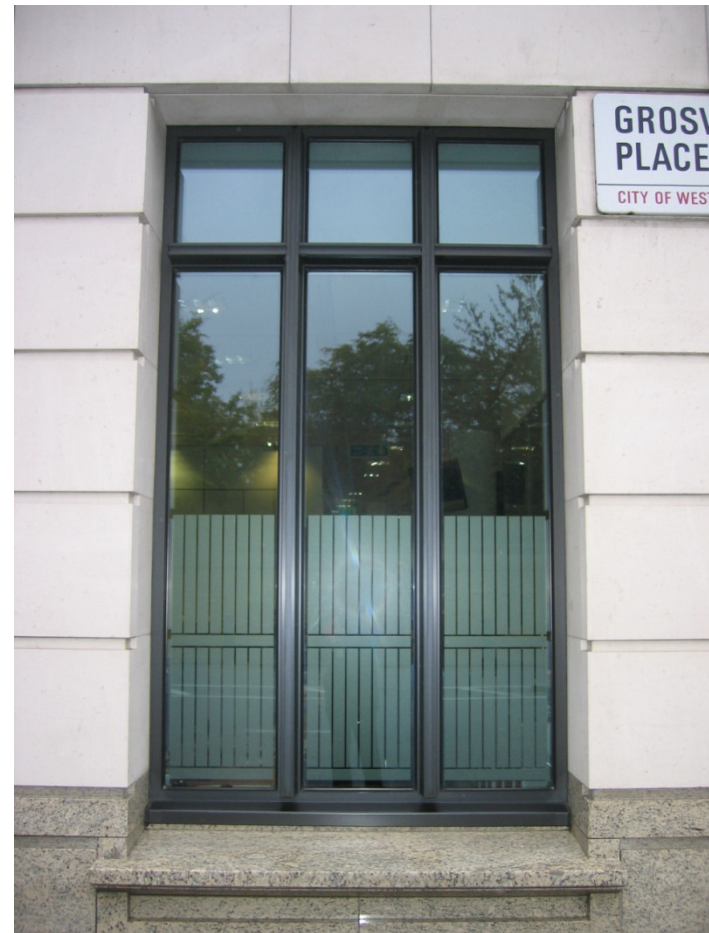
Hobart House
10 Grosvenor Place
London SW1

Address of building	Hobart House 10, Grosvenor Place London SW1
Date of independent inspection	October 2007
Use of building	Offices
Date of construction	1998
Environment	High traffic density – centre of London
Evidence of regular cleaning or maintenance	No
External parts of building which were anodised	Window frames
Type of anodising	Batch
Anodiser	United Anodisers: LHT Anodisers, Uxbridge
Description of anodic colour and treatment	Anolok II Dark blue-grey B 717
Original anodic film layer on anodised parts (microns)	Class 25 µm (AASC specifications)
Anodic film layer on date of independent inspection (microns)	26.4 µm
Visible signs of corrosion or surface degradation	None
Conclusion	No deterioration in anodic film protection after 9 years service life. No visible evidence of corrosion notwithstanding high density polluted urban environment. No discernable colour change.

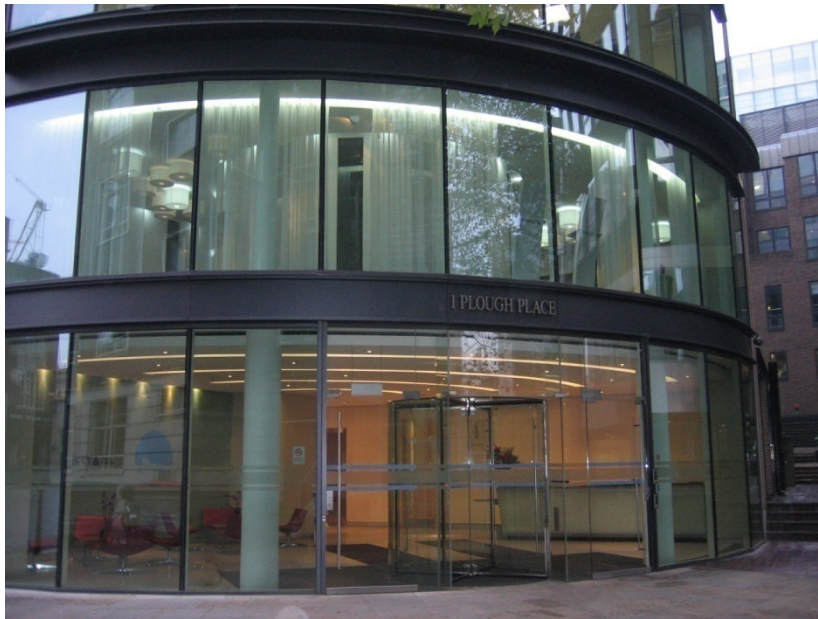
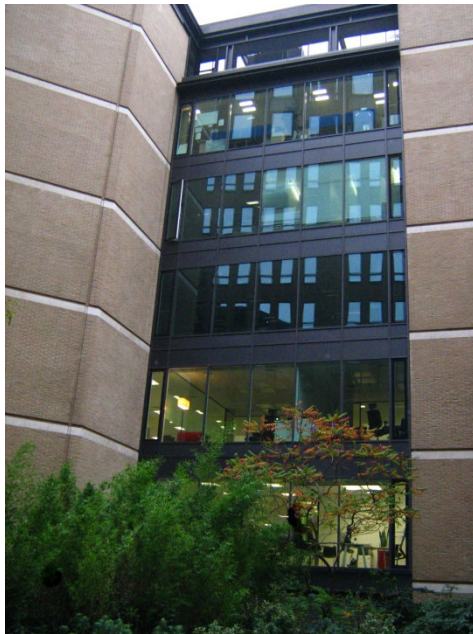
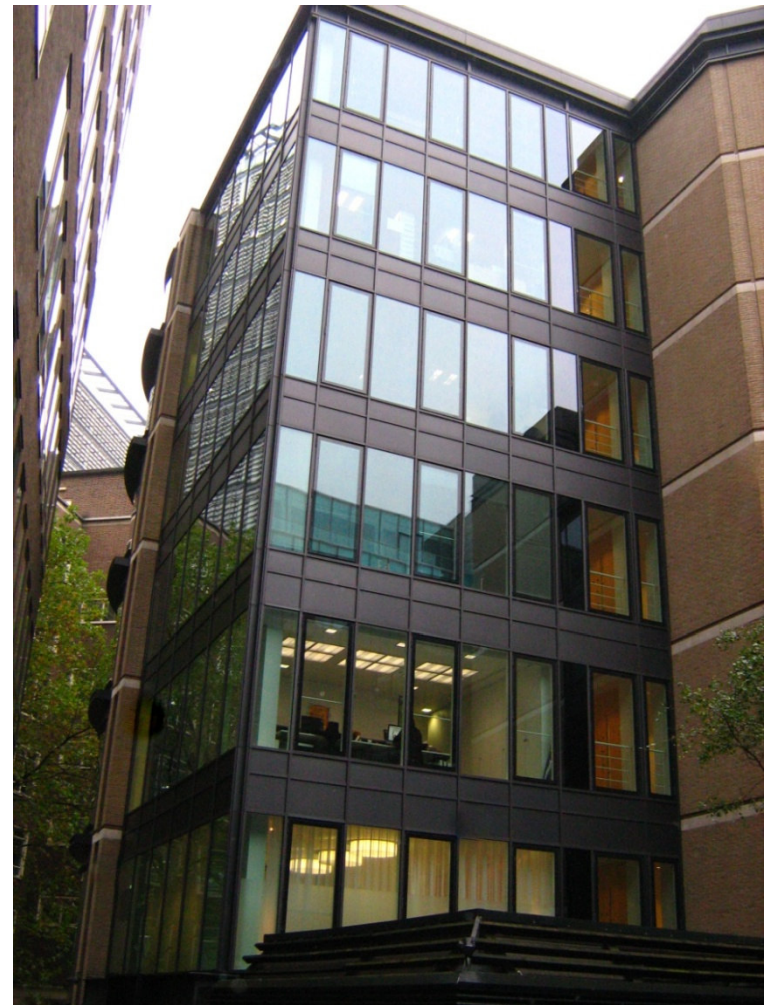
**40rty building
3-5 Plough Place
London EC4**

Address of building	40rty building 3-5 Plough Place London EC4
Date of independent inspection	October 2007
Use of building	Offices
Date of construction	2000
Environment	Urban – Quiet street – Centre of London
Evidence of regular cleaning or maintenance	No
External parts of building which were anodised	Window frames – Solid panels
Type of anodising	Batch
Anodiser	United Anodisers: LHT Anodisers, Uxbridge
Description of anodic colour and treatment	Anolok II blue-grey 715
Original anodic film layer on anodised parts (microns)	Class 25 μm (AASC specifications)
Anodic film layer on date of independent inspection (microns)	27.4 μm
Visible signs of corrosion or surface degradation	None
Conclusion	No deterioration in anodic film protection after 7 years service life. No visible evidence of corrosion. No discernable colour change.

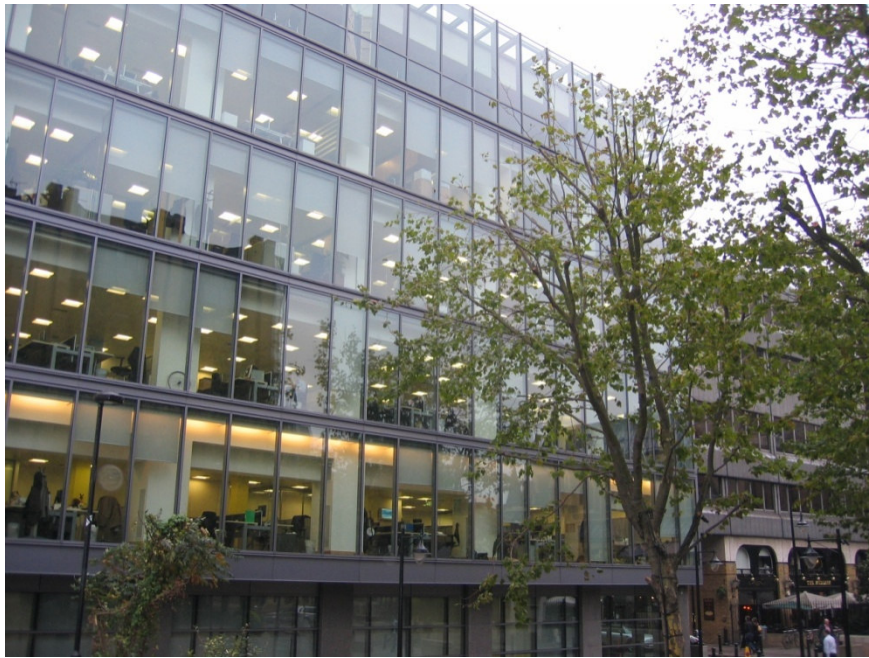
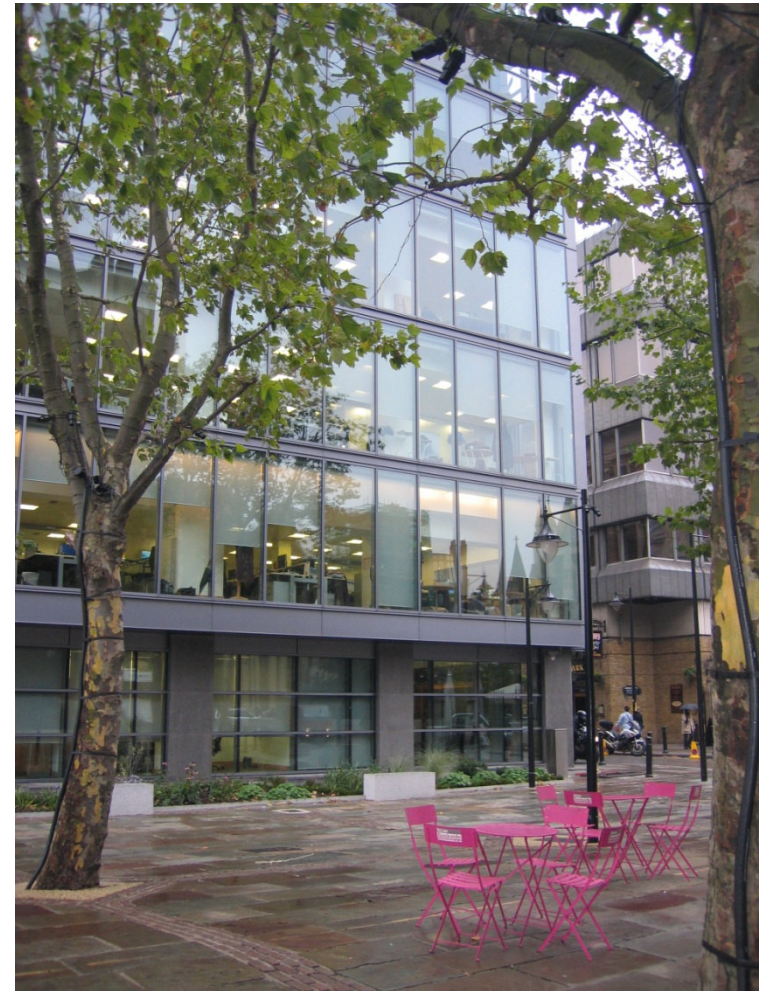
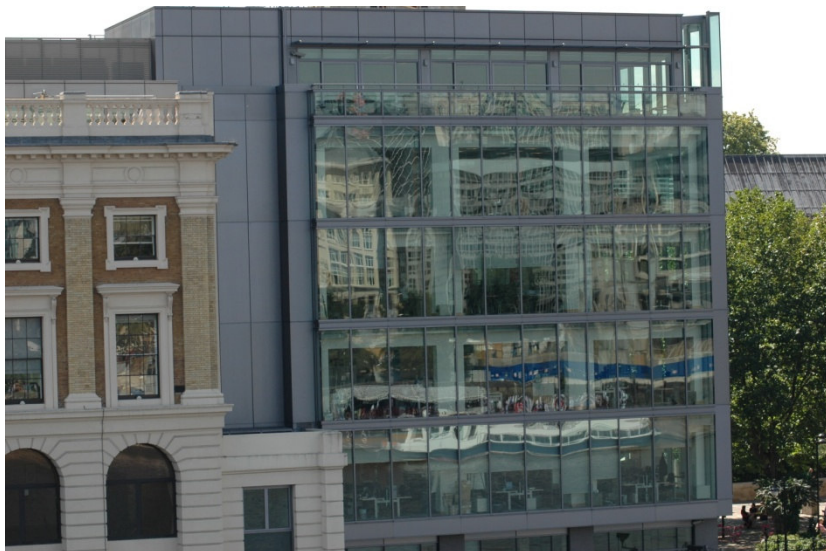
**Two London Bridge
Southwark
London SE1**

Address of building	Two London Bridge Southwark London SW1
Date of independent inspection	October 2007
Use of building	Offices
Date of construction	1997
Environment	Urban – Adjacent to the River Thames – Centre of London
Evidence of regular cleaning or maintenance	No
External parts of building which were anodised	Window frames – Solid panels
Type of anodising	Batch
Anodiser	United Anodisers: LHT Anodisers, Uxbridge
Description of anodic colour and treatment	Anolok II Pale blue-grey B 711
Original anodic film layer on anodised parts (microns)	Class 25 μm (AASC specifications)
Anodic film layer on date of independent inspection (microns)	27.8 μm
Visible signs of corrosion or surface degradation	None
Conclusion	No deterioration in anodic film protection after 10 years service life. No visible evidence of corrosion notwithstanding high density polluted urban environment. No discernable colour change.

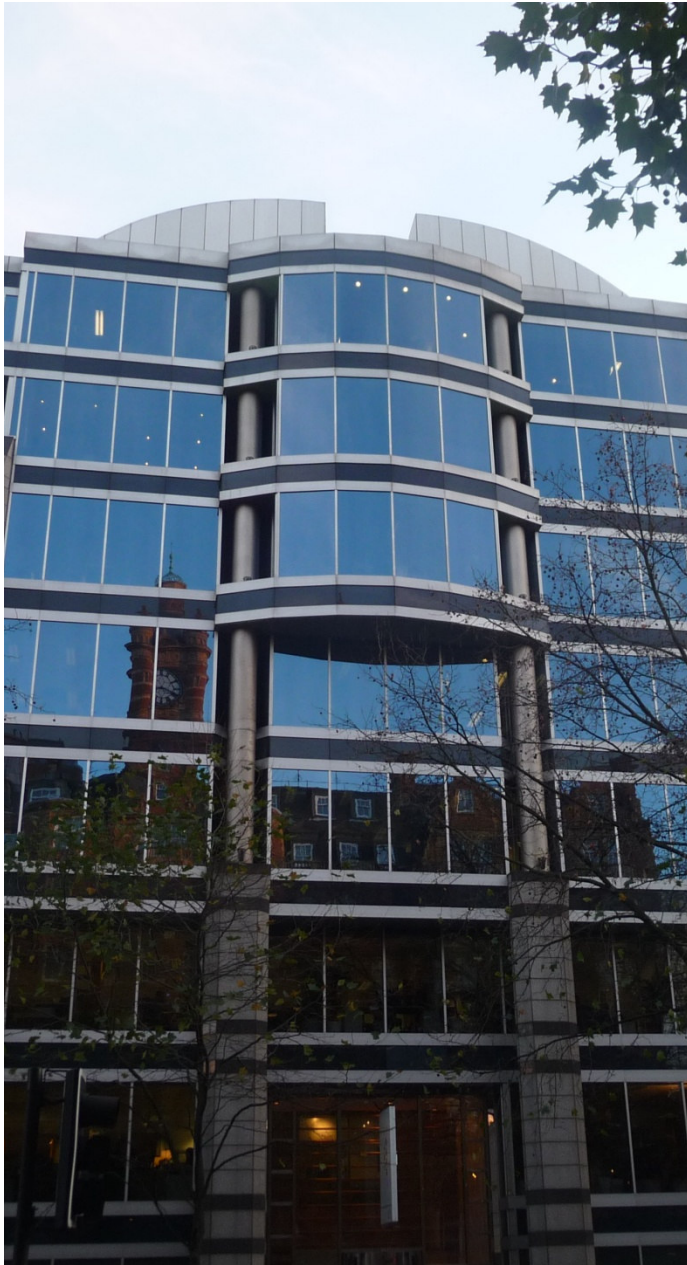
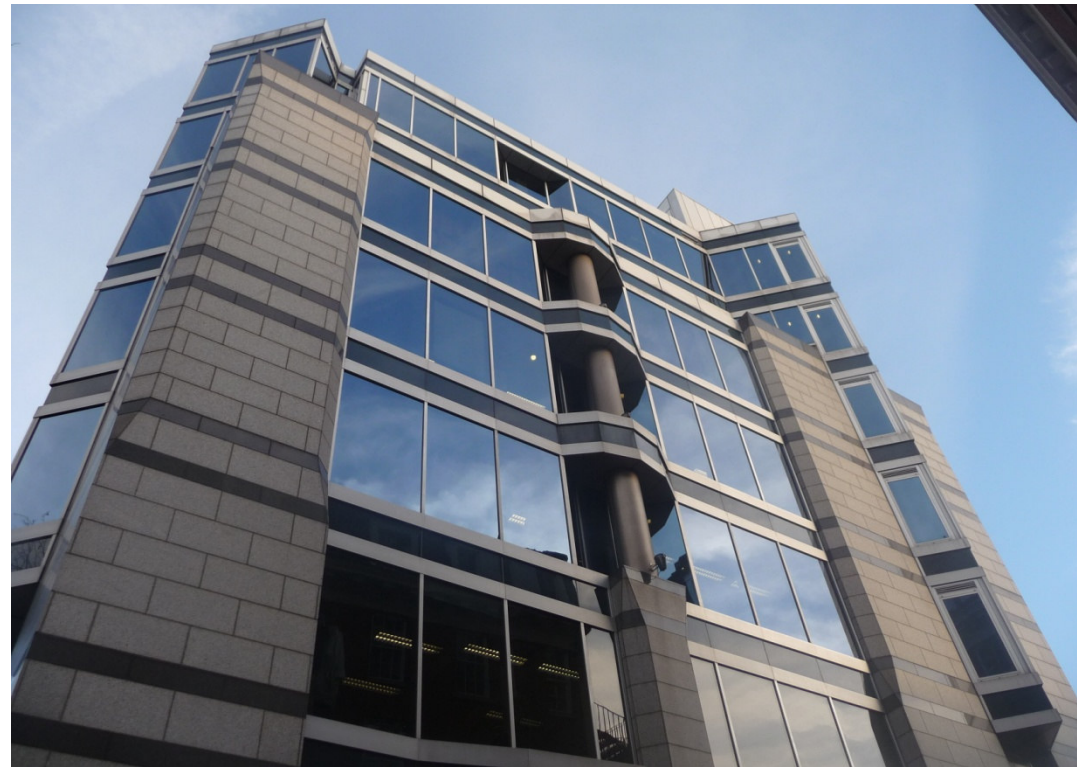
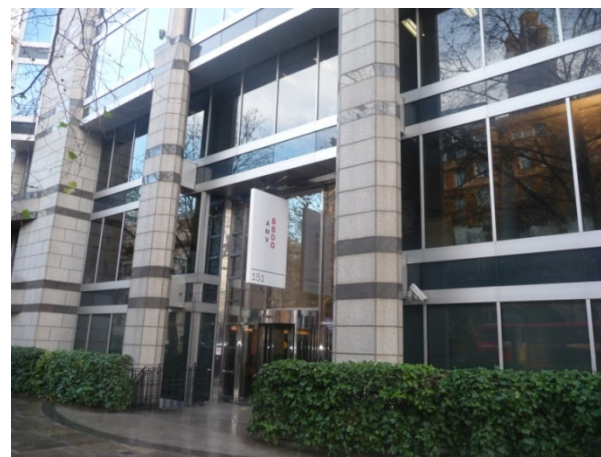
**Enford House
191 Marylebone Road
London NW1**

Address of building	Enford House 191 Marylebone Road London NW1
Date of independent inspection	November 2008
Use of building	AMV – BBDO offices
Date of construction	1990
Environment	Urban - High traffic density
Evidence of regular cleaning or maintenance	No
External parts of building which were anodised	Window frames – Solid panels
Type of anodising	Batch
Anodiser	United Anodisers: LHT Anodisers, Uxbridge
Original anodic film layer on anodised parts (microns)	Class 25 µm (AASC specifications)
Description of anodic colour and treatment	Clear Anodising
Anodic film layer on date of independent inspection (microns)	28.6 µm
Visible signs of corrosion or surface degradation	None
Conclusion	No deterioration in anodic film protection after 18 years service life. No visible evidence of corrosion notwithstanding high density polluted urban environment.

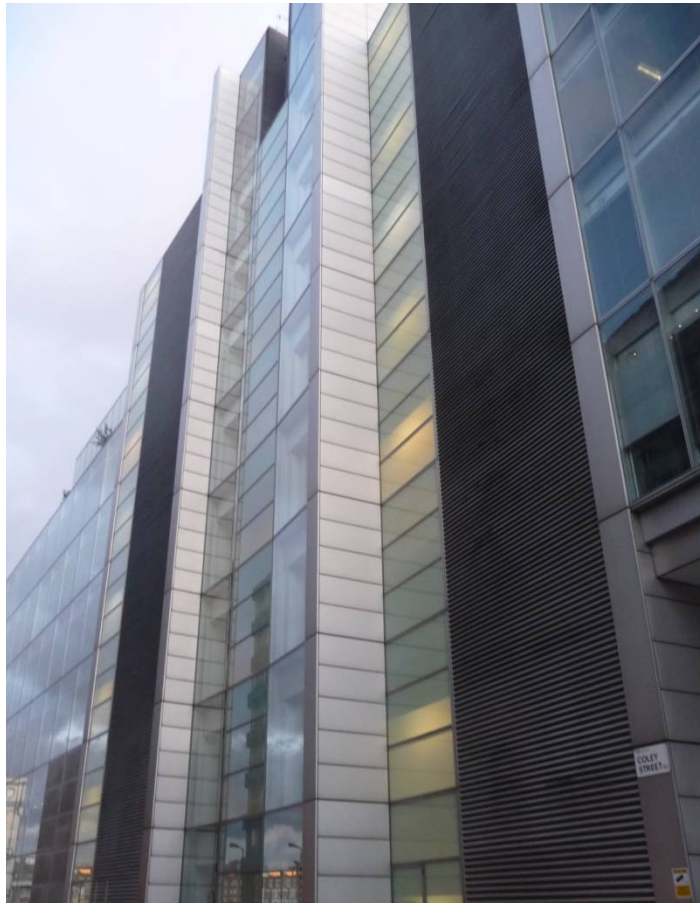
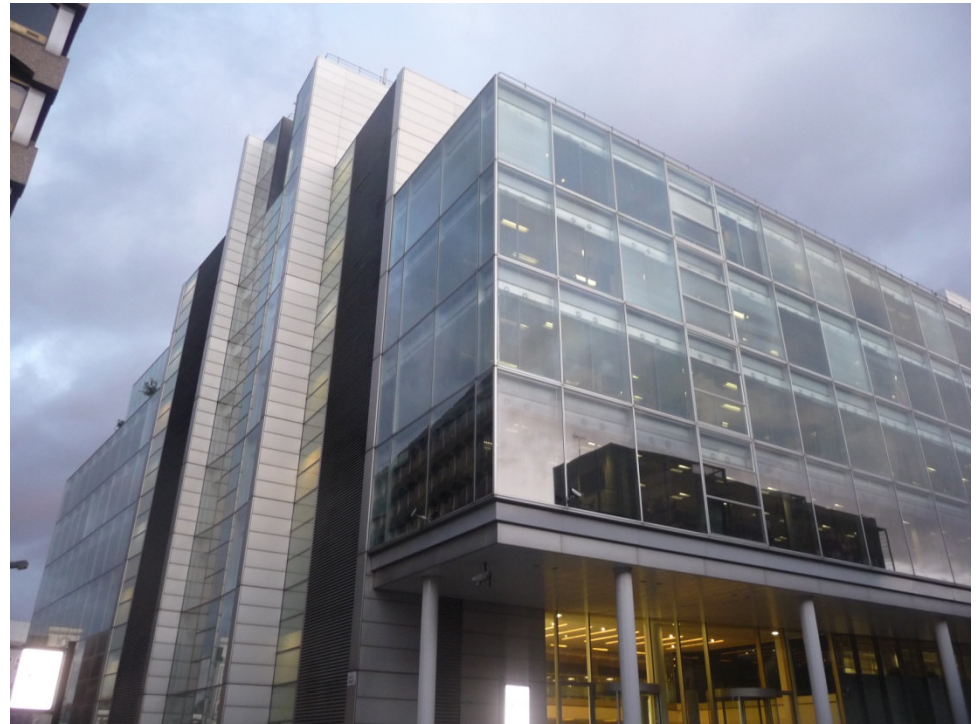
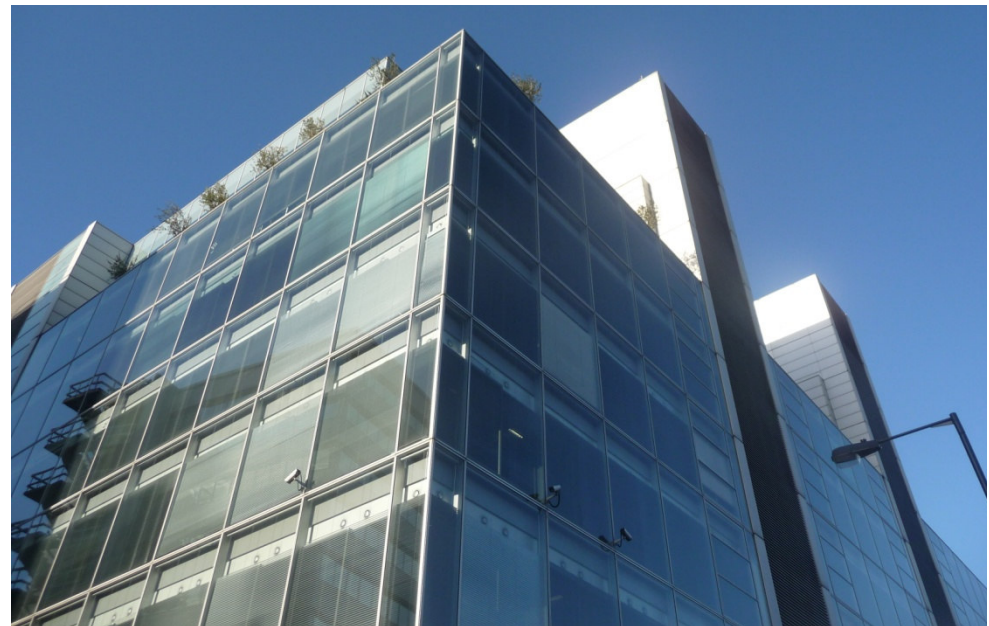
Address of building	ITN Headquarters 200 Grays Inn Road London WC1
Date of independent inspection	November 2008
Use of building	Television news company offices
Date of construction	1990
Environment	High traffic density – centre of London
Evidence of regular cleaning or maintenance	No
External parts of building which were anodised	Façade : Window frames – Solid panels Louvers : sheets
Type of anodising	Batch
Anodiser	United Anodisers: LHT Anodisers, Uxbridge
Description of anodic colour and treatment	Clear Anodising
Original anodic film layer on anodised parts (microns)	Class 25 μm (AASC specifications) for façade Not determined for louvers
Anodic film layer on date of independent inspection (microns)	28.7 μm on façade elements; 22.7 μm on louvers
Visible signs of corrosion or surface degradation	None
Conclusion	No deterioration in anodic film protection after 18 years service life. No visible evidence of corrosion notwithstanding high density polluted urban environment. Some minor colour differences between panels remain visible due to variations in the base metal supplied by the customer for anodising, which was not in accordance with the recommendations of LHT Anodisers.

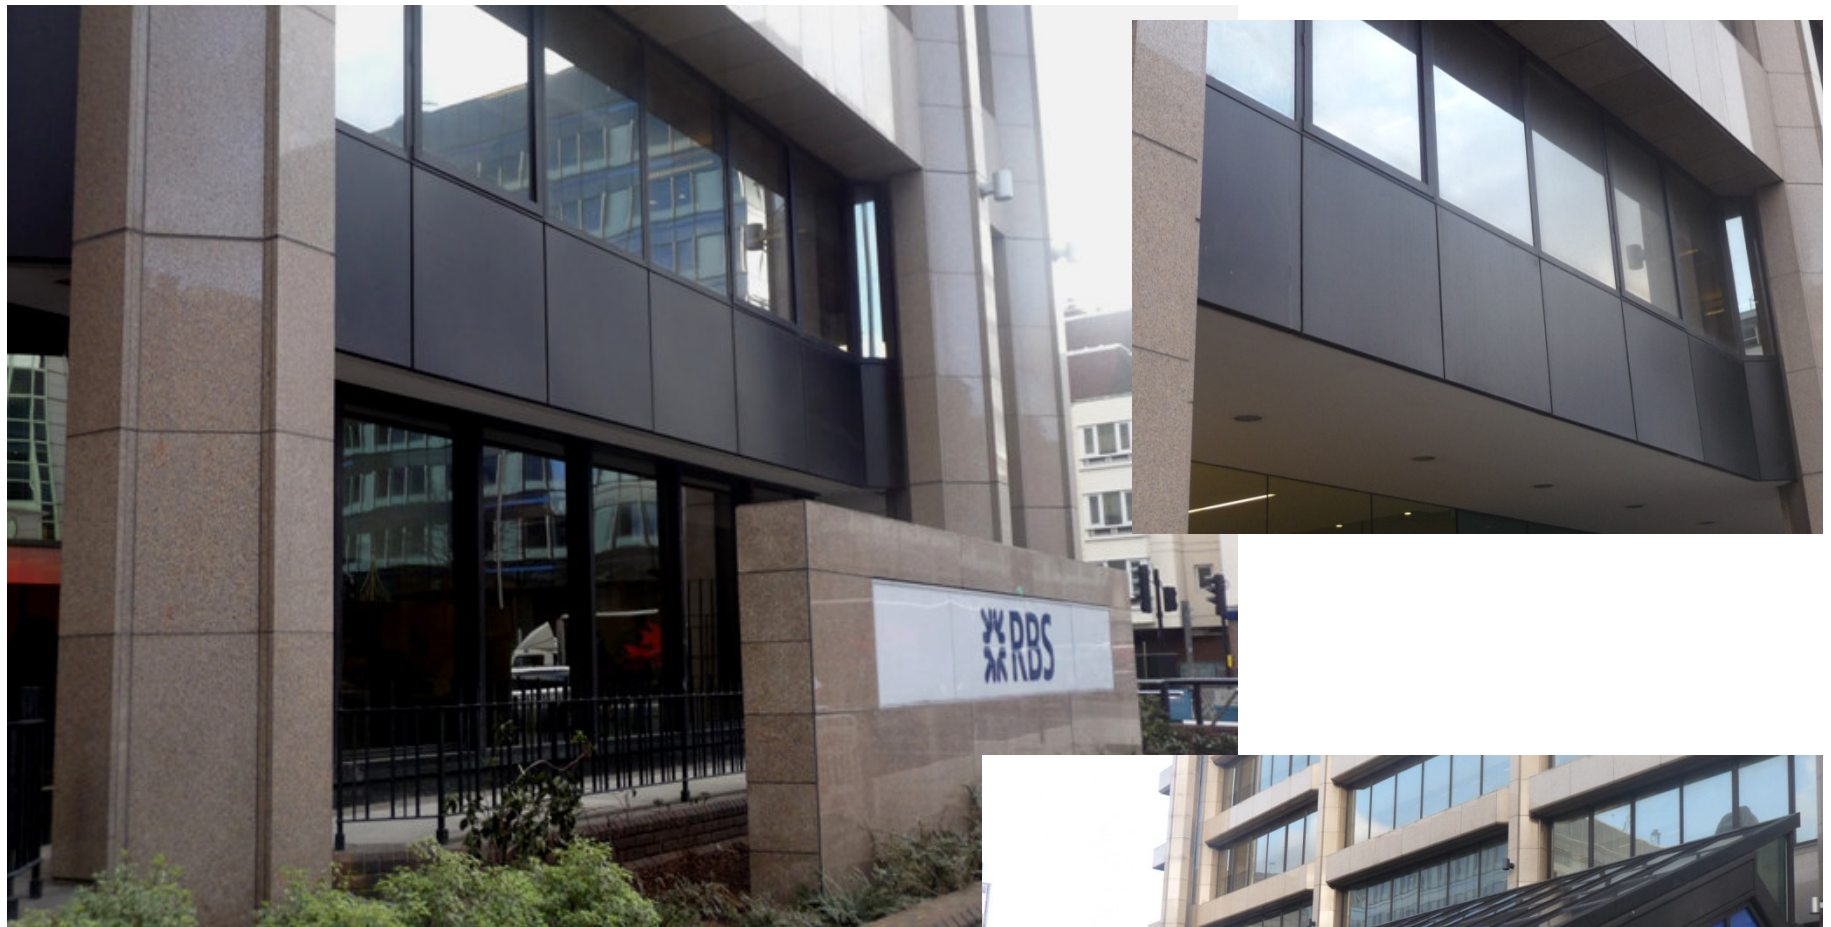
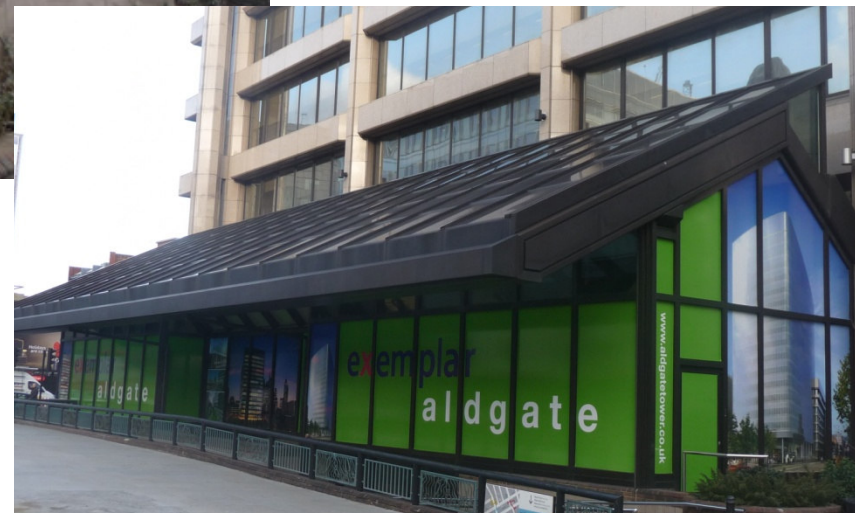
**RBS – Aldgate Building
(ex. Sedgwick centre)
Whitechapel High Street
London E1**

Address of building	RBS – Aldgate Building (ex. Sedgwick centre) Whitechapel High Street London E1
Date of independent inspection	November 2008
Use of building	Bank offices
Date of construction	1977
Environment	High traffic density – financial district of London
Evidence of regular cleaning or maintenance	No
External parts of building which were anodised	Window frames – Canopy – Solid Panels
Type of anodising	Batch
Anodiser	United Anodisers: LHT Anodisers, Uxbridge
Description of anodic colour and treatment	Anolok I - Dark Bronze – 547
Original anodic film layer on anodised parts (microns)	Class 25 µm (AASC specifications)
Anodic film layer on date of independent inspection (microns)	28.6 µm
Visible signs of corrosion or surface degradation	None
Conclusion	No deterioration in anodic film protection after 31 years service life. No visible evidence of corrosion notwithstanding high density polluted urban environment. No discernable colour change.

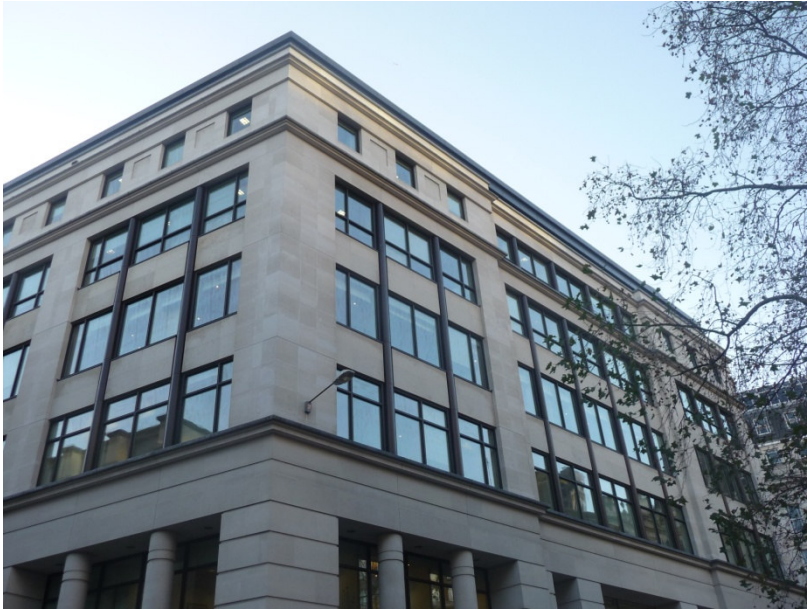
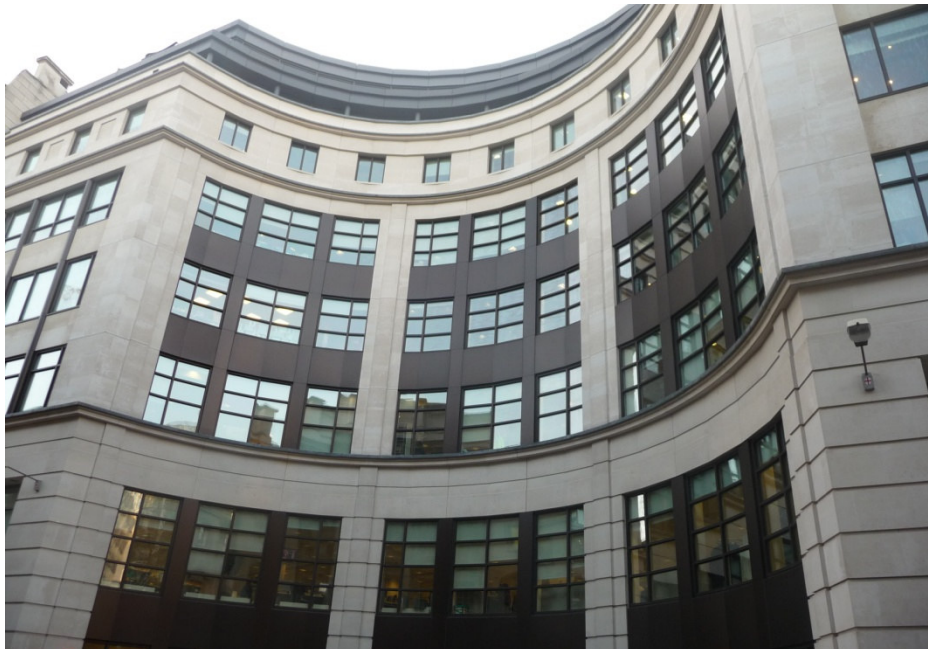
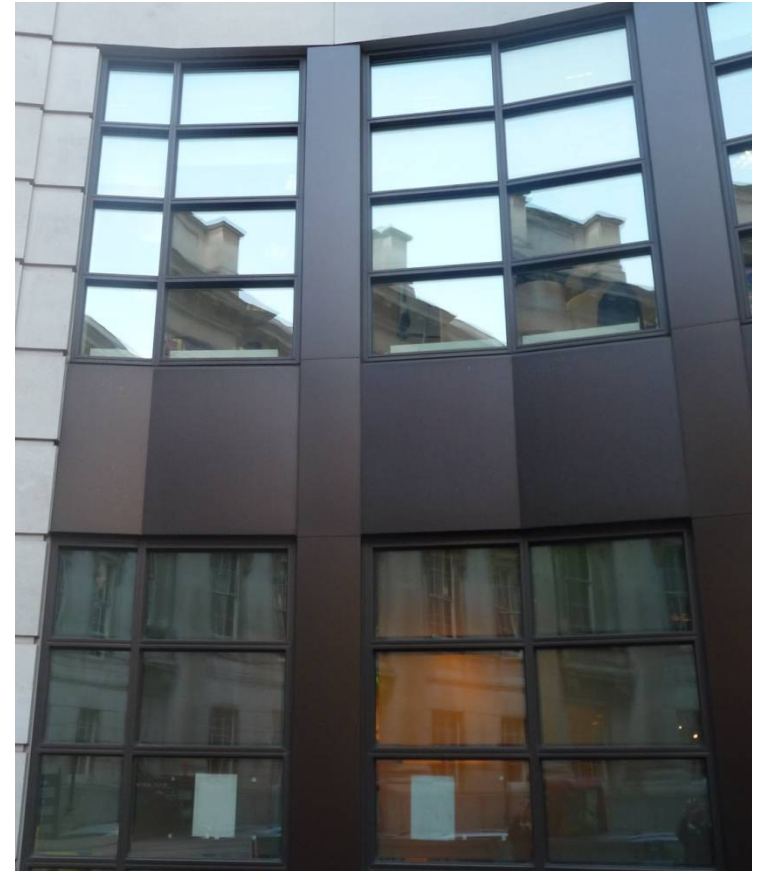
Address of building	Investec – RBS Building 2 Gresham street London EC2
Date of independent inspection	November 2008
Use of building	Bank offices
Date of construction	1996
Environment	London centre - High traffic density
Evidence of regular cleaning or maintenance	No
External parts of building which were anodised	Window frames
Type of anodising	Batch
Anodiser	United Anodisers: Heywood Metal Finishers, Huddersfield
Description of anodic colour and treatment	Anolok I Dark Bronze -547
Original anodic film layer on anodised parts (microns)	Class 25 µm (AASC specifications)
Anodic film layer on date of independent inspection (microns)	29 µm
Visible signs of corrosion or surface degradation	None
Conclusion	No deterioration in anodic film protection after 12 years service life. No visible evidence of corrosion notwithstanding high density polluted urban environment. No discernable colour change.
