Independently certified audit of the long term on-site
performance of batch anodised aluminium
extrusions and panels on exterior architectural
applications in the UK

**UNITED
ANODISERS**

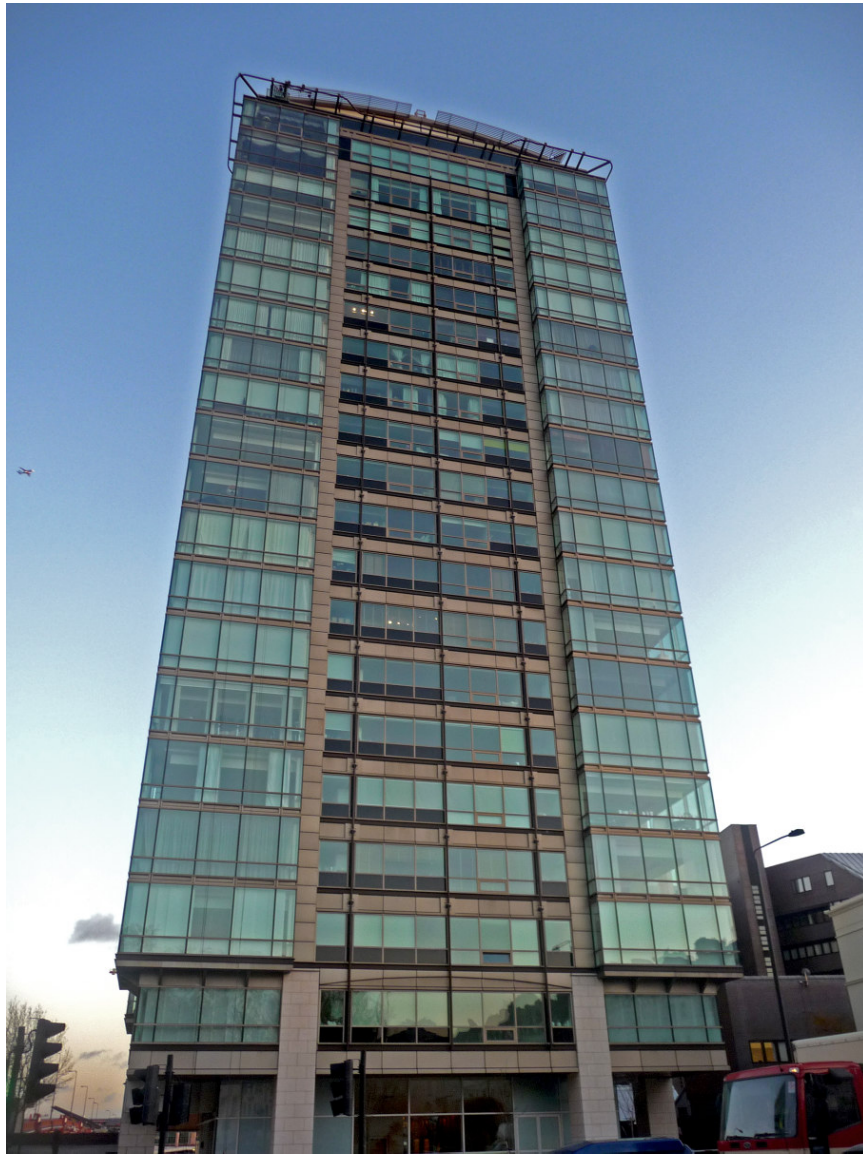
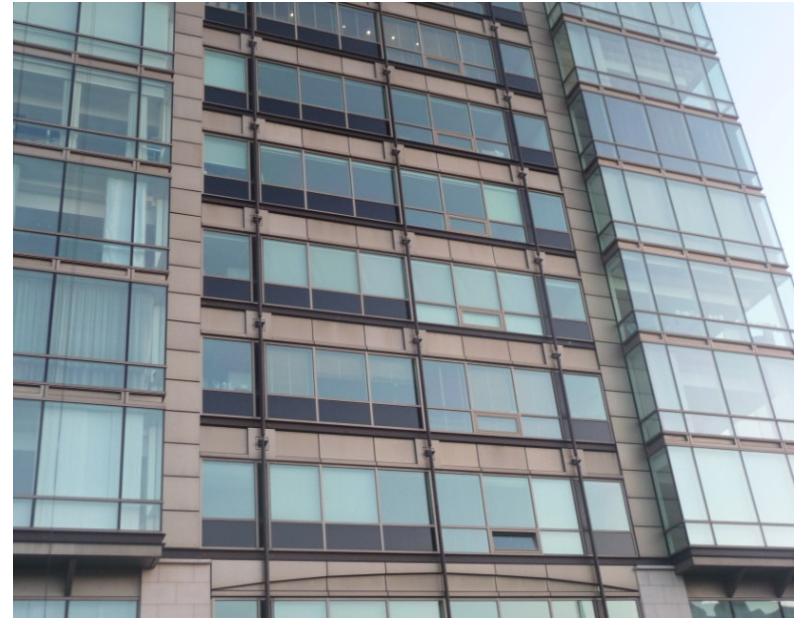
The Panoramic-Rivermill House
152 Grosvenor Road
London SW1

Address of building	The Panoramic-Rivermill House 152 Grosvenor road London SW1
Date of independent inspection	November 2008
Use of building	Residential
Date of construction	1999
Environment	Adjacent to the river Thames - Centre of London
Evidence of regular cleaning or maintenance	No
External parts of building which were anodised	Window frames – Solid Panels
Type of anodising	Batch
Anodiser	United Anodisers: LHT Anodisers, Uxbridge
Description of anodic colour and treatment	Anolok I - Light bronze 541 and dark bronze 547
Original anodic film layer on anodised parts (microns)	Class 25 µm (AASC specifications)
Anodic film layer on date of independent inspection (microns)	No accessible for measurement
Visible signs of corrosion or surface degradation	None
Conclusion	No deterioration in anodic film protection after 9 years service life. No visible evidence of corrosion notwithstanding high density polluted urban environment. No discernable colour change.

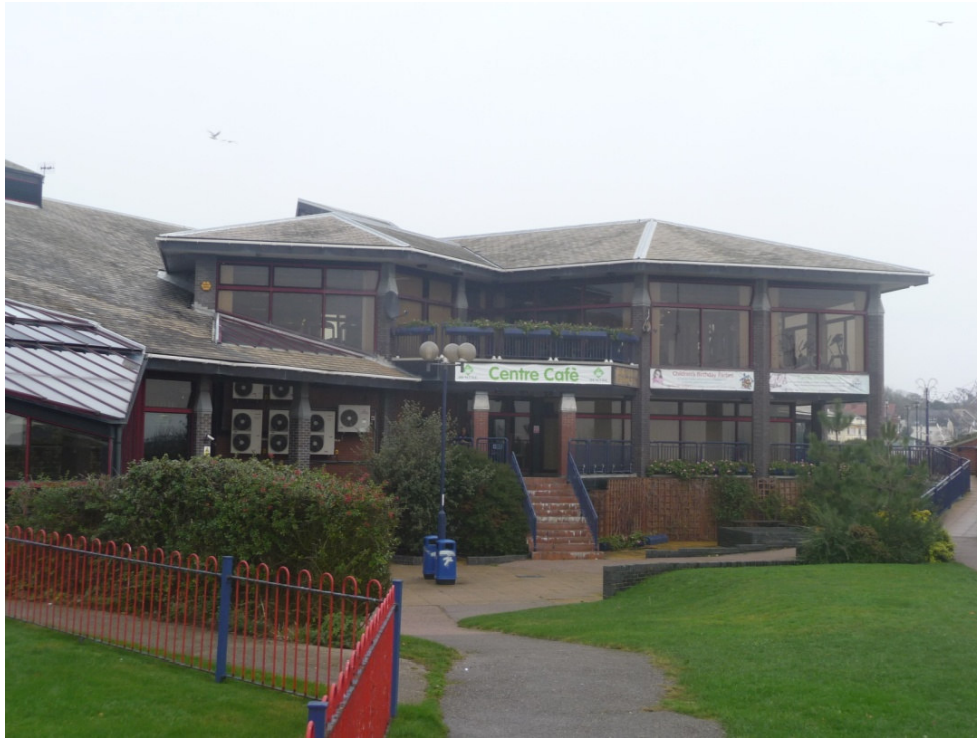
**Felixstowe Leisure Centre
Undercliff Road West,
Felixstowe, Suffolk**

Address of building	Felixstowe Leisure Centre Undercliff Road West, Felixstowe, Suffolk
Date of independent inspection	November 2008
Use of building	Leisure centre
Date of construction	1988
Environment	Marine – Sea front – North Sea coast
Evidence of regular cleaning or maintenance	No
External parts of building which were anodised	Window frames
Type of anodising	Batch
Anodiser	United Anodisers: LHT Anodisers, Uxbridge
Description of anodic colour and treatment	Sandalor Red C62/2
Original anodic film layer on anodised parts (microns)	Class 25 μm (AASC specifications)
Anodic film layer on date of independent inspection (microns)	29.1 μm
Visible signs of corrosion or surface degradation	None
Conclusion	No deterioration in anodic film protection after 20 years service life. No visible evidence of corrosion notwithstanding marine environment. No discernable colour change.

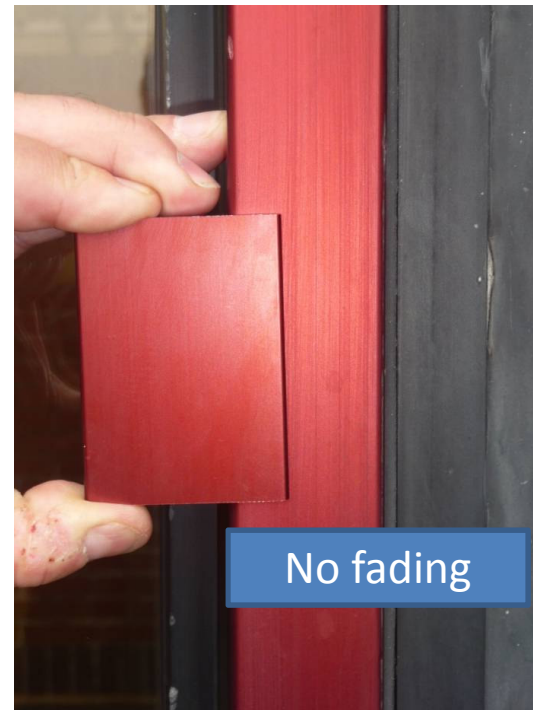
No fading

No corrosion on
anodised Al

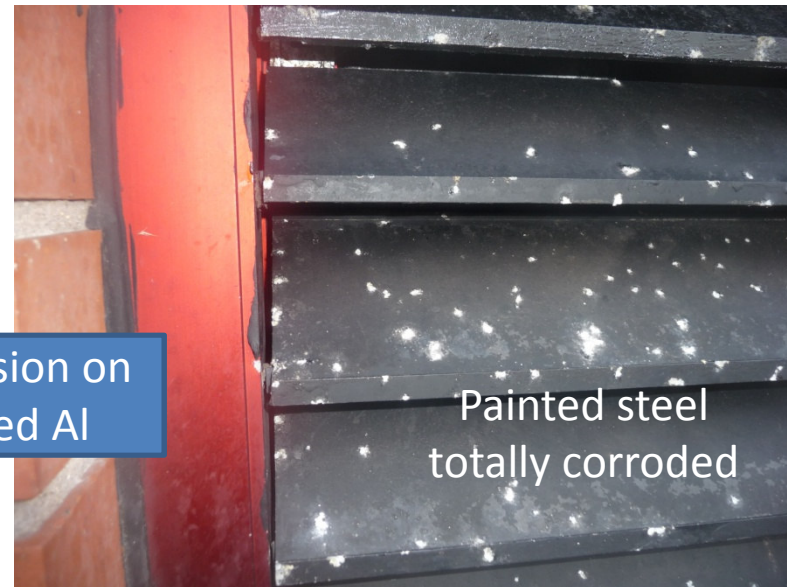
Painted steel
totally corroded

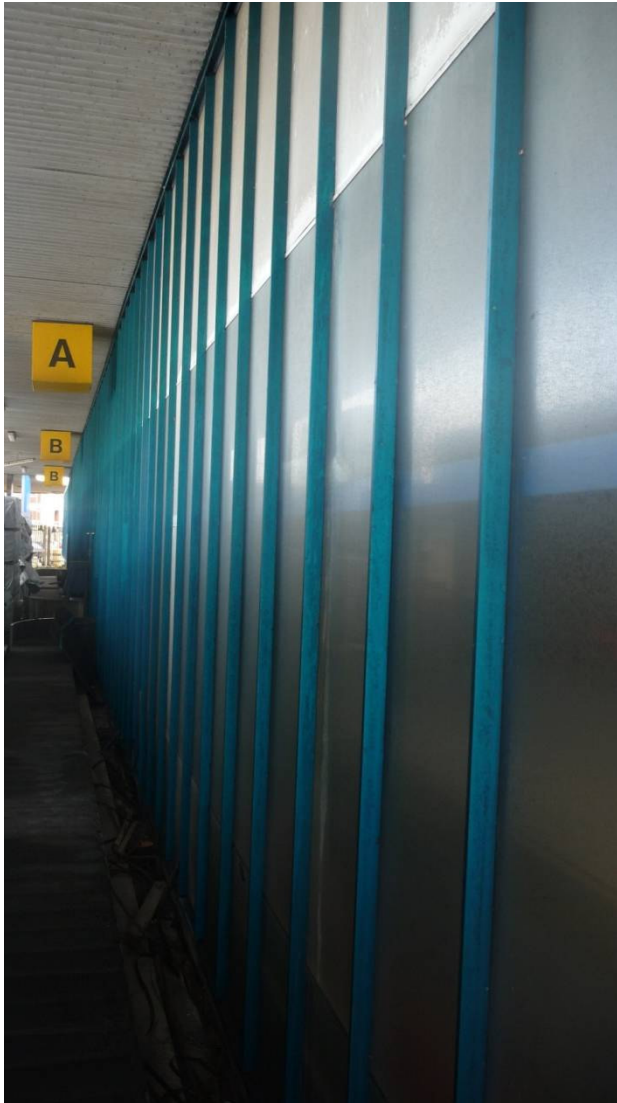
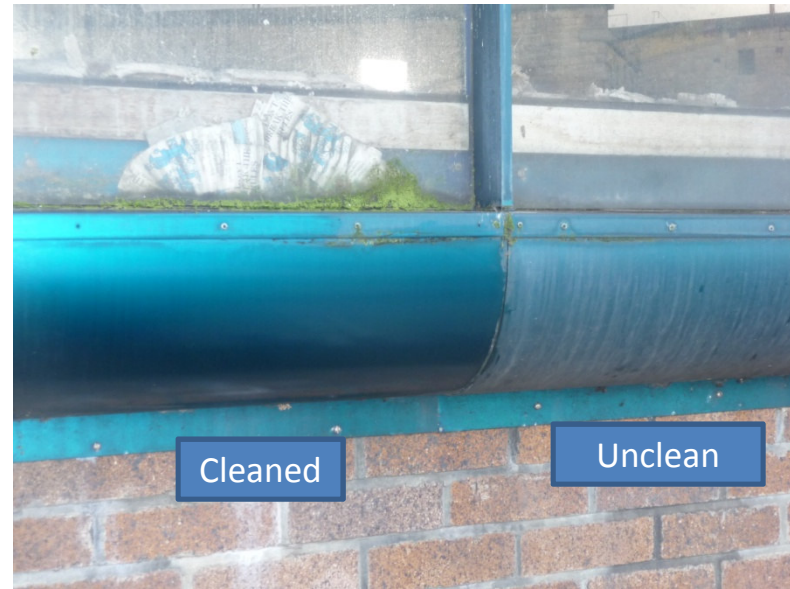
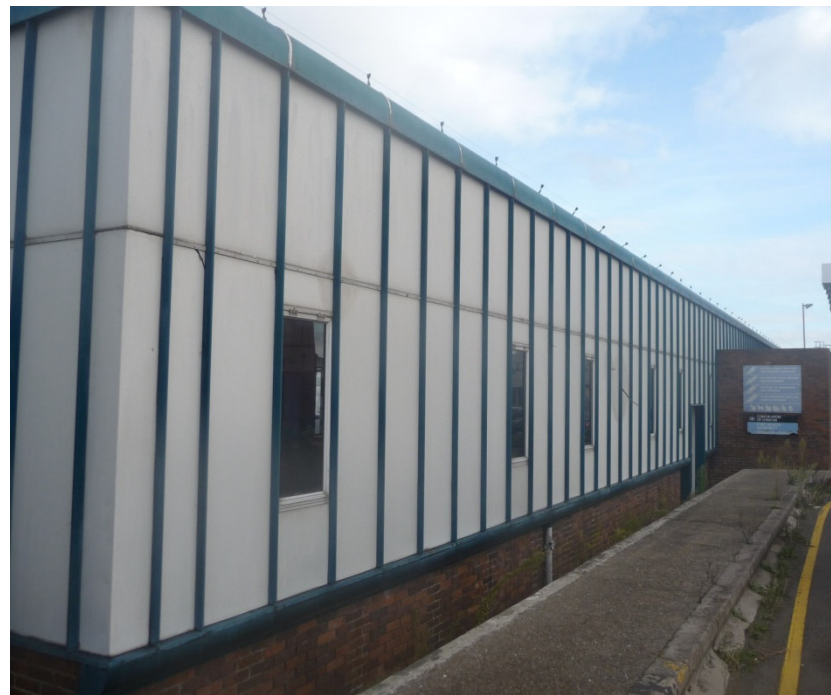
**Ex. Olau Line Offices
Port of Sheerness
Sheerness , Kent**

Address of building	Ex. Olau Line Offices Port of Sheerness Sheerness, Kent
Date of independent inspection	November 2008
Use of building	Shipping line offices
Date of construction	1985
Environment	Marine – Harbour front - Industrial – English Channel coast
Evidence of regular cleaning or maintenance	No (disaffected since 1994)
External parts of building which were anodised	Window frames – Sheets (curved)
Type of anodising	Batch
Anodiser	United Anodisers: LHT Anodisers, Uxbridge
Description of anodic colour and treatment	Sandalor Turquoise C63/3
Original anodic film layer on anodised parts (microns)	Class 25 μm (AASC specifications)
Anodic film layer on date of independent inspection (microns)	28.1 μm
Visible signs of corrosion or surface degradation	Very limited in a single place – all other materials in the neighbourhood are severely corroded
Conclusion	No deterioration in anodic film protection after more than 14 years service life. Small isolated area of corrosion. Front line marine environment. No discernable colour change.

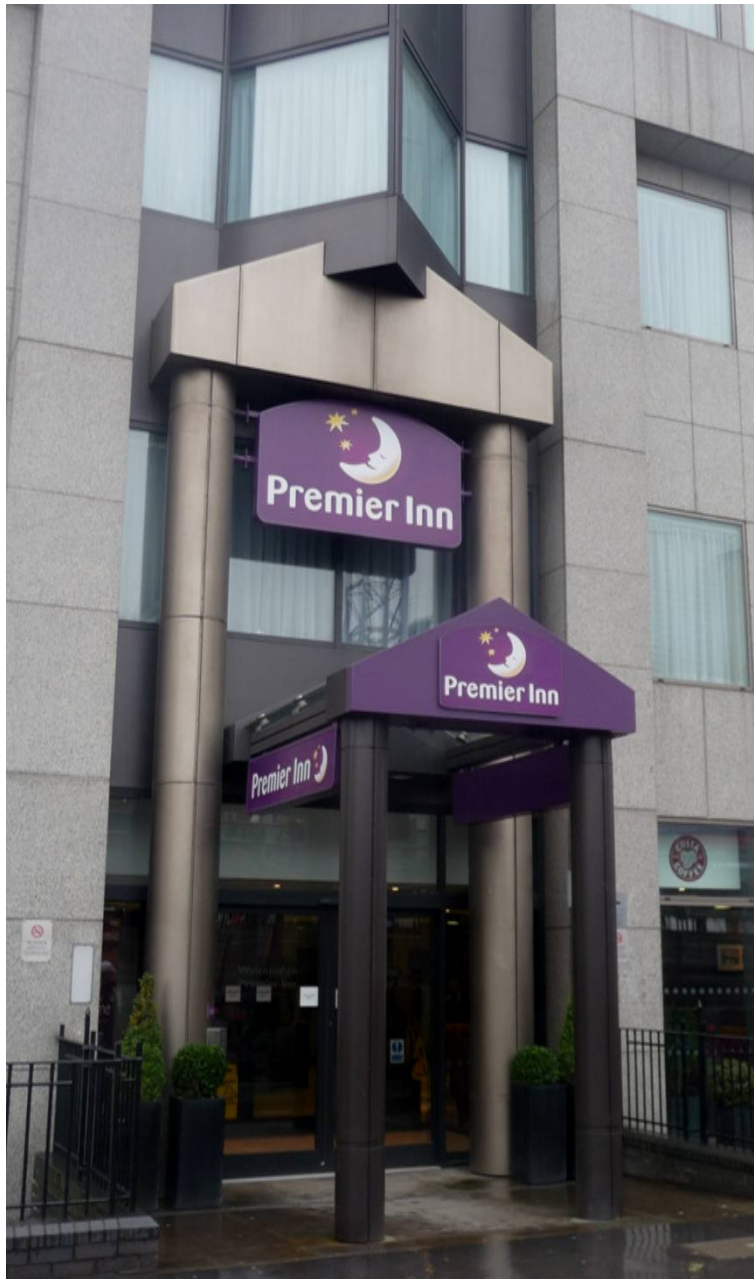
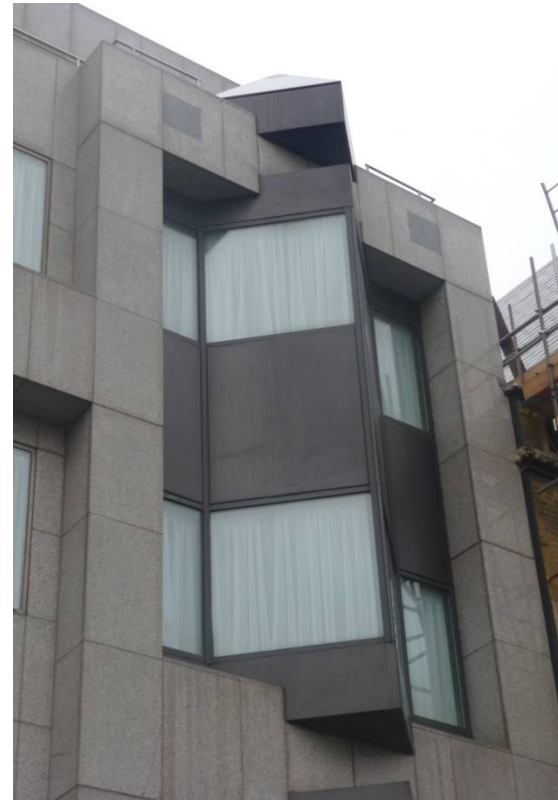
**Premier Inn
24 Prescott Street
London E1**

Address of building	Premier Inn 24 Prescott Street London E1
Date of independent inspection	November 2008
Use of building	Hotel
Date of construction	1988
Environment	Quiet street – Financial district of London
Evidence of regular cleaning or maintenance	No
External parts of building which were anodised	Flat and curved panels
Type of anodising	Batch
Anodiser	United Anodisers : LHT Anodisers, Uxbridge
Description of anodic colour and treatment	Anolok I Light bronze 541 Anolok II Dark blue-grey 717
Original anodic film layer on anodised parts (microns)	Class 25 µm (AASC specifications)
Anodic film layer on date of independent inspection (microns)	30.5 µm (only measured on bronze)
Visible signs of corrosion or surface degradation	None
Conclusion	No deterioration in anodic film protection after 19 years service life. No visible evidence of corrosion . No discernable colour change.

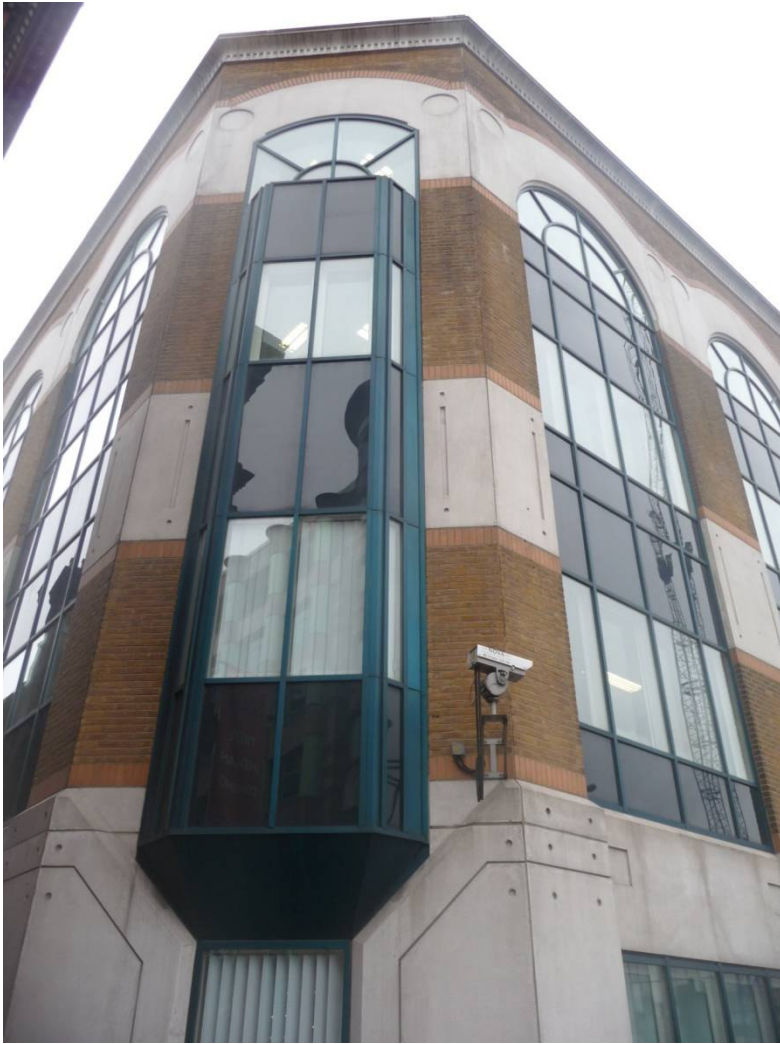
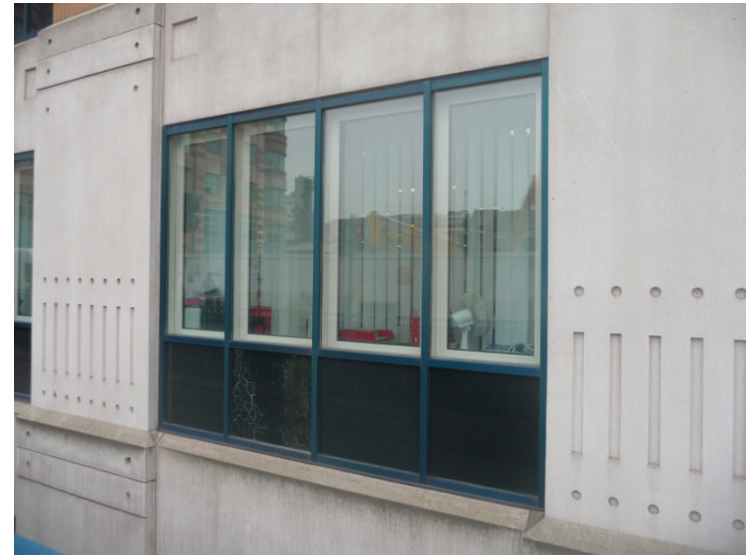
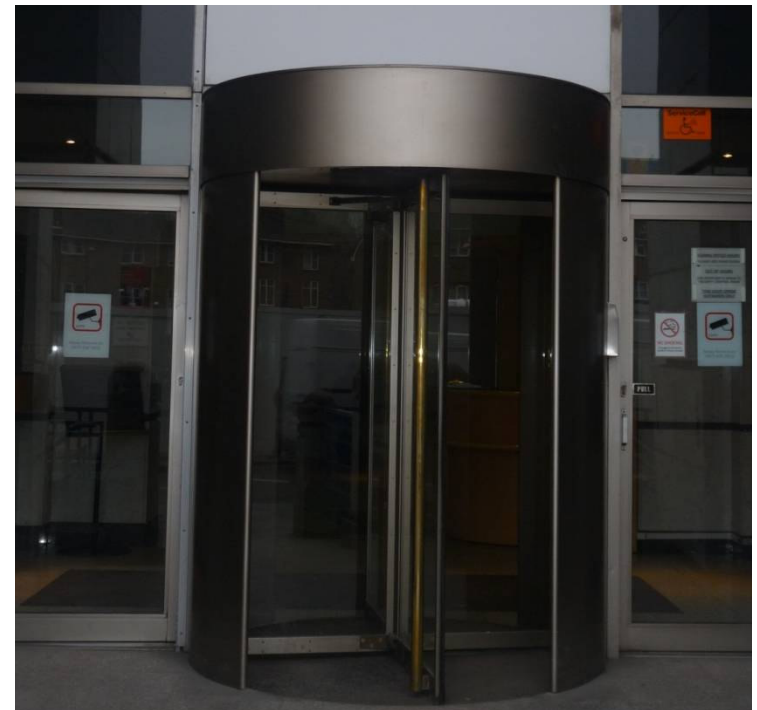
Address of building	Abbey National Building 21 Prescott Street London E1
Date of independent inspection	November 2008
Use of building	Offices
Date of construction	1989
Environment	Quiet street – Financial district of London
Evidence of regular cleaning or maintenance	No
External parts of building which were anodised	Sheets (Bronze) Windows frame (Sandalor)
Type of anodising	Batch
Anodiser	United Anodisers: LHT Anodisers, Uxbridge
Description of anodic colour and treatment	Anolok I Light bronze 543 Sandalor Turquoise C 63/3
Original anodic film layer on anodised parts (microns)	Class 25 μm (AASC specifications)
Anodic film layer on date of independent inspection (microns)	27.5 μm (bronze) 30.5 μm (turquoise)
Visible signs of corrosion or surface degradation	None
Conclusion	No deterioration in anodic film protection after 19 years service life. No visible evidence of corrosion . No discernable colour change.

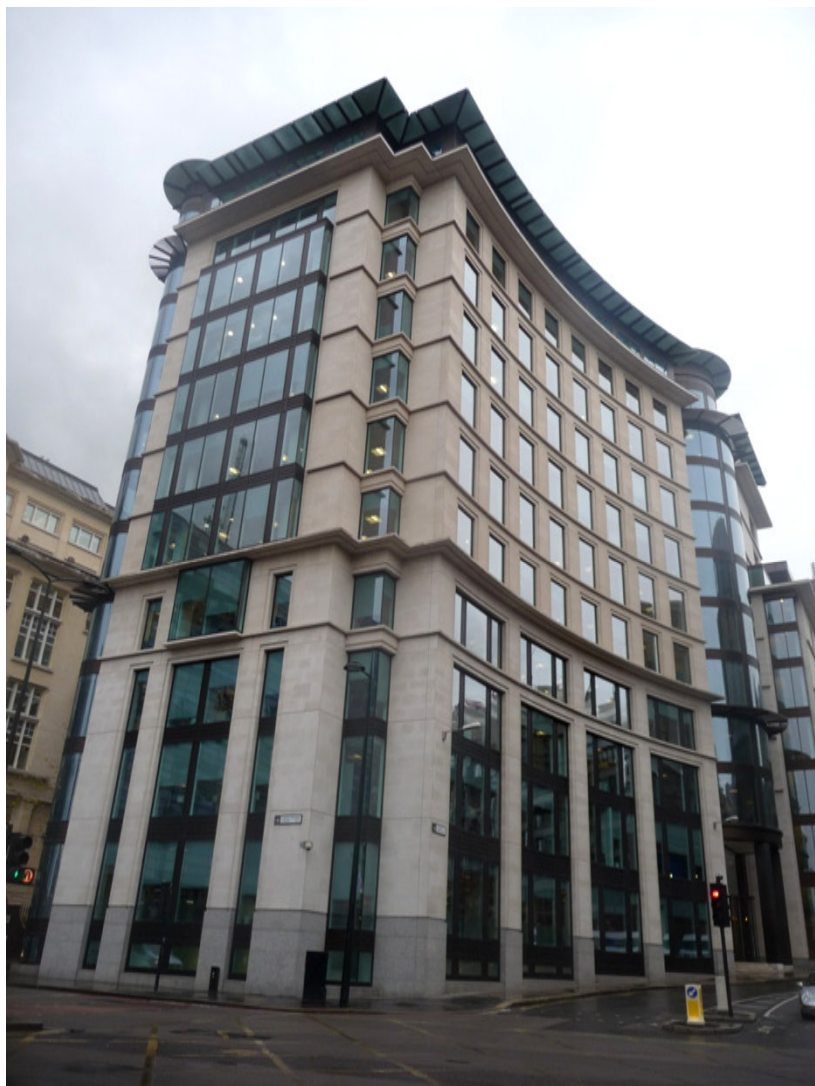
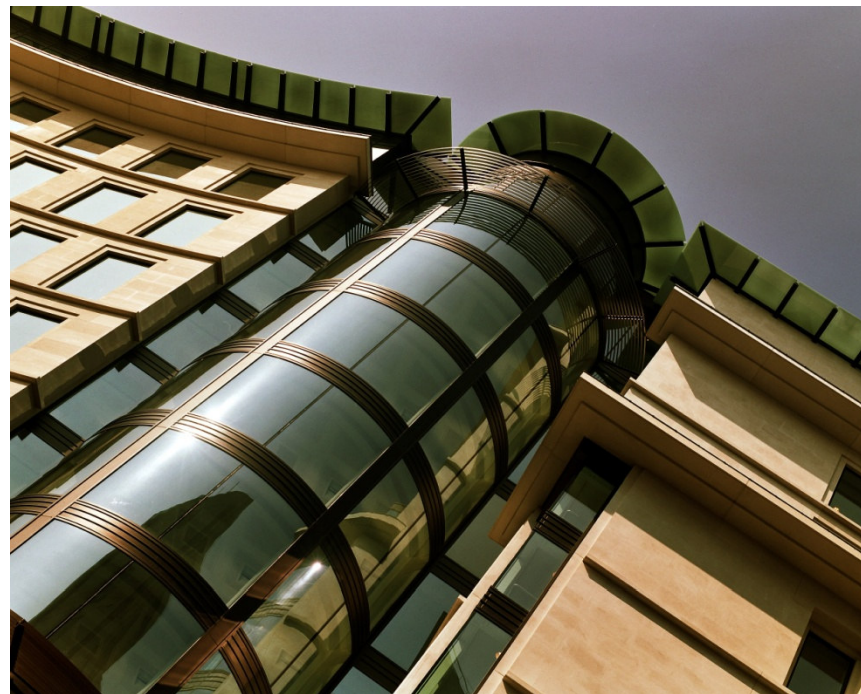
**12 Arthur Street
London EC4**

Address of building	12 Arthur Street London EC4
Date of independent inspection	November 2008
Use of building	Prestigious office complex
Date of construction	2003
Environment	Urban – Centre of London
Evidence of regular cleaning or maintenance	No
External parts of building which were anodised	Window frames – Sheets
Type of anodising	Batch
Anodiser	United Anodisers: Heywood Metal Finishers, Huddersfield
Description of anodic colour and treatment	Anolok I Bronze 547
Original anodic film layer on anodised parts (microns)	Class 25 µm (AASC specifications)
Anodic film layer on date of independent inspection (microns)	28.5 µm
Visible signs of corrosion or surface degradation	None
Conclusion	No deterioration in anodic film protection after 5 years service life. No visible evidence of corrosion. No discernable colour change.

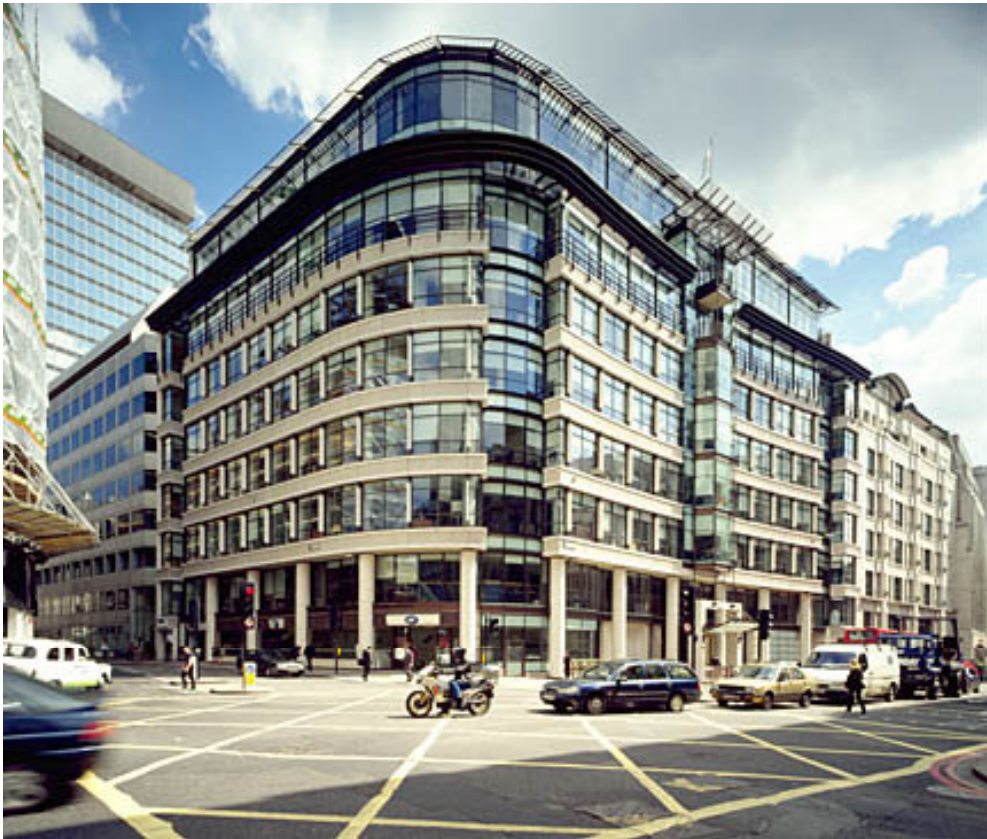
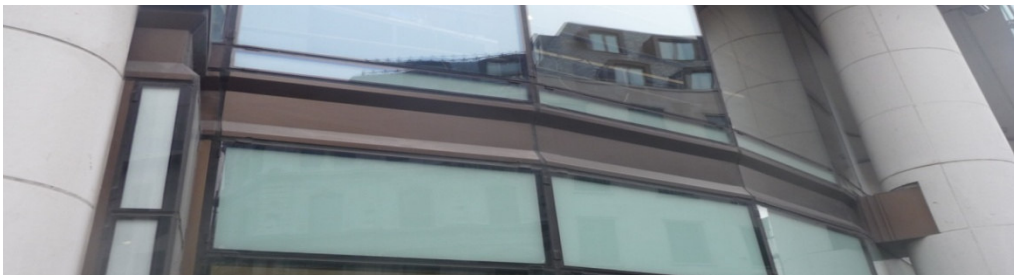
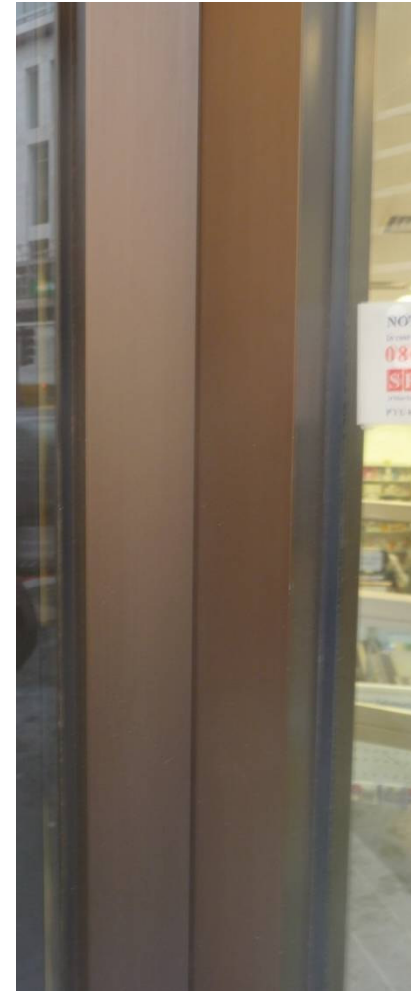
**60 Gracechurch Street
London EC3**

Address of building	60 Gracechurch Street London EC3
Date of independent inspection	November 2008
Use of building	Pharmacy + offices
Date of construction	1997
Environment	Urban – Centre of London
Evidence of regular cleaning or maintenance	No
External parts of building which were anodised	Window frames – Extrusion sections
Description of anodic colour and treatment	Anolok I Bronze 545
Type of anodising	Batch
Anodiser	United Anodisers : LHT Anodisers, Uxbridge
Original anodic film layer on anodised parts (microns)	Class 25 µm (AASC specifications)
Anodic film layer on date of independent inspection (microns)	27.4 µm
Visible signs of corrosion or surface degradation	None
Conclusion	No deterioration in anodic film protection after 11 years service life. No visible evidence of corrosion . No discernable colour change.

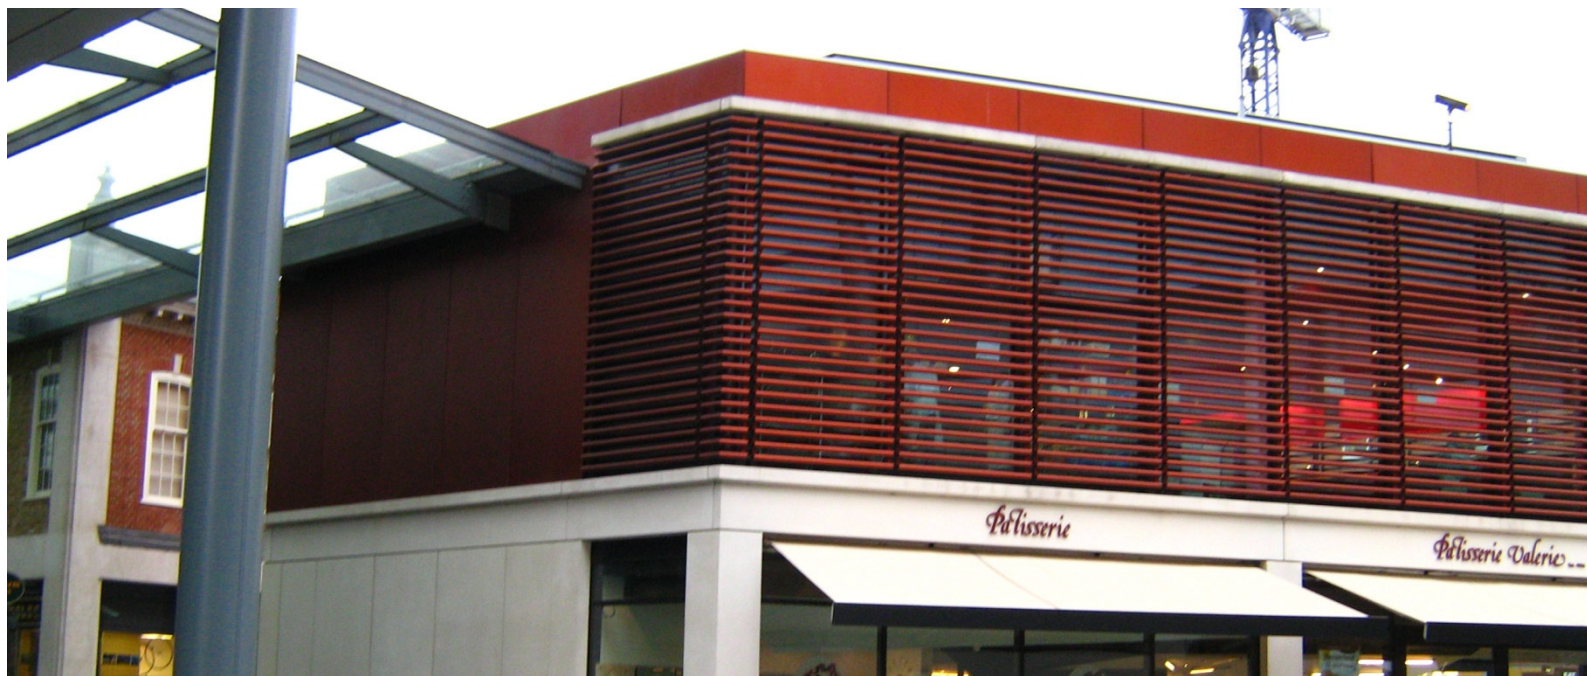
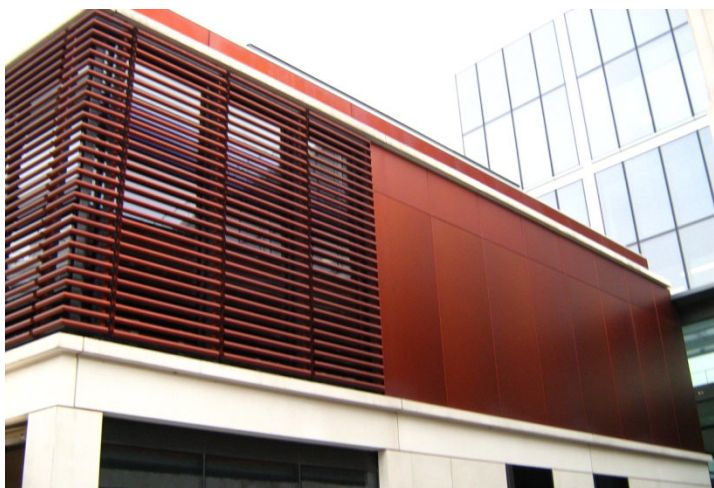
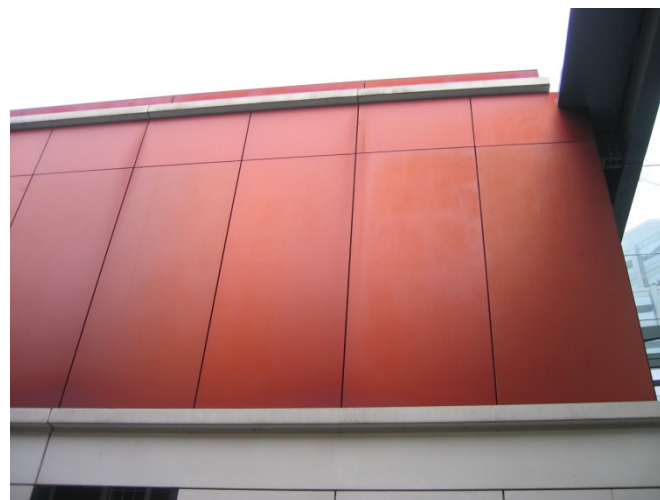
**Bishop Square
London E1**

Address of building	Bishop Square London E1
Date of independent inspection	September 2008
Use of building	Patisserie
Date of construction	2005
Environment	Urban – Centre of London
Evidence of regular cleaning or maintenance	No
External parts of building which were anodised	Tubes - Panels
Description of anodic colour and treatment	Sanodal – Orange 3LW
Type of anodising	Batch
Anodiser	United Anodisers: LHT Anodisers, Uxbridge
Original anodic film layer on anodised parts (microns)	Class 25 µm (AASC specifications)
Anodic film layer on date of independent inspection (microns)	Not accessible for measurement
Visible signs of corrosion or surface degradation	None
Conclusion	No visible evidence of corrosion or discoloration after 3 years service life in urban environment. No discernable colour change.
