BULLETIN NUMBER: SB-0013

DATE: 03/02/2023

K-XESC – Side Shift Cylinder Control

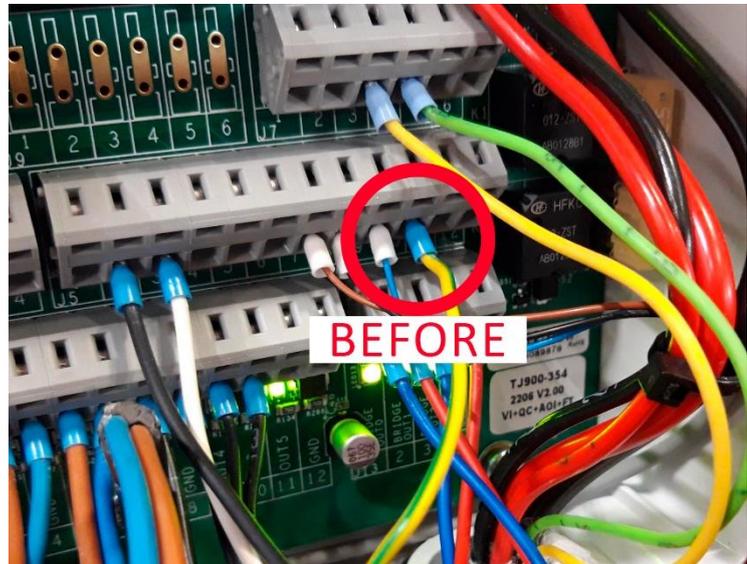
Before update: J5 – pin 10

There have been several cases where the side shift cylinder is activated while the spread unit is folded and locked in the centre position. This causes the hydraulic side shift cylinder to bend. This problem has occurred if there is poor power supply (low voltage) from the tractor.

2. Move the yellow/green 12V supply wire from J5 - pin 10 to J12-pin 11. (see photos and attached diagram)
