**\*30691-4 OY3 #3 December 2023 / Building 2 / 1st Floor / 1st Floor Bldg 2.**

**\*30691-4 OY3 #3 December 2023 / Building 2 / 2nd Floor / 2nd Floor Bldg 2. (2nd Floor Bldg 2)**

## \*30691-4 OY3 #3 December 2023 / Building 2 / 3rd Floor / 3rd Floor Bldg 2

## \*30691-4 OY3 #3 December 2023 / Building 2 / 4th Floor Bldg 2 RFS (4th Floor Bldg 2 RFS layers)

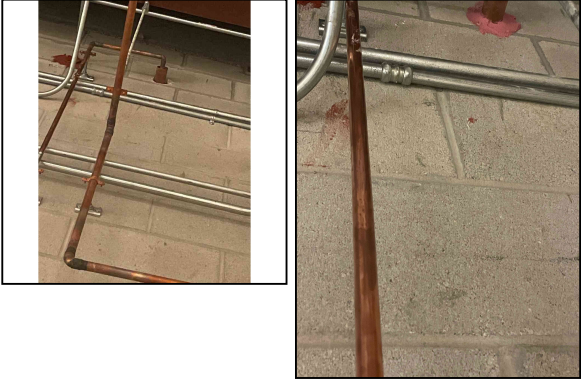
| Icon | Punch # | ID | Room Number | System | Inspection Type | Item | Type | Fire Rating | Wall Material | Action | Resource | Comments | Due | Type Comment | Created By | Priority |
|---|---|---|---|---|---|---|---|---|---|---|---|---|---|---|---|---|
| | 1713 | 885619 | | cja1080 | Repairs | TP-Wall | Metallic Pipe | 1 Hour Smoke Zone Barrier | Concrete | Repair | | | 12/14/23 | | MS | |
| Repair 12/14/23 12/23/23 NFPA 101 Section 8.5<br>Room Number 110103 12/14/23 12/23/23<br>Wall Direction 12/14/23 12/23/23 East<br>Lineal Feet 12/14/23 12/23/23<br>Repair 12/14/23 12/23/23 NFPA 101 Section 8.5 | | | | | | | | | | | | | | | | |

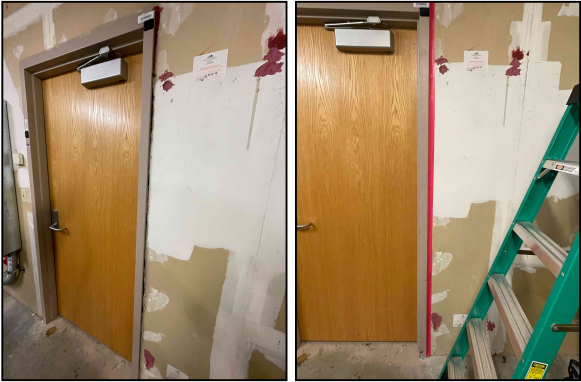
| Icon | Punch # | ID | Room Number | System | Inspection Type | Item | Type | Fire Rating | Wall Material | Action | Resource | Comments | Due | Type Comment | Created By | Priority |
|---|---|---|---|---|---|---|---|---|---|---|---|---|---|---|---|---|
| | 2333 | 887412 | | hwd0236 | Repairs | TP-Wall | Blank Opening | 1 Hour Smoke Zone Barrier | Gypsum | Repair | | | 2/19/24 | | MS | |
| Repair 2/19/24 2/19/24 NFPA 101 Section 8.5<br>Room Number 134243 2/19/24 2/19/24<br>Wall Direction 2/19/24 2/19/24 south<br>Lineal Feet 2/19/24 2/19/24<br>Repair 2/19/24 2/19/24 NFPA 101 Section 8.5 | | | | | | | | | | | | | | | | |

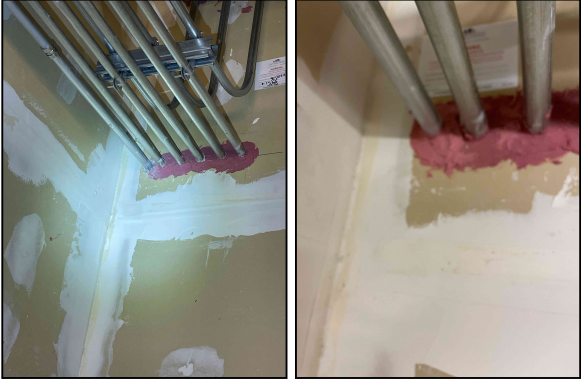
| Icon | Punch # | ID | Room Number | System | Inspection Type | Item | Type | Fire Rating | Wall Material | Action | Resource | Comments | Due | Type Comment | Created By | Priority |
|---|---|---|---|---|---|---|---|---|---|---|---|---|---|---|---|---|
| | 2039 | 885755 | | | Repairs | TP-Wall | Metallic Pipe | 1 Hour Smoke Zone Barrier | Gypsum | Repair | | | 12/17/23 | | MS | |
| Repair 12/17/23 12/23/23 NFPA 101 Section 8.5<br>Room Number 210321a 12/17/23 12/18/23<br>Wall Direction 12/17/23 12/23/23 West<br>Lineal Feet 12/17/23 12/23/23<br>Repair 12/17/23 12/23/23 NFPA 101 Section 8.5 | | | | | | | | | | | | | | | | |

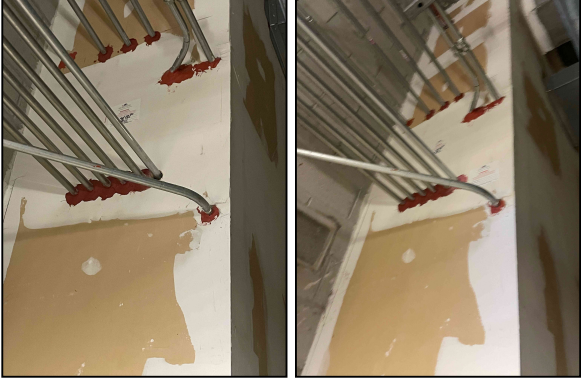
| Icon | Punch # | ID | Room Number | System | Inspection Type | Item | Type | Fire Rating | Wall Material | Action | Resource | Comments | Due | Type Comment | Created By | Priority |
|---|---|---|---|---|---|---|---|---|---|---|---|---|---|---|---|---|
| | 2040 | 885756 | | caj1080 | Repairs | TP-Wall | Metallic Pipe | 1 Hour Smoke Zone Barrier | Gypsum | Repair | | | 12/17/23 | | MS | |
| Repair 12/17/23 12/23/23 NFPA 101 Section 8.5<br>Room Number 210321 12/17/23 12/18/23<br>Wall Direction 12/17/23 12/23/23 East<br>Lineal Feet 12/17/23 12/23/23<br>Repair 12/17/23 12/23/23 NFPA 101 Section 8.5 | | | | | | | | | | | | | | | | |

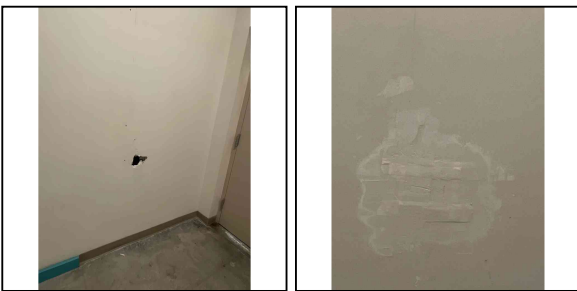
| Icon | Punch # | ID | Room Number | System | Inspection Type | Item | Type | Fire Rating | Wall Material | Action | Resource | Comments | Due | Type Comment | Created By | Priority |
|---|---|---|---|---|---|---|---|---|---|---|---|---|---|---|---|---|
| | 1293 | 885966 | | | Large Opening | Large Opening | Sections of walls missing | | Gypsum | Repair | | | 2/13/24 | | MS | |
| | Repair | 2/13/24 | | | NFPA 101 Section 8.5 | | | | | | | | | | | |
| | Room Number | st14 | 2/13/24 | | | | | | | | | | | | | |
| | Wall Direction | 2/13/24 | | | East | | | | | | | | | | | |

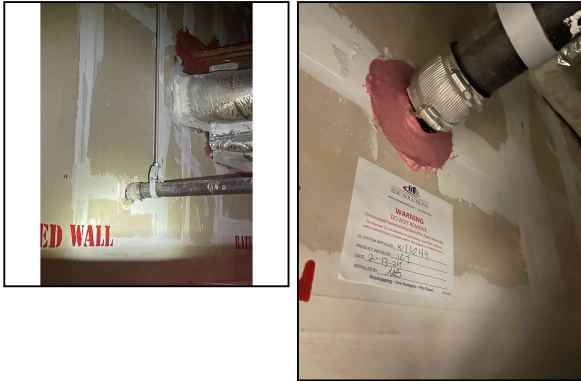
| Icon | Punch # | ID | Room Number | System | Inspection Type | Item | Type | Fire Rating | Wall Material | Action | Resource | Comments | Due | Type Comment | Created By | Priority |
|---|---|---|---|---|---|---|---|---|---|---|---|---|---|---|---|---|
| | 1302 | 885983 | | w1049 | Repairs | TP-Wall | Metallic Pipe | 1 Hour Smoke Zone Barrier | Gypsum | Complete | | | 2/13/24 | | MS | |
| | Repair | 2/13/24 | | | 2/13/24 | NFPA 101 Section 8.5 | | | | | | | | | | |
| | Room Number | 420604 | 2/13/24 | | 2/13/24 | | | | | | | | | | | |
| | Wall Direction | 2/13/24 | | | 2/13/24 | west | | | | | | | | | | |
