| Due Diligence | | | | | |
| Y.O.M | 2014 | Make & Model | SUBARU FORESTER | Model Code | FB20 |
| Reg. No. (if appl.) | KDD077U | VIN Number | SJ5-046810 | Engine No. | — |

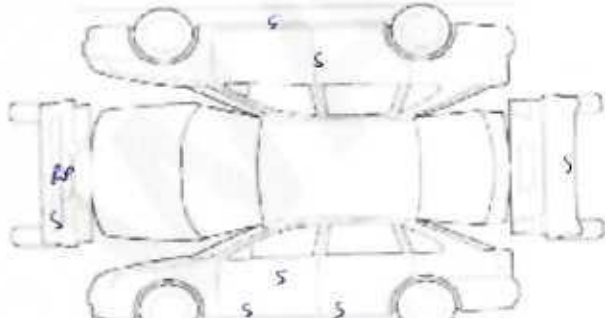
| Body/Exterior Inspection | | |
|---|---|---|
| | D = Dent | General Comments:<br>MINOR SCRATCHES<br>REPAINTED PANELS |
| | SR = Surface Rust | Structural & Underbody Comments:<br>MINOR SURFACE RUST<br>ON EXHAUST SOME<br>UNDERBODY PLASTICS<br>DAMAGED |
