123 Example Address Avenue, Christchurch  
Building Report

22/04/2026

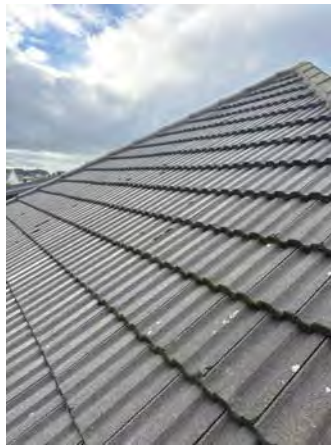
Chip in tile.

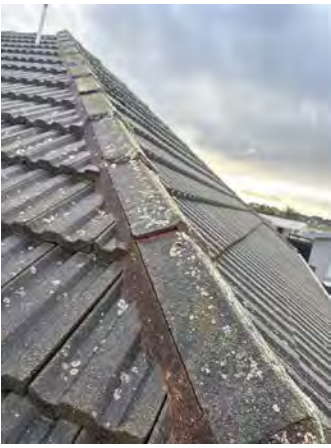
Example - typical cracking and separation to mortar on tile hips and ridge capping throughout.

Cracking has been noted in the mortar on the tile hips and ridge capping; it is common to see this type of cracking here. The cracked mortar should be ground out and re-pointed to help maintain weather tightness. A proper penetration flashing should be installed to the hot water boiler over pipe penetration.

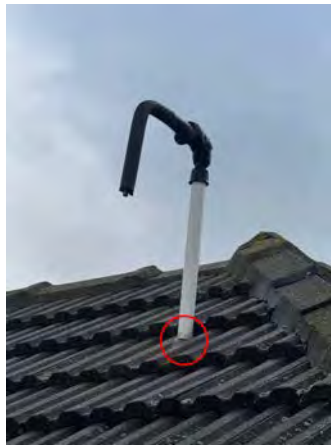
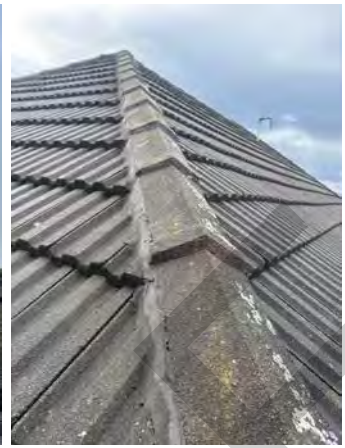
No flashing installed to hot water boiler over pipe penetration.

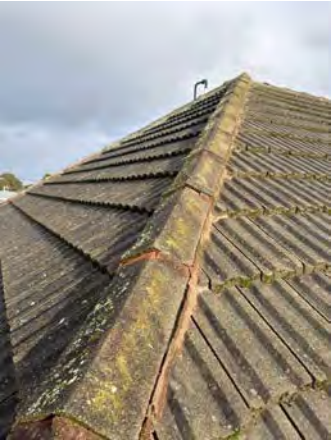
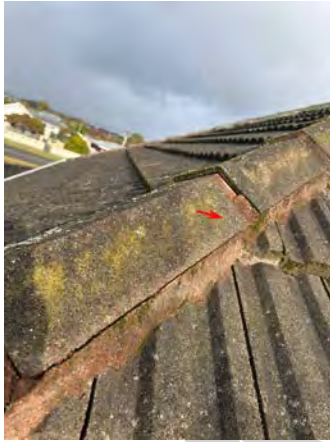
Minor crack to tile on eastern hip. This is best replaced.

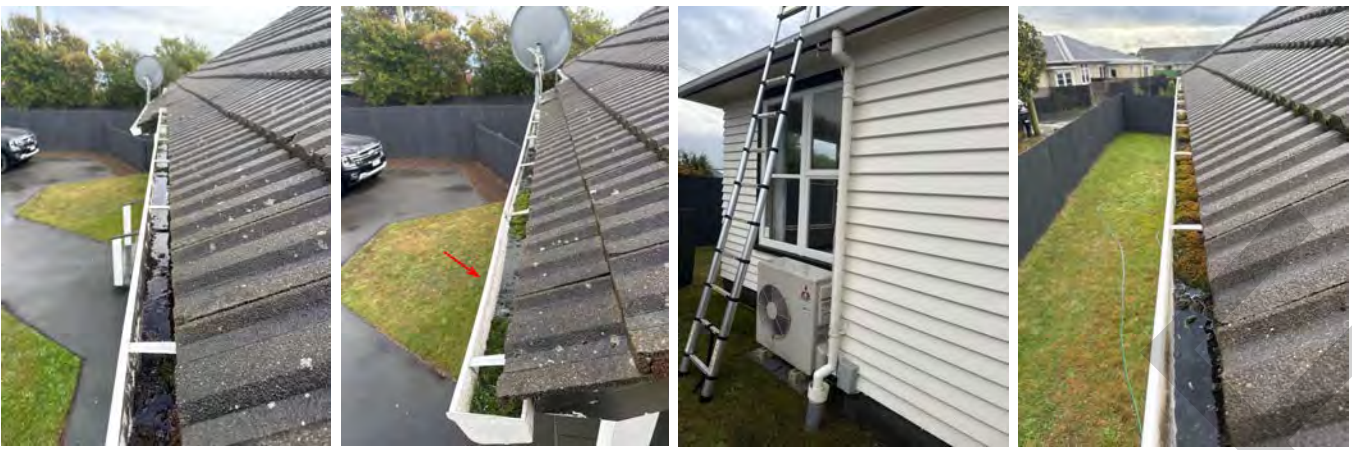
Some sagging to gutter above main entryway.

Downpipes on the main dwelling discharge into ground risers. The gutter above the main entryway is sagging and needs adjusting. One small cracked section of gutter is best replaced. Remove debris and vegetation from the gutters to prevent blockages.

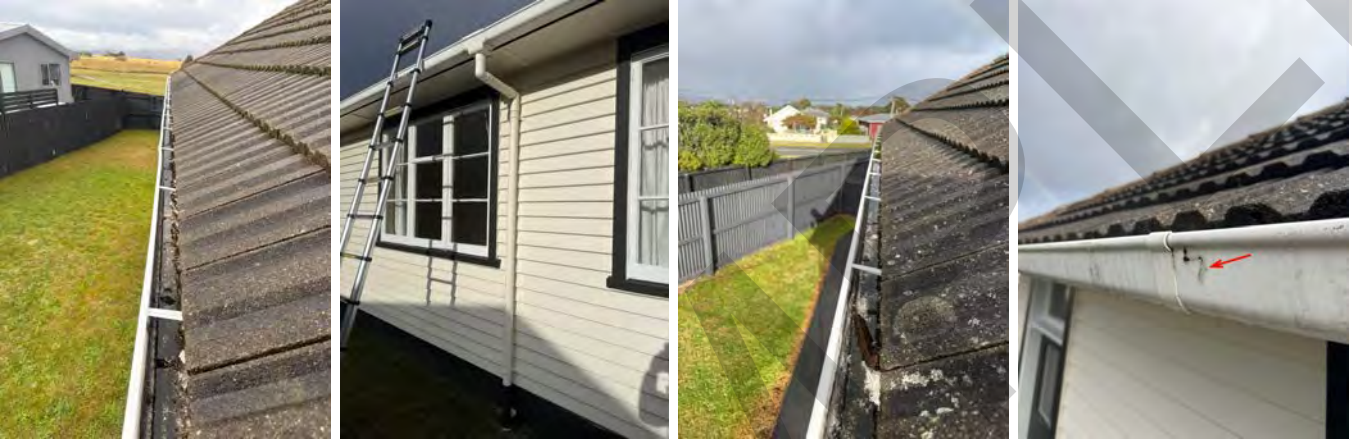
Crack in gutter.

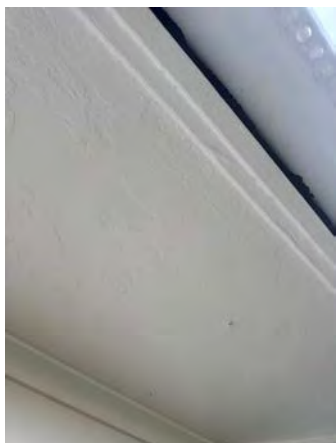
Close up example of notable weathering to some sections of soffit.

The soffit and fascia has notable weathering throughout, typical of its age and the fact that it has a tile roof above it which can allow some moisture in. The soffit and fascia appear okay however they are generally weathered and have sustained some moisture damage over the years. Some paint touch ups are needed in places. Cracked soffit sheets should be replaced but should be asbestos tested prior to any work being carried out.

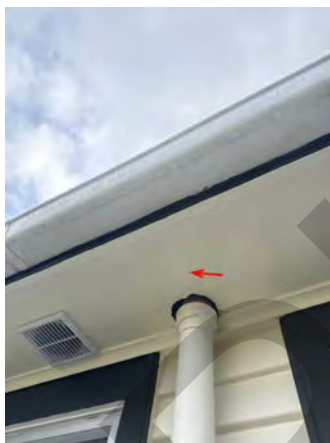
Crack in soffit.

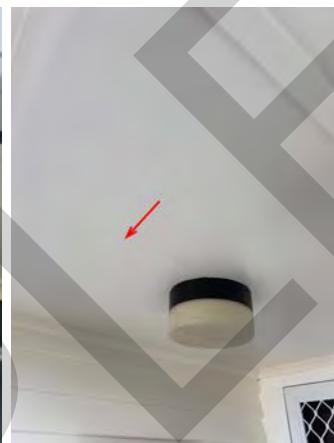
Crack in soffit.

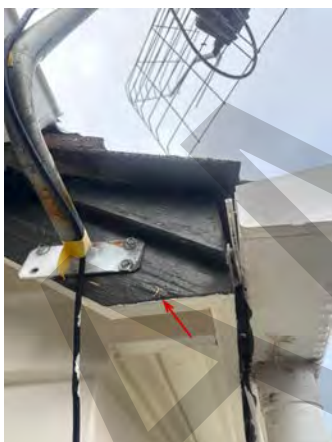
Example - some paint degrading in areas.

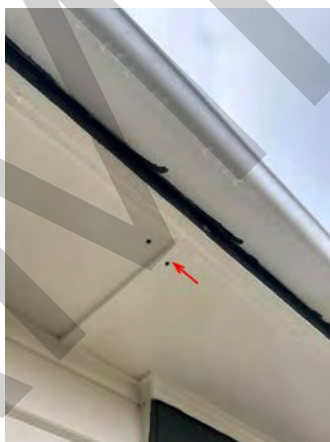
Fill obsolete holes.

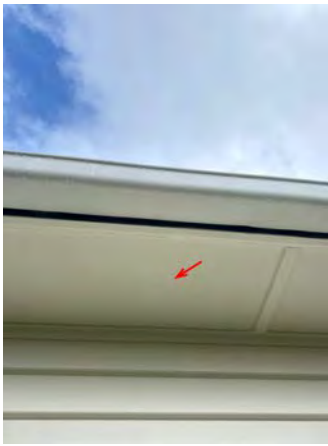
Cracked soffit.

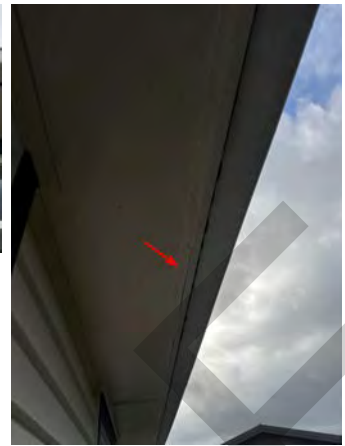
Splitting to scotias here.

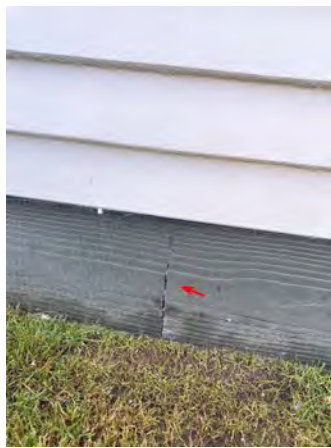
Cracked board.

Damaged sheets could be replaced. Check over and replace any popped nails where necessary. The fibre cement sheeting finishes below ground level in areas which can cause it to prematurely degrade. Please note, due to the era in which this house was constructed, the fibre cement has the potential to contain asbestos; however this was not tested or confirmed during this inspection.

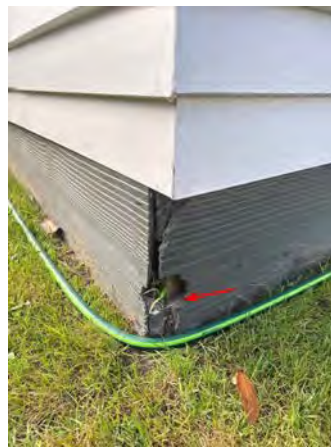
Damage to fibre cement.

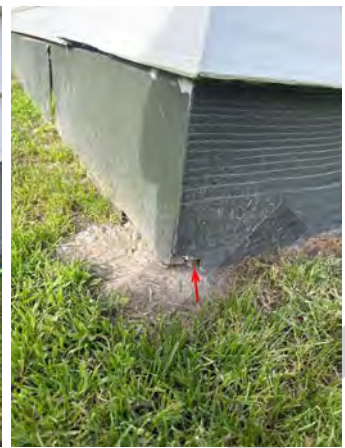
Some chips to sheet that is used as the sub floor access.

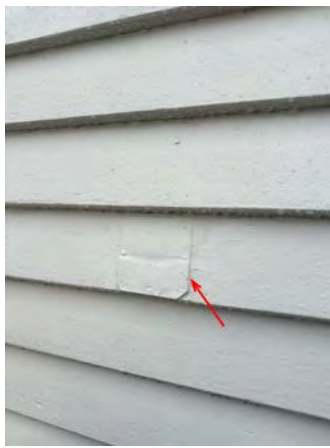
Rot under the penetration patch. Replace board here.

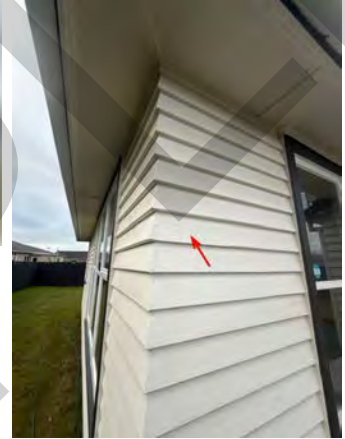
Split. Monitor this.

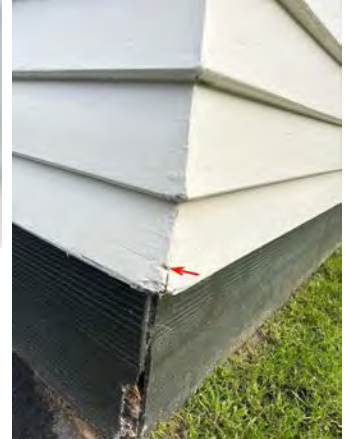
Minor rot.

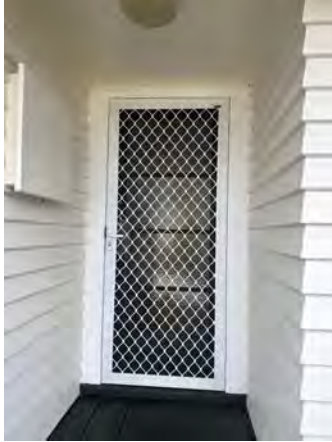
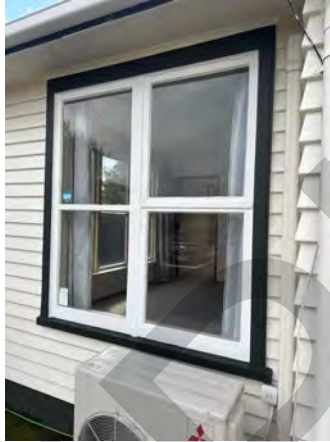
Rot to corner.

Exterior joinery comments are based on a visual assessment only; testing of the joinery function is found in the interior section of this report. The joinery has general moderate weathering throughout. It appears okay but should be meticulously maintained to extend its lifespan. One rotten and one broken section of frame should be replaced.

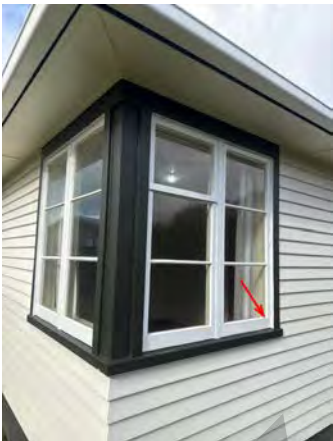
Broken frame.

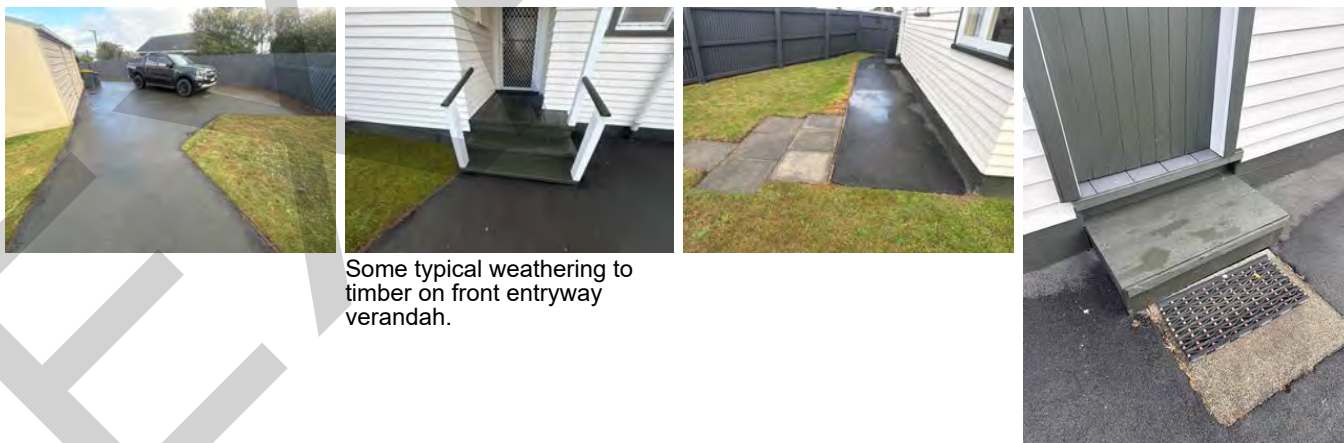
Some typical weathering to timber on front entryway verandah.

Typical weathering to step.

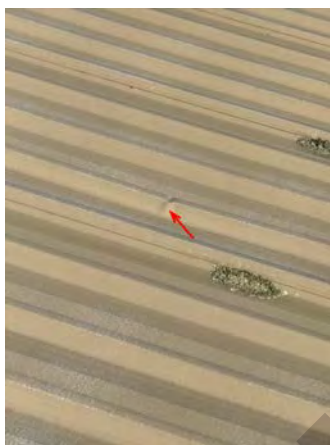
Minor dent to roof.

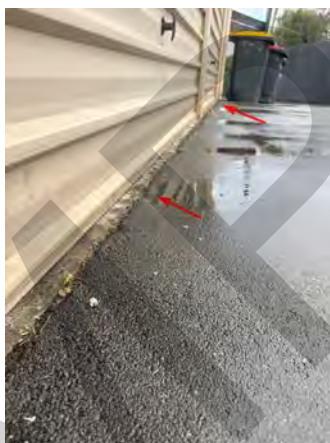
No garage door rebate or gutter. This makes the garage more susceptible to water tracking under the door.

The roof is fastened down with pop rivets, nails and screws. Nails are prone to popping overtime and should be replaced where necessary. The roof does look to lack in fixings and it would benefit from having additional fixings fitted to the cladding and flashings to better secure it. The roof is also due for a clean and repaint. Epoxy crack repairs look to have been carried out to the walls and slab. Some minor cracks to the walls appear have just been plastered over and should be epoxy repaired. The garage doors are manually operated and working fine. Interior lights weren't operating. They do appear to be disconnected at the power supply. It is recommended that a garage door rebate or gutter be installed to prevent water intrusion under the main doors.

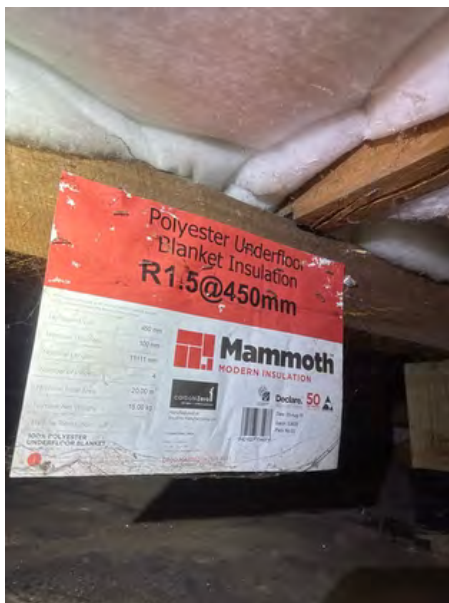
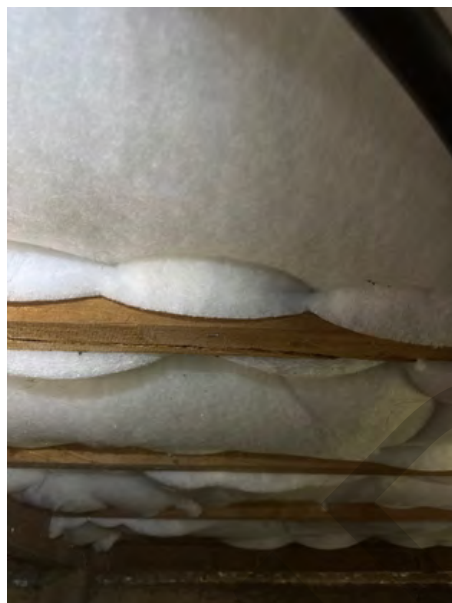
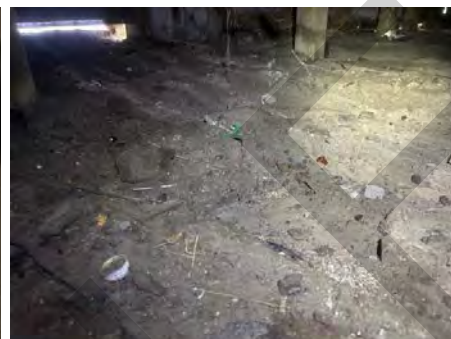
Some gaps in polythene membrane in places.

Fit any loose insulation anywhere it is slipping out of place. The polythene membrane barrier has not been fitted well or taped at the joins. This also has gaps in areas.

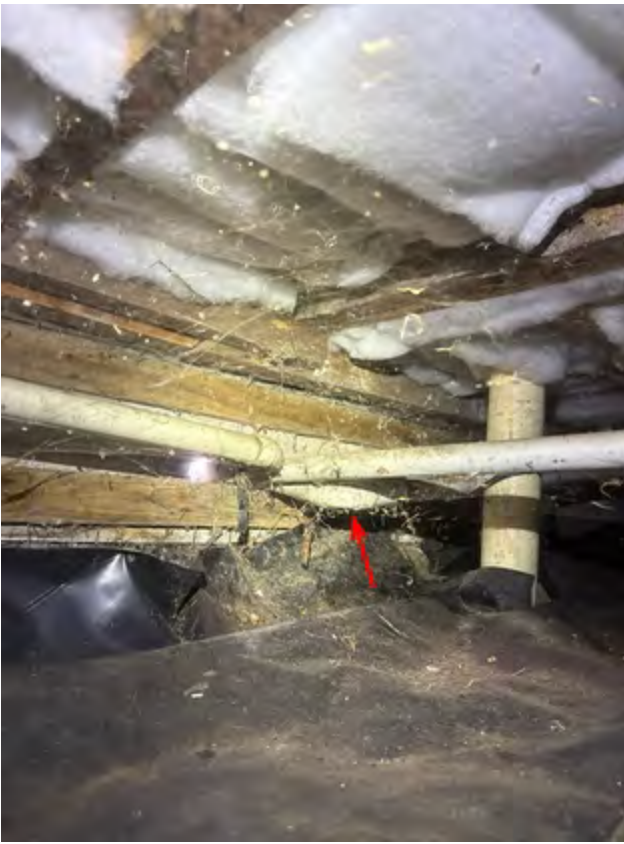
Bottom waste is running up hill. This needs adjusting.

No leaks identified. One waste pipe noted slopes uphill and needs to be adjusted to prevent blockages.

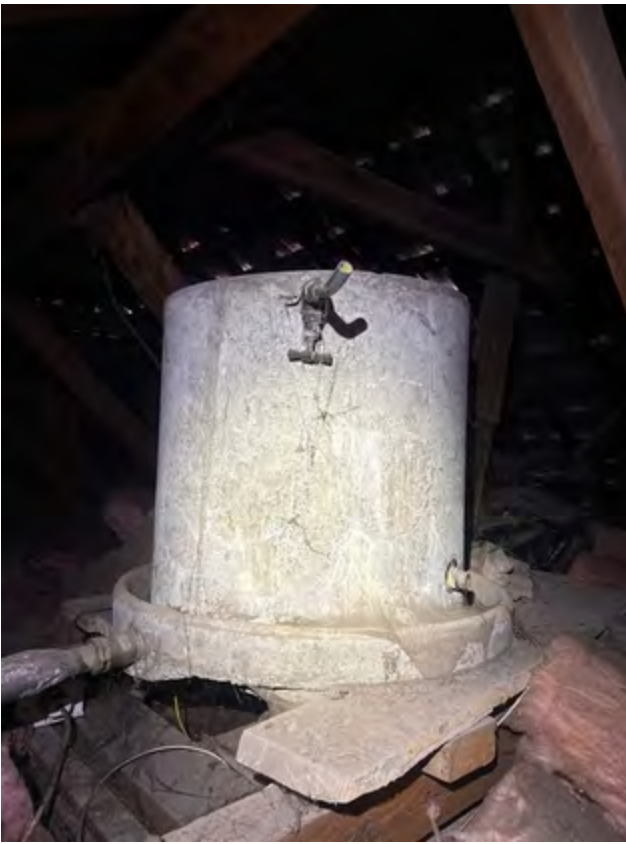
Obsolete header tank is best removed from the ceiling cavity.

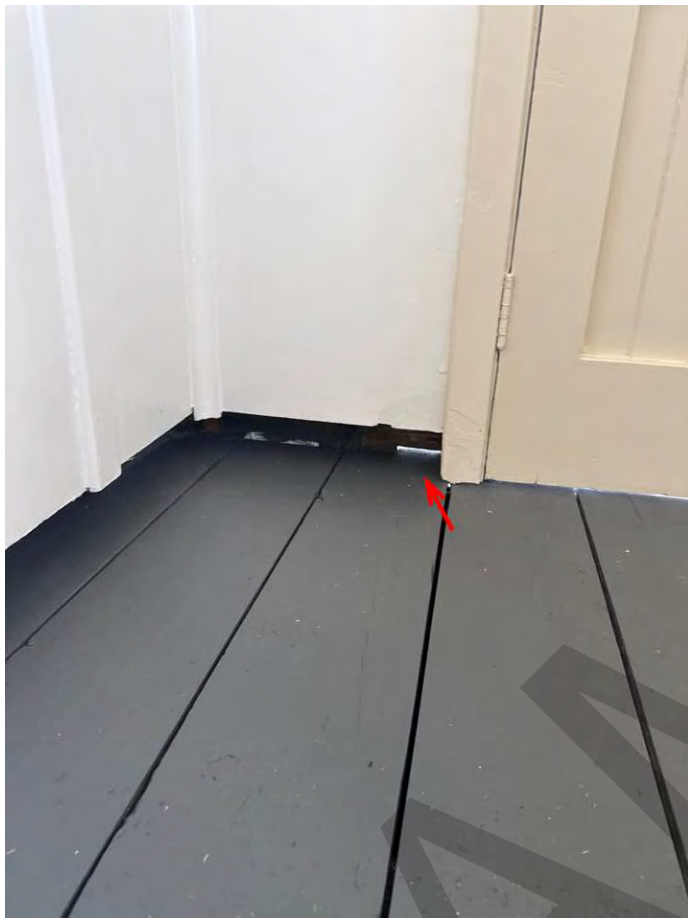
Opening and gaps by rear laundry door could be closed off to prevent draught.

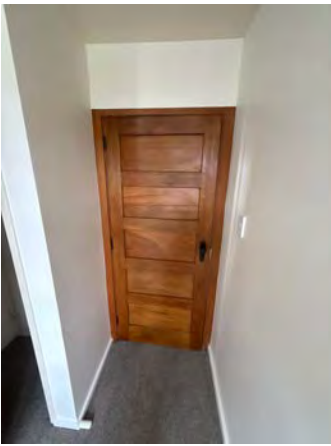
Some splitting to door panel. Striker plate has been notched out to a rough standard and the latch return on the handle is weak.

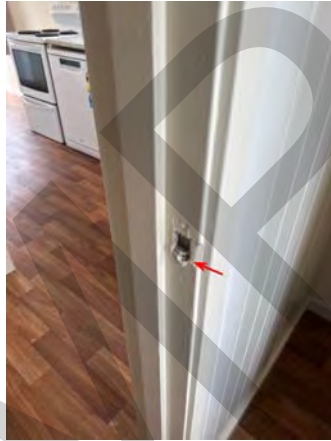
Laundry door striker plate is broken.

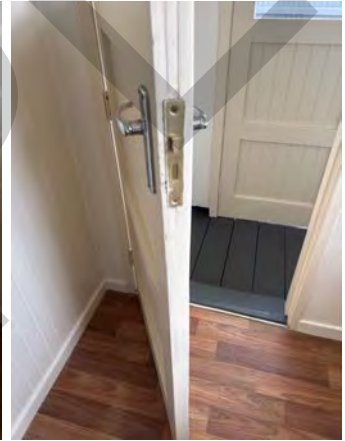
Some splitting and filler use in this door. Monitor this. Latch is also not recessed back into the door at the top.

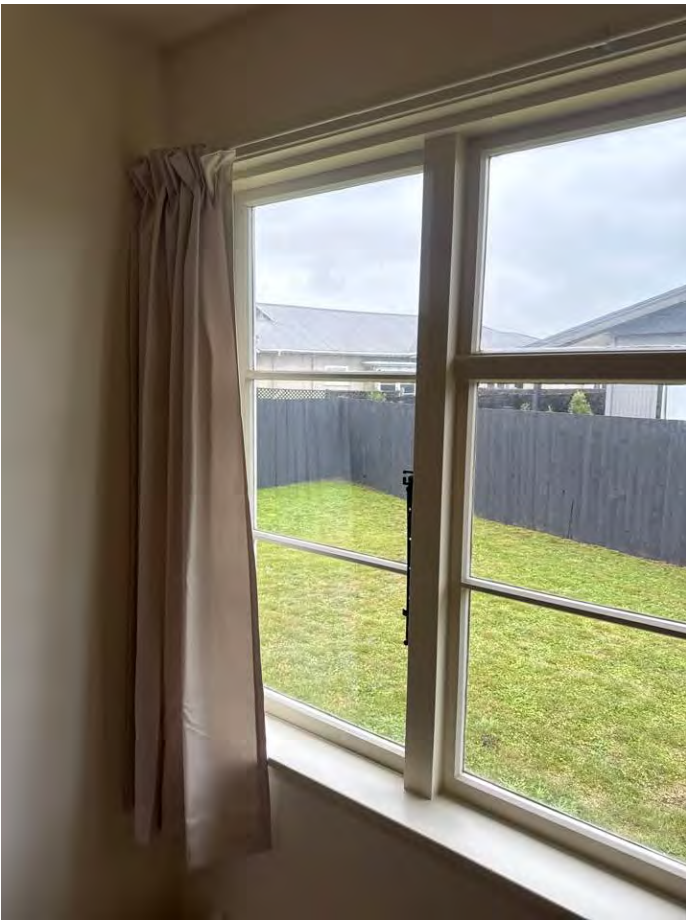
Window needs an ease.

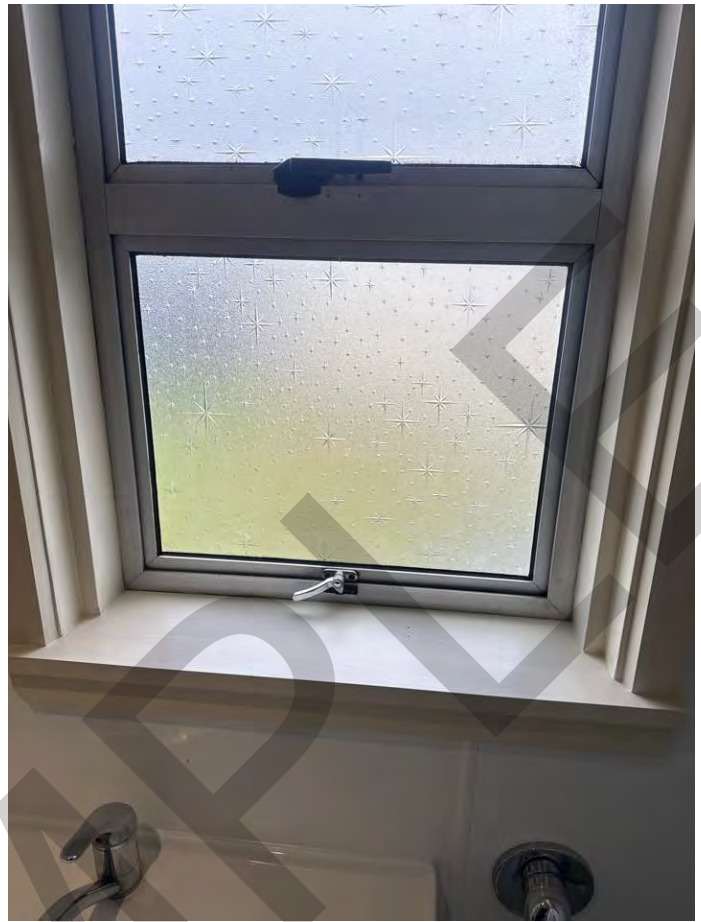
Window needs a slight ease. The latch is also catching the frame.

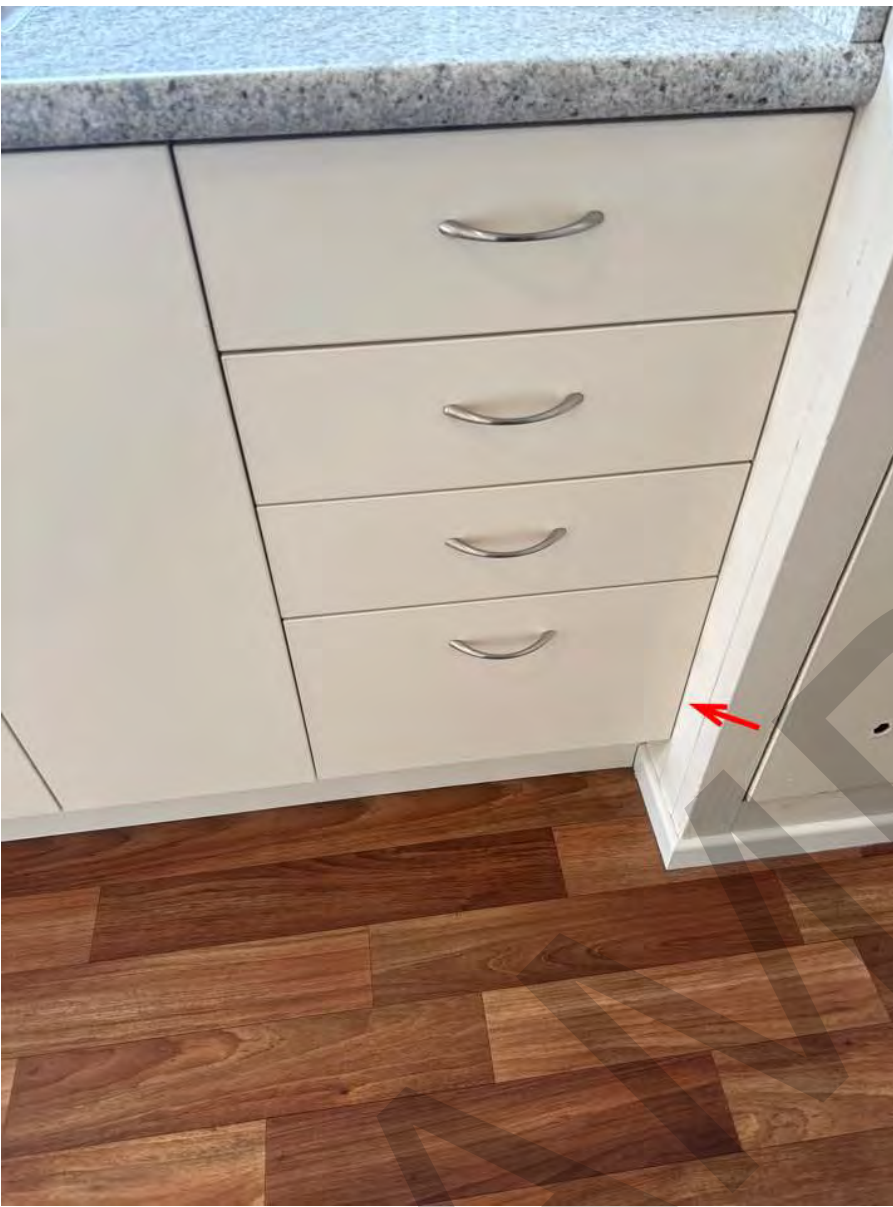
Bottom drawer catches slightly.

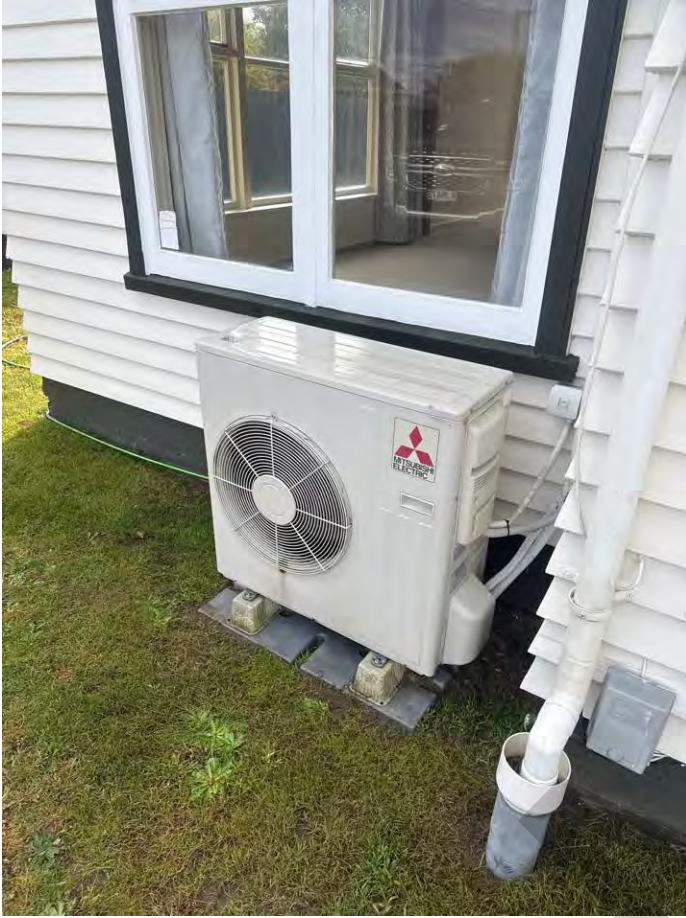
Some surface rust to condenser enclosure.
