# Case Study

Clarksville, TN

Carbon Fiber Grid Stitch

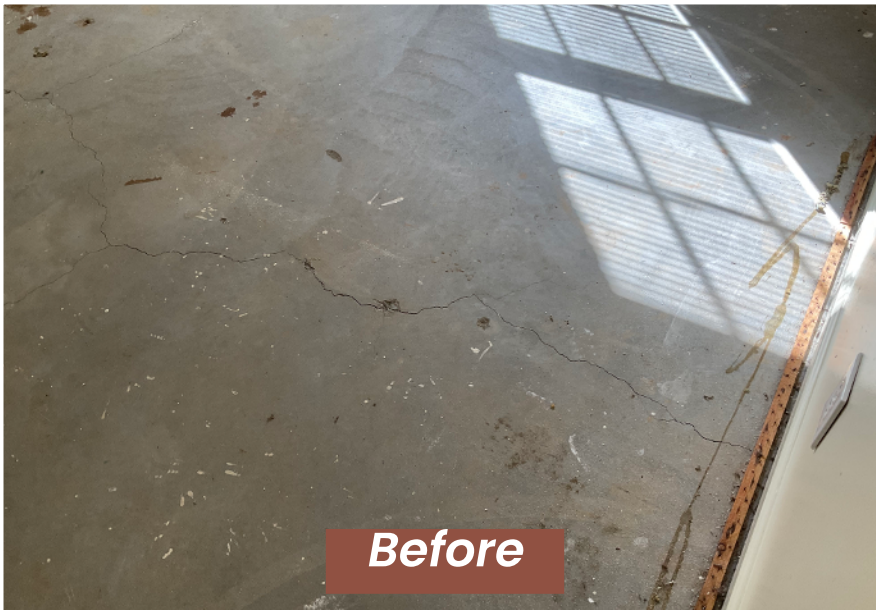
*Before*

Maintenance crews discovered a significant crack running across the concrete floor while replacing carpet inside the property. The crack extended parallel to the rear wall and raised concerns about structural stability and long-term performance of the slab.

Upon inspection, the USS team found the concrete floor had settled more than 1.5 inches vertically. This settlement created a major crack across the slab and caused visible gaps beneath the exterior walls and baseboards. The slab had also begun separating from the structure itself, resulting in a loss of lateral support and compromising the integrity of the floor system.

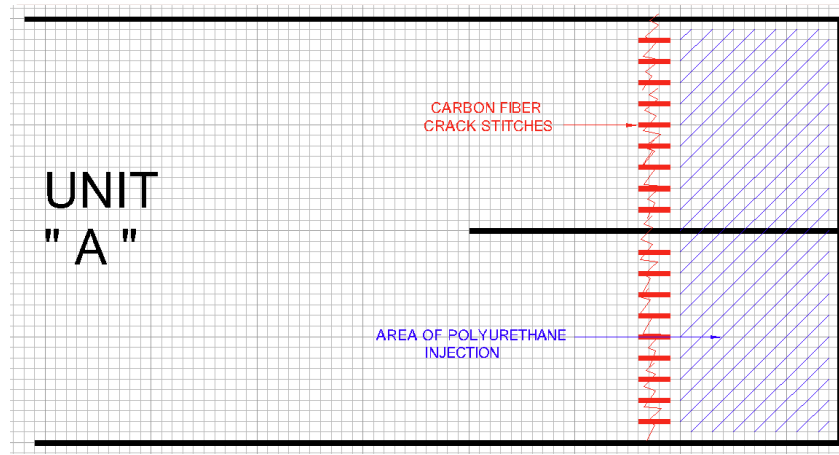
- One of the biggest challenges on this project was the amount of vertical settlement that had already occurred. The slab had dropped over 1.5 inches, creating uneven flooring conditions and structural separation between the slab and surrounding building components. The crack extended across the concrete floor, making stabilization critical before any cosmetic repairs could be considered.
- The settlement also created voids beneath the slab, meaning the floor no longer had proper support underneath. Restoring both elevation and structural integrity required a solution that addressed the underlying soil and void issues while reinforcing the damaged concrete.
