# GIIGNL

## **Technical Study Group**

### **Incident identification database**

**Osaka, Sept 29th – Oct 2nd 2025**

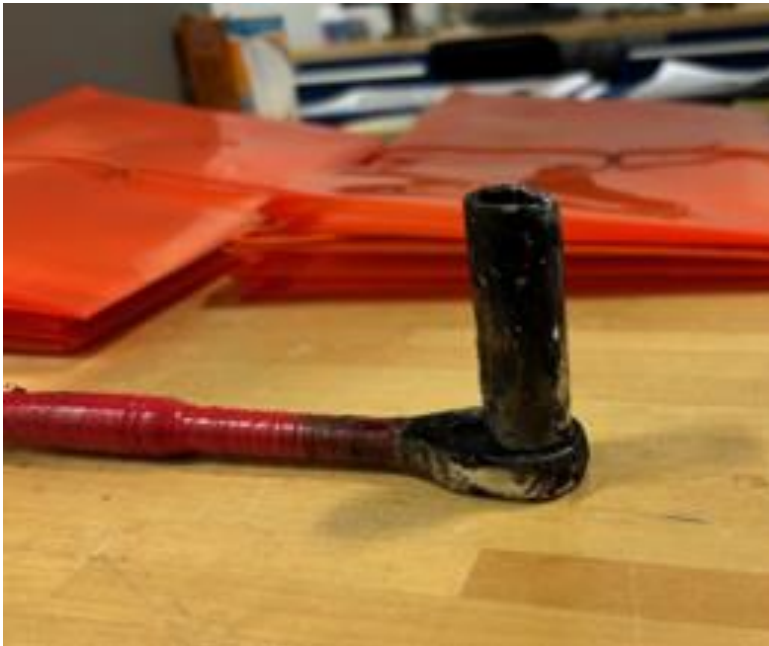
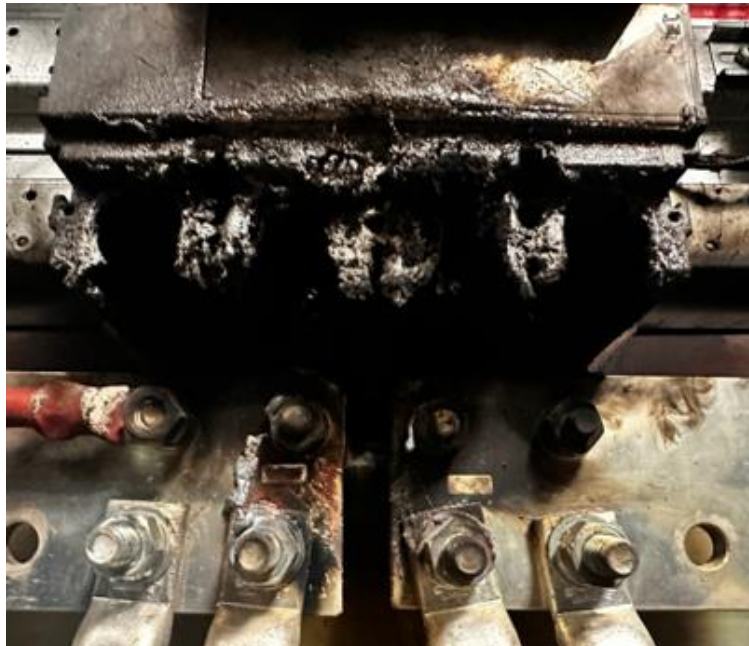
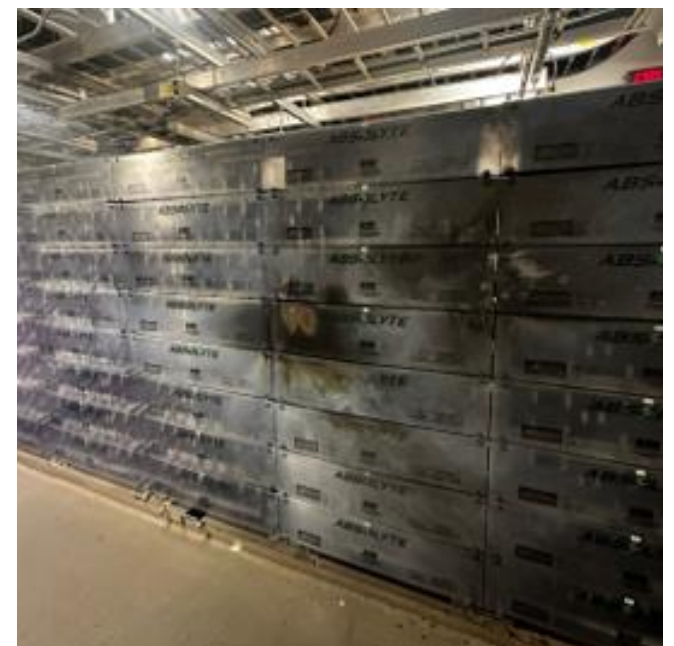
- Incident N° 1939 concerns a scheduled Uninterruptible Power Supply annual testing. Incorrect tools (uninsulated) used for tightening nuts were used. Short circuit was caused by the contact of the uninsulated tool and the energized elements. Arc was detected by F&G system.
- Develop tool list that every site and electrical technician should have
- Revise battery connection procedure with additional safety measures
