# Plus Seven Inspect

## Plus Seven Inspection - SAMPLE REPORT

70345 Blue Ridge Mountain  
Tucson, Arizona, 85750

Inspection Type: Home Inspection

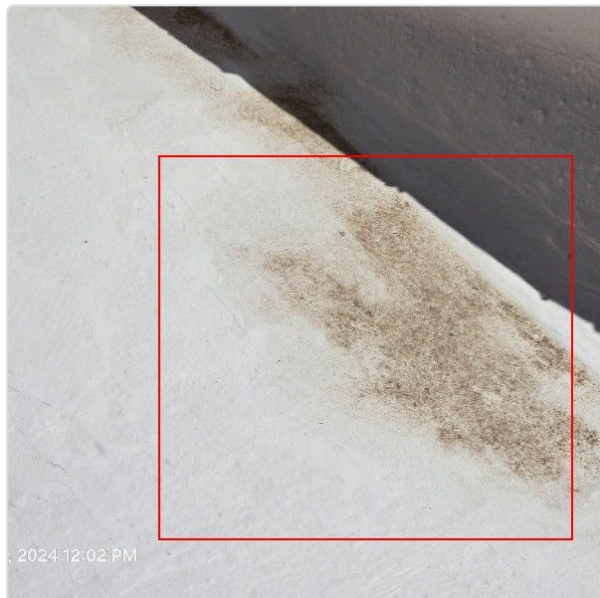
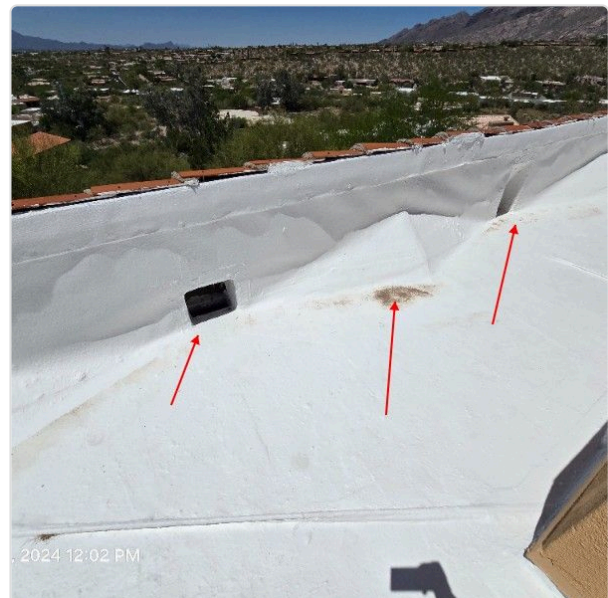
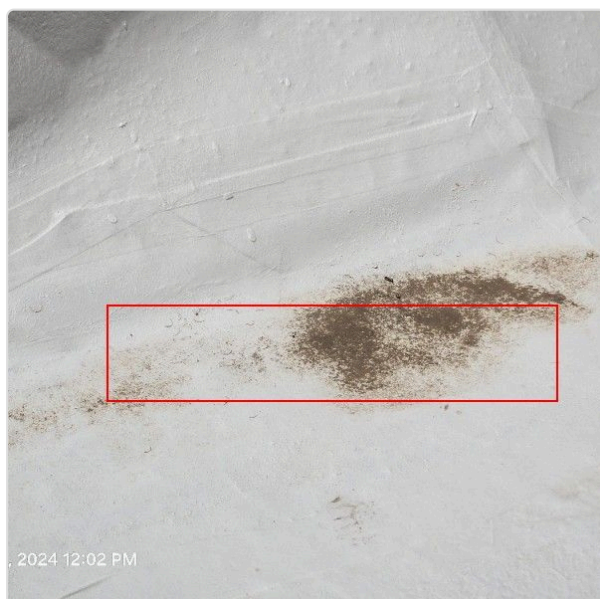
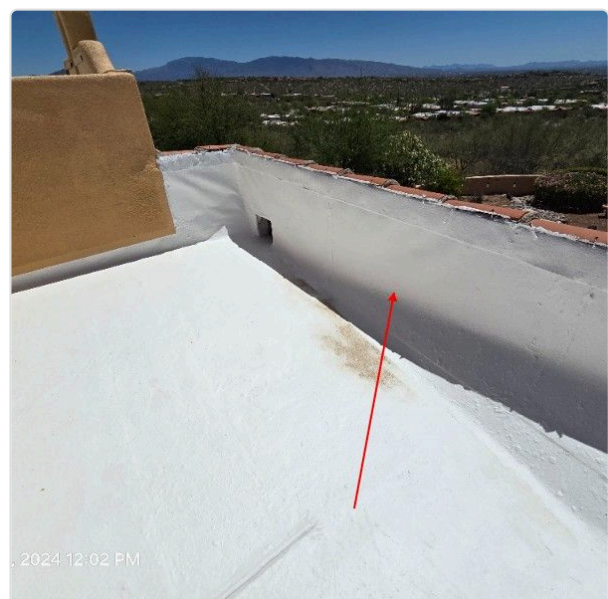
**Description:** Areas of ponding noted along the roof structure. Recommend correction of the slope of the effected area to prevent pooling water from causing accelerated wear on the roof surface.

**Severity:** RECOMMENDATIONS / IMPROVEMENT ITEMS

**Recommendation:** Contact a qualified roofing professional.

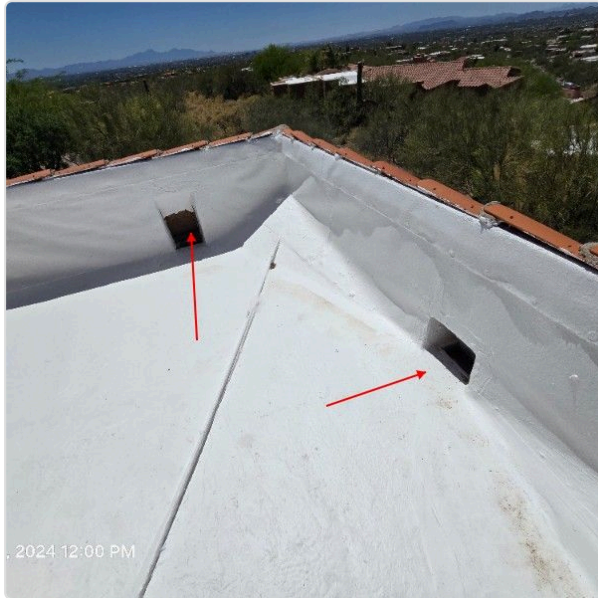
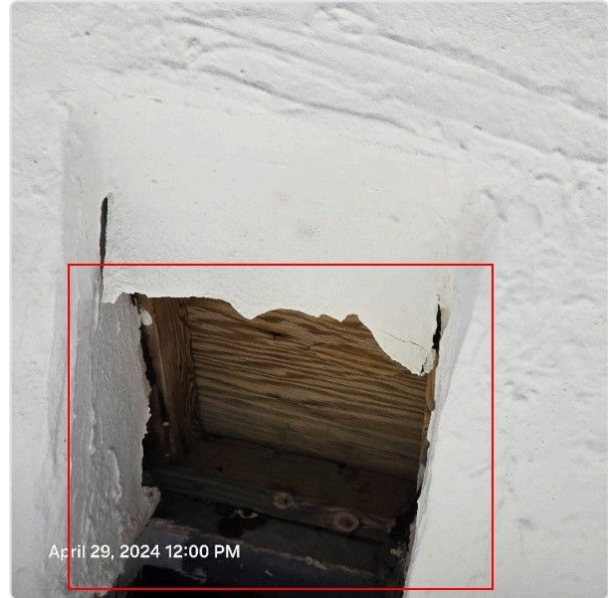
**Location:** SOUTH AWNING ROOF

## ROOF - OPEN PENETRATIONS

**Description:** Open/unsealed roof penetrations noted. Recommend sealing the penetrations to prevent a source of water intrusion.

**Severity:** RECOMMENDATIONS / IMPROVEMENT ITEMS

**Recommendation:** Contact a qualified roofing contractor.

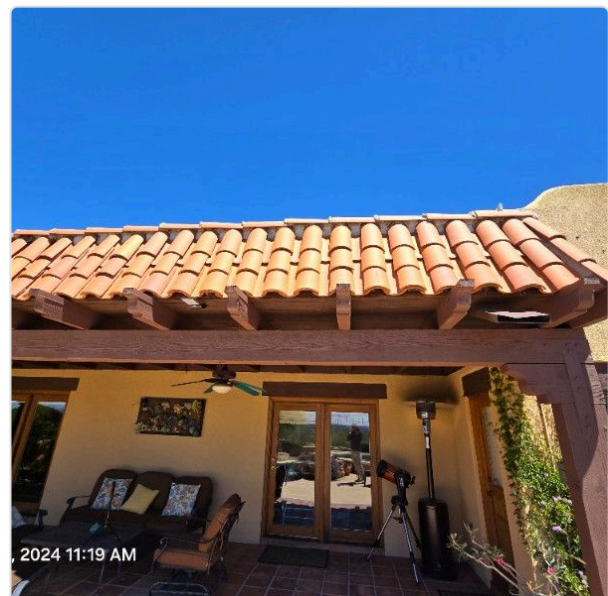
**Location:** SOUTH PATIO

## INSUFFICIENT UNDERLAYMENT

**Description:** Underlayment did not extend to the edge of the roof. Recommend further evaluation by a roofing professional and correction of underlayment if roof work is performed on this area.

**Severity:** RECOMMENDATIONS / IMPROVEMENT ITEMS

**Recommendation:** Contact a qualified roofing professional.

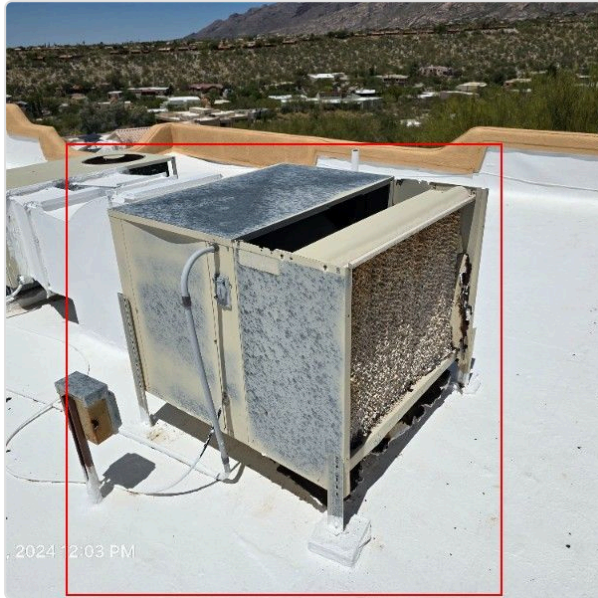
**Location:** CENTER ROOF

## EVAPORATIVE COOLER - ABANDONED

**Description:** An evaporative cooler was present on the roof and appeared to longer be in use. Recommend removal of the evaporative cooler to reduce the risk of leaks.

**Severity:** MATERIAL DEFECTS / SAFETY ITEMS

**Recommendation:** Contact a qualified general contractor.

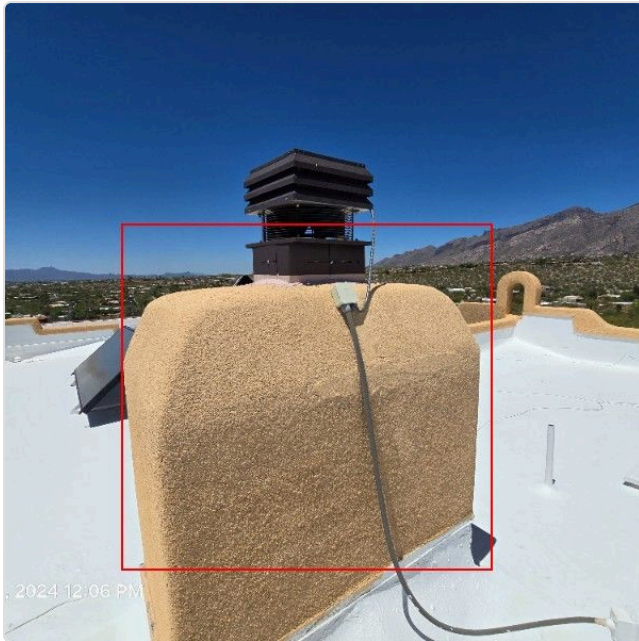
**Chimney Condition:** Appears satisfactory and functional at the time of the inspection.

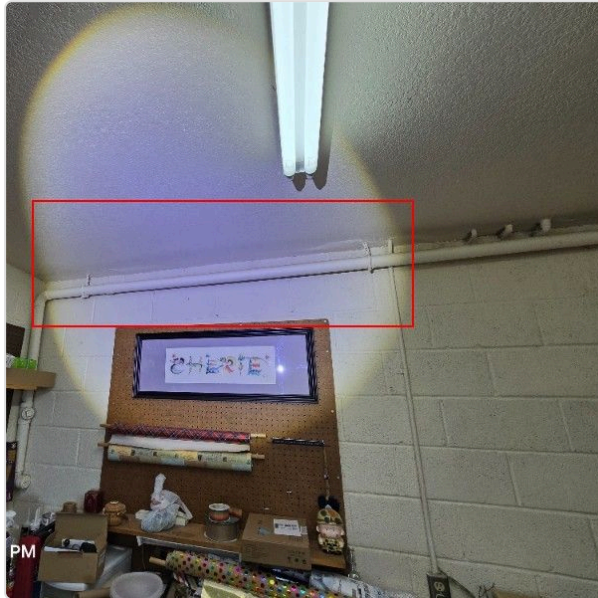
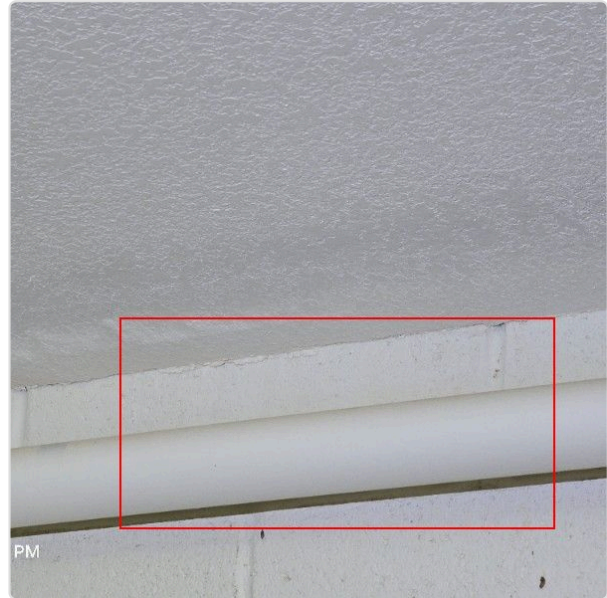
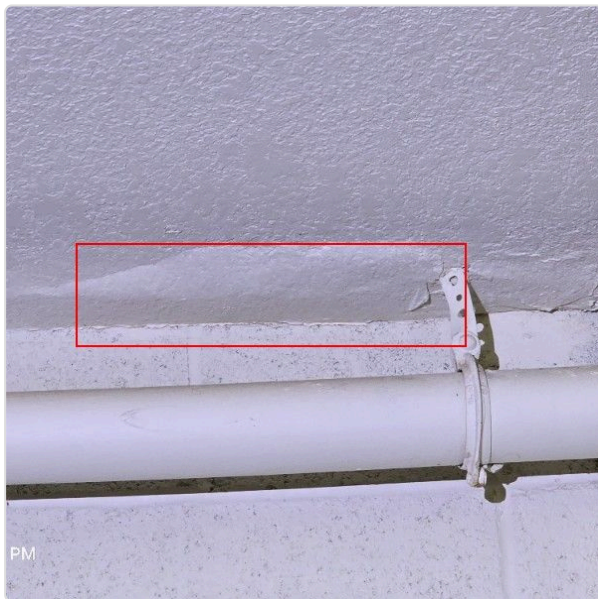
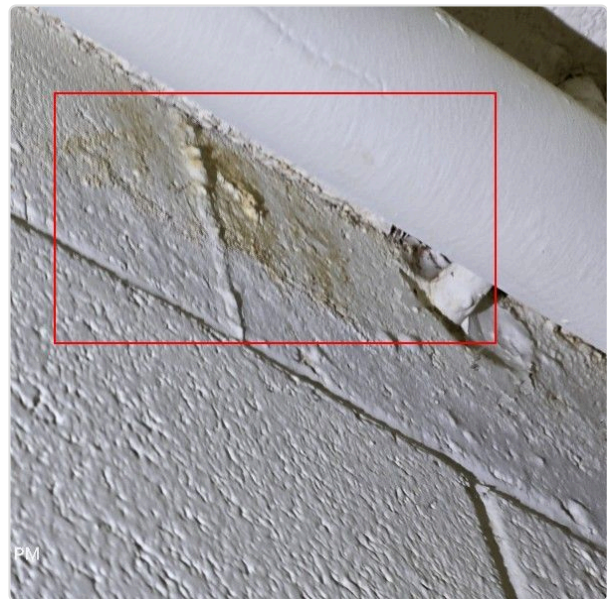
## ROOF STRUCTURE / WATER STAINING

**Description:** Water staining was present in the attic. Recommend identifying the source of the water into the home and repair of water source to prevent further water damage.

**Severity:** RECOMMENDATIONS / IMPROVEMENT ITEMS

**Recommendation:** Contact a qualified roofing professional.

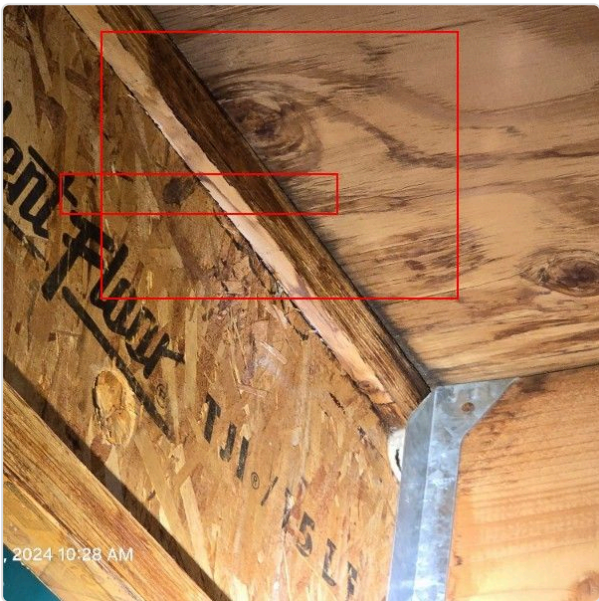
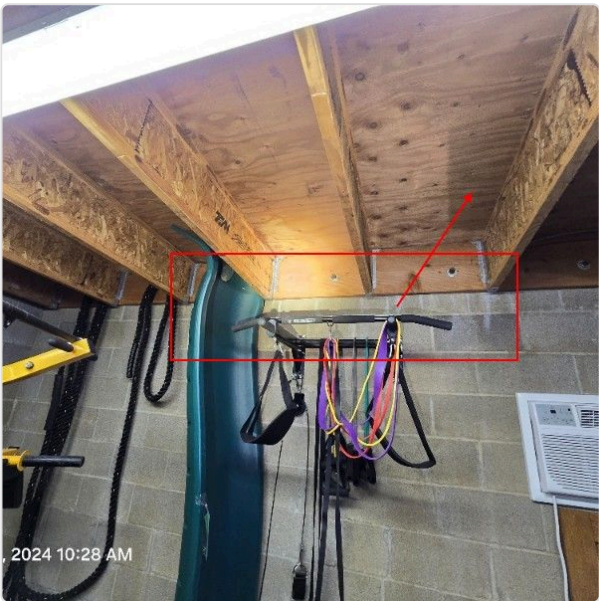
Location: DETACHED GARAGE

ROOF STRUCTURE / WATER STAINING

Description: Water staining was present in the attic. Recommend identifying the source of the water into the home and repair of water source to prevent further water damage.

Severity: RECOMMENDATIONS / IMPROVEMENT ITEMS

Recommendation: Contact a qualified roofing professional.

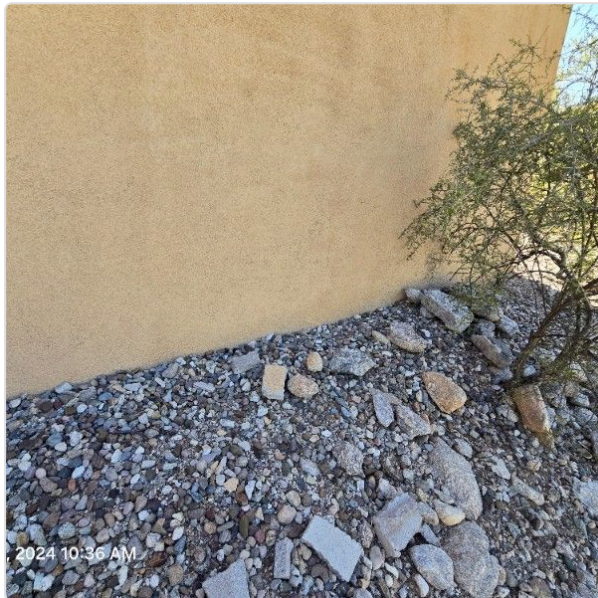
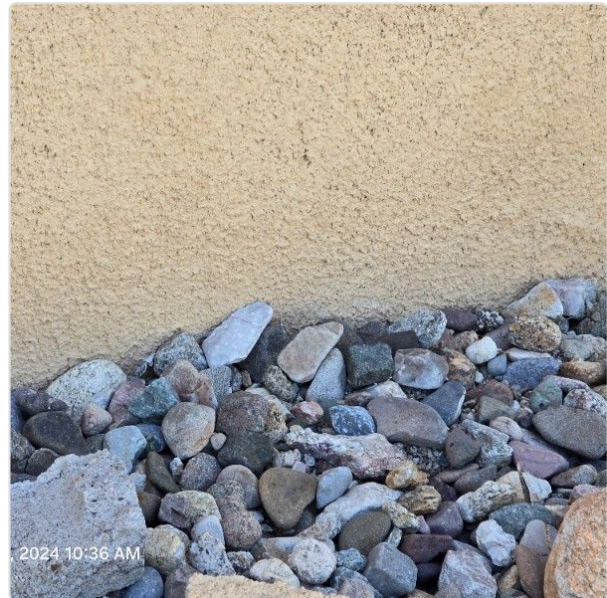
**Description:** The siding is in contact with the grade (earth), or hardscape instead of terminating above the grade. This can allow pests and moisture to more easily enter the home, and make it more difficult to identify the presence of wood-destroying insects. Regular pest inspections are recommended.

**Severity:** MONITOR / MAINTENANCE ITEMS

**Recommendation:** Contact a stucco repair contractor

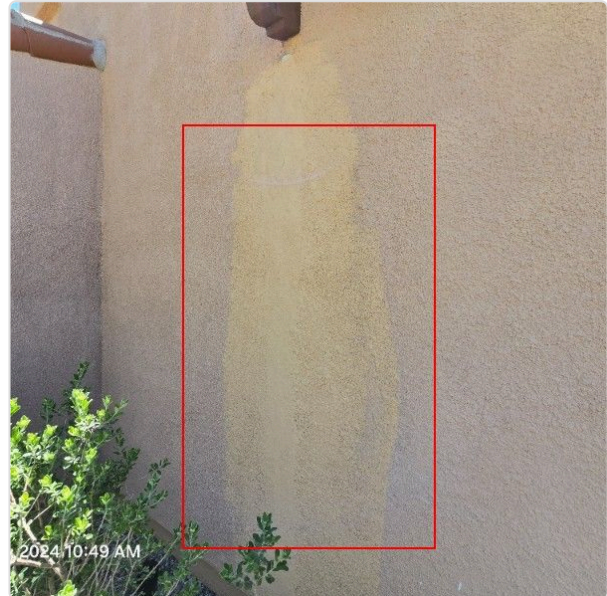
## PRIOR STUCCO REPAIR NOTED

**Description:** FYI - There are indications that previous repairs to the stucco has been performed. The stucco repair appears satisfactory but should be monitored for future cracking. Recommend inquiring with the seller as to the conditions present that required repair.

**Severity:** MONITOR / MAINTENANCE ITEMS

**Recommendation:** Contact the seller for more info

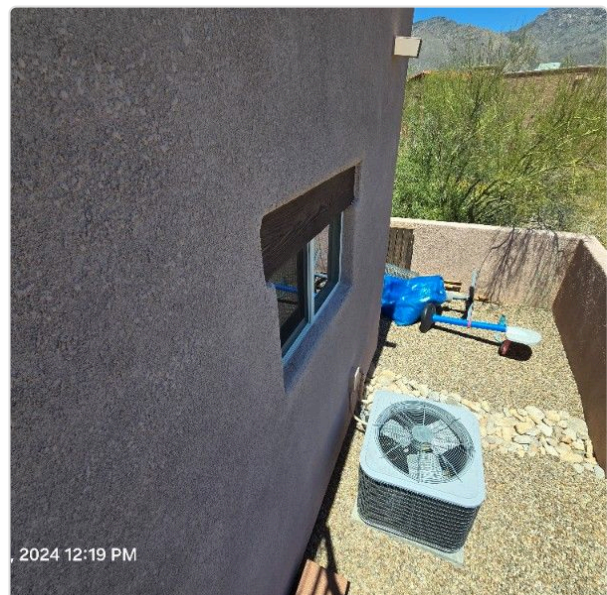
**Location:** EAST SIDE OF STRUCTURE

## STUCCO - HAIRLINE CRACKS

**Description:** One or more stucco cracks noted along the exterior of the home. Patching and painting of cracks is recommended to prevent water from entering behind the stucco.

**Severity:** MONITOR / MAINTENANCE ITEMS

**Recommendation:** Contact a qualified painting contractor.

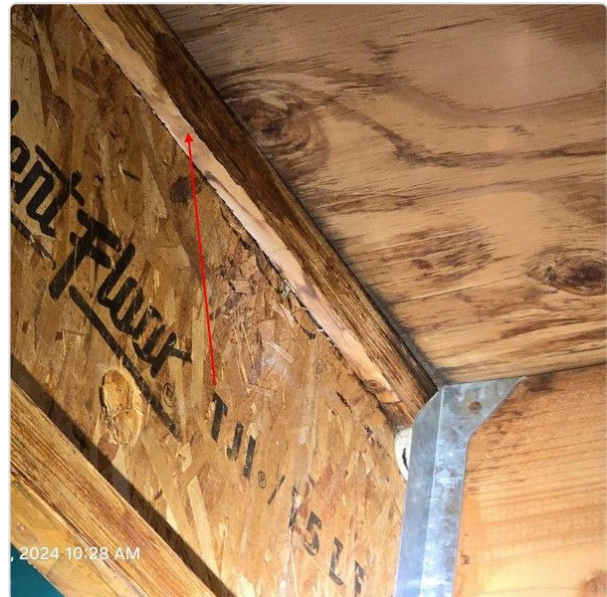
### Water Damage and Staining at West Garage Wall and Decking

**Description:** Observed water damage and staining on the west wall of the garage at multiple locations. Additional water staining was noted on the decking area co-located with the scupper above, indicating potential water intrusion or drainage issues.

**Severity:** RECOMMENDATIONS / IMPROVEMENT ITEMS

**Recommendation:** Recommend further evaluation to identify the source of water intrusion and repair affected areas. Improve drainage around the scupper and repair or replace damaged materials to prevent ongoing water damage.

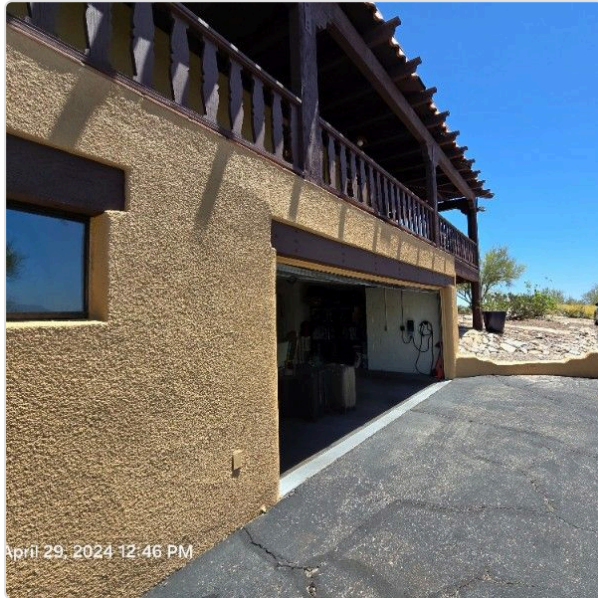
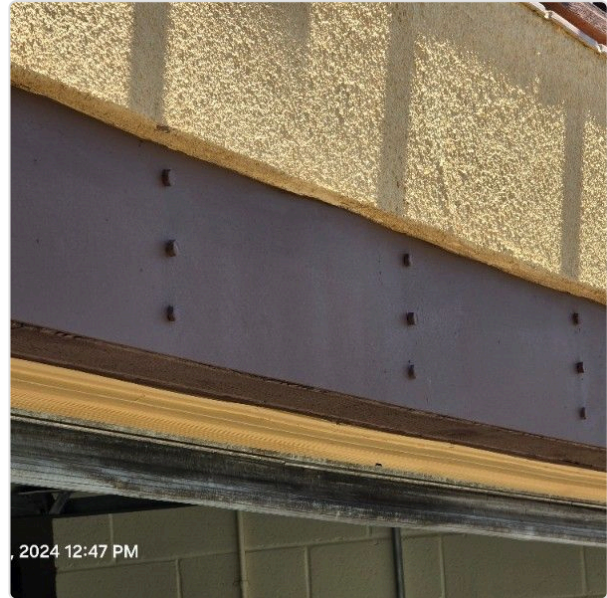
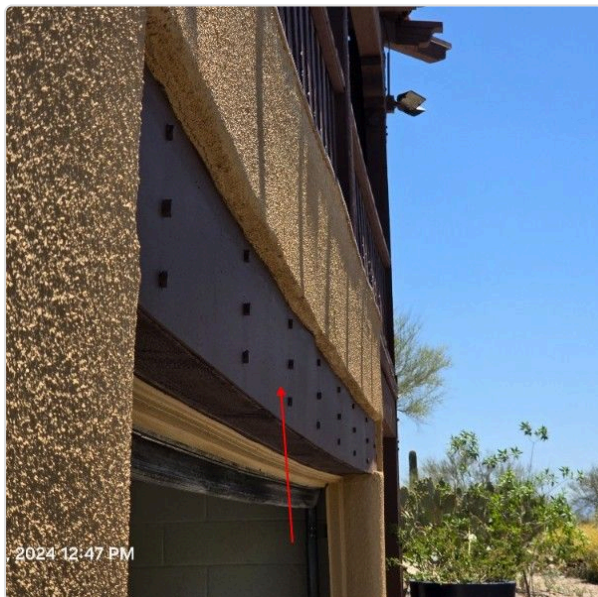
**Description:** Portions of the support beam were sagging. This may indicate an issue with the integrity of the porch. Recommend evaluation and repair.

**Severity:** MATERIAL DEFECTS / SAFETY ITEMS

**Recommendation:** Contact a qualified general contractor

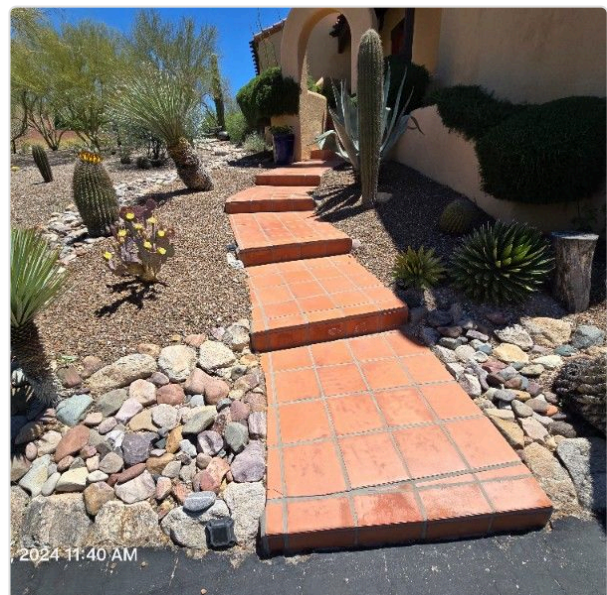
### Stairs - Missing Handrails

**Description:** It is recommended to have handrails installed on stairs with 3 or more risers (steps).

**Severity:** RECOMMENDATIONS / IMPROVEMENT ITEMS

**Recommendation:** Contact a qualified general contractor.

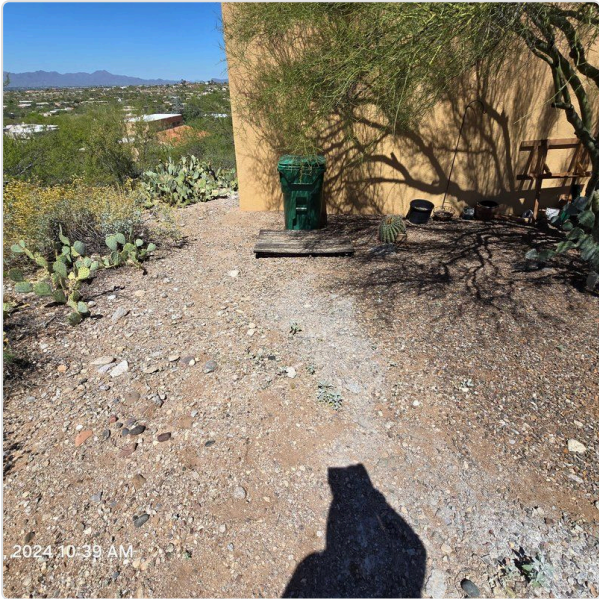
Improper Grading Causing Water Pooling Against East Side of Garage

Severity: RECOMMENDATIONS / IMPROVEMENT ITEMS

Recommendation: Recommend minor corrections to the grading in this area to redirect water away from the house and prevent pooling.

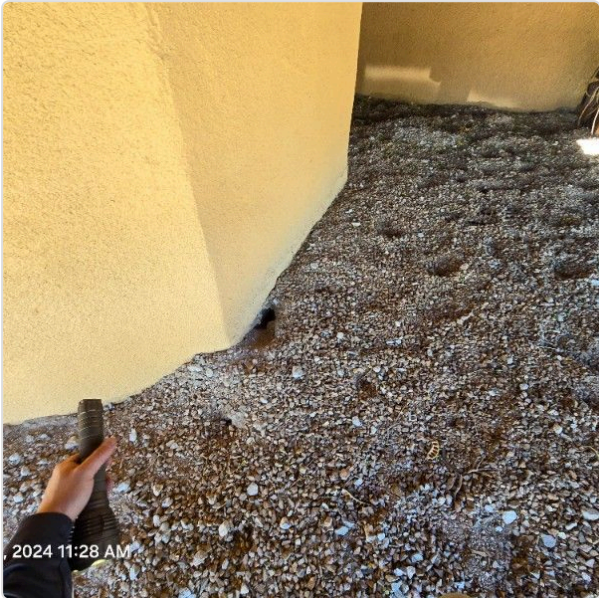
Location: WEST DECK

GRADE - INDICATION OF PESTS

Description: There are indications that pests may be present or were present in the past. Recommend a qualified pest control company to evaluate.

Severity: MONITOR / MAINTENANCE ITEMS

Recommendation: Contact a qualified pest control specialist.

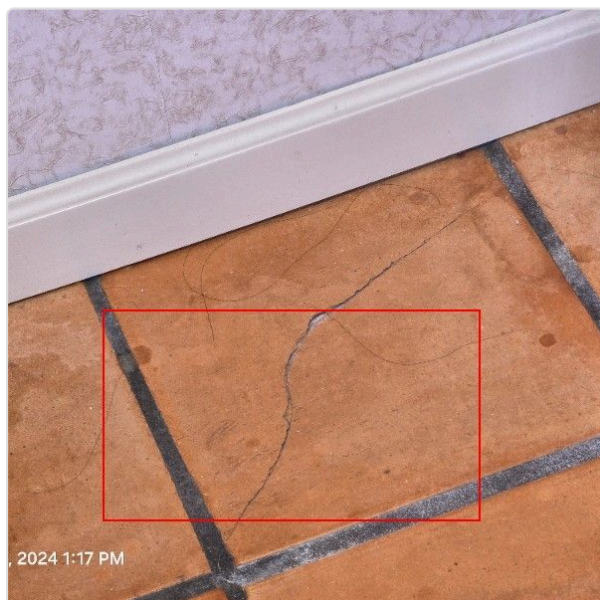
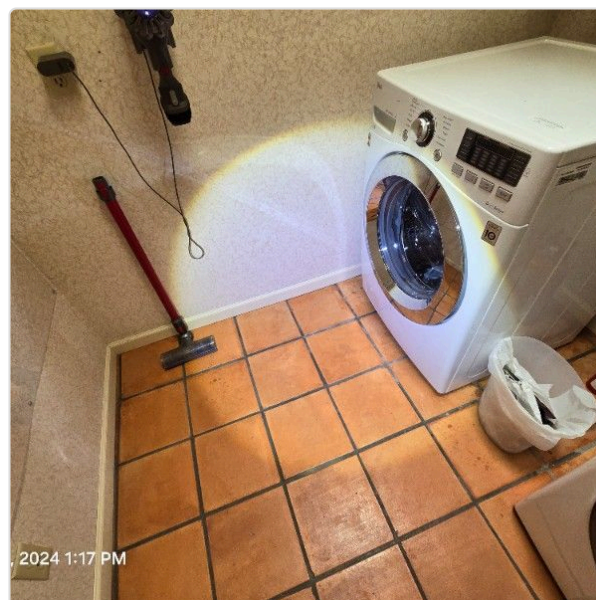
#### Cracked Tiles in Laundry Room and Entryway

**Description:** There are cracked tiles observed in the laundry room and at the entryway. No underlying damage was noted, but the tiles are somewhat delicate and prone to cracking.

**Severity:** MONITOR / MAINTENANCE ITEMS

**Recommendation:** Monitor the cracked tiles for further deterioration and consider repair or replacement to prevent potential damage or safety hazards.

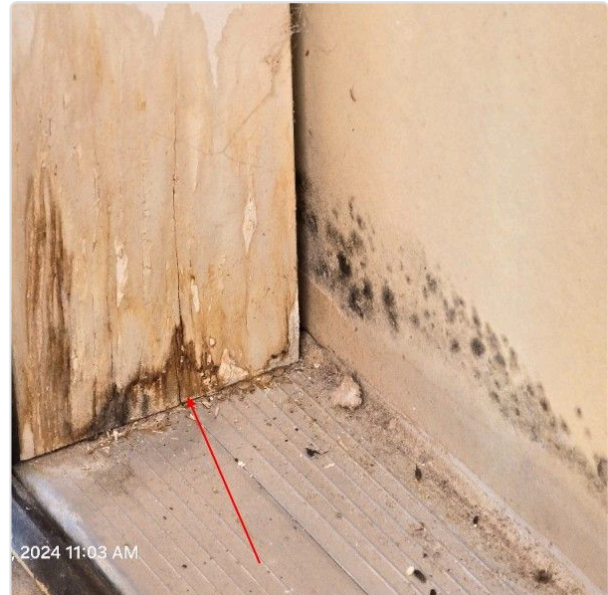
**Description:** There is possible organic growth on the walls. Further evaluation is recommended, and remediation if required.

**Severity:** MATERIAL DEFECTS / SAFETY ITEMS

**Recommendation:** Contact a qualified mold inspection professional

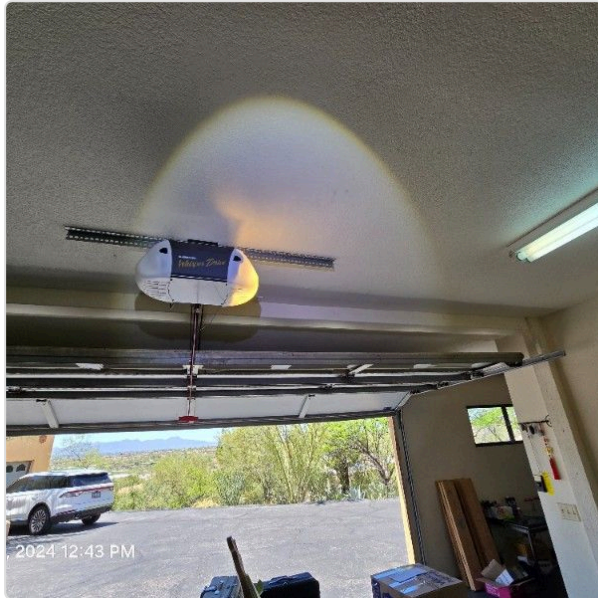
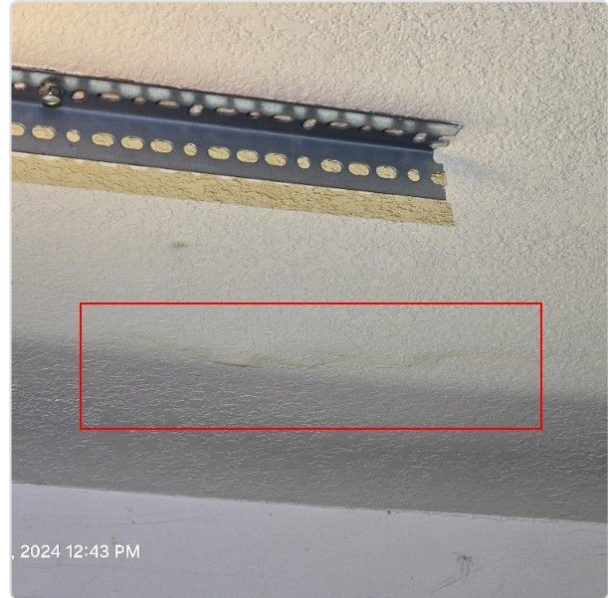
## CEILINGINGS AND WALLS - WATER DAMAGE

**Severity:** RECOMMENDATIONS / IMPROVEMENT ITEMS

**Recommendation:** Contact a qualified general contractor.

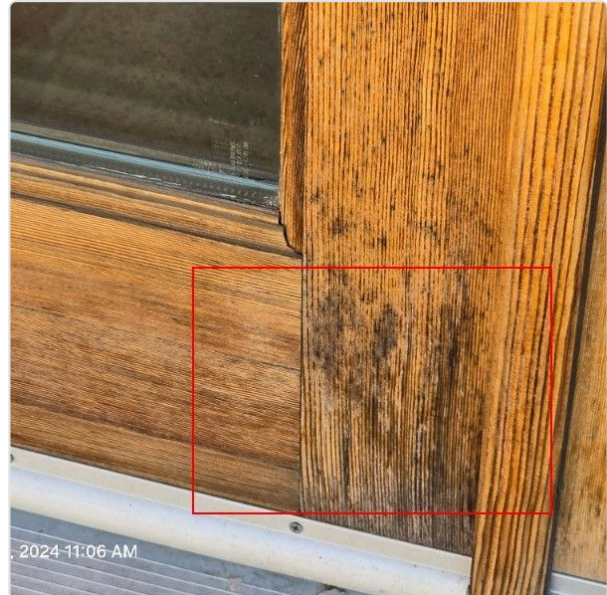
**Location:** SOUTHEAST SIDE OF STRUCTURE

## DOOR - SEALANT WEATHERING

**Severity:** MONITOR / MAINTENANCE ITEMS

**Recommendation:** Contact a qualified painting contractor.

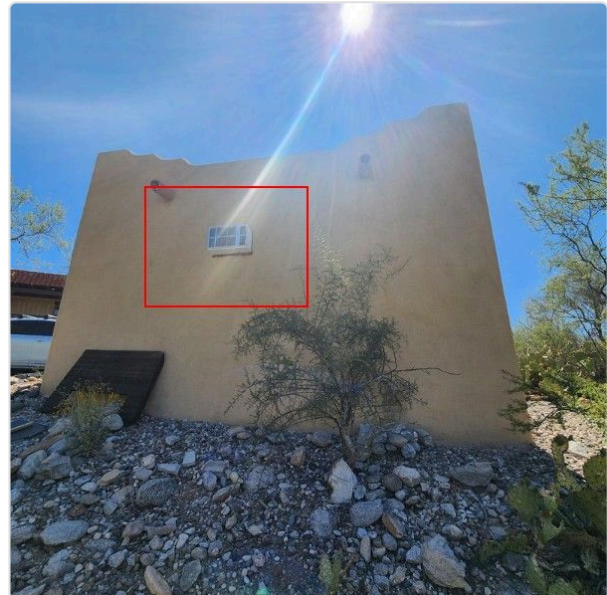
**Severity:** RECOMMENDATIONS / IMPROVEMENT ITEMS

**Recommendation:** Remove or replace the window-mounted air conditioner with an approved cooling solution. Consider installing proper roof insulation in the garage to mitigate heat buildup.

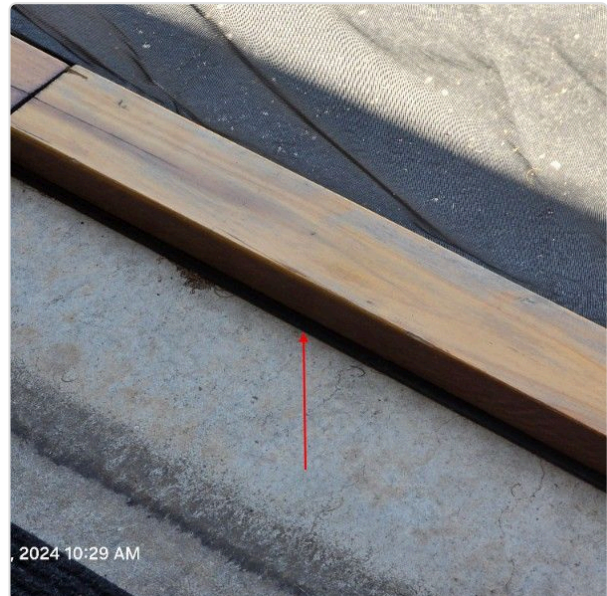
**Location:** DETACHED GARAGE

## GARAGE FRAMED IN

**Severity:** MONITOR / MAINTENANCE ITEMS

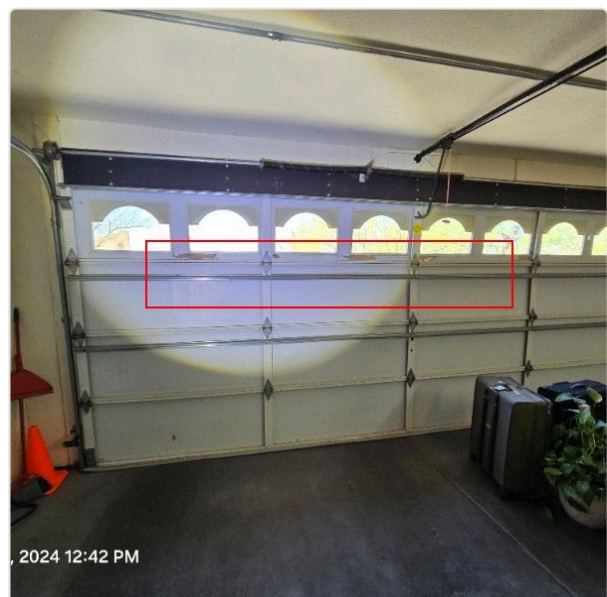
**Location:** GARAGE

## GARAGE DOOR - DAMAGE

**Severity:** RECOMMENDATIONS / IMPROVEMENT ITEMS

**Recommendation:** Contact a qualified garage door contractor.

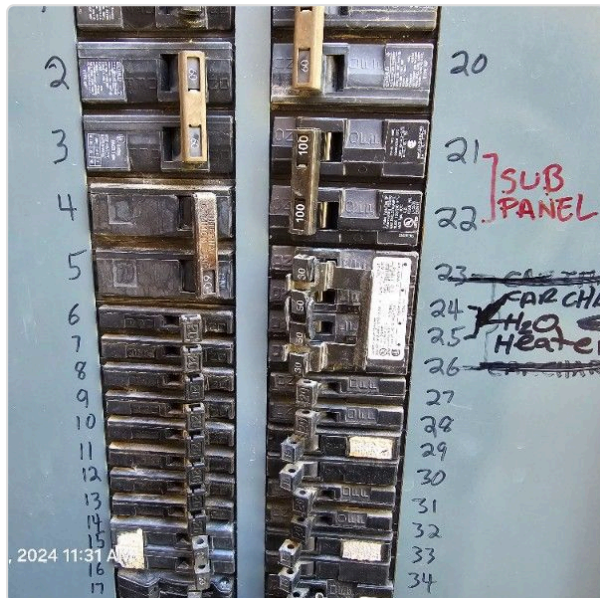
**Location:** MAIN PANEL - WEST SIDE OF STRUCTURE

## COVER - INCOMPLETE, INCORRECT, OR MISSING LEGEND

**Severity:** MONITOR / MAINTENANCE ITEMS

**Recommendation:** Contact a qualified electrical contractor.

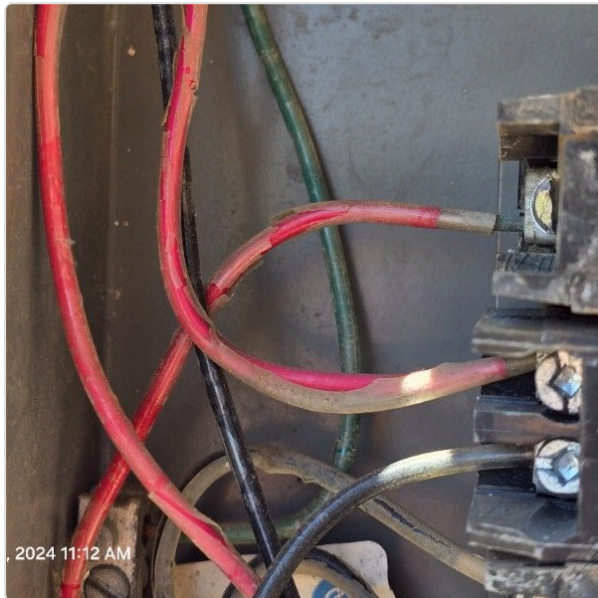
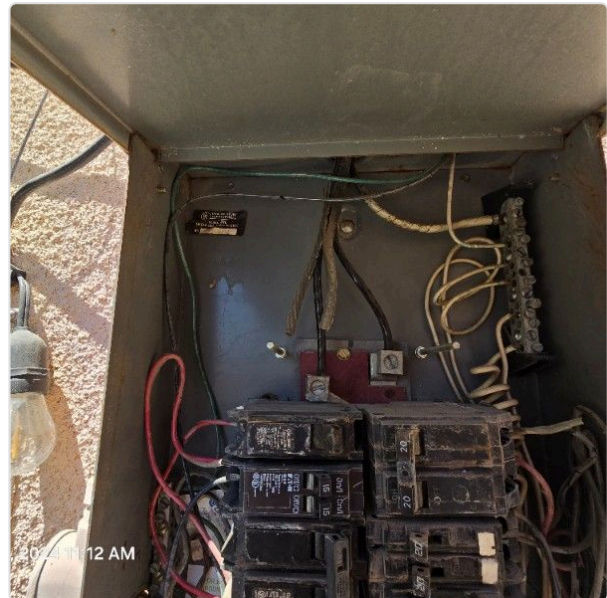
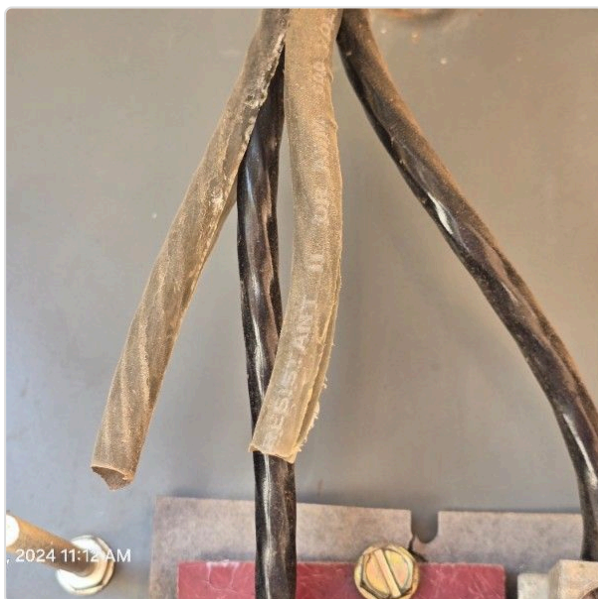
**Location:** EAST EXTERIOR - POOL PANEL

## UV DAMAGED WIRING

**Severity:** RECOMMENDATIONS / IMPROVEMENT ITEMS

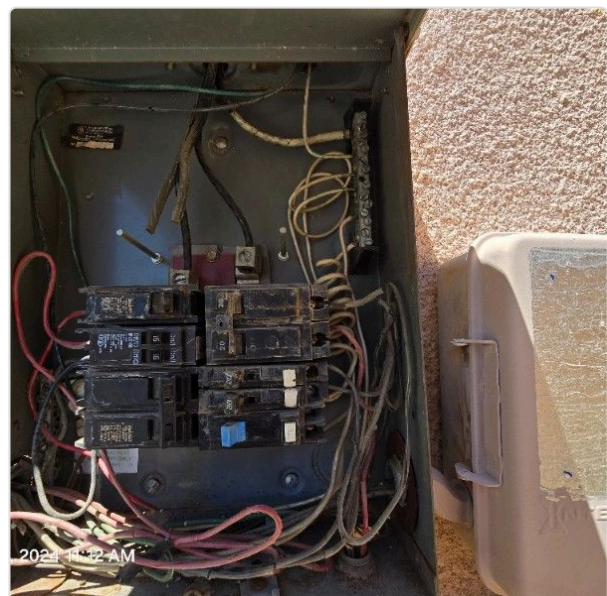
**Location:** EAST EXTERIOR - POOL PANEL

## PANEL - FOUR WIRE FEED MISSING

**Severity:** RECOMMENDATIONS / IMPROVEMENT ITEMS

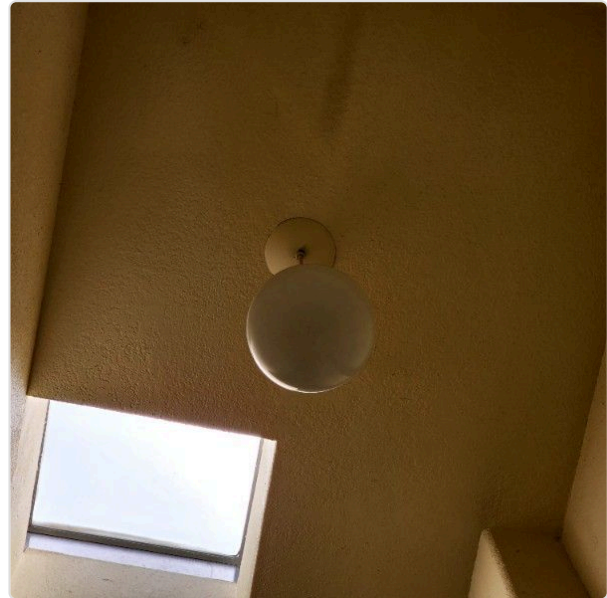
**Location:** GARAGE

## LIGHT(S) - NOT FUNCTIONAL / INOPERABLE

**Severity:** MONITOR / MAINTENANCE ITEMS

**Recommendation:** Contact a qualified electrical contractor.

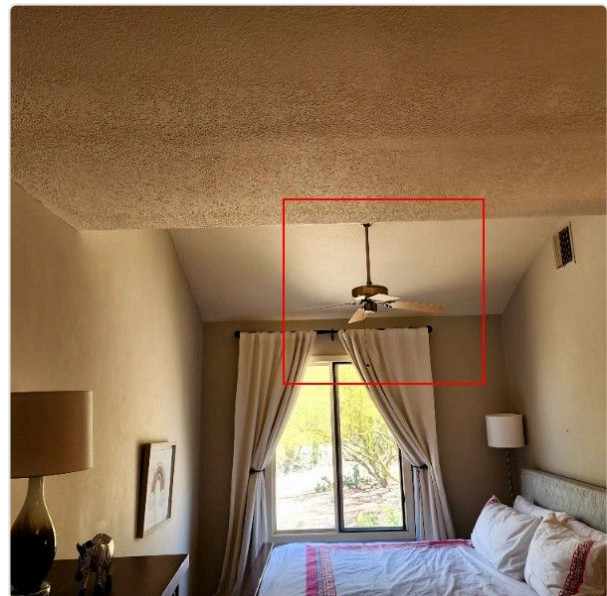
**Location:** NORTHWEST BEDROOM

## CEILING FAN - INOPERABLE

**Severity:** RECOMMENDATIONS / IMPROVEMENT ITEMS

**Recommendation:** Contact a qualified electrical contractor

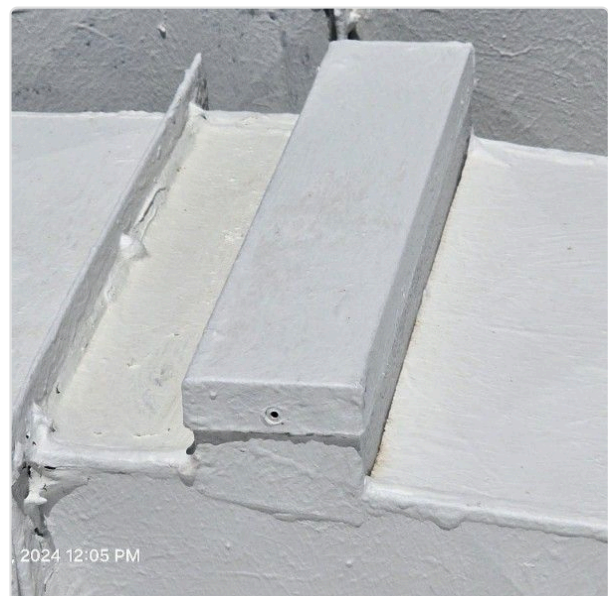
## EVAPORATIVE COOLER - MISSING SUPPORT

**Severity:** RECOMMENDATIONS / IMPROVEMENT ITEMS

**Recommendation:** Recommend further evaluation by a licensed HVAC professional to confirm conditioned air is not escaping the system.

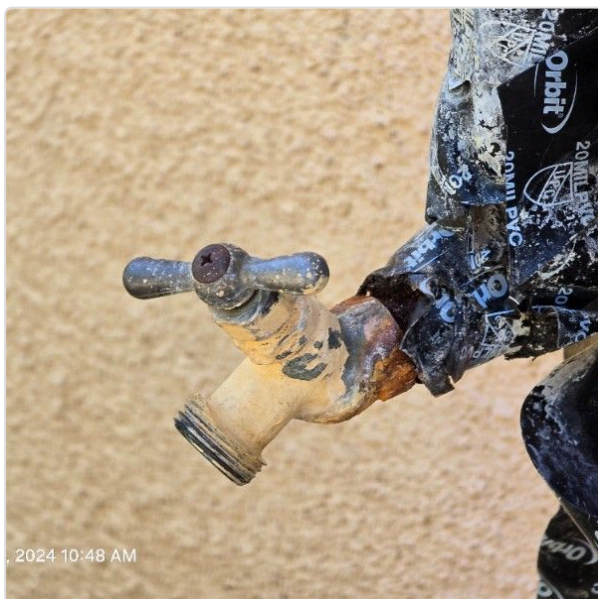
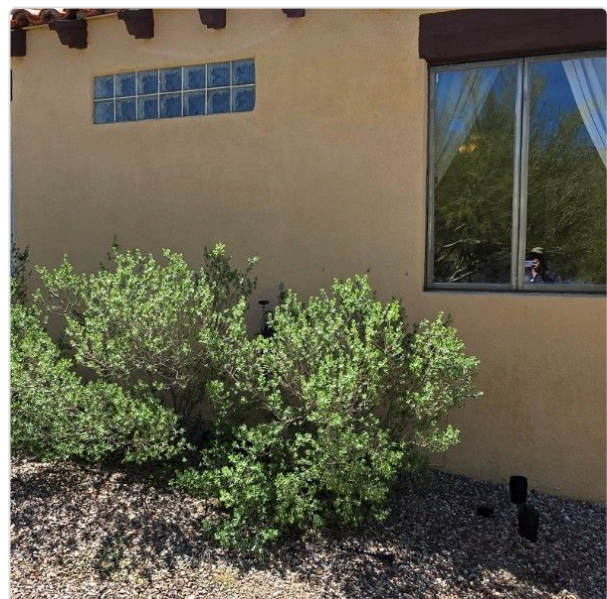
**Location:** SOUTH PATIO

## NO SERVICE

**Severity:** RECOMMENDATIONS / IMPROVEMENT ITEMS

**Recommendation:** Contact a qualified plumbing contractor

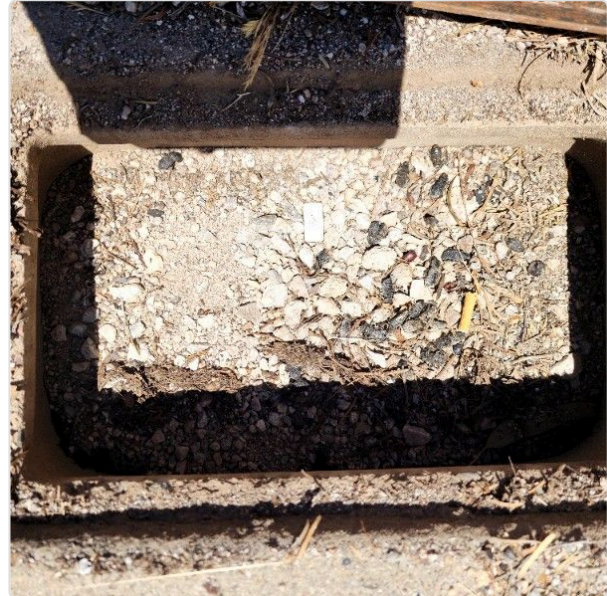
**Location:** DRIVEWAY

## WATER METER / WATER SHUTOFF - BURIED

**Severity:** MONITOR / MAINTENANCE ITEMS

**Recommendation:** Contact a handyman or DIY project

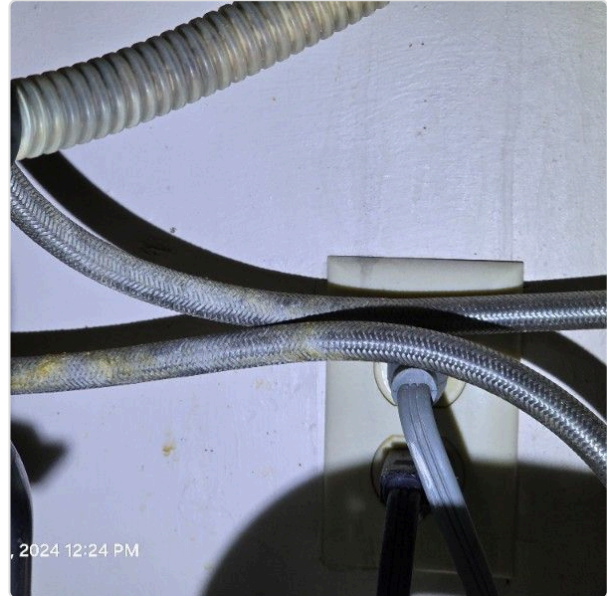
**Location:** KITCHEN

## PLUMBING - INDICATIONS OF PREVIOUS LEAK

**Severity:** MONITOR / MAINTENANCE ITEMS

**Recommendation:** Contact a qualified plumbing contractor

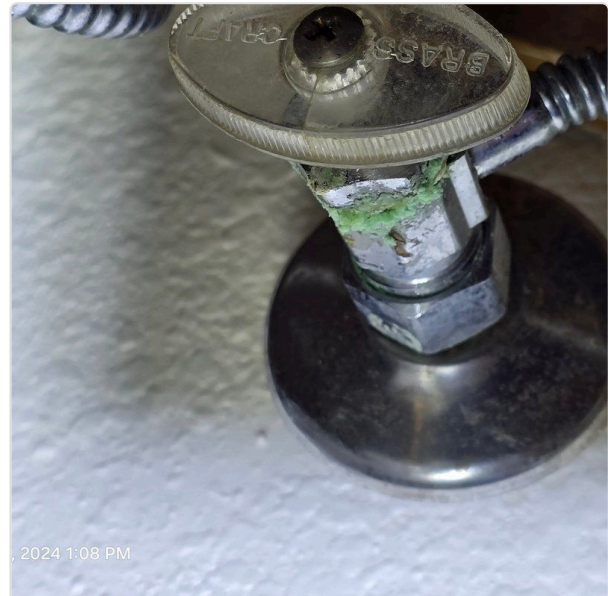
**Location:** His-and-Hers Bathroom

## Significant Buildup on Angle Stop

**Severity:** RECOMMENDATIONS / IMPROVEMENT ITEMS

**Recommendation:** Recommend cleaning and inspection of the angle stop to assess for corrosion or blockage and replacement if necessary to ensure proper function.

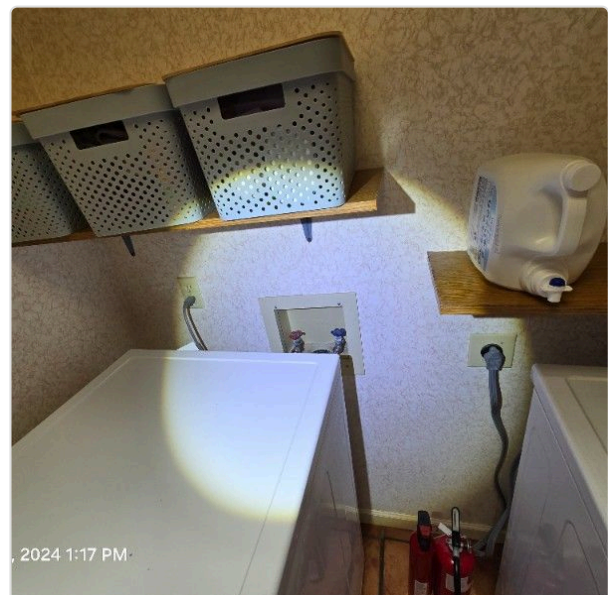
**Location:** LAUNDRY

## PLUMBING - CORROSION/BUILDUP

**Severity:** RECOMMENDATIONS / IMPROVEMENT ITEMS

**Recommendation:** Contact a qualified plumbing contractor.

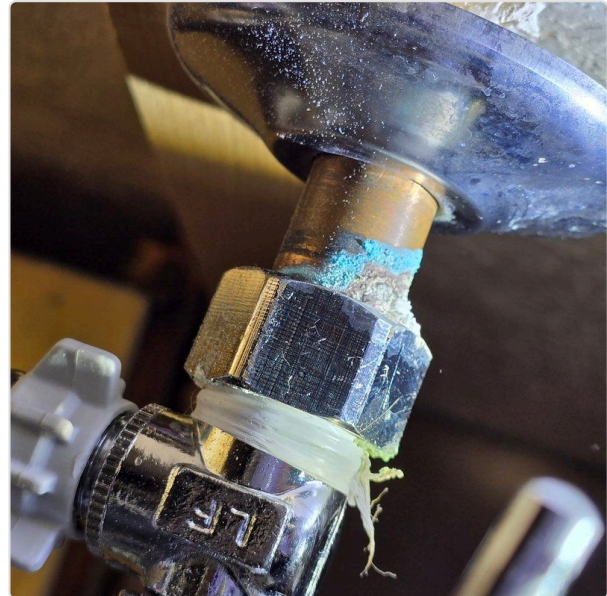
**Location:** Hall Bathroom

## Corroded and Leaking Angle Stops in Hall Bathroom

**Severity:** RECOMMENDATIONS / IMPROVEMENT ITEMS

**Recommendation:** Evaluate all angle stops in the house for condition and replace as necessary to prevent leaks and further corrosion.
