**70345 BLUE RIDGE MOUNTAIN**

# **PLUS SEVEN INSPECTION - SAMPLE REPORT**

Inspection Type: Home Inspection

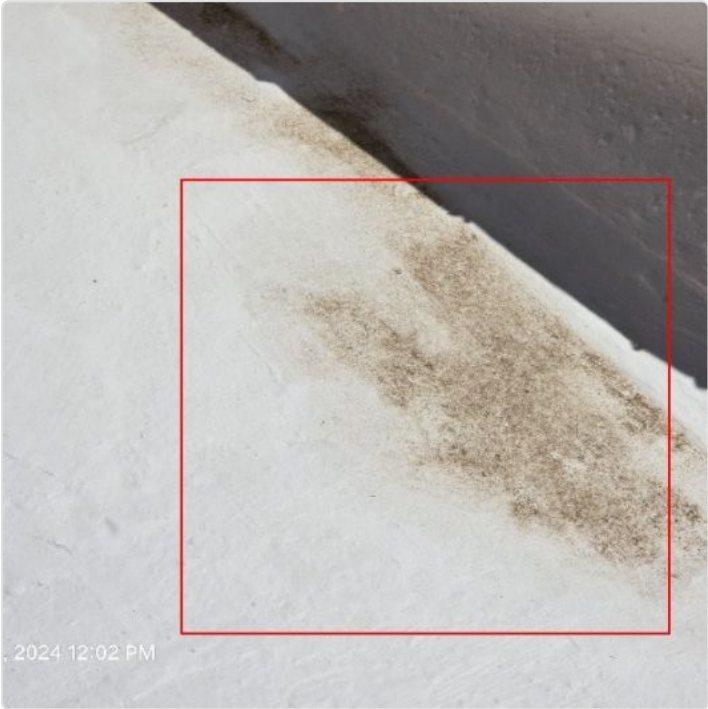
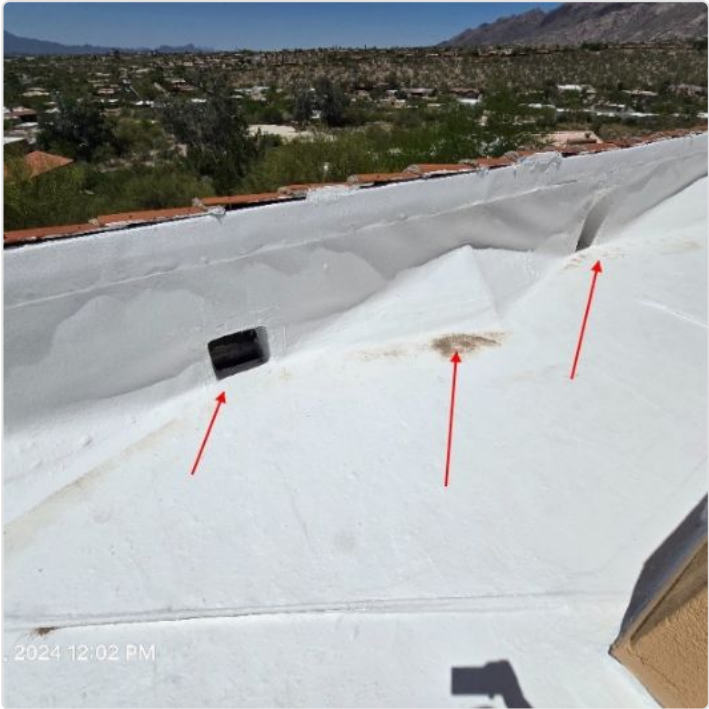
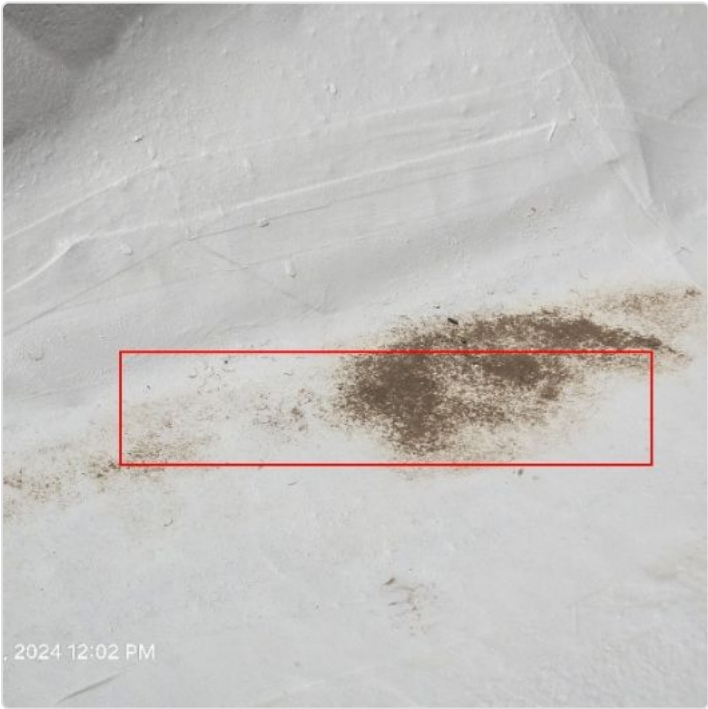
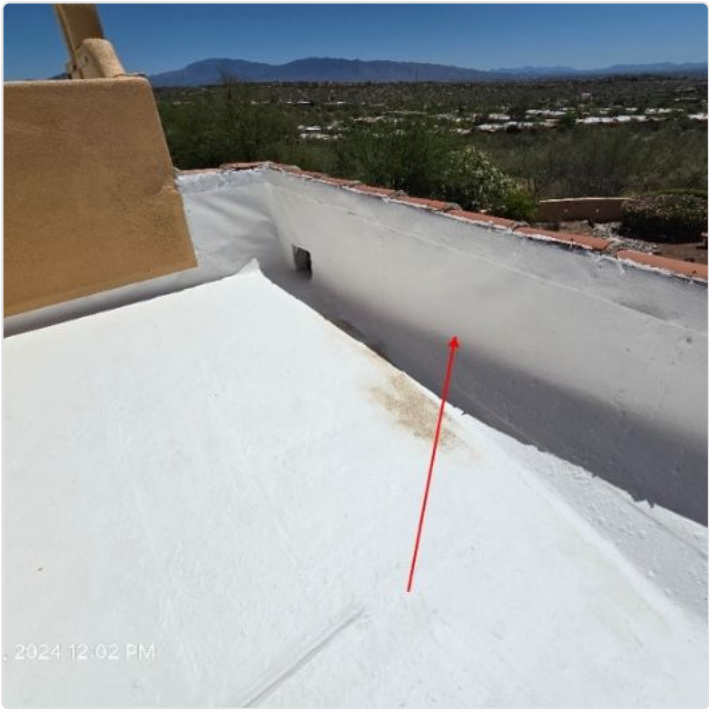
**Description:**  
Areas of ponding noted along the roof structure. Recommend correction of the slope of the effected area to prevent pooling water from causing accelerated wear on the roof surface.

**Severity:**  
RECOMMENDATIONS / IMPROVEMENT ITEMS

**Recommendation:**  
Contact a qualified roofing professional.

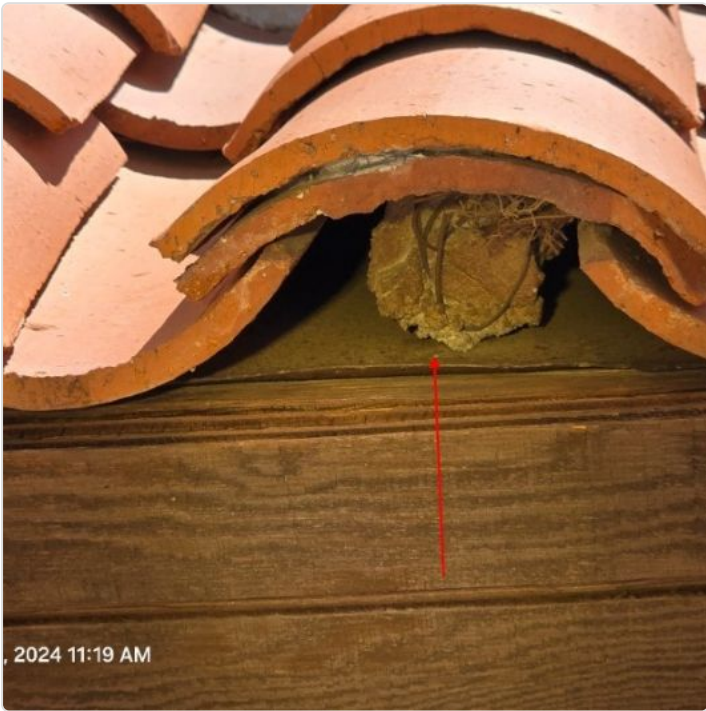
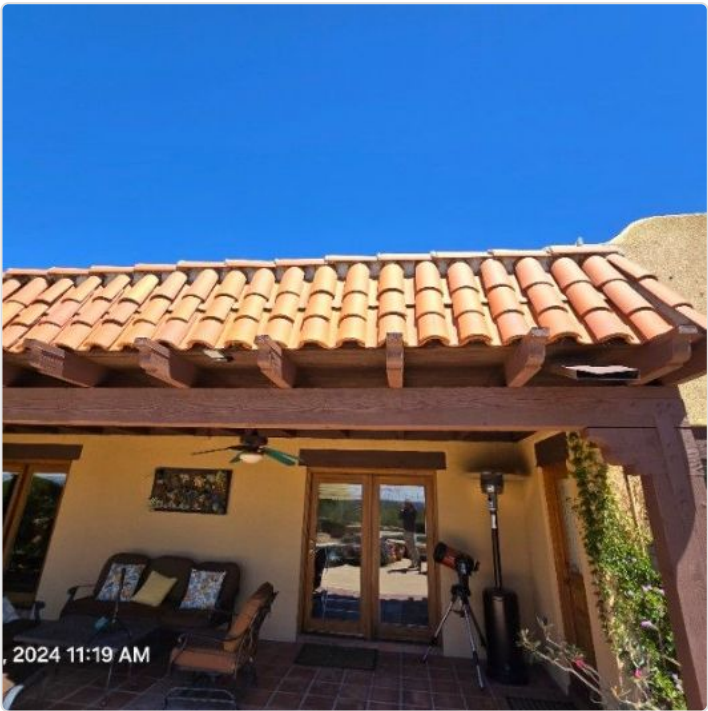
INSUFFICIENT UNDERLAYMENT

**Location:**  
SOUTH PATIO

**Description:**  
Underlayment did not extend to the edge of the roof. Recommend further evaluation by a roofing professional and correction of underlayment if roof work is performed on this area.

**Severity:**  
RECOMMENDATIONS / IMPROVEMENT ITEMS

**Recommendation:**  
Contact a qualified roofing professional.

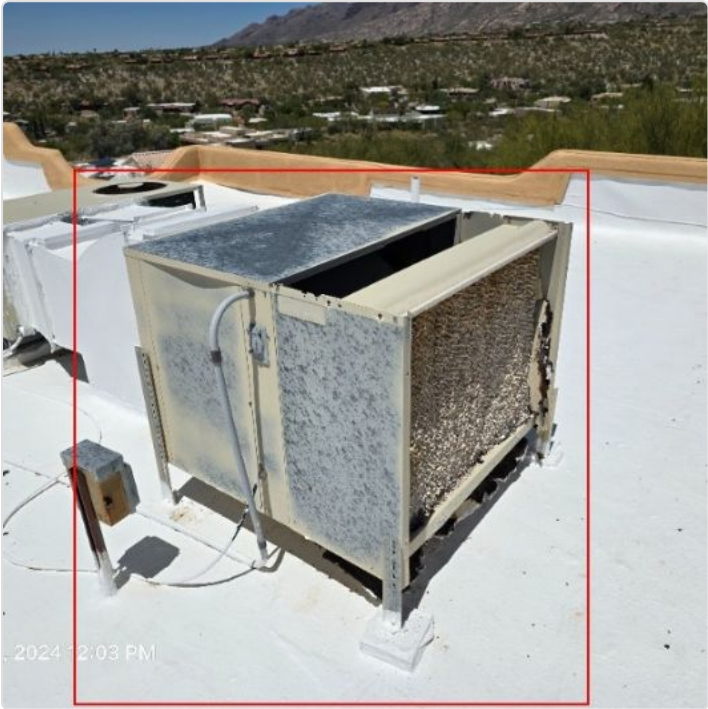
EVAPORATIVE COOLER - ABANDONED

**Location:**  
CENTER ROOF

**Description:**  
An evaporative cooler was present on the roof and appeared to longer be in use. Recommend removal of the evaporative cooler to reduce the risk of leaks.

**Severity:**  
MATERIAL DEFECTS / SAFETY ITEMS

**Recommendation:**  
Contact a qualified general contractor.

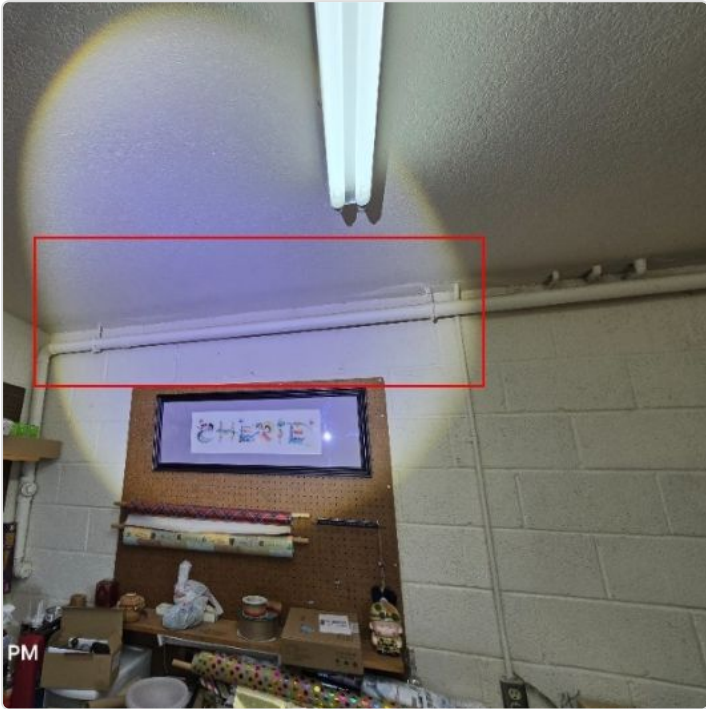
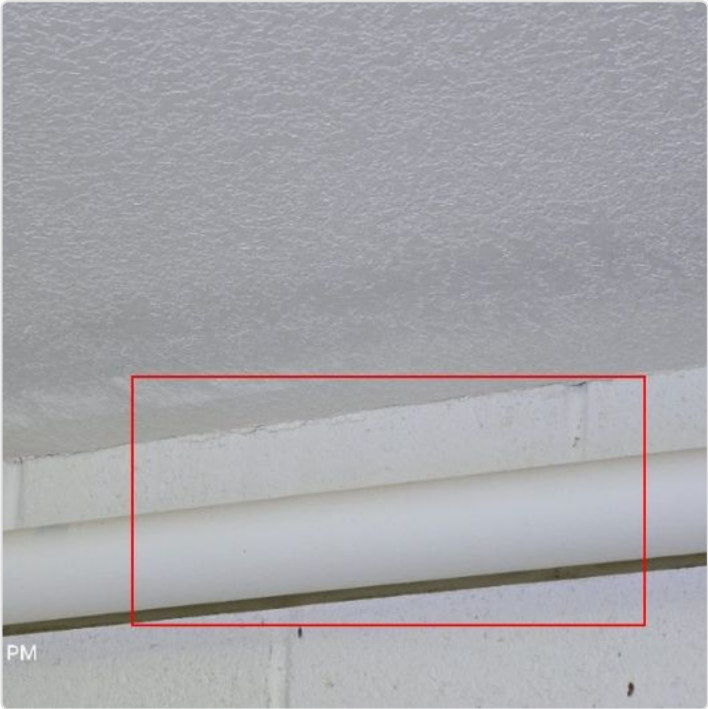
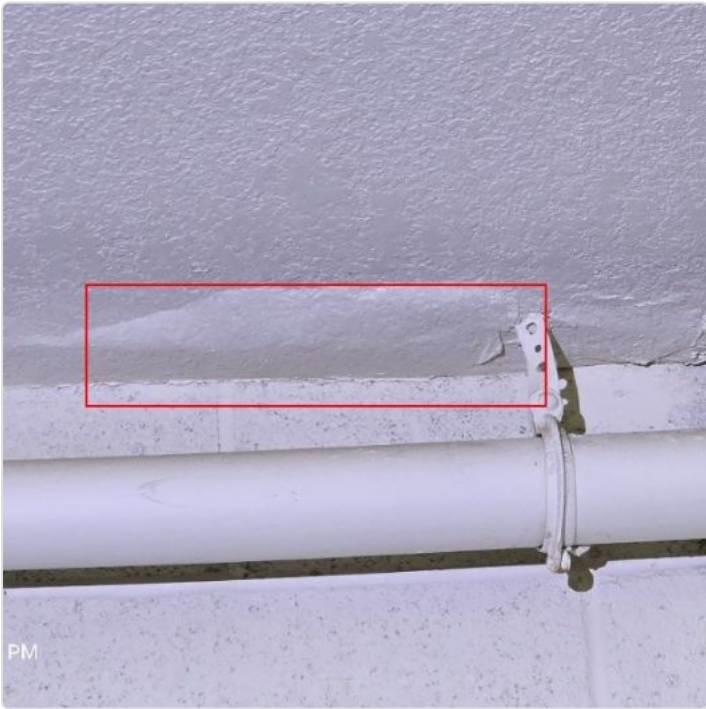
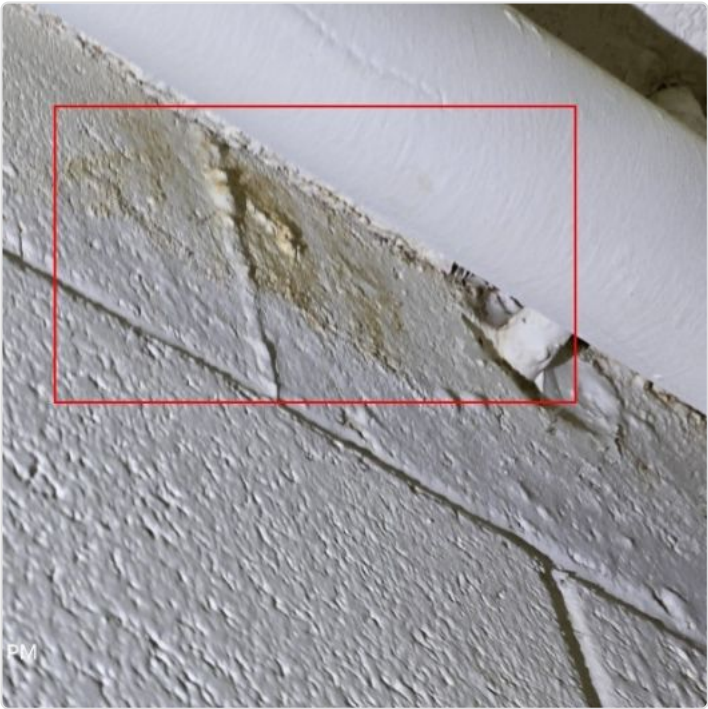
ROOF STRUCTURE / WATER STAINING

**Description:**  
Water staining was present in the attic. Recommend identifying the source of the water into the home and repair of water source to prevent further water damage.

**Severity:**  
RECOMMENDATIONS / IMPROVEMENT ITEMS

**Recommendation:**  
Contact a qualified roofing professional.

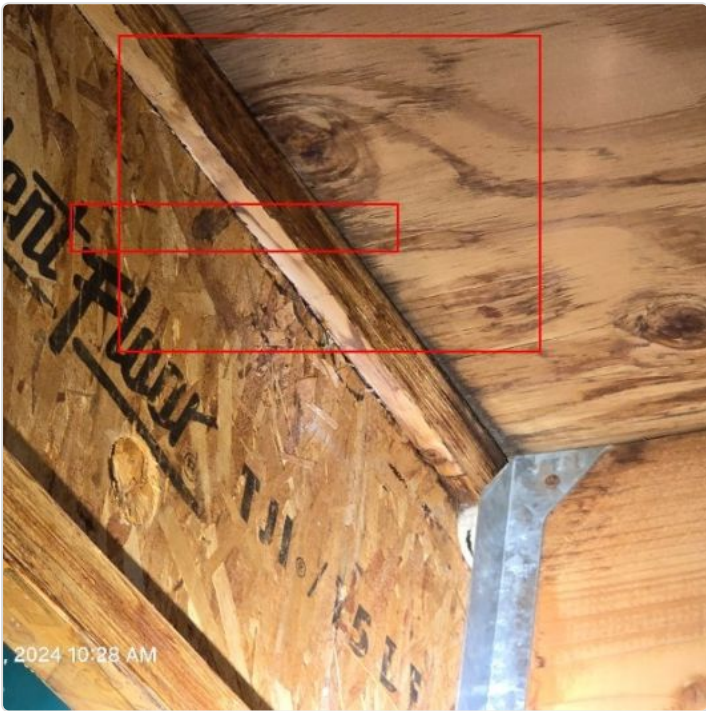
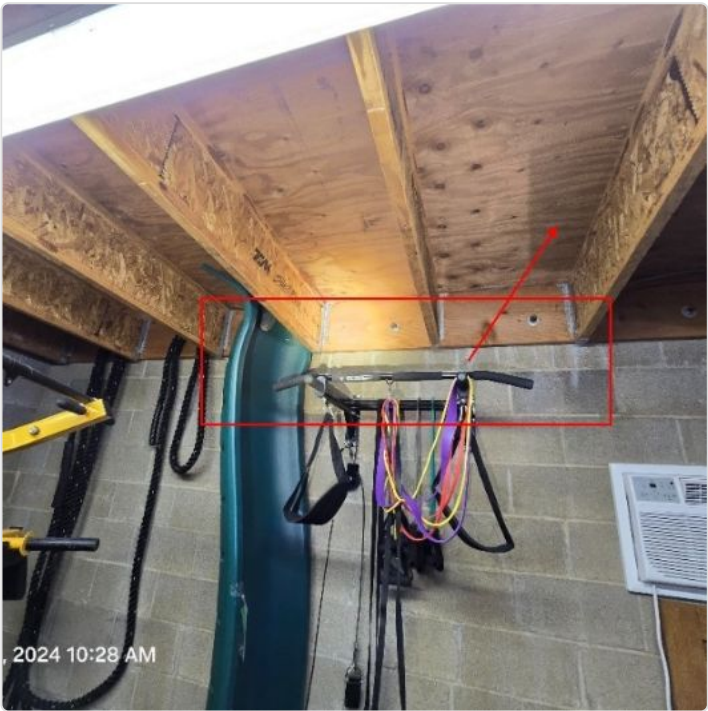
ROOF STRUCTURE / WATER STAINING

**Location:**  
DETACHED GARAGE

**Description:**  
Water staining was present in the attic. Recommend identifying the source of the water into the home and repair of water source to prevent further water damage.

**Severity:**  
RECOMMENDATIONS / IMPROVEMENT ITEMS

**Recommendation:**  
Contact a qualified roofing professional.

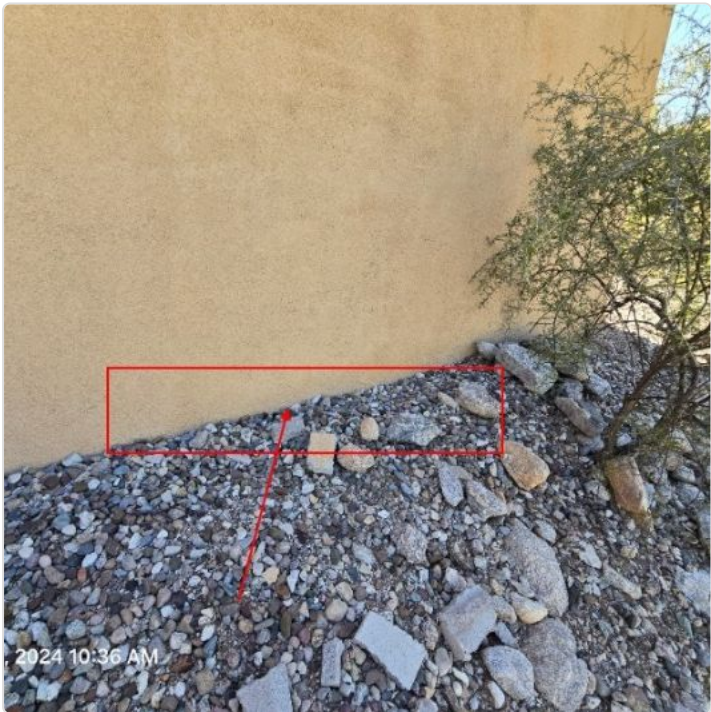
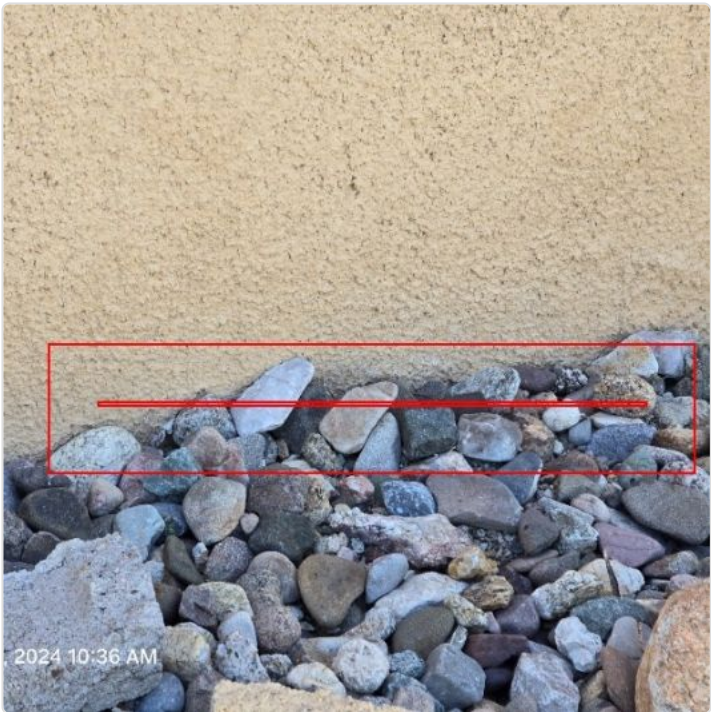
Description:  
The siding is in contact with the grade (earth), or hardscape instead of terminating above the grade. This can allow pests and moisture to more easily enter the home, and make it more difficult to identify the presence of wood-destroying insects. Regular pest inspections are recommended.

Severity:  
MONITOR / MAINTENANCE ITEMS

Recommendation:  
Contact a stucco repair contractor

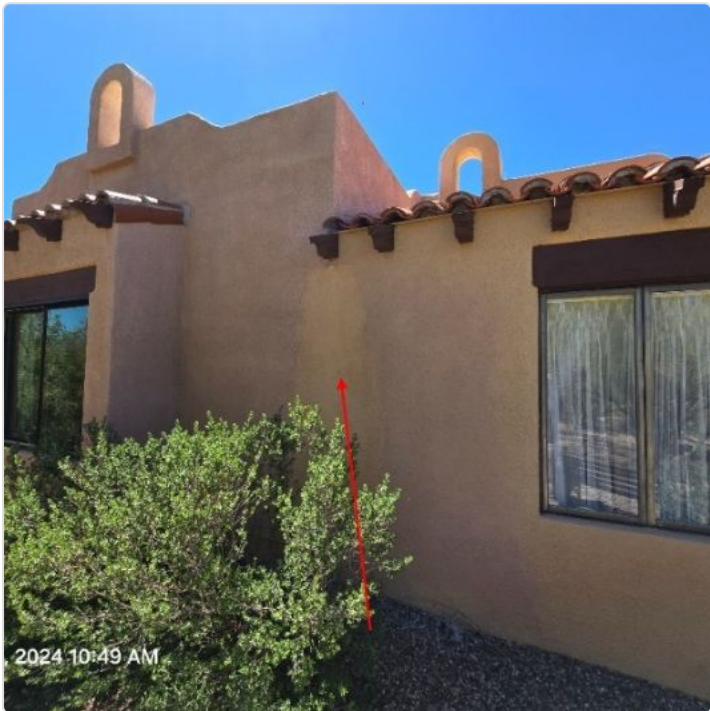
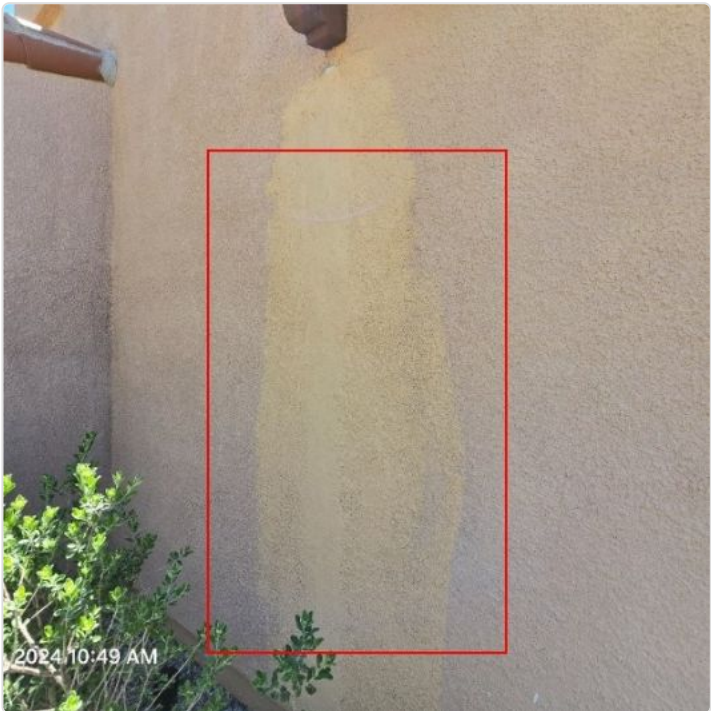
PRIOR STUCCO REPAIR NOTED

**Description:**  
FYI - There are indications that previous repairs to the stucco has been performed. The stucco repair appears satisfactory but should be monitored for future cracking. Recommend inquiring with the seller as to the conditions present that required repair.

**Severity:**  
MONITOR / MAINTENANCE ITEMS

**Recommendation:**  
Contact the seller for more info

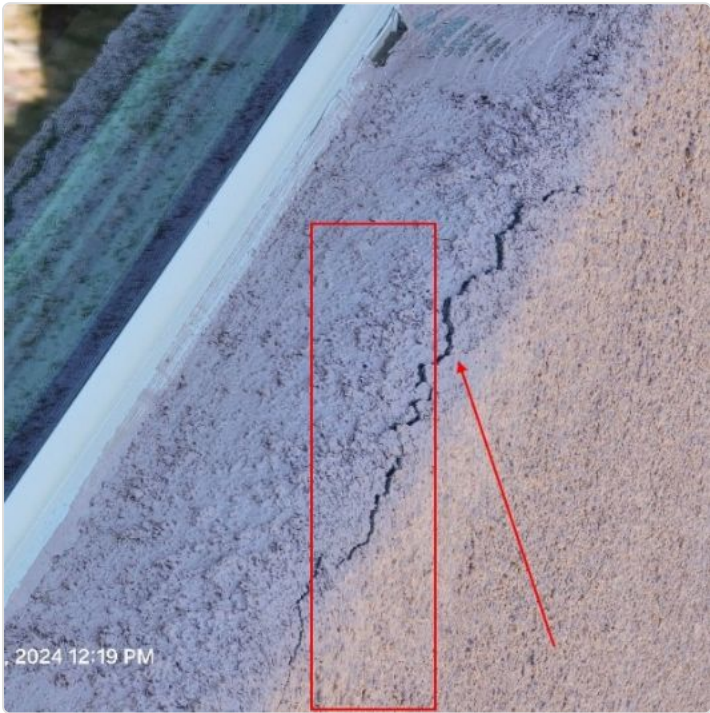
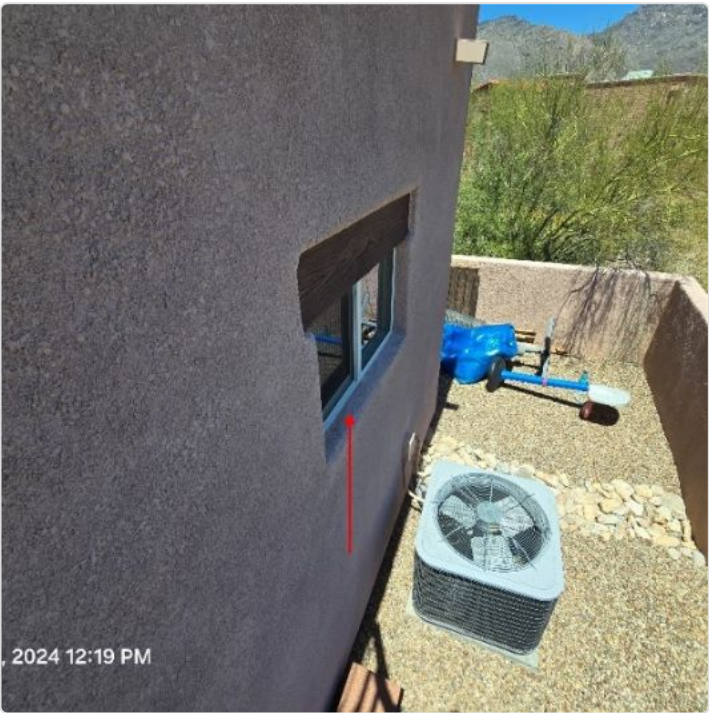
STUCCO - HAIRLINE CRACKS

**Location:**  
EAST SIDE OF STRUCTURE

**Description:**  
One or more stucco cracks noted along the exterior of the home. Patching and painting of cracks is recommended to prevent water from entering behind the stucco.

**Severity:**  
MONITOR / MAINTENANCE ITEMS

**Recommendation:**  
Contact a qualified painting contractor.

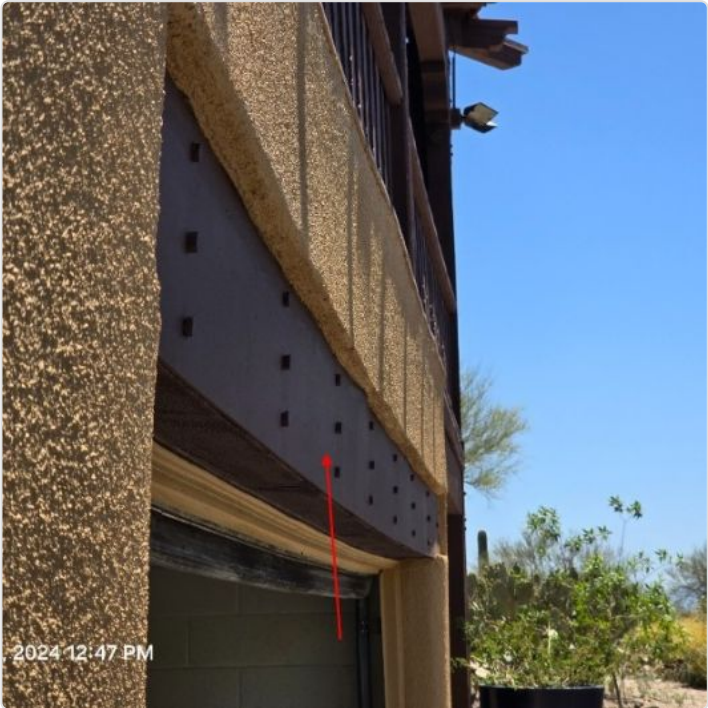
**Description:**  
Portions of the support beam were sagging. This may indicate an issue with the integrity of the porch. Recommend evaluation and repair.

**Severity:**  
MATERIAL DEFECTS / SAFETY ITEMS

**Recommendation:**  
Contact a qualified general contractor

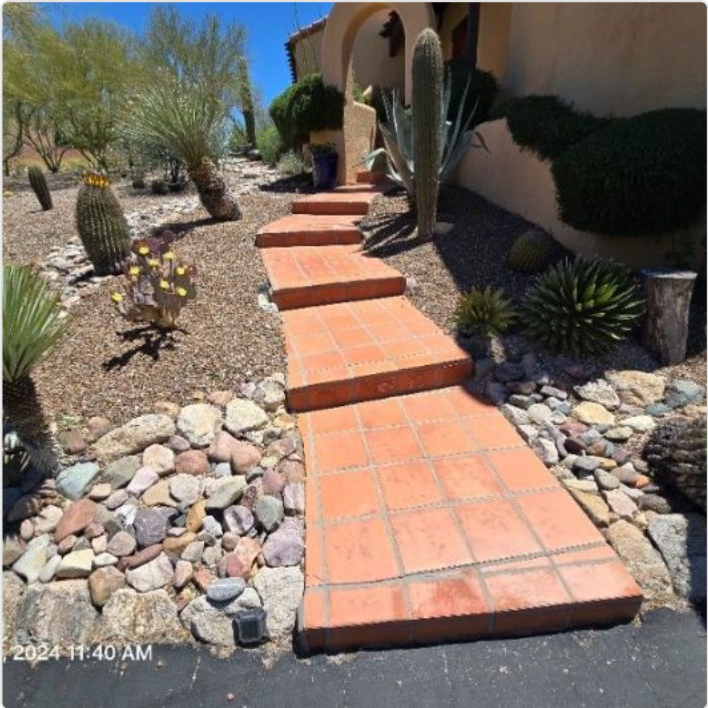
Stairs - Missing Handrails

**Description:**  
It is recommended to have handrails installed on stairs with 3 or more risers (steps).

**Severity:**  
RECOMMENDATIONS / IMPROVEMENT ITEMS

**Recommendation:**  
Contact a qualified general contractor.

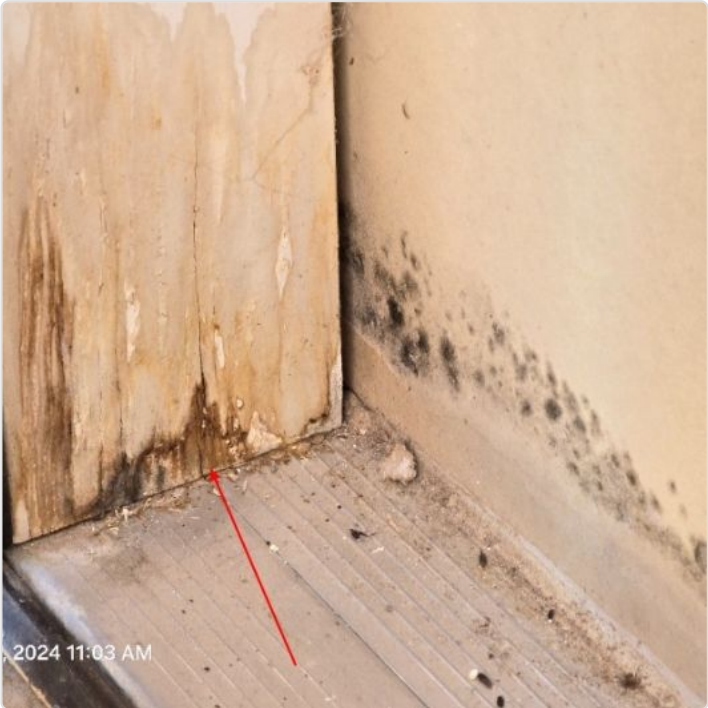
**Description:**  
There is possible organic growth on the walls. Further evaluation is recommended, and remediation if required.

**Severity:**  
MATERIAL DEFECTS / SAFETY ITEMS

**Recommendation:**  
Contact a qualified mold inspection professional

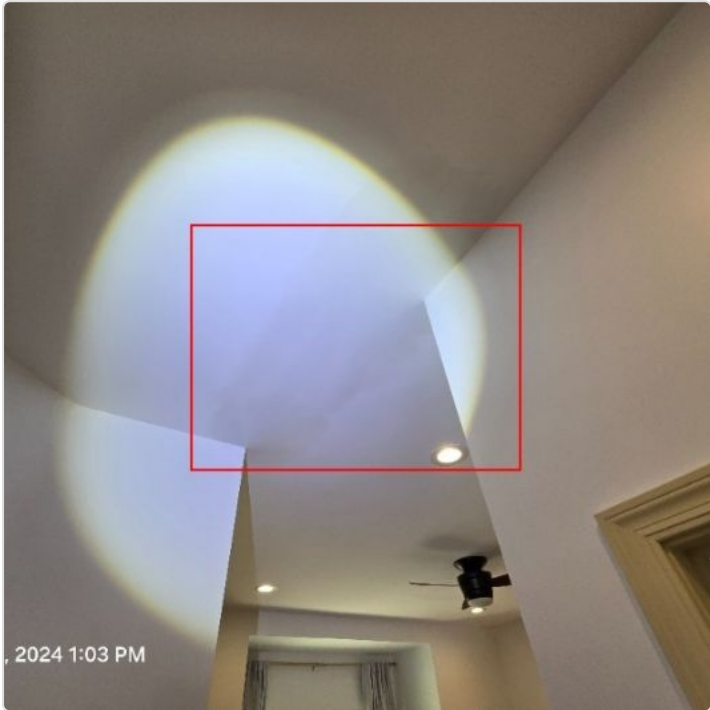
CEILINGINGS AND WALLS - PREVIOUS REPAIRS

**Location:**  
NORTHEASTERN BEDROOM CEILING

**Description:**  
FYI - Indications of previous repairs were noted. Recommend clarifying with the seller as to the conditions that necessitated the repairs.

**Severity:**  
MONITOR / MAINTENANCE ITEMS

**Recommendation:**  
Contact the seller for more info

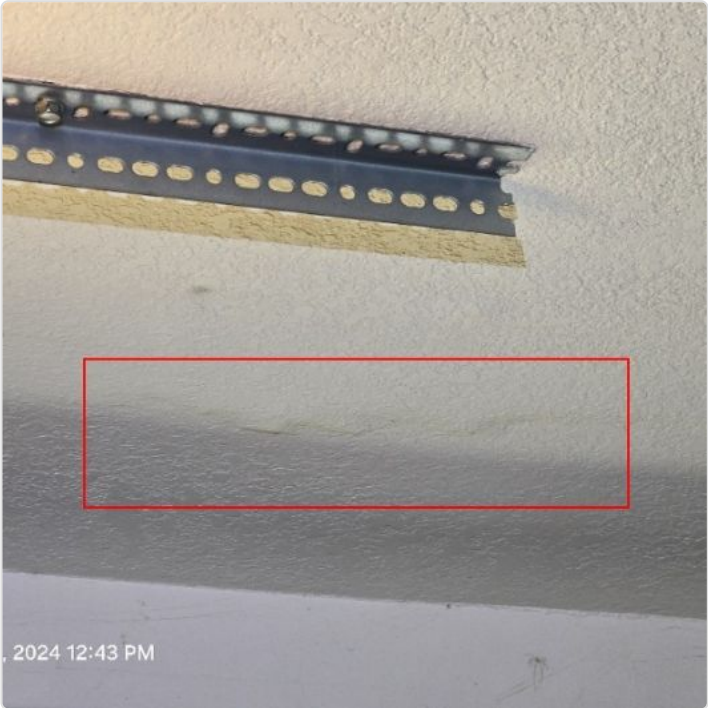
CEILINGINGS AND WALLS - WATER DAMAGE

**Location:**  
GARAGE

**Description:**  
Water stains/water damage noted. Recommend evaluation for potential water intrusion issues and repair/replace affected wall coverings as required.

**Severity:**  
RECOMMENDATIONS / IMPROVEMENT ITEMS

**Recommendation:**  
Contact a qualified general contractor.

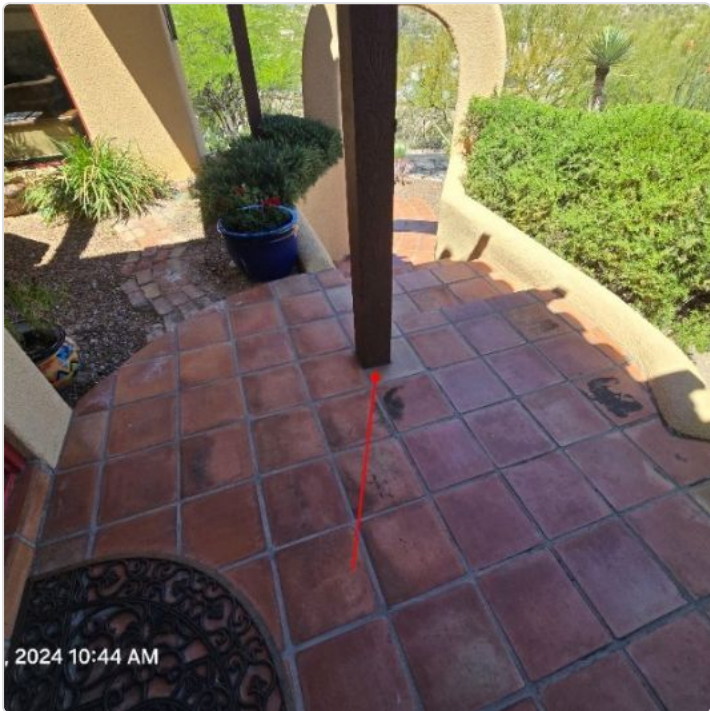
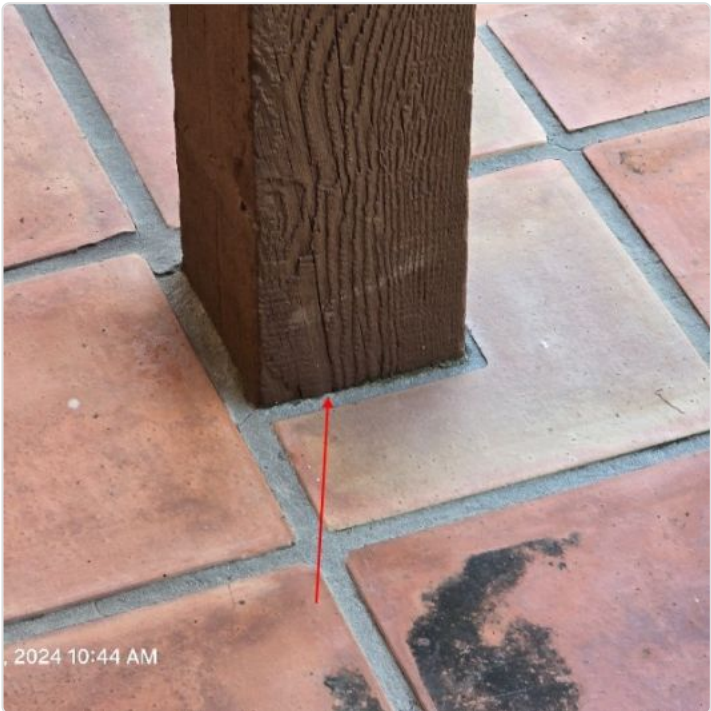
**Description:**  
The posts show areas of wood contacting earth/concrete. This can drastically accelerate degradation or rotting of the column. Recommend installation of a standoff base underneath the column.

**Severity:**  
MONITOR / MAINTENANCE ITEMS

**Recommendation:**  
Contact a qualified general contractor

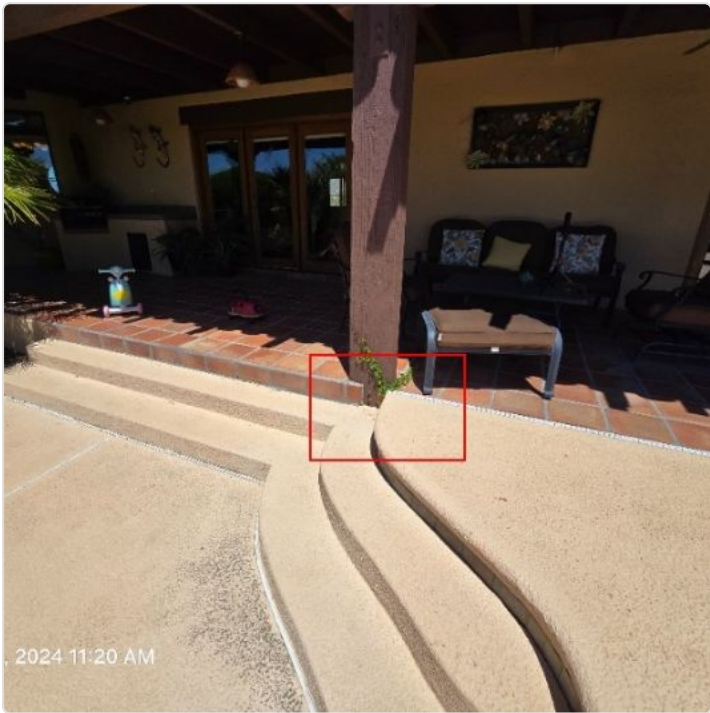
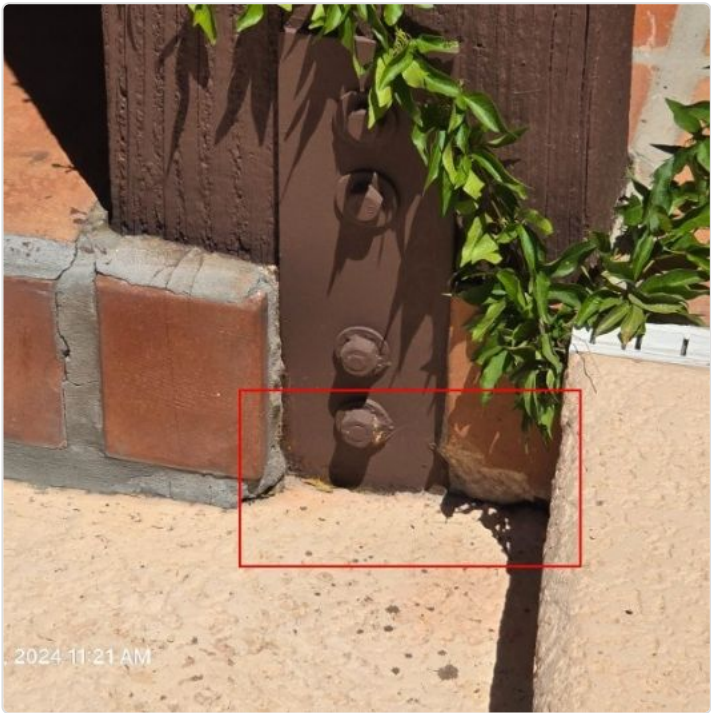
COLUMNS - WOOD TO EARTH/CONCRETE CONTACT

Location:  
SOUTH PATIO

Description:  
The posts show areas of wood contacting earth/concrete. This can drastically accelerate degradation or rotting of the column. Recommend installation of a standoff base underneath the column.

Severity:  
MONITOR / MAINTENANCE ITEMS

Recommendation:  
Contact a qualified general contractor.

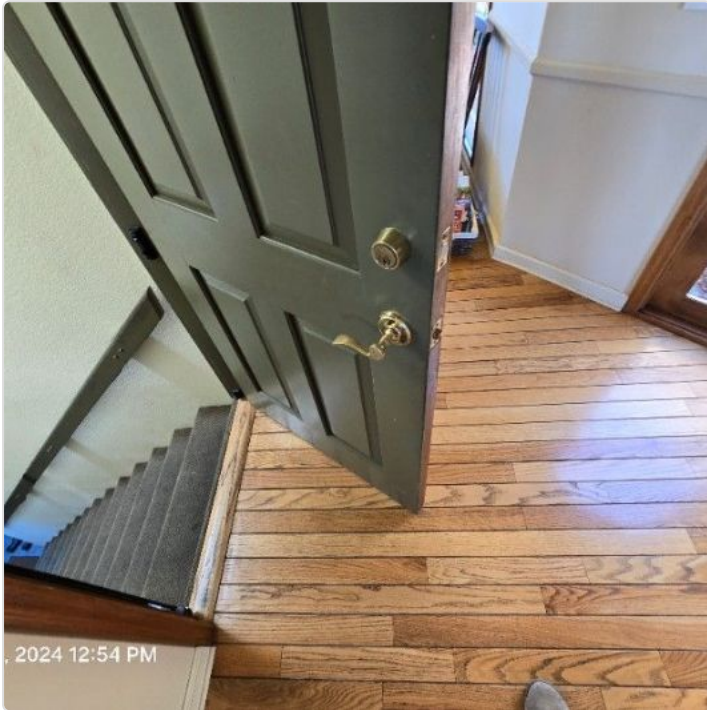
## DOOR - LOOSE HARDWARE

**Description:**  
The door hardware appears to be loose. Recommend repair to allow proper operation of the door.

**Severity:**  
MONITOR / MAINTENANCE ITEMS

**Recommendation:**  
Contact a qualified handyman.

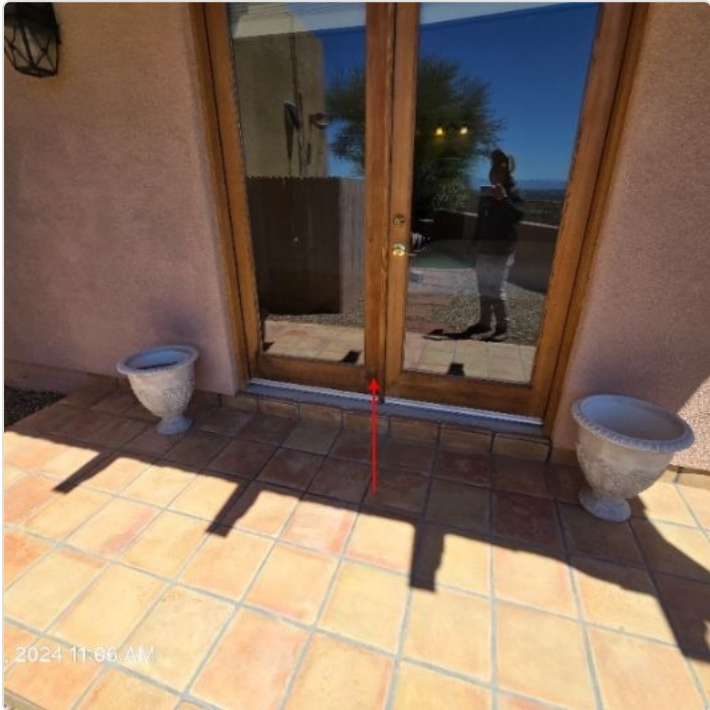
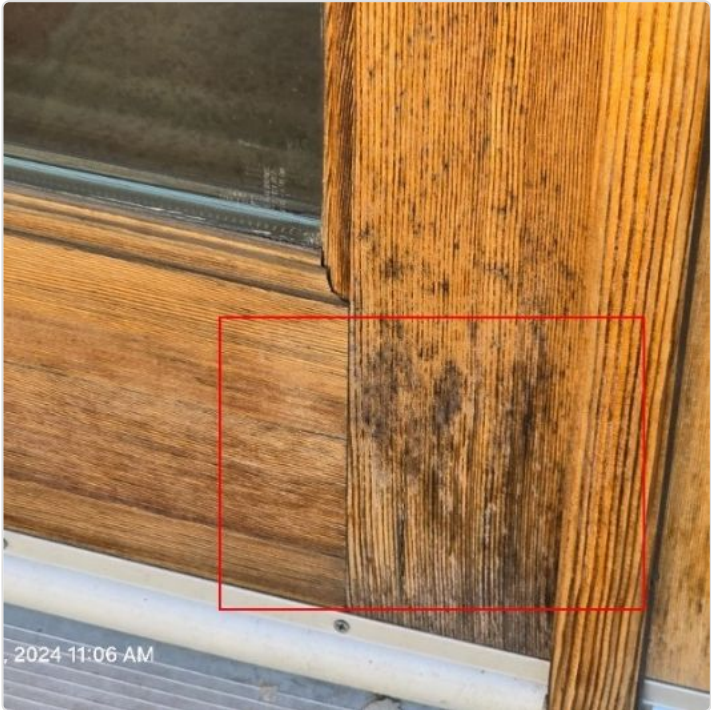
DOOR - SEALANT WEATHERING

**Location:**  
SOUTHEAST SIDE OF STRUCTURE

**Description:**  
Portions of the door sealant is weathered. Recommend recoating to prevent damage from rain water and sun exposure.

**Severity:**  
MONITOR / MAINTENANCE ITEMS

**Recommendation:**  
Contact a qualified painting contractor.

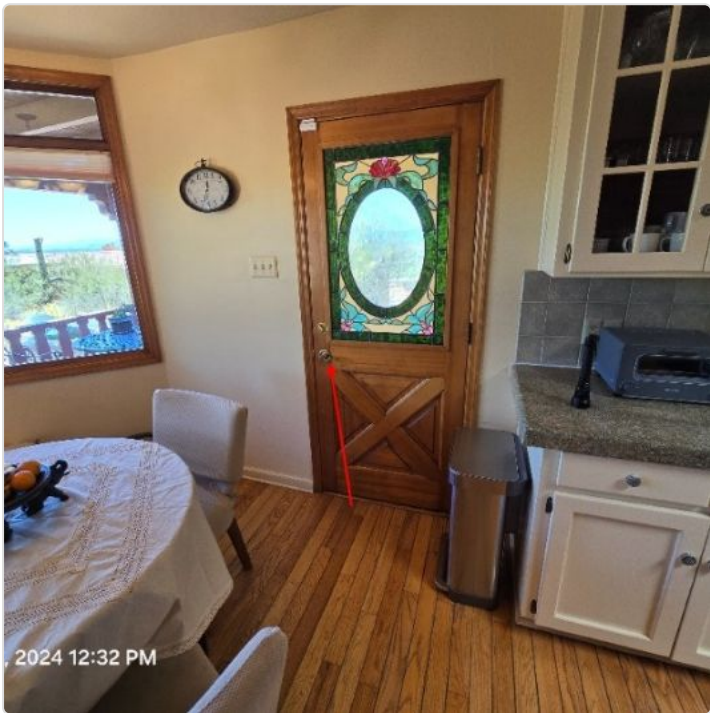
**Description:**  
The door was difficult to lock. Recommend adjusting the hardware to allow smooth operation of the door.

**Severity:**  
MONITOR / MAINTENANCE ITEMS

**Recommendation:**  
Contact a handyman or DIY project

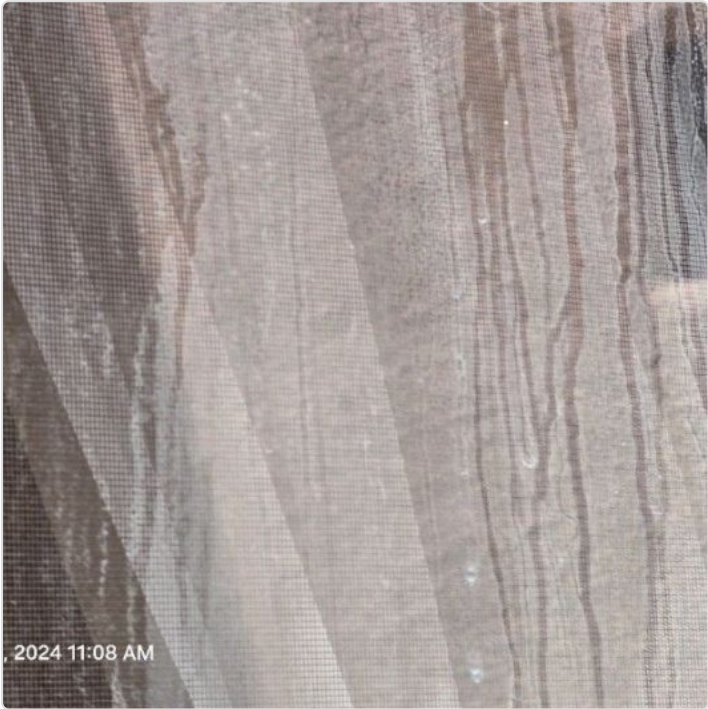
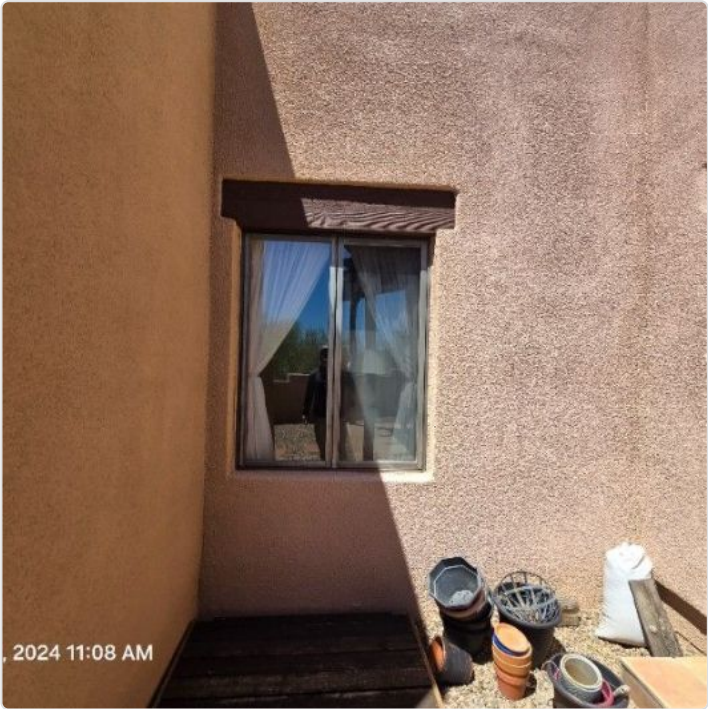
WINDOW - FAILED DUAL PANE SEAL

**Description:**  
There are indications that a dual pane window seal has failed. Recommend replacement to ensure the appropriate insulating value of the window is achieved.

**Severity:**  
RECOMMENDATIONS / IMPROVEMENT ITEMS

**Recommendation:**  
Contact a qualified window repair/installation contractor.

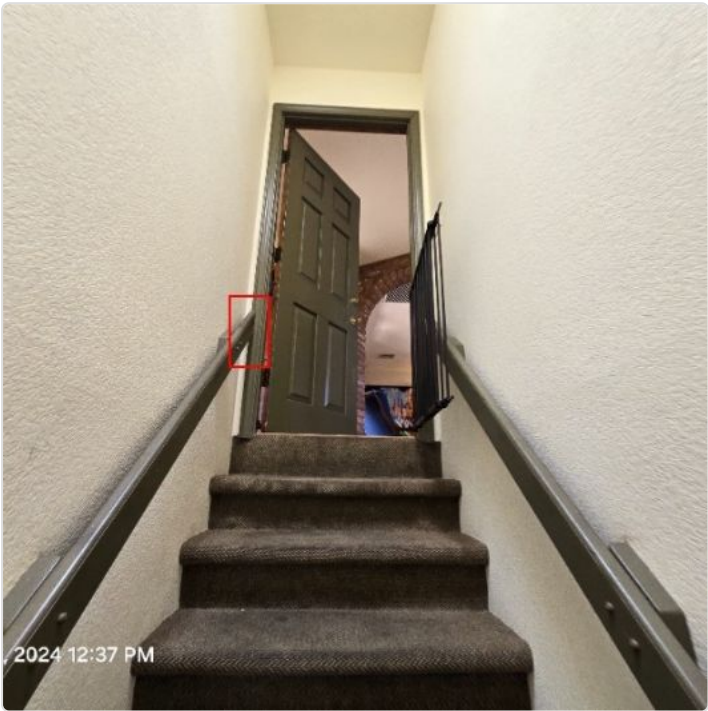
**Description:**  
The stairway handrails end do not return to wall. This can cause a person's clothing to catch when using the handrail. Recommend repairs or improvements to reduce the risk of injury.

**Severity:**  
RECOMMENDATIONS / IMPROVEMENT ITEMS

**Recommendation:**  
Contact a qualified general contractor.

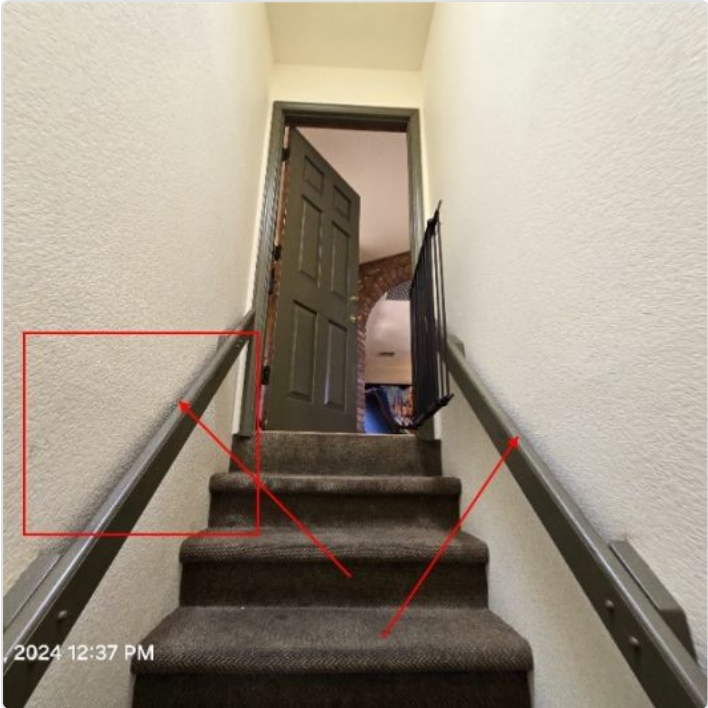
HANDRAIL - TOO LOW

The handrail height was too low. Recommend replacing with the handrail to prevent accidental falls.

RECOMMENDATIONS / IMPROVEMENT ITEMS

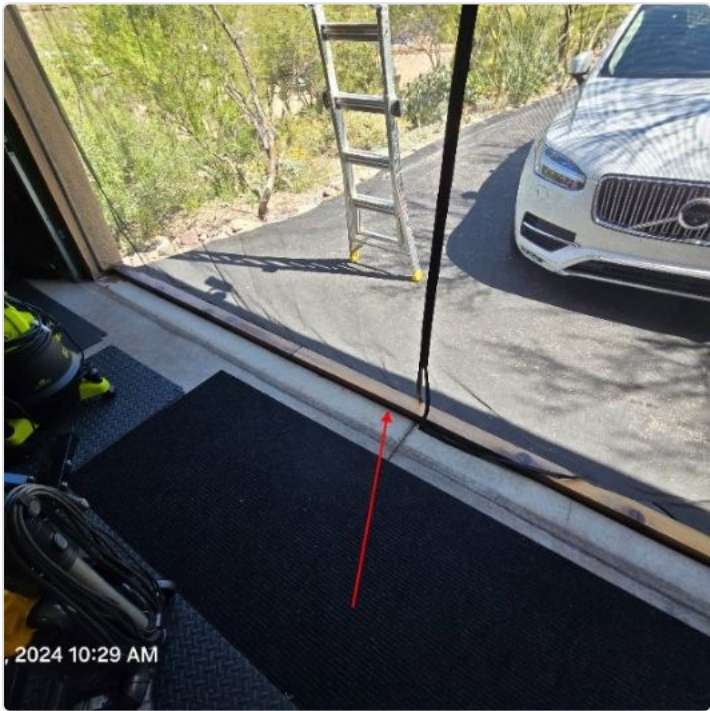
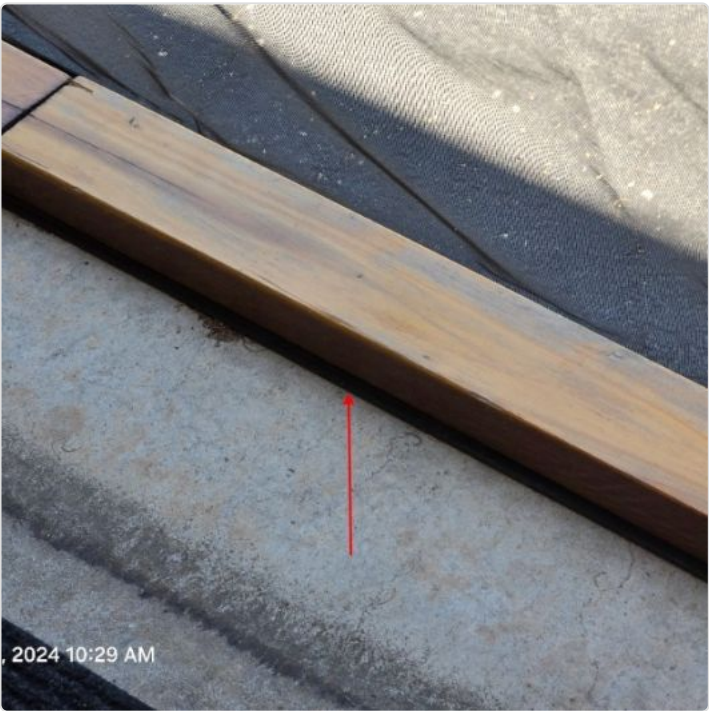
Garage is framed in for the addition of a mesh screen. Garage is not usable for car use unless framing is removed. Recommend removing framing if use for vehicles is required.

MONITOR / MAINTENANCE ITEMS

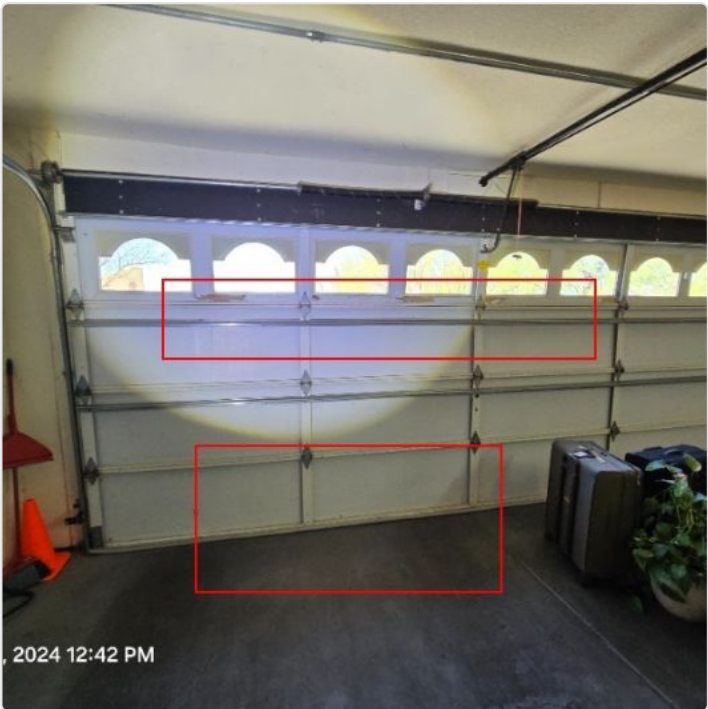
GARAGE DOOR - DAMAGE

**Location:**  
GARAGE

**Description:**  
Damage noted at the garage door panel. Damage does not appear to affect the operation of the door. Recommend repair of affected garage door panels

**Severity:**  
RECOMMENDATIONS / IMPROVEMENT ITEMS

**Recommendation:**  
Contact a qualified garage door contractor.

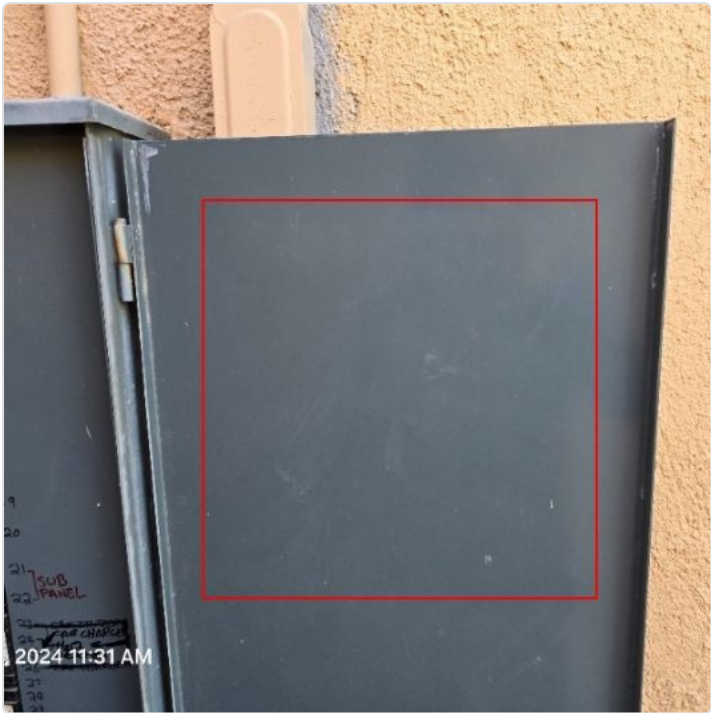
PANEL IDENTIFICATION LABEL MISSING/DAMAGED

**Description:**  
Limitation - The electrical panel label was missing or otherwise illegible. Electrical panel labels contain important information regarding amperage, voltages, permitted breakers, ground lug quantities, schematics, etc. The proper installation or condition of any components that depend on information contained on this label are excluded from this inspection.

**Severity:**  
MONITOR / MAINTENANCE ITEMS

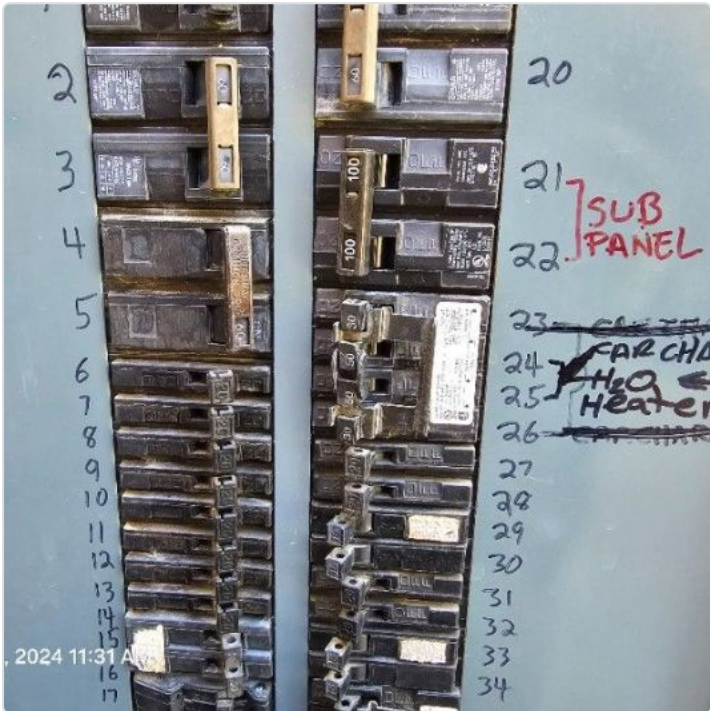
COVER - INCOMPLETE, INCORRECT, OR MISSING LEGEND

**Location:**  
MAIN PANEL - WEST SIDE OF STRUCTURE

**Description:**  
The legend for the electrical panel was missing, incomplete, or incorrect. A proper legend is required so that breakers are properly labeled, ensuring correct circuits are shut off in case of the need of service, etc. Complete, legible labeling of all circuit breakers is recommended.

**Severity:**  
MONITOR / MAINTENANCE ITEMS

**Recommendation:**  
Contact a qualified electrical contractor.
