**70345 BLUE RIDGE MOUNTAIN**

# **PLUS SEVEN INSPECTION - SAMPLE REPORT**

Inspection Type: Home Inspection

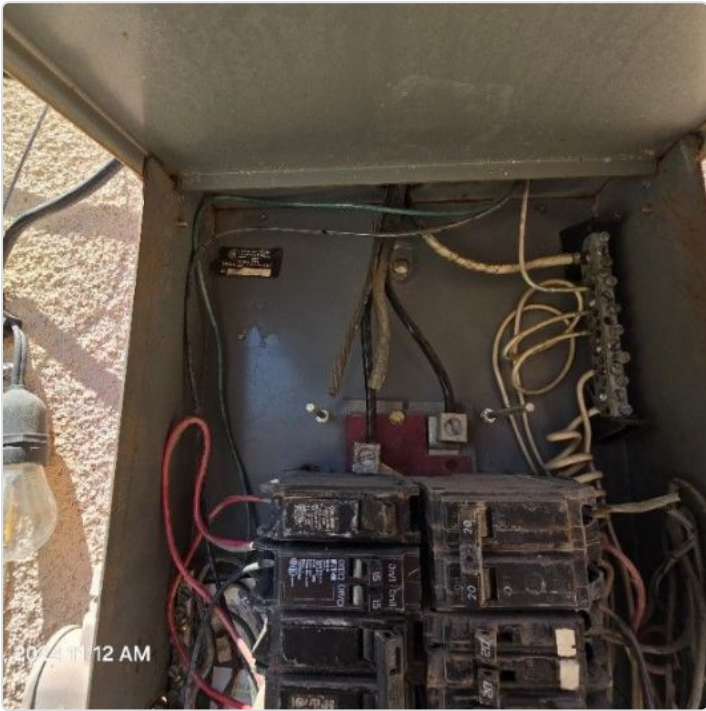
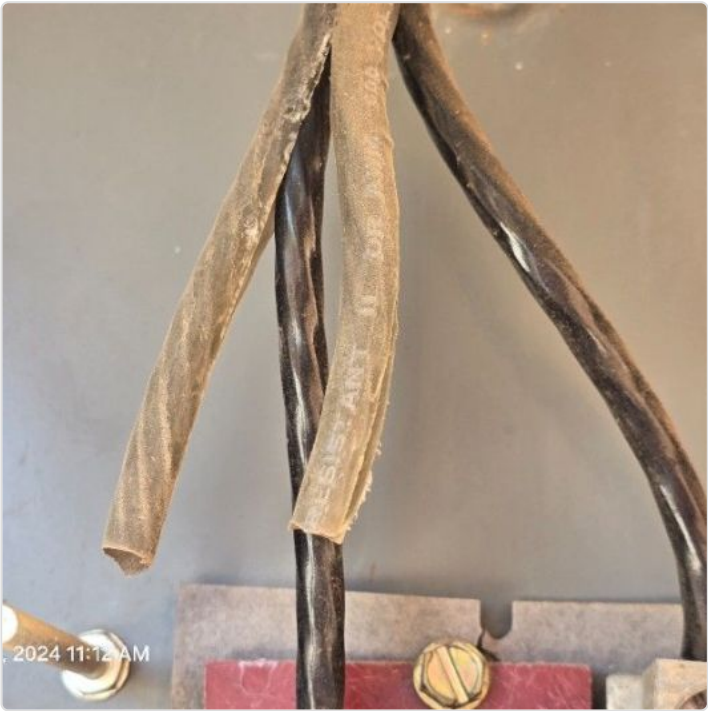
UV DAMAGED WIRING

**Description:**  
Advanced UV damage was noted on wires inside of panel. Recommend further evaluation by a licensed electrician for repair as required.

**Severity:**  
RECOMMENDATIONS / IMPROVEMENT ITEMS

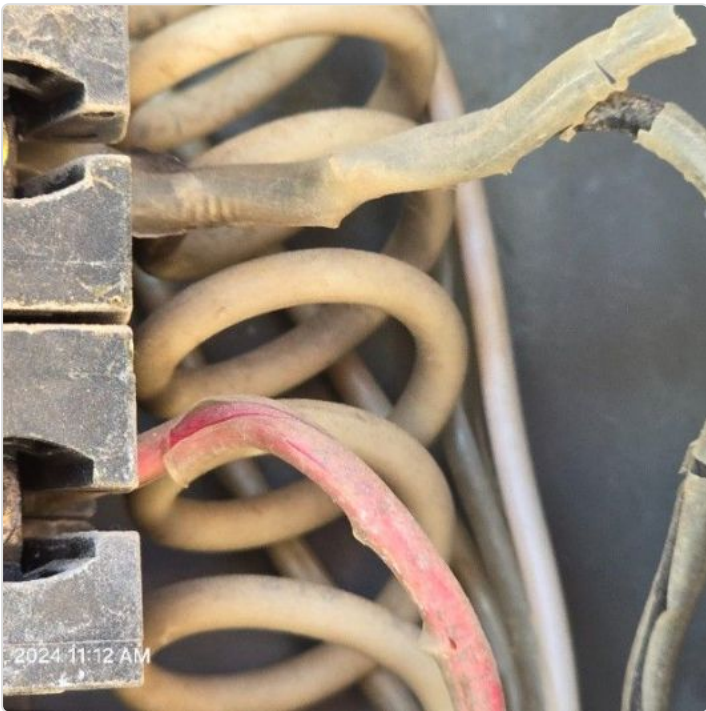
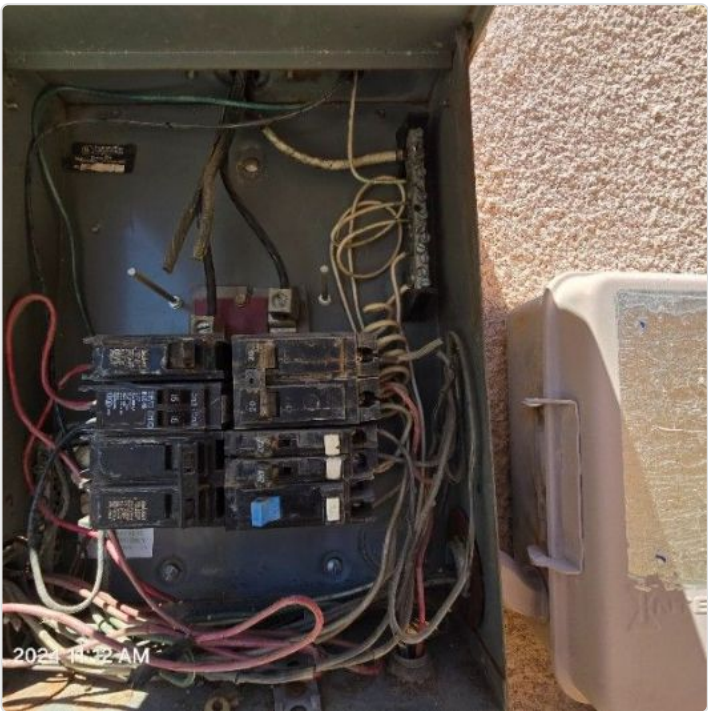
**Description:**  
Open knockout(s) were present in the distribution panel. Knockout caps should be installed by a licensed electrician or other qualified person to keep mice out of the panel box, and to avoid a potential electrocution hazard.

**Severity:**  
RECOMMENDATIONS / IMPROVEMENT ITEMS

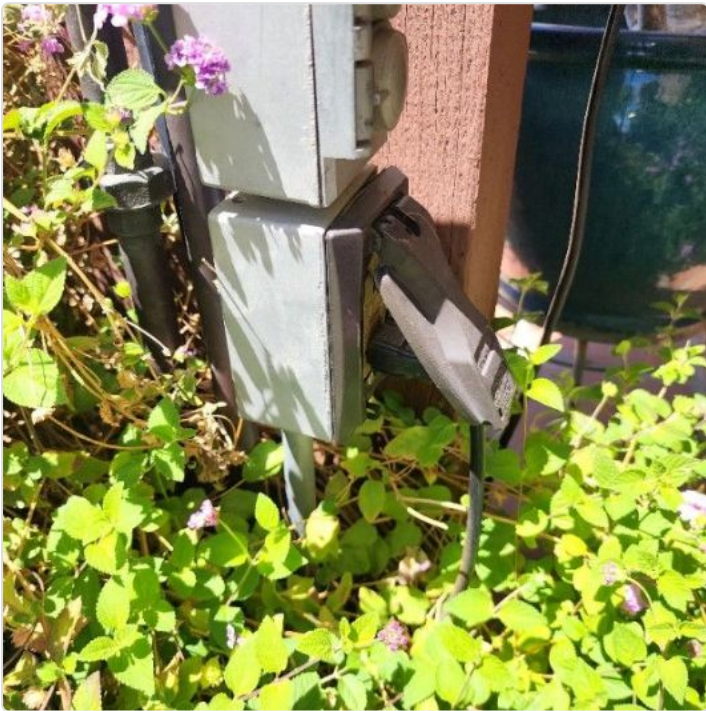
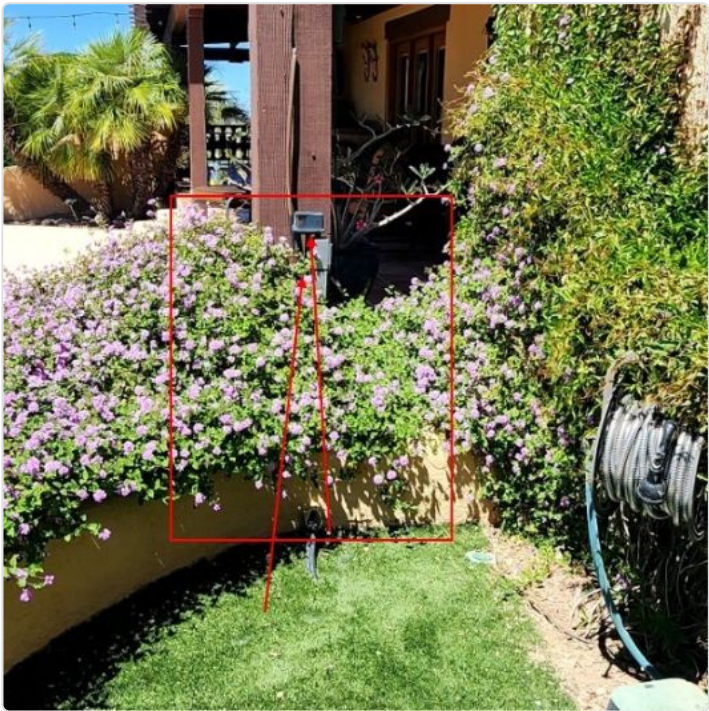
WEATHERPROOF COVER(S) - MISSING IN-USE WEATHERPROOF COVER

**Description:**  
An in-use exterior receptacle was missing a weatherproof cover rated for continuous use. Recommend installation of a weatherproof cover rated for continuous use.

**Severity:**  
RECOMMENDATIONS / IMPROVEMENT ITEMS

**Recommendation:**  
Contact a qualified electrical contractor.

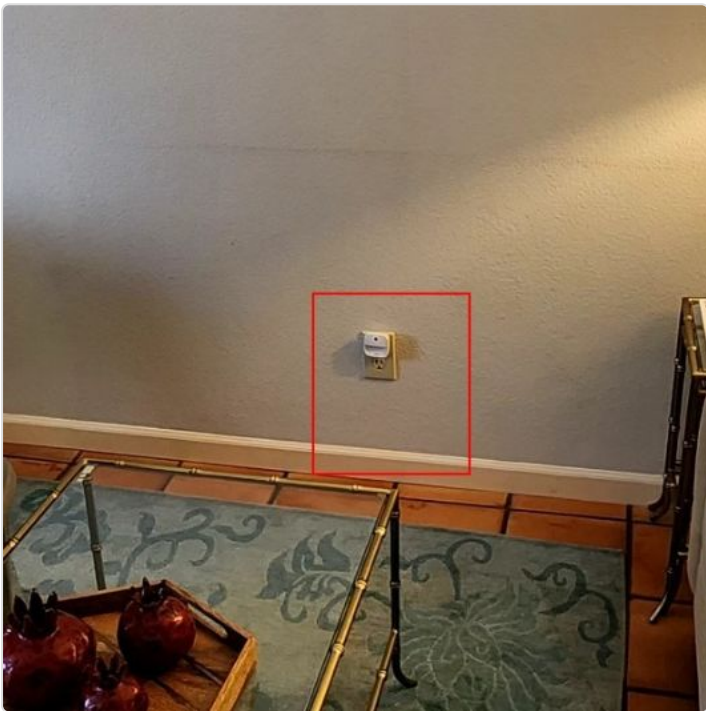
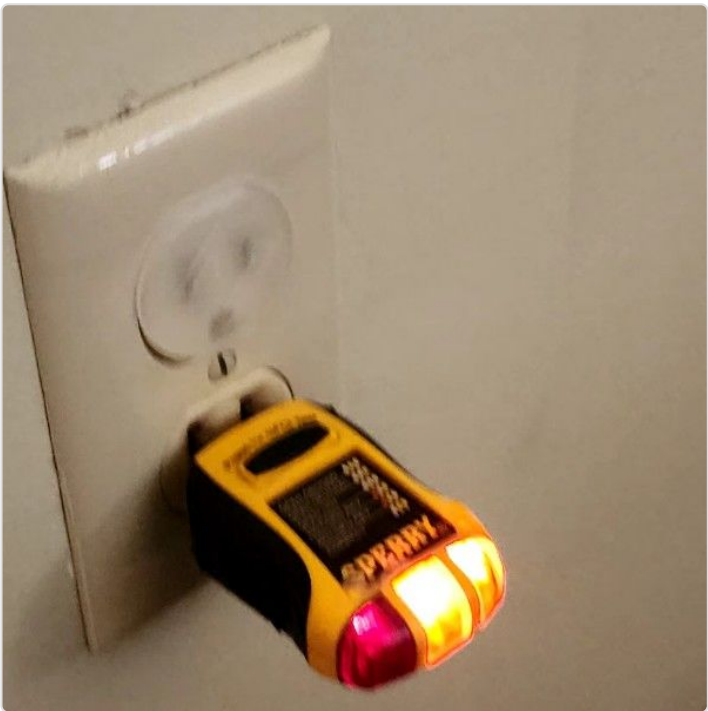
RECEPTACLE(S) - LOOSE AT WALL

RECOMMENDATIONS / IMPROVEMENT ITEMS

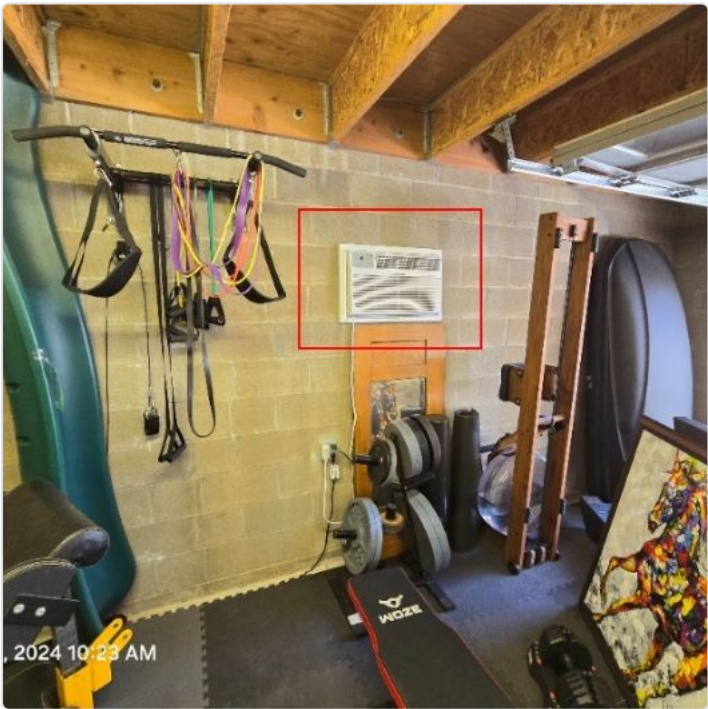
### UNAPPROVED INSTALLATION OF WINDOW MOUNT AC

- Location:**  
DETACHED GARAGE - EAST WALL
- Description:**  
An air conditioner unit that was designed to mount in a window was affixed permanently using unapproved installation techniques and materials. Recommend removing the unit and repairing the affected areas.
- Recommendation:**  
Contact a qualified HVAC professional.
- Severity:**  
RECOMMENDATIONS / IMPROVEMENT ITEMS

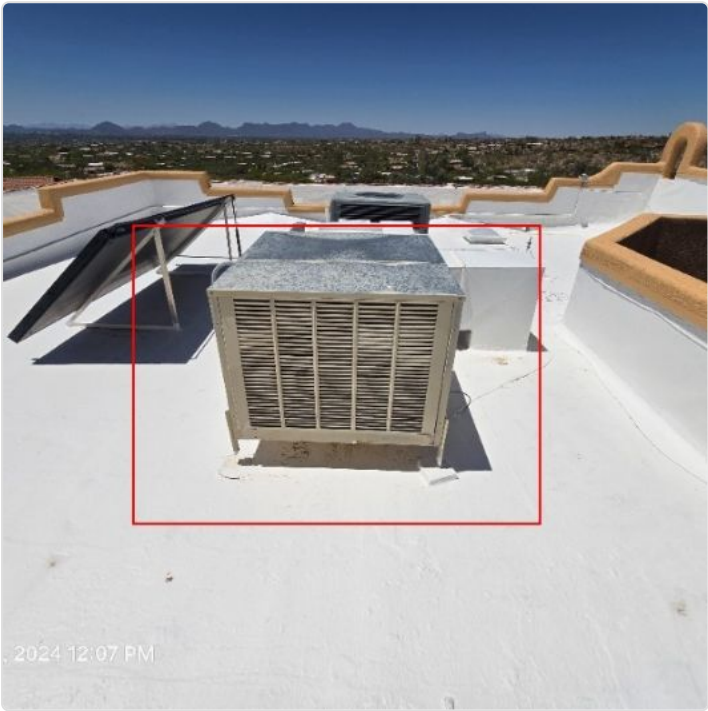
EVAPORATIVE COOLER - MISSING SUPPORT

**Location:**  
ROOF

**Severity:**  
RECOMMENDATIONS / IMPROVEMENT ITEMS

**Recommendation:**  
Recommend installation of support or removal of evaporative cooler by a licensed roofing contractor to prevent water intrusion and deterioration of roof surface.

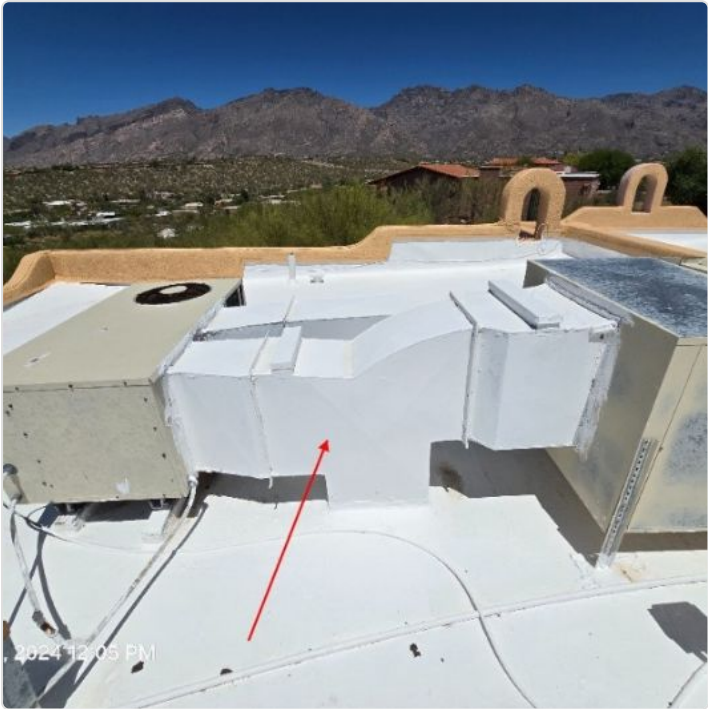
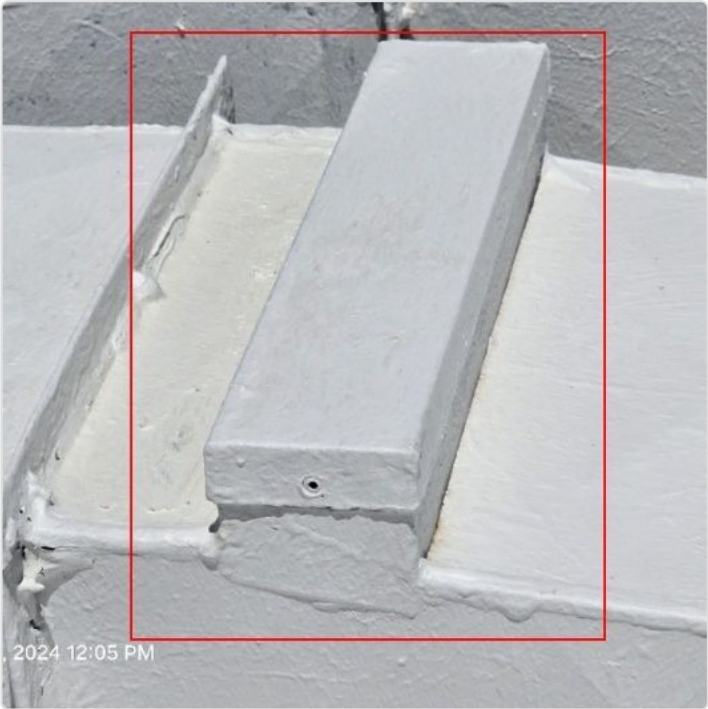
DUCT - ROOF DUCTING REQUIRES FURTHER REVIEW

**Location:**  
ROOF

**Severity:**  
RECOMMENDATIONS / IMPROVEMENT ITEMS

**Recommendation:**  
Recommend further evaluation by a licensed HVAC professional to confirm conditioned air is not escaping the system.

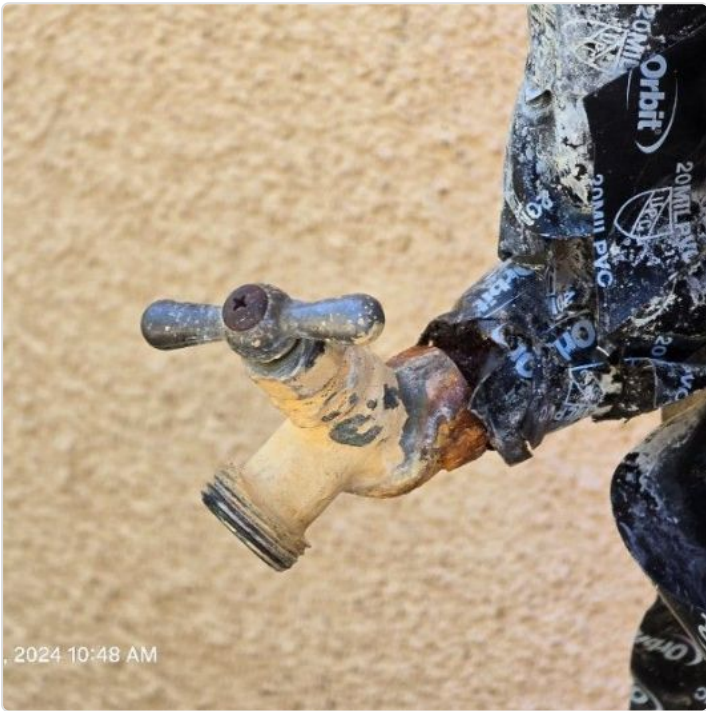
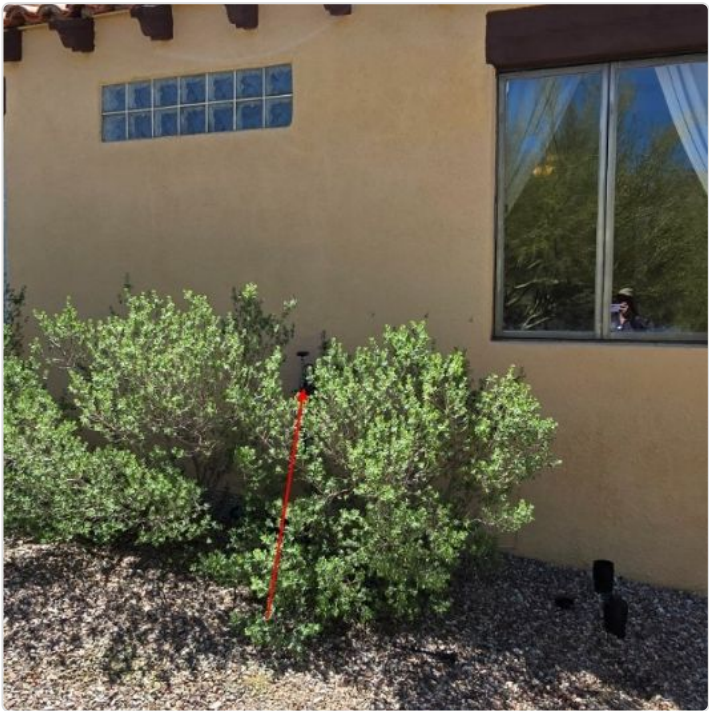
**NO SERVICE**

**Location:**  
SOUTH PATIO

**Severity:**  
RECOMMENDATIONS / IMPROVEMENT ITEMS

**Recommendation:**  
Contact a qualified plumbing contractor

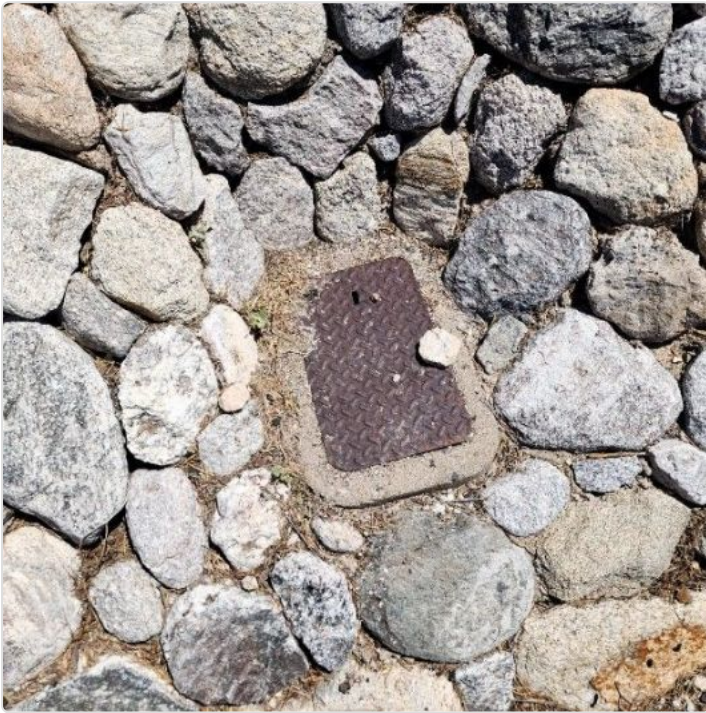
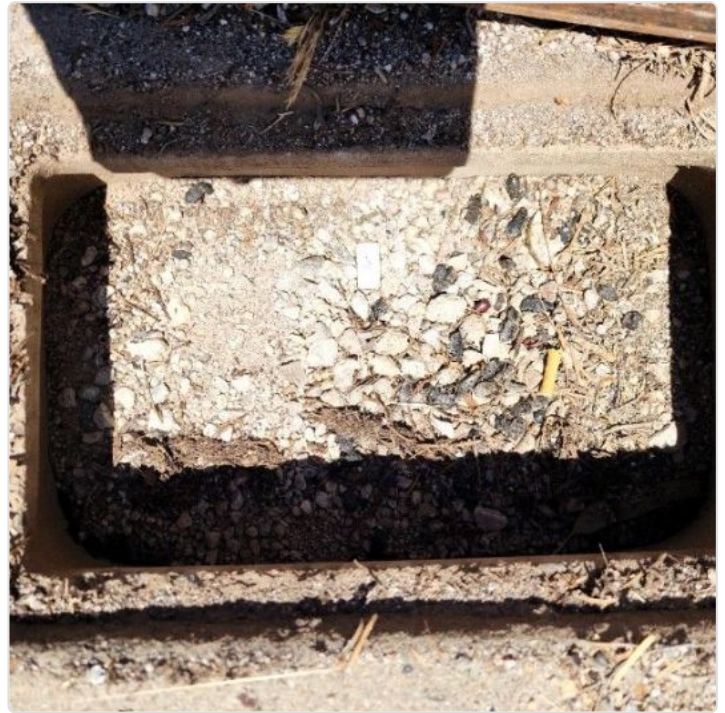
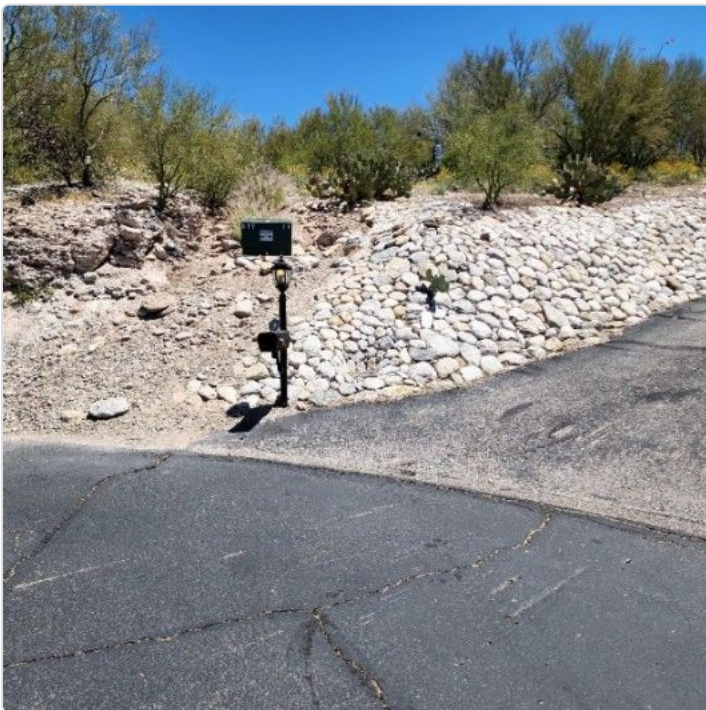
**WATER METER / WATER SHUTOFF - BURIED**

**Location:**  
DRIVEWAY

MONITOR / MAINTENANCE ITEMS

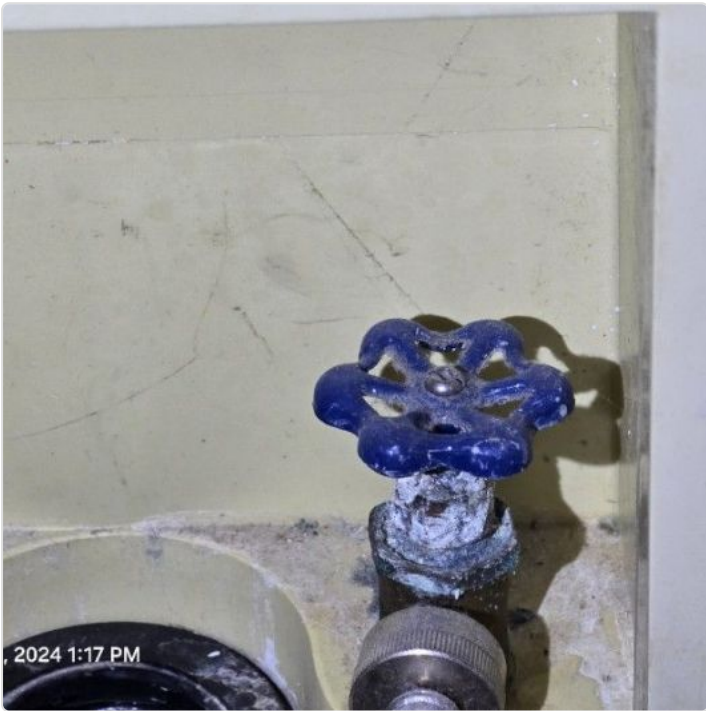
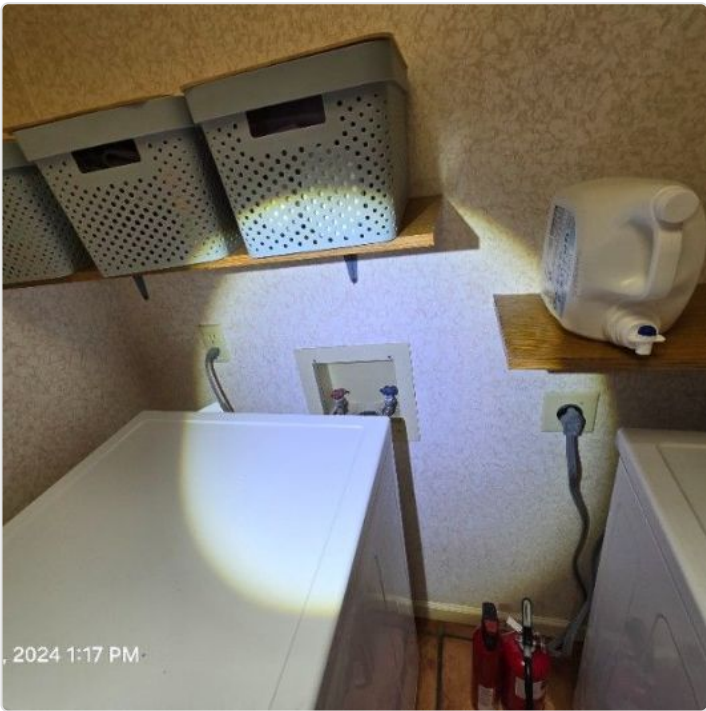
PLUMBING - CORROSION/BUILDUP

**Location:**  
LAUNDRY

**Severity:**  
RECOMMENDATIONS / IMPROVEMENT ITEMS

**Recommendation:**  
Contact a qualified plumbing contractor.
