# Durability of GFRP Composite Rods

Results from preliminary field tests don't match data from accelerated lab tests

BY AFTAB MUFTI, NEMKUMAR BANTHIA, BRAHIM BENMOKRANE, MOHAMED BOULFIZA, AND JOHN NEWHOOK

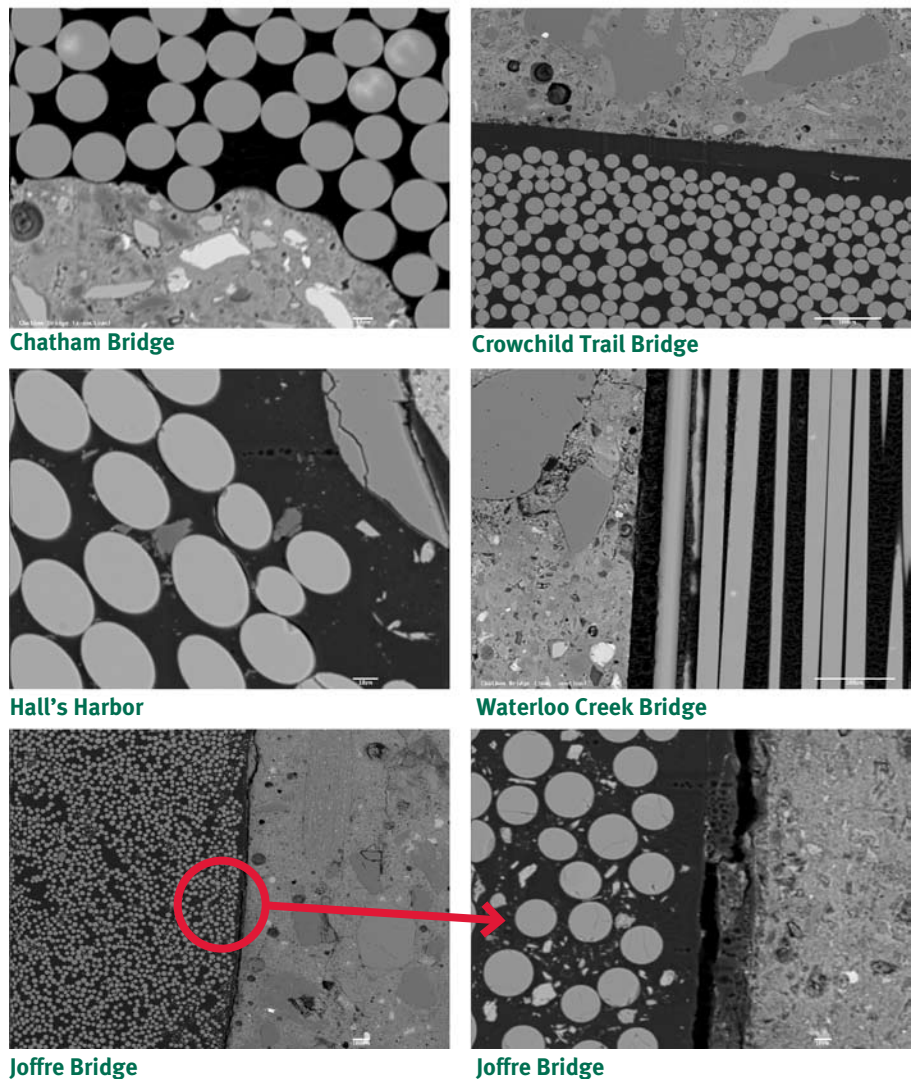
SEM was used to visually examine the effects of exposure at a high magnification on the constituent materials of the GFRP. Typical SEM micrographs are shown in Fig. 3. In each of the five structures, there was no sign of any damage to the GFRP. None of the fibers lost any cross-sectional area, and no degradation of the fibers was visible. Furthermore, individual fibers were intact with no gaps between the fibers and the matrix. There was also no evidence of deterioration at the glass/matrix interface—good contact was noted between individual glass fibers and the surrounding polymer matrix as well as between the sand grains and the matrix. Although drying in the SEM chamber can lead to interfacial damage and therefore make it difficult to observe the integrity of

**Fig. 3: Scanning electron micrographs of GFRP extracted from each structure indicated no signs of deterioration in the fibers or polymer matrix. The visible interfacial damage is apparently the result of drying in the SEM chamber, as no such damage was observed using an optical microscope**

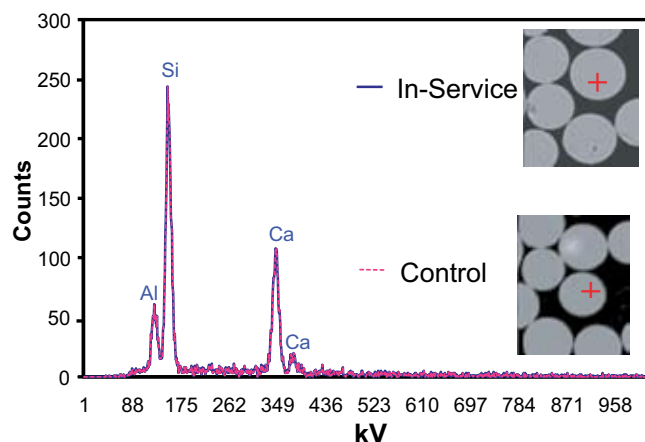
In Fig. 4, the EDX plot for in-service glass fiber from the Hall's Harbor Wharf is compared with the plot for companion control GFRP rods stored under controlled conditions in the laboratory. The chemical composition of fibers in each rod showed the absence of zirconium (Zr), thus confirming that the investigated GFRP contained E-glass and not alkali-resistant (AR) glass. This was true for all structures. Figure 4 also shows that the EDX plots for glass fiber in in-service GFRP samples were virtually identical to those for control specimens. This indicates that there was no deterioration of the glass fiber. In Fig. 5, EDX plots for the polymeric matrix from the in-service GFRP in the Joffre Bridge are compared with control GFRP bars kept under controlled conditions in the laboratory. The two spectra are alike, indicating that no deterioration occurred in the field. As expected, the matrix in both specimens contained mainly carbon (C); however, some additional elements such as silicon (Si), aluminum (Al), and calcium (Ca) were also detected.

**Fig. 4: EDX scans for in-service and control glass fibers from Hall's Harbor Wharf**

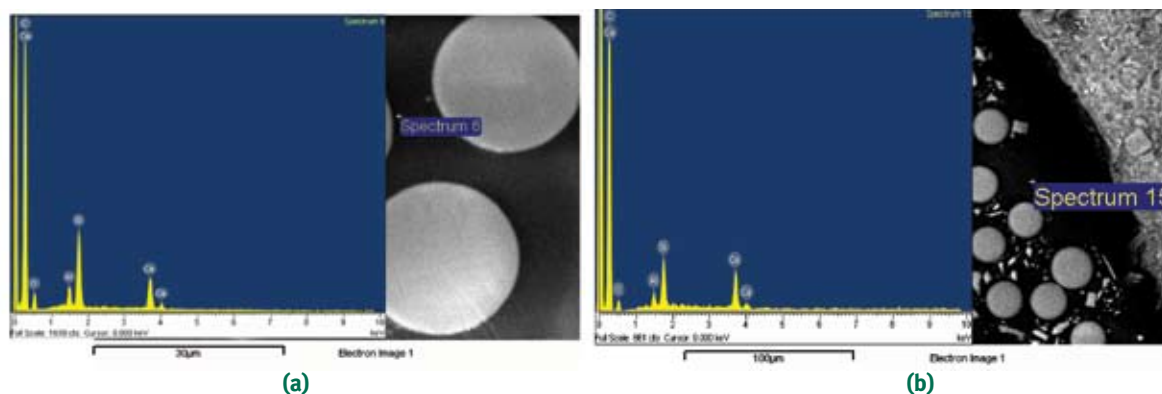
Fig. 5: EDX scans for the polymer matrix from the Joffe Bridge: (a) in-service matrix; and (b) control matrix

dissolution, leaching, and ion exchange, the chemical compositions of the glass and matrix change. The concrete pore solution consists mainly of sodium ( $\text{Na}^+$ ) and potassium ( $\text{K}^+$ ) ions with hydroxyl ions ( $\text{OH}^-$ ) as counter ions. Other elements present in the solution are either very insoluble, such as calcium ions ( $\text{Ca}^{2+}$ ), or have low solubility such as magnesium (Mg), aluminum (Al), silicon (Si), iron (Fe), and sulfate ions ( $\text{SO}_4^{2-}$ ). Because the EDX can't detect elements lighter than sodium (Na), the  $\text{OH}^-$  cannot be detected. The  $\text{OH}^-$  and cations ( $\text{Na}^+$ ,  $\text{K}^+$ ), however will diffuse together for charge neutrality to be satisfied. Therefore, a strong indication of alkali migration from concrete pore solution toward the glass fibers would lead to the presence of Na or K in the matrix. Observations on several specimens indicated that neither Na nor K was present in the matrix (Fig. 5).

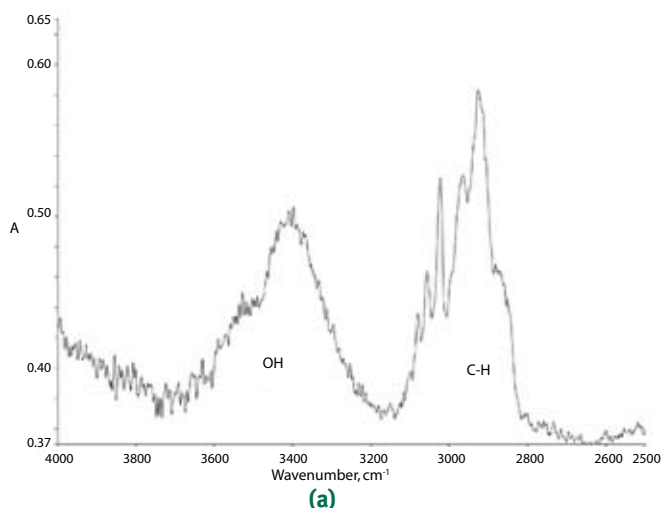
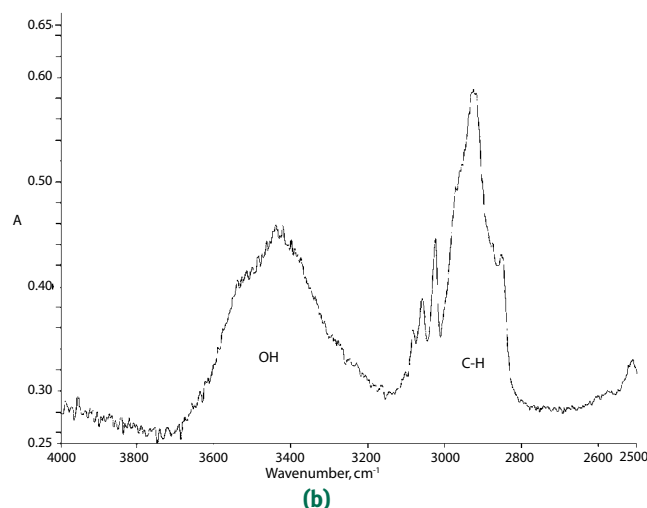
Fig. 6: FTIR spectra for GFRP in the Joffe Bridge: (a) in-service GFRP; and (b) control GFRP

into powder. The pellet method with spectroscopic grade potassium bromide (KBr) was used to obtain the infrared spectra. The relative amounts of hydroxyl groups in the specimens were measured by determining the ratio of the maximum of the band corresponding to the hydroxyl groups (at a wavenumber of  $3430\text{ cm}^{-1}$ ) and the band corresponding to the carbon-hydrogen groups (at a wavenumber of  $2900\text{ cm}^{-1}$ ) in the FTIR spectra. The C-H content was assumed to be constant. Because the vinyl-ester resins naturally contain hydroxyl groups, all the spectra present a strong absorption band in this region. Typical results of the FTIR analysis for control and in-service GFRP samples from the Joffre Bridge are presented in Fig. 6 and show that there was no significant change in the spectra of the specimens. Similar conclusions were drawn for rods from other structures.

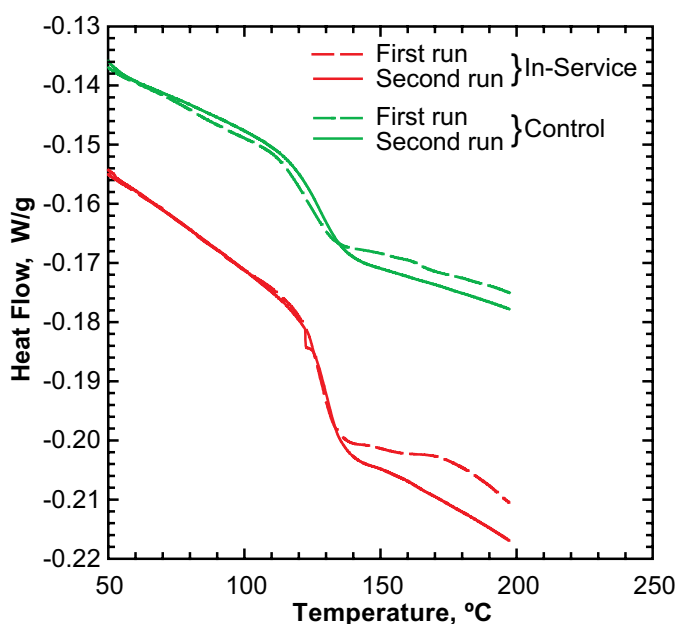
**Fig. 7: DSC results for the in-service and control polymer matrix in GFRP from the Joffre Bridge. The  $T_g$  for the matrix is indicated by the sharp drop in the curves**

The  $T_g$  measurements were carried out on small pieces cut from GFRP extracted from the cores. The measurements were taken in air between  $40$  and  $200\text{ }^{\circ}\text{C}$  ( $104$  and  $392\text{ }^{\circ}\text{F}$ ) at a heating rate of  $10\text{ }^{\circ}\text{C/minute}$  ( $18\text{ }^{\circ}\text{F/minute}$ ). Typical results are given in Fig. 7. There was no appreciable difference between the glass transition temperature for in-service GFRP and control GFRP. Similar conclusions were drawn for all other structures.
