# Egenkontroll DC

01.09.2025 19:46 CEST

Tallhedsgatan 15, 945 82, Norrfjärden

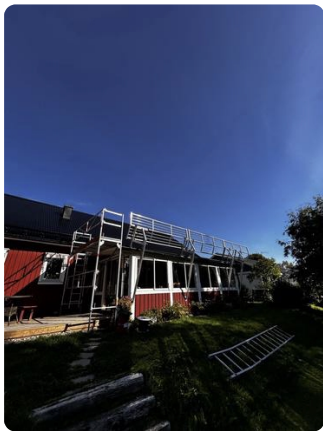
PHOTO 1

Picture(s) of scaffolding

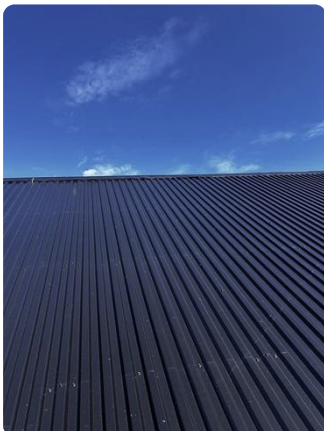
PHOTO 2

**Any damages prior to assembly?**

» Damage detected

Any damages prior to assembly?

// Damage detected

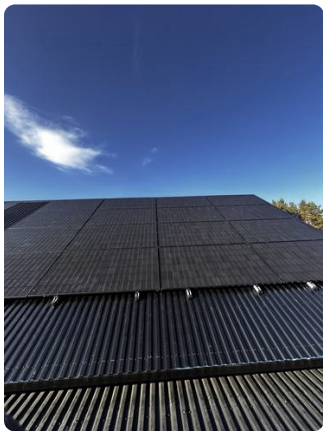
PHOTO 4

Panels installed according to the layout (Picture of all panels visible required\*).

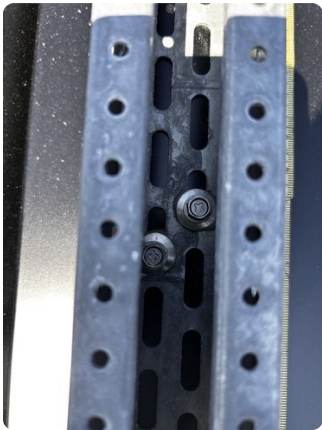
PHOTO 7

Appropriate metal self tapping screws were used for screwing rails

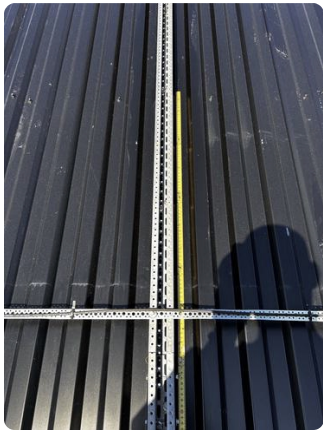
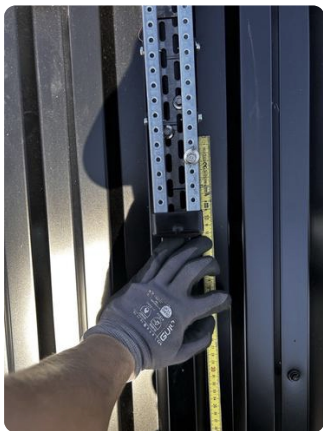
Maximum distance between each screw < 30cm c-c

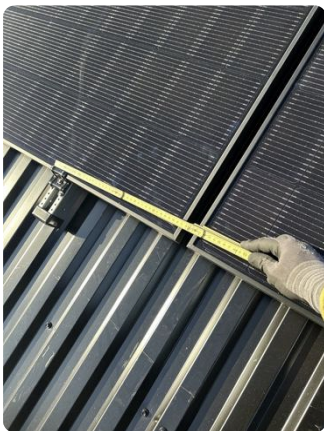
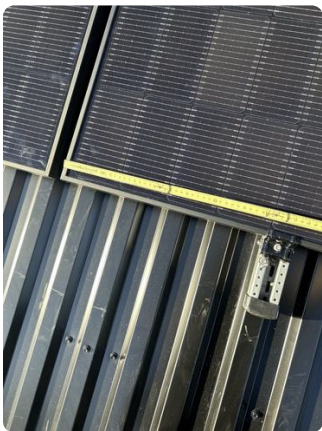
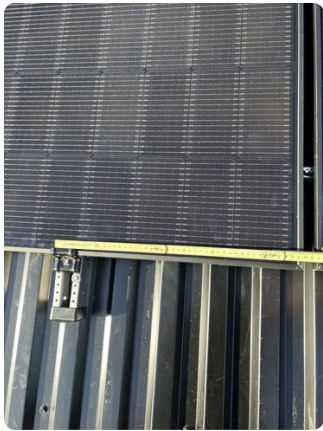
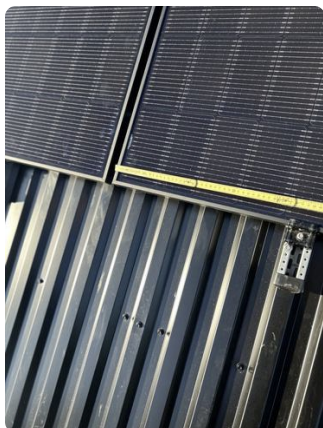
Rail within the distance of 15cm-45cm from panel end.

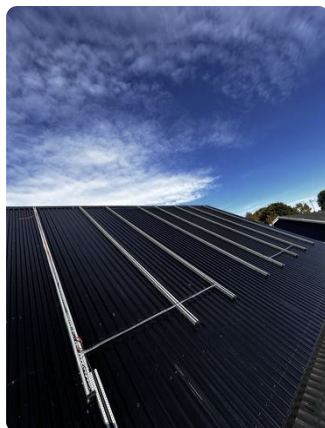
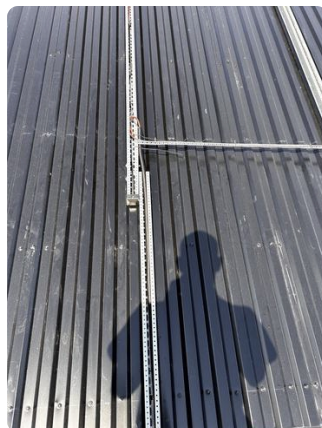
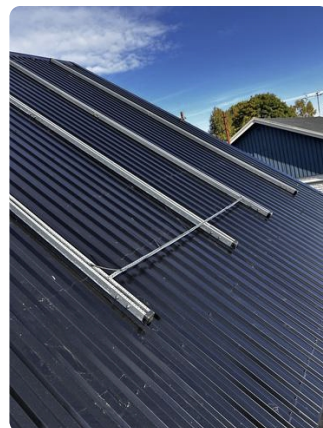
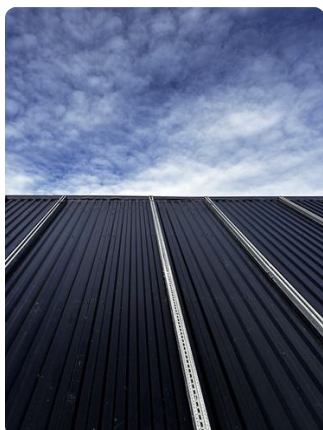
DC cables secured correctly under panels and not laid over sharp edges.

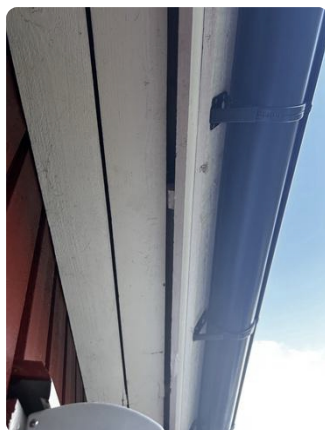
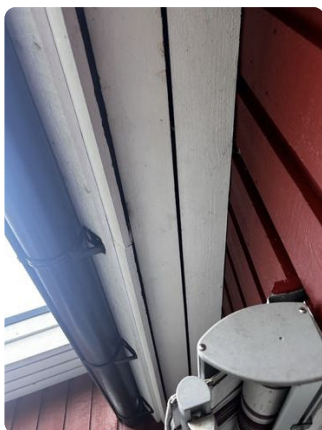
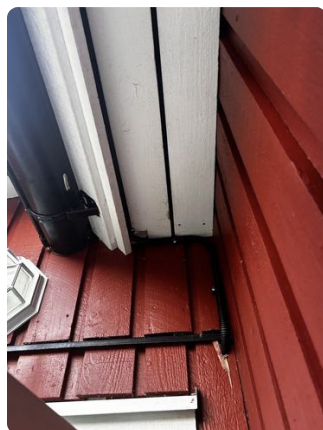
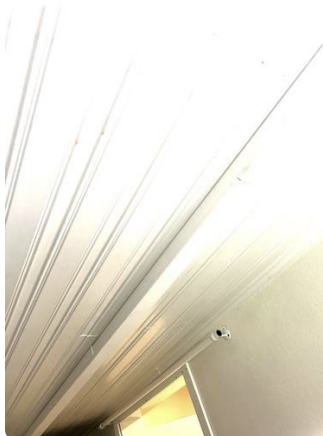
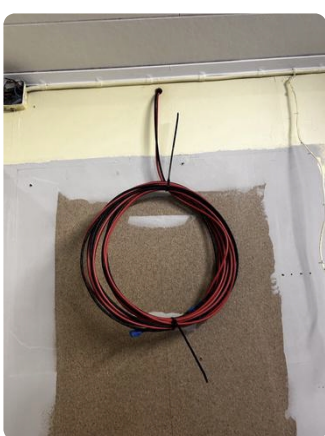
DC cables protected and sealed from the roof to the inverter.

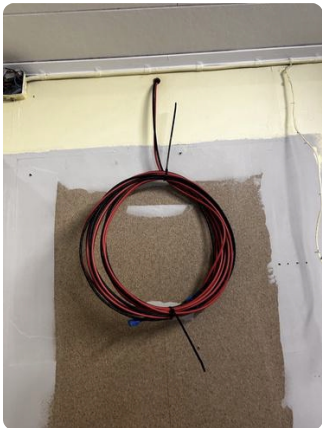
PHOTO 25

**Is there any unfinished work or tasks that need to be completed?**

» We ran out of cable and had to leave the cable as is.

Is there any unfinished work or tasks that need to be completed?

We ran out of cable and had to leave the cable as is.

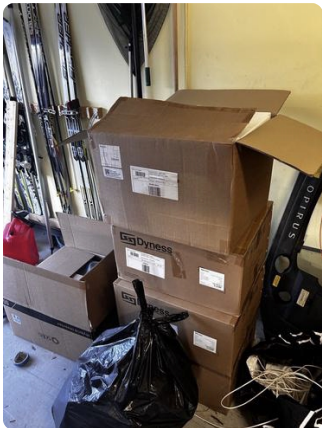
PHOTO 26

Battery tower assembled for electrician? (Pictures of delivered electrician material also required)
