Report Summary

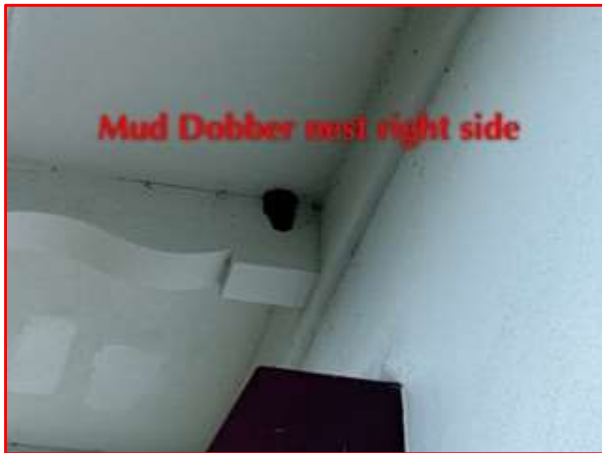
Figure 2-1

1) A couple of Mud Dauber nests were observed in soffit areas. Recommend cleaning off.

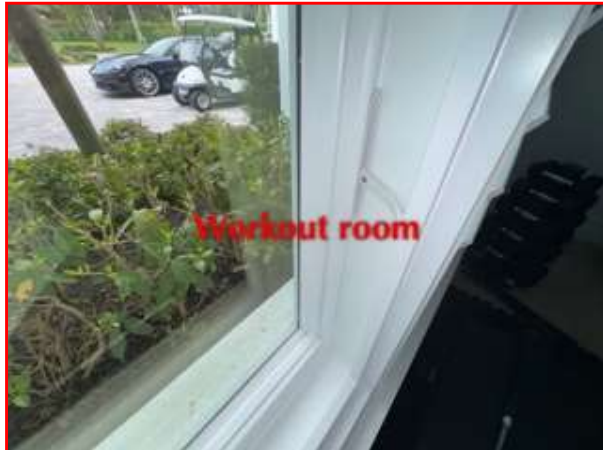
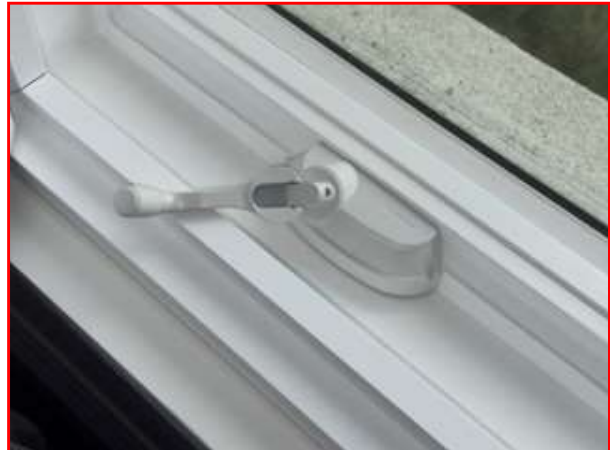
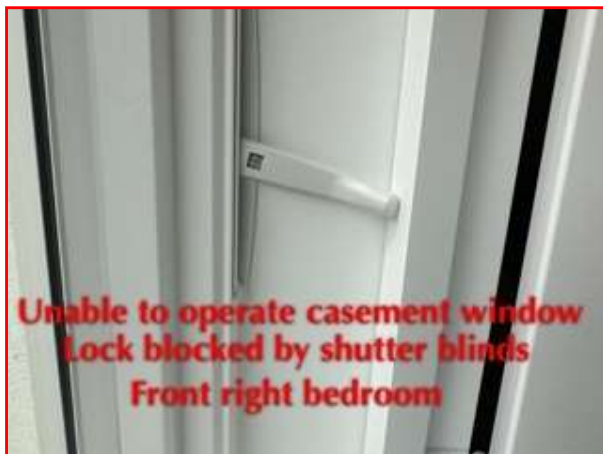
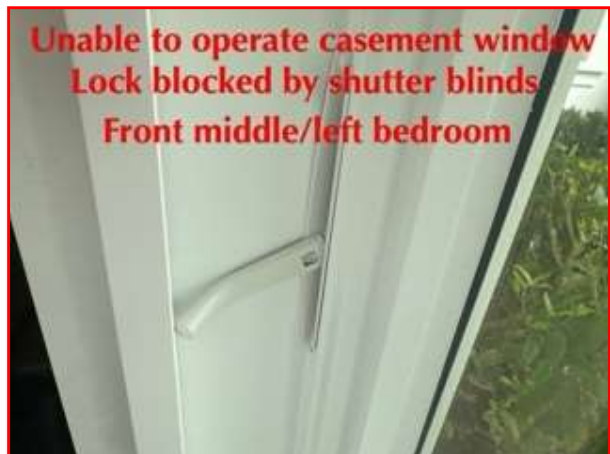
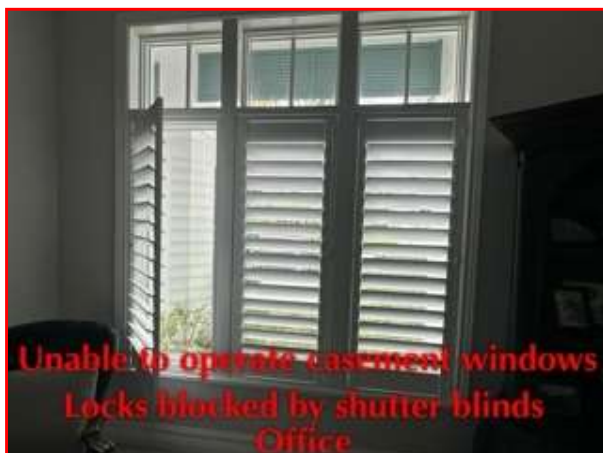
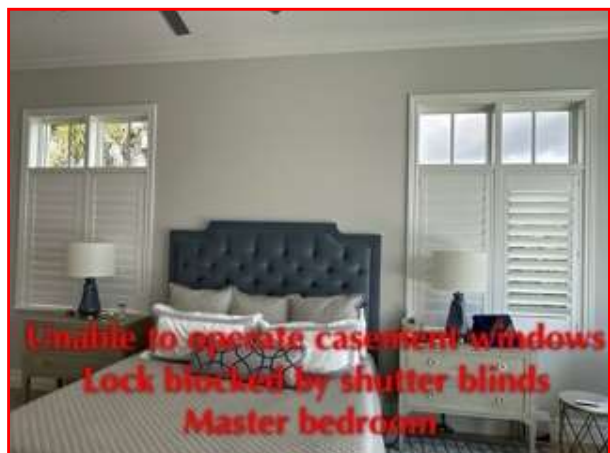
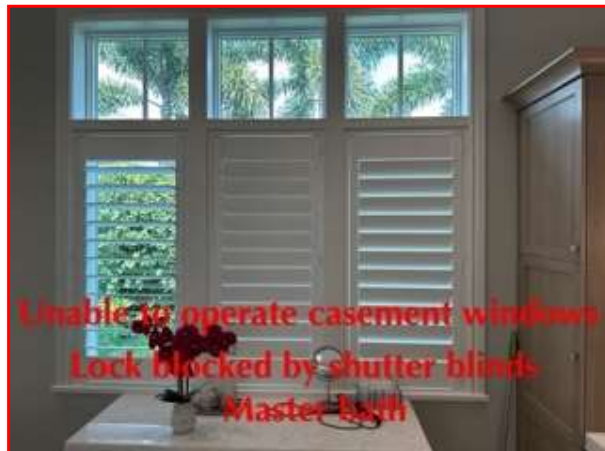
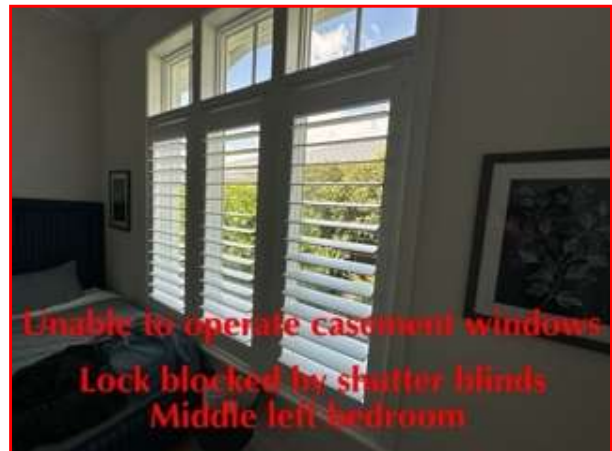
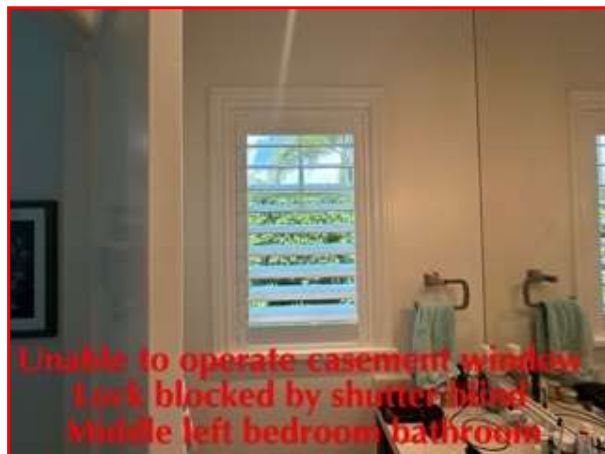
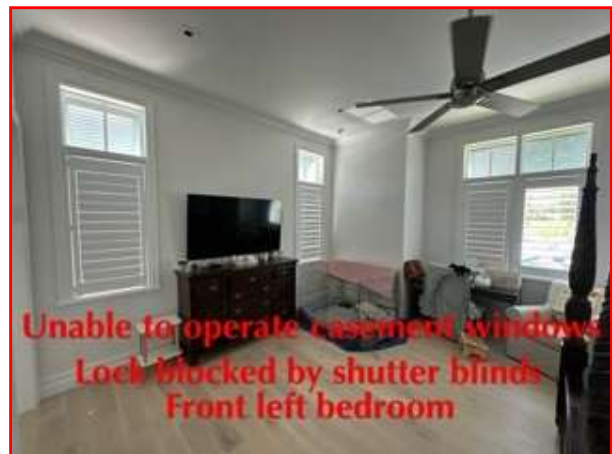
2) Plantation shutters around the home are installed without a frame on most windows. They are installed as an inside mount and they are blocking the Anderson window crank handles and locks. Because of this, egress windows in bedrooms cannot be opened because the plantation shutters are blocking the Anderson latch mechanisms. If the installer had used an outside mount frame, this would not be an issue. Possibly Anderson has a hardware solution that doesn't hit the plantation shutters. Recommend solving this issue for egress and fire safety. The below pictures are examples of what was observed:

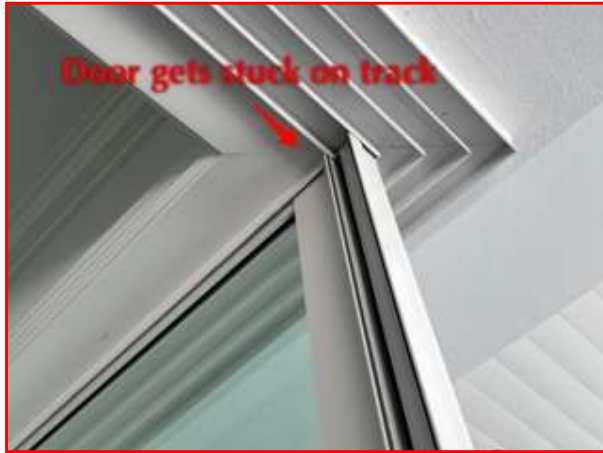
Figure 4-1

3) Service the slider off the dining room. The panel gets caught at the top track. Paint wear to the track can be seen. Recommend a sliding door contractor repair for easier operation of the door and to prevent further finish damage.

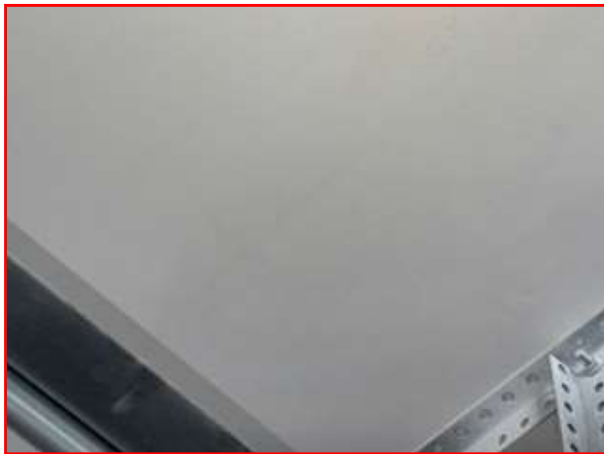
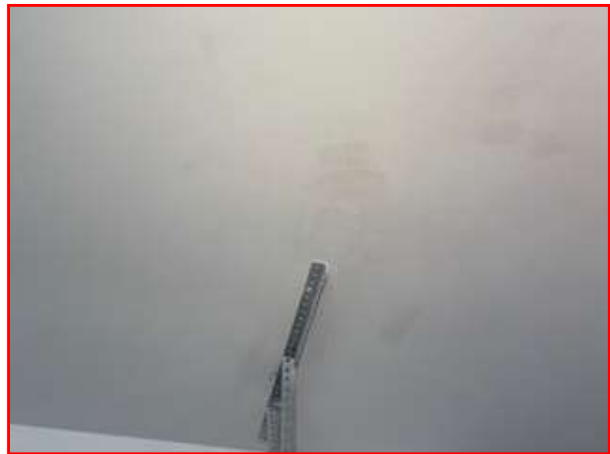
4) There are garage ceiling touchup areas by the openers. It appears the garage door opener framing was relocated and the installer had to spackle the abandoned holes. Recommend refinishing the ceiling.

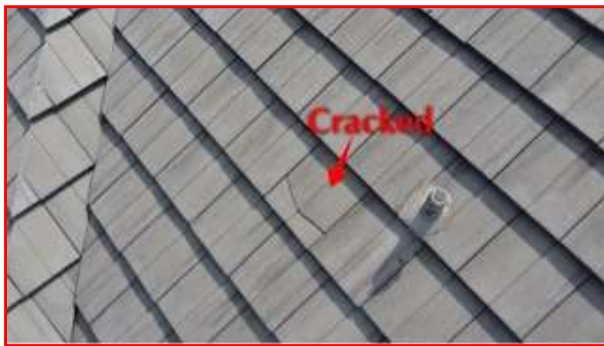
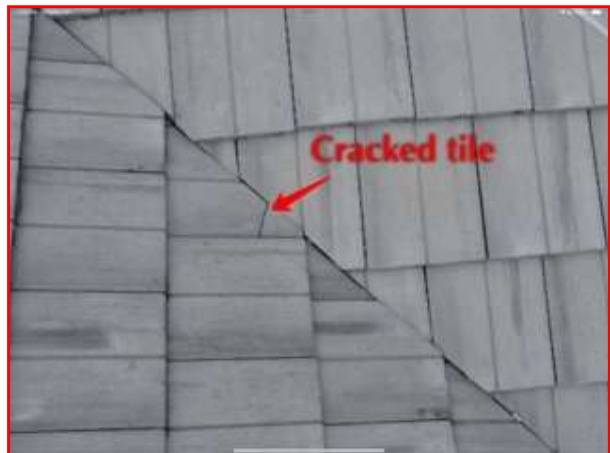
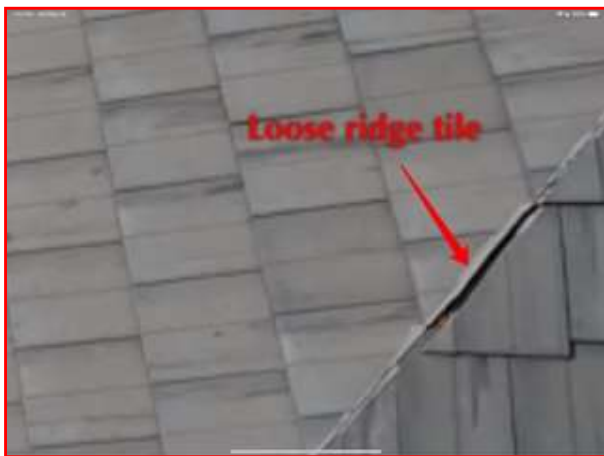
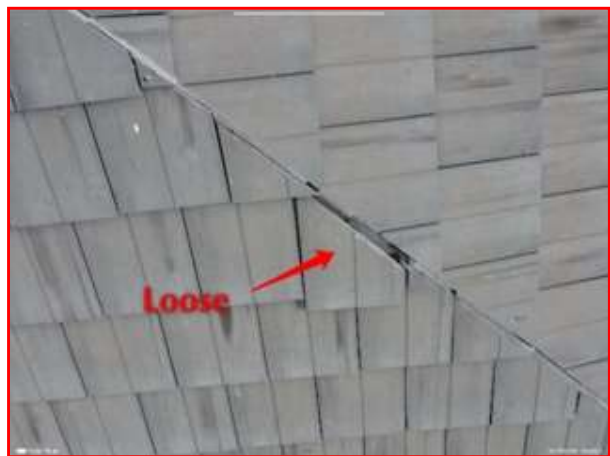
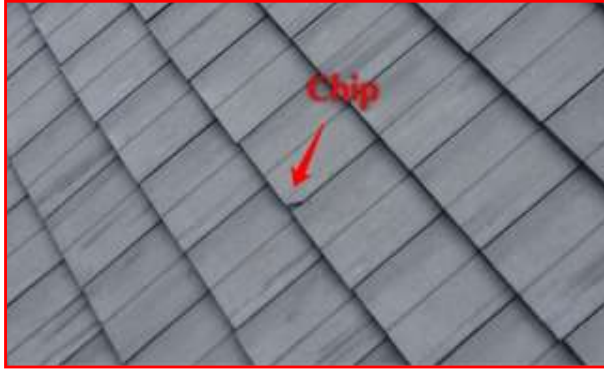
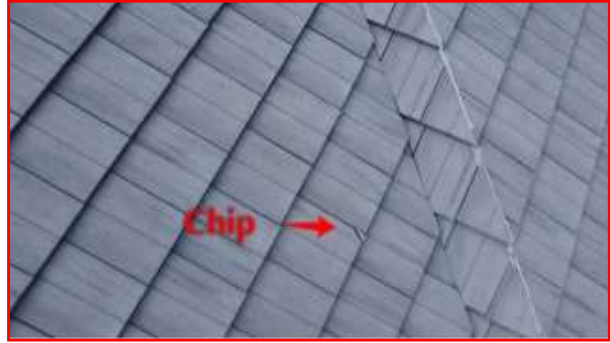
5) The average life expectancy of a concrete tile roof in South Florida is 18- 25 years. There are a few cracked and chipped tiles. A few slipped tiles were also observed. Recommend the installing roofer evaluate the entire roof and replace cracked tiles, mortar any chips, and secure loose tiles. The roofer should also service the mitered Ridge tiles and edges where needed. Insurance companies do not like to see any type of roof damage. On the separate 4 Point Report, the roof is marked unsatisfactory because of the current damage issues that need repair. When the repairs are made, we can re-photograph the roof and change the Report to satisfactory should you need it in the future for insurance. It is important to maintain roofing tiles for maximum life. The below pictures are examples of what was observed may not be all the damage that needs repair:

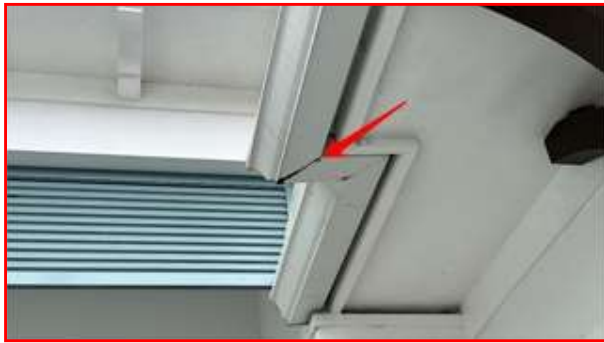
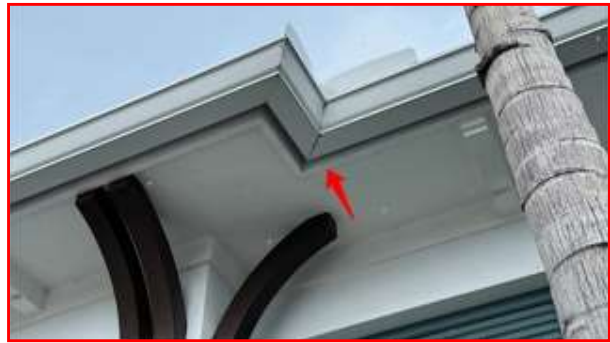
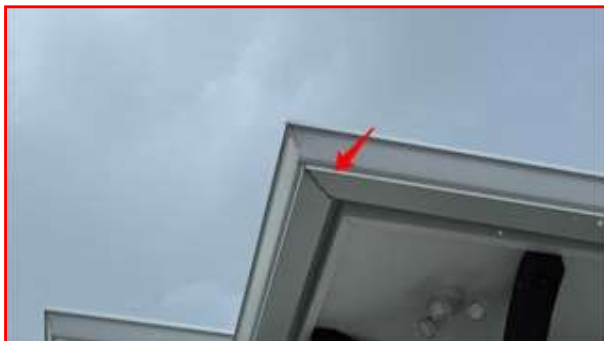
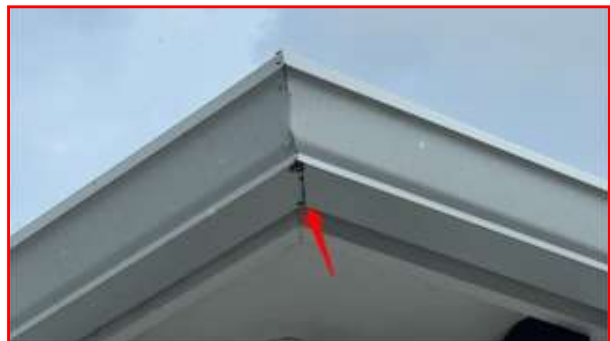
6) Some staining was observed at gutter joints around the home. Recommend cleaning gutters and re-sealing joints to prevent leakage.

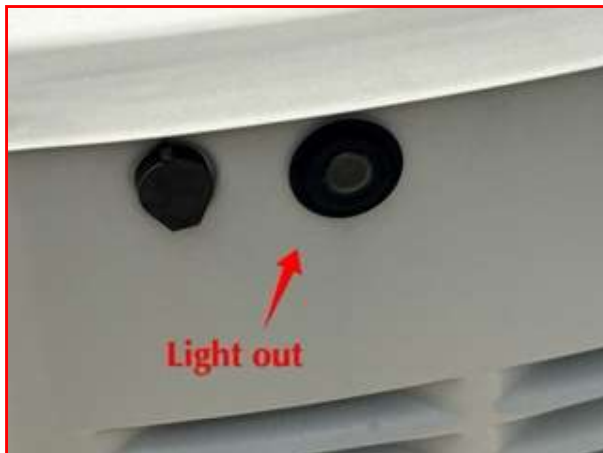
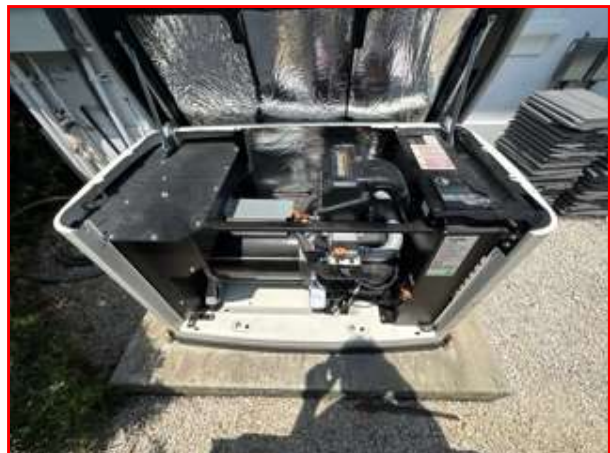
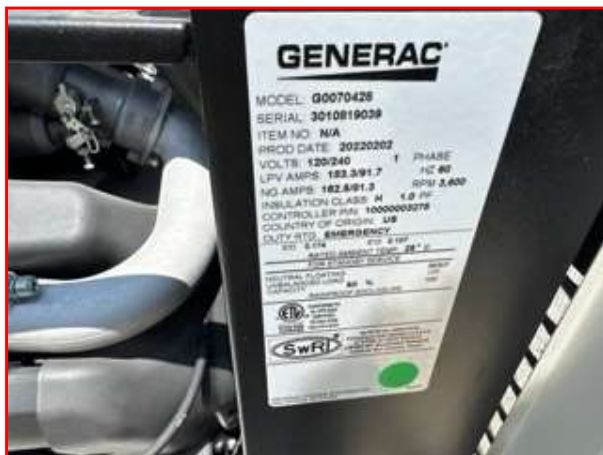
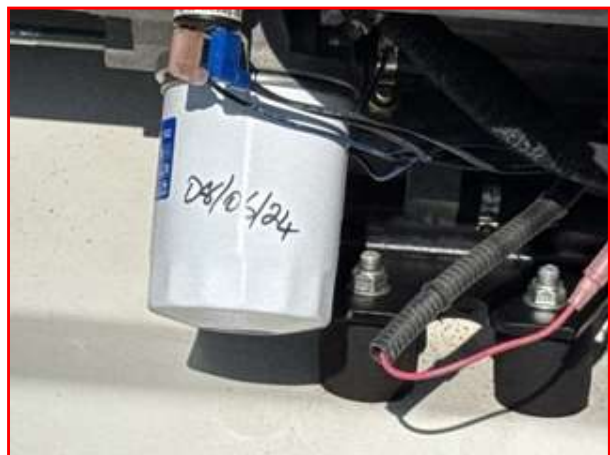
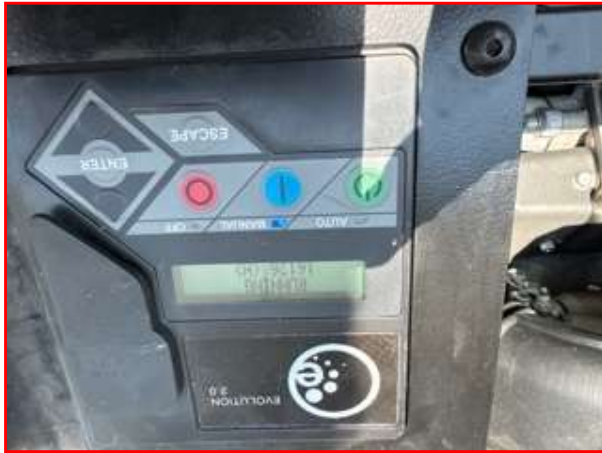
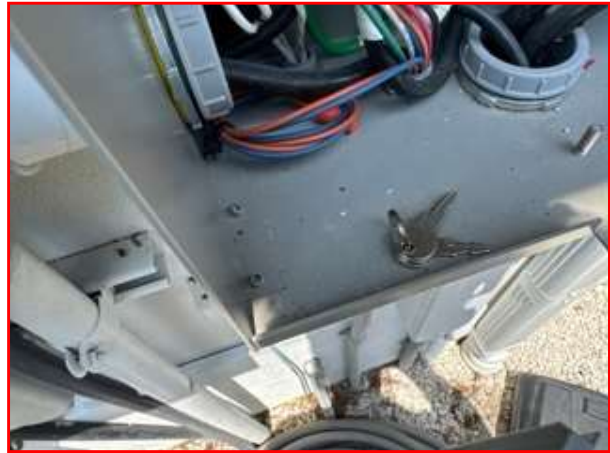
7) A 2022 natural gas generator is located on the right side of the home. It looked like the green status indicator light is not working. Contact the servicing contractor for further evaluation and repair.

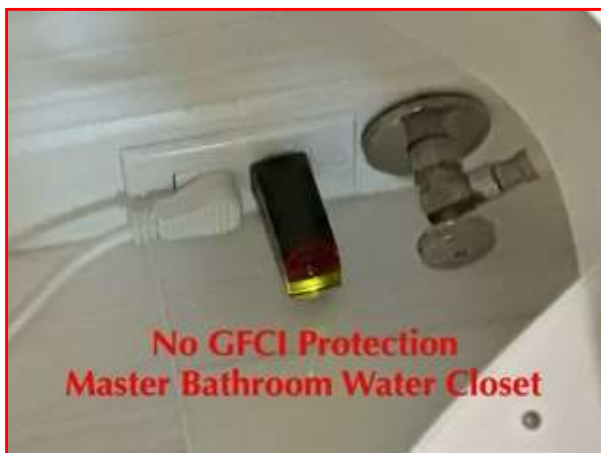
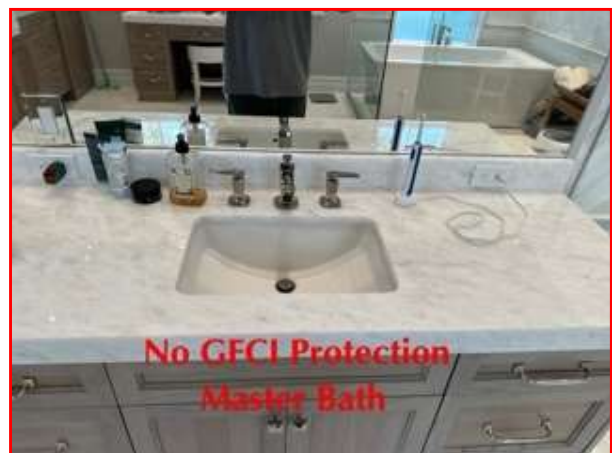
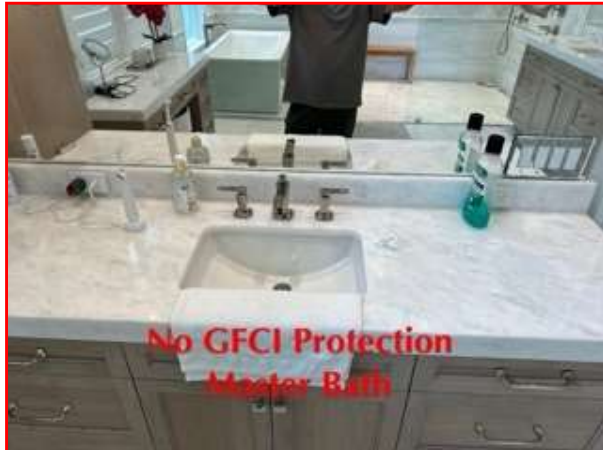
8) Bathrooms are considered wet areas and all receptacles should be GFCI protected. There is no protection in the master bathroom. Recommend an electrician install receptacle protection for electrical safety.

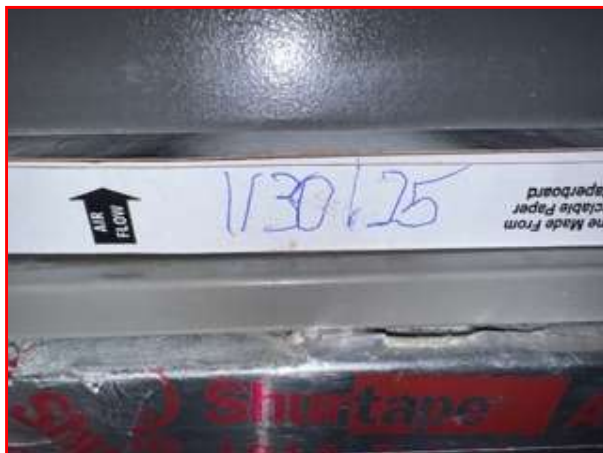
Figure 22-1

9) The air filters in the home appear to have been changed in January 2025. It is generally recommended that filters get changed every 3 to 4 months. Recommend changing all filters.

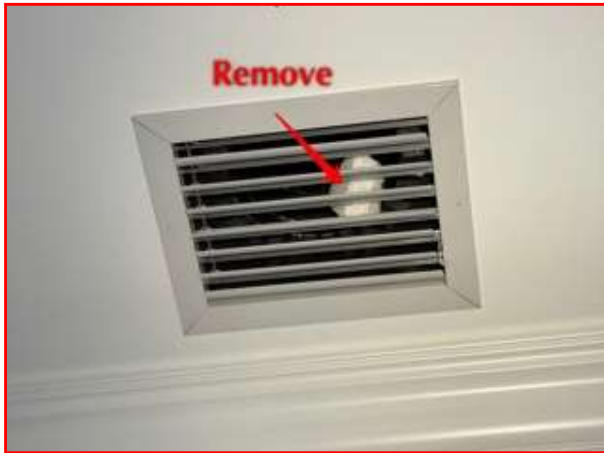
Figure 23-1

10) In the hallway off the garage, there is a piece of foam in the ceiling supply vent. Recommend removing. This was probably leftover during construction.

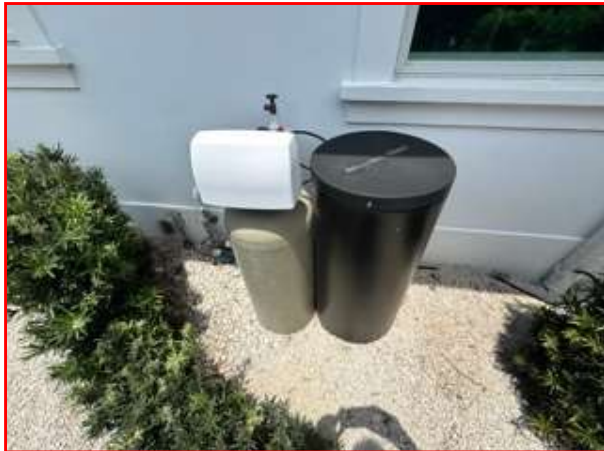
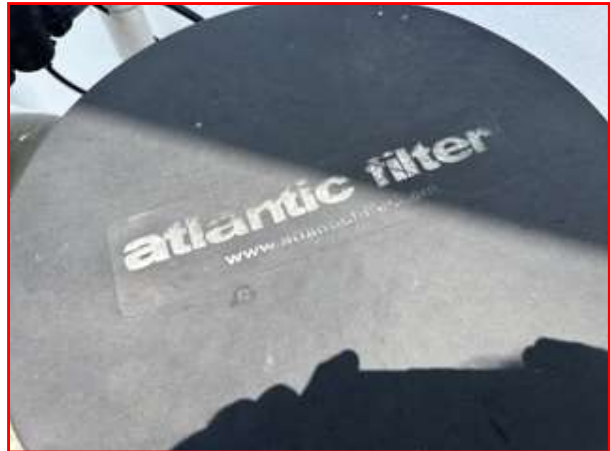
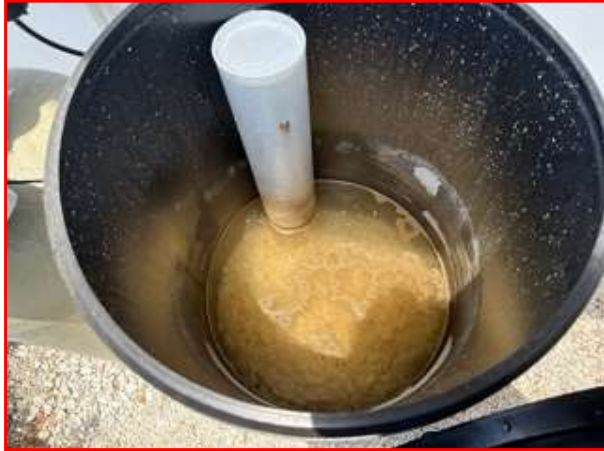
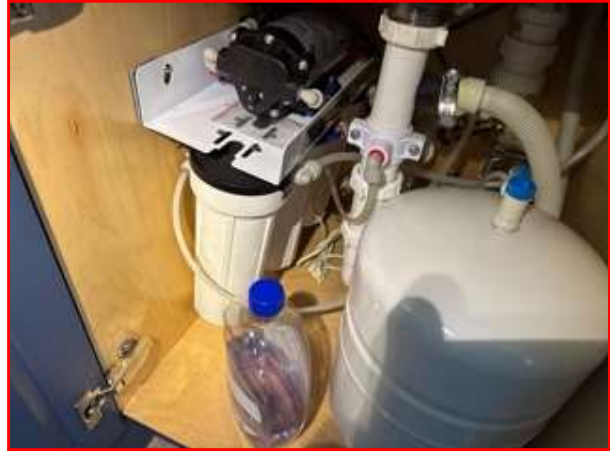
11) Filtration systems are not inspected other than to locate any visible leaks. The softener salt tank appeared to be just about out of salt. Recommend having Atlantic Filter service the system outside and the under-sink osmosis system.

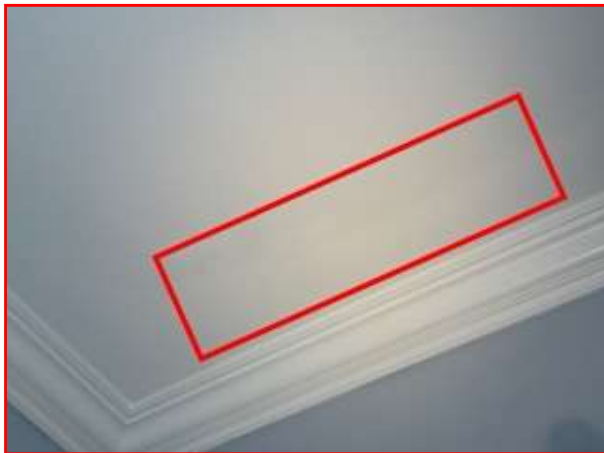
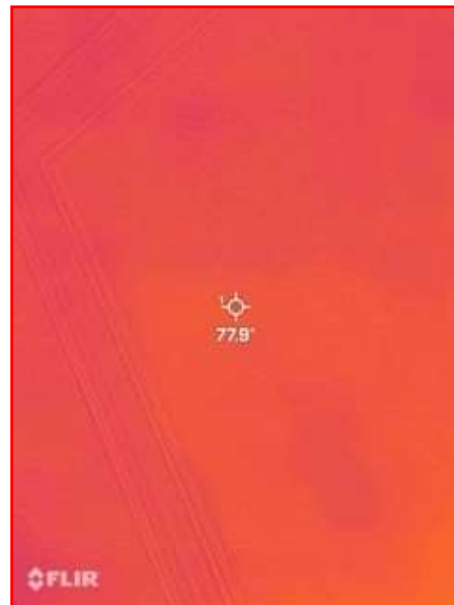
12) There is a light blemish above the washer and dryer in the laundry room. The area appears to be dry. Recommend refinishing.

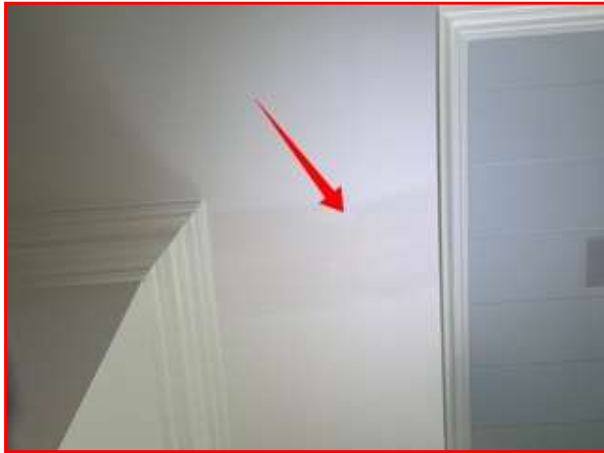
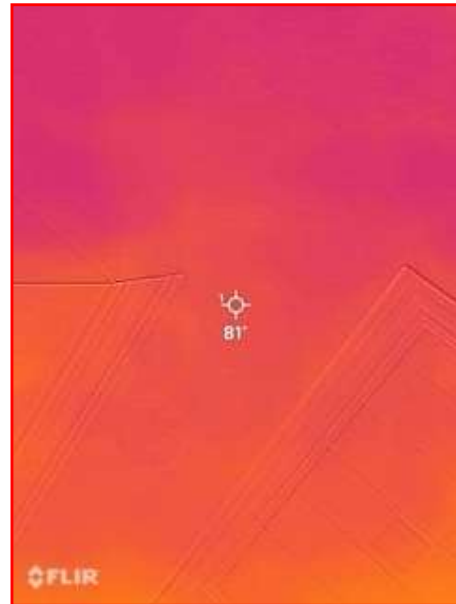
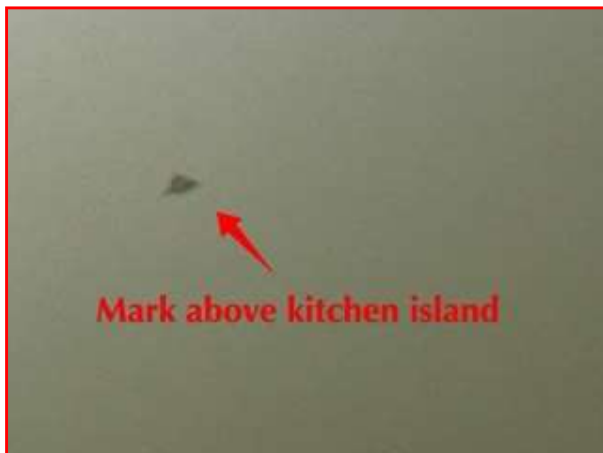
13) There is a ceiling Sheetrock joint repair near the dinette. The area was dry at time of inspection. Recommend refinishing. There is also a mark in the ceiling above the island that should be repaired.

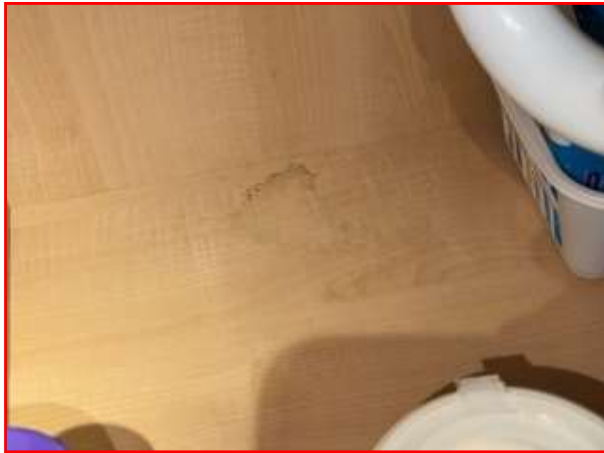
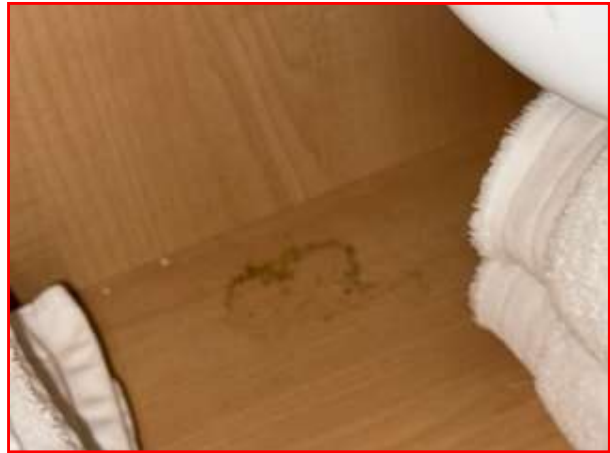
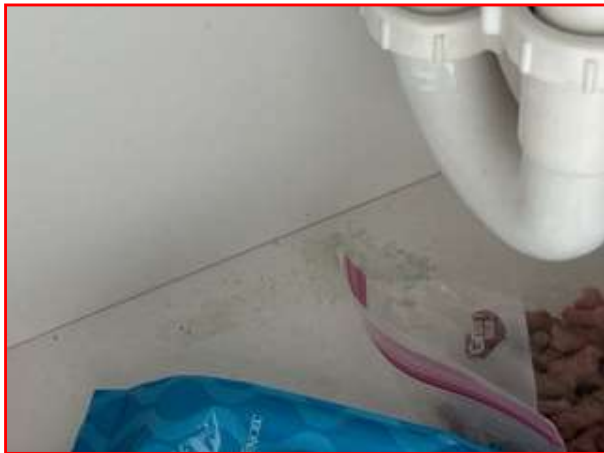
14) There was light staining/residue under the shutoffs in the under sink cabinets in the bathrooms, laundry and kitchens. All of these areas were dry. They appear to be left over residue from a plumber when installing the shut off valves. Recommend cleaning all the sink base cabinets. Below pictures are examples of what was observed:

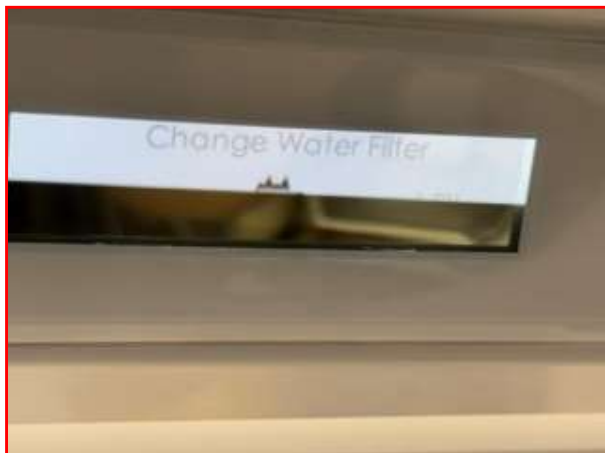
Figure 35-1

16) Replace both of the kitchen refrigerator water filters.

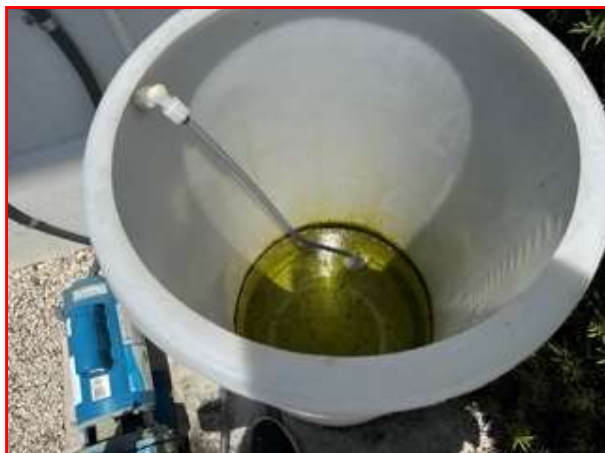
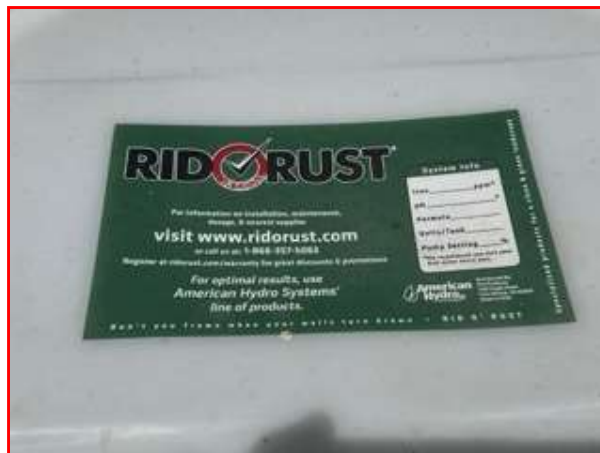
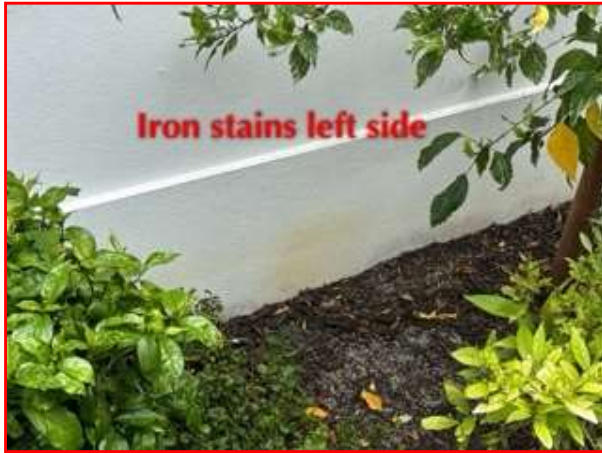
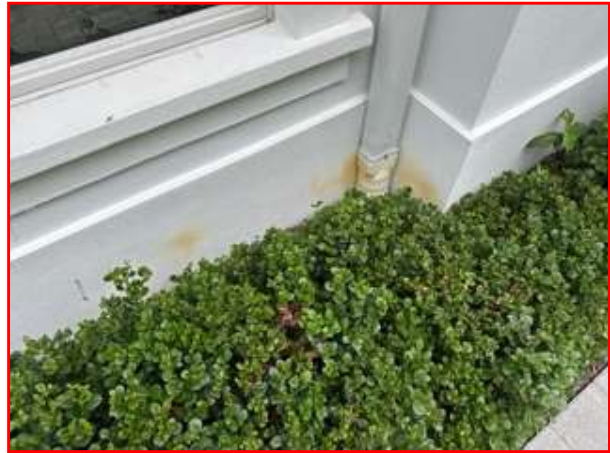
17) There is an irrigation rust control tank at the irrigation equipment. The tank is empty. Some staining was observed on exterior walls, which may be the result of there being little or no rust prevention chemical. Recommend a rust control chemical contractor check the system and fill the tank. Recommend cleaning the walls with a rust stain remover.

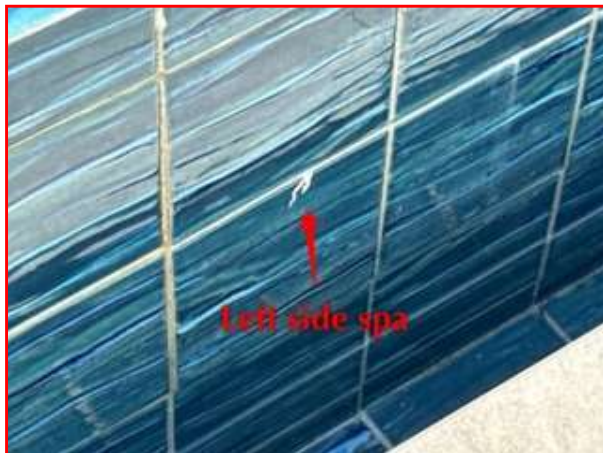
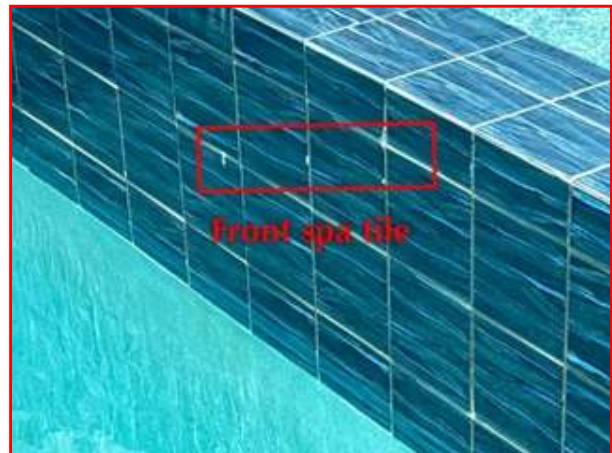
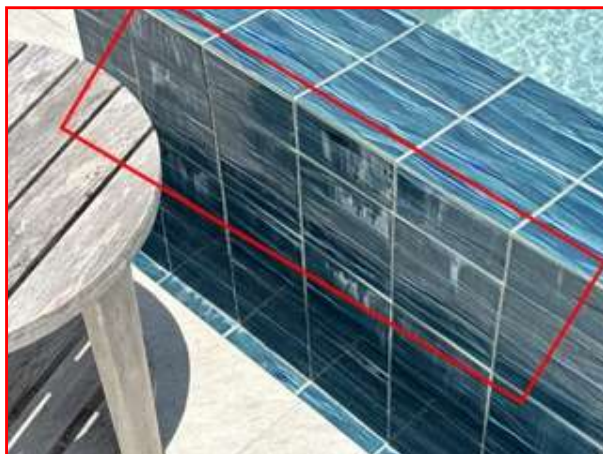
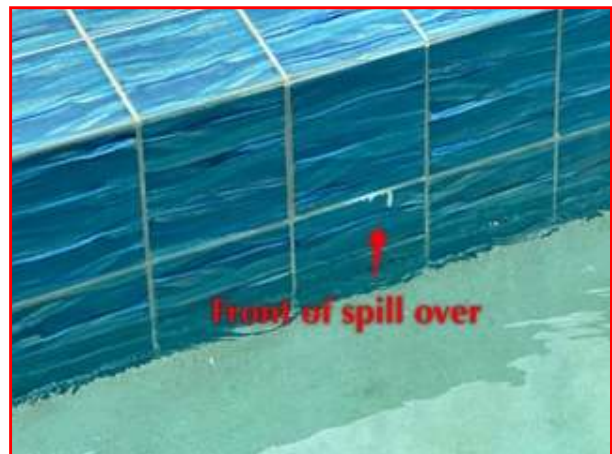
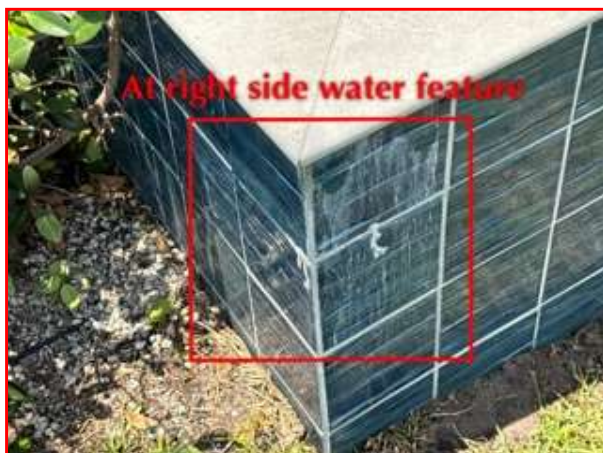
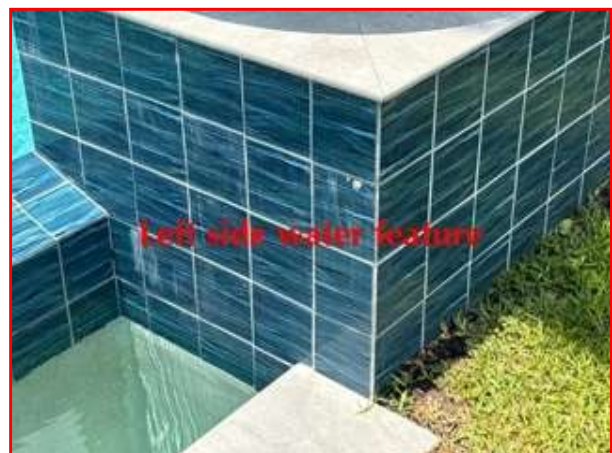
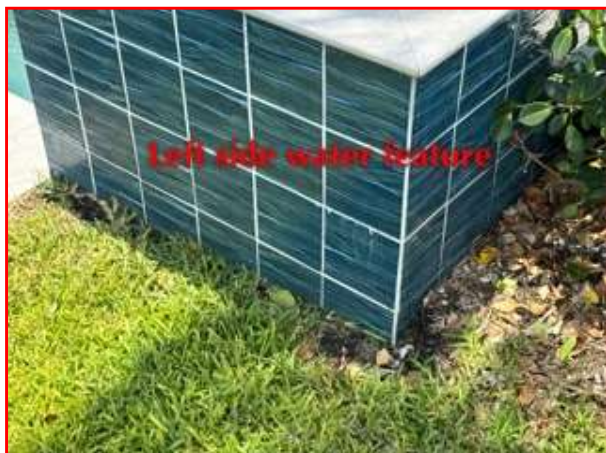
18) There are multiple areas of visible calcium deposits, forming around the pool and spa. Calcium deposits forming at the joints is a common issue where moisture draws mineral salts, like calcium carbonate, from the grout or substrate to the surface, leaving behind white, chalky residue. This is especially prevalent when tiles are installed over damp surfaces, or if poor-quality grout or improper waterproofing has been used. To address this, surface deposits can be removed with a stiff brush, vinegar solution (if safe for the materials), or a commercial efflorescence cleaner. However, if the problem persists, it may indicate deeper moisture issues or installation defects. To prevent recurrence, it's important to ensure proper curing, seal the grout once dry, and address any underlying water infiltration or ventilation problems. Recommend further evaluation by the pool installer for cleaning and repair if needed. The below pictures are examples of what was observed.

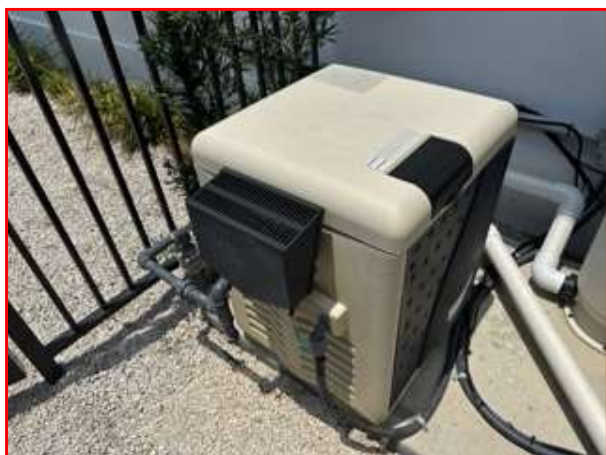
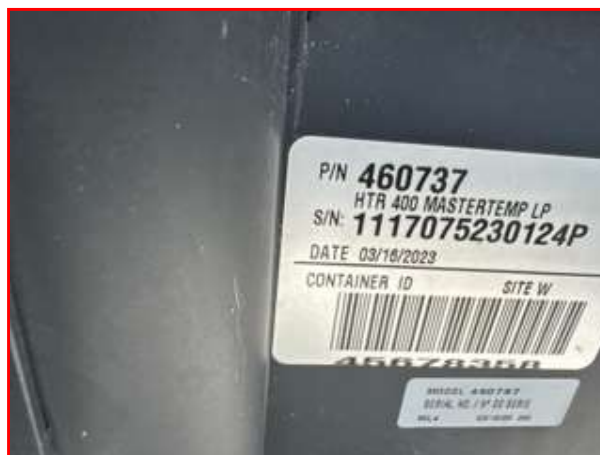
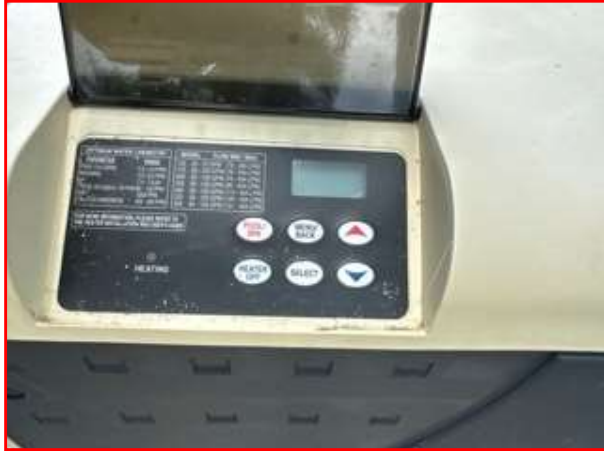
19) The pool heater was powered off. I was unable to power it on. Possibly it is functioning properly and I was just unable to operate it properly. Recommend verifying function.
