## Yacht Performance Center, LLC

# MECHANICAL REPORT PERFORMED 02/13/2025

Vessel name: Bella Regazza

Make: Bayliner Model: 325

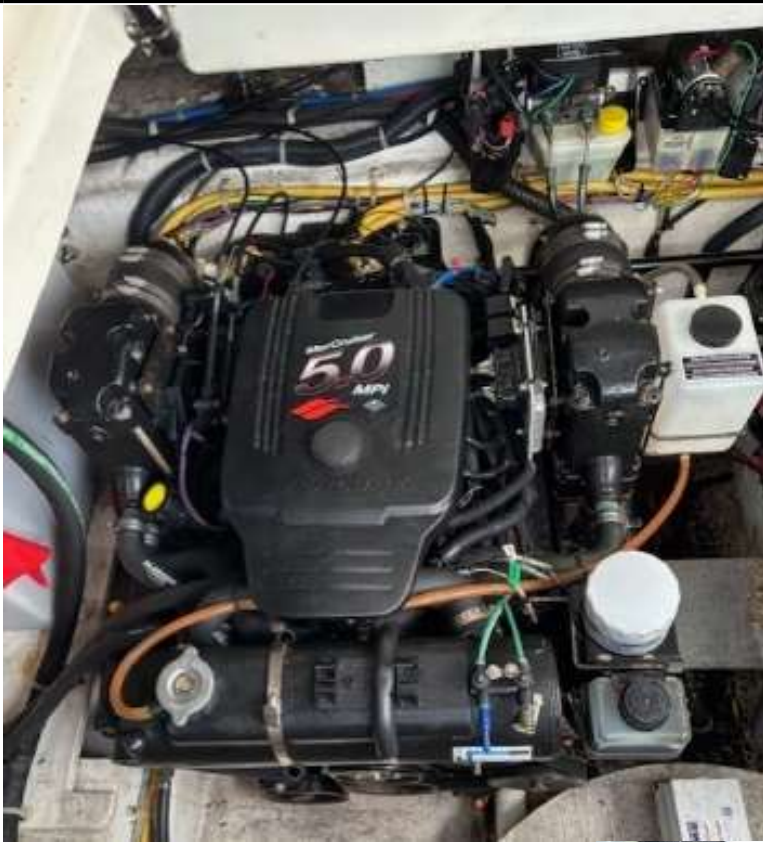
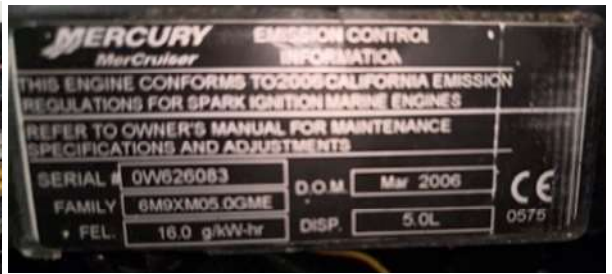
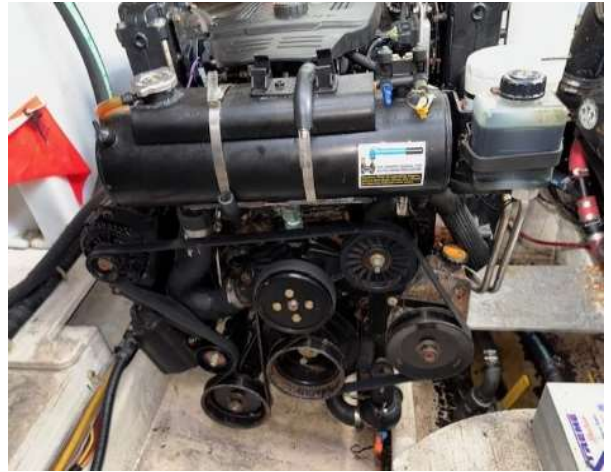
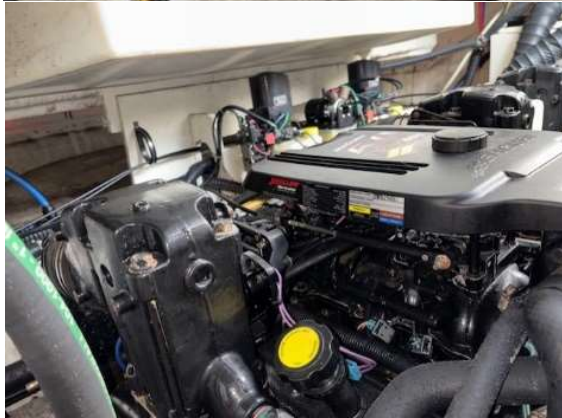
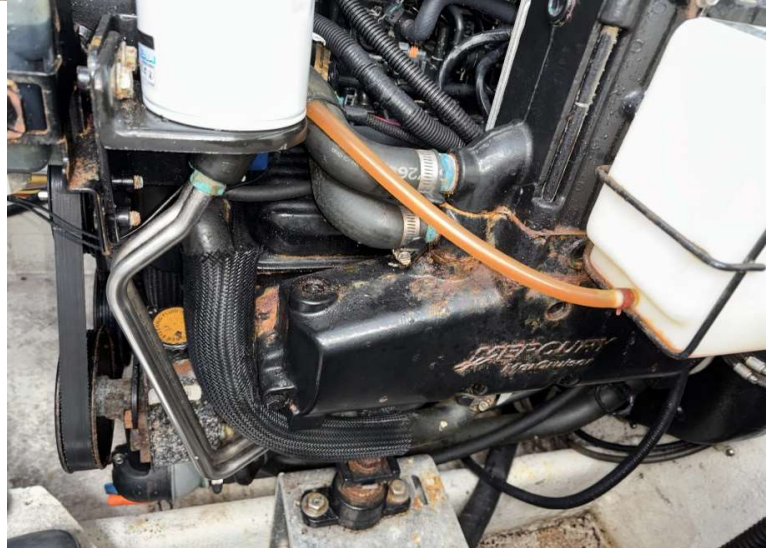
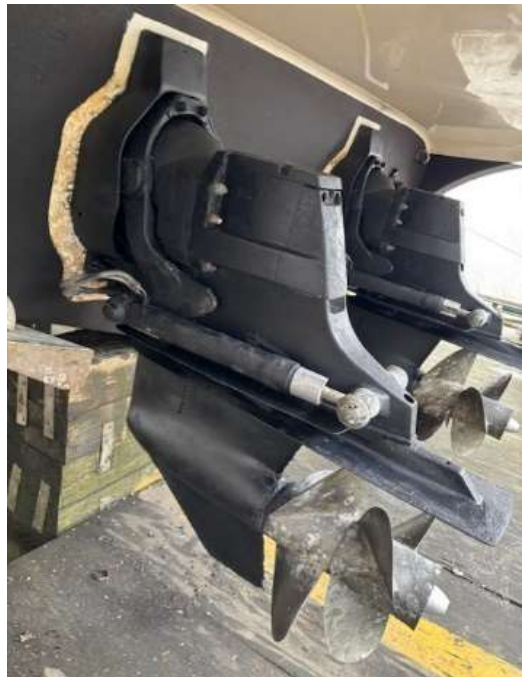
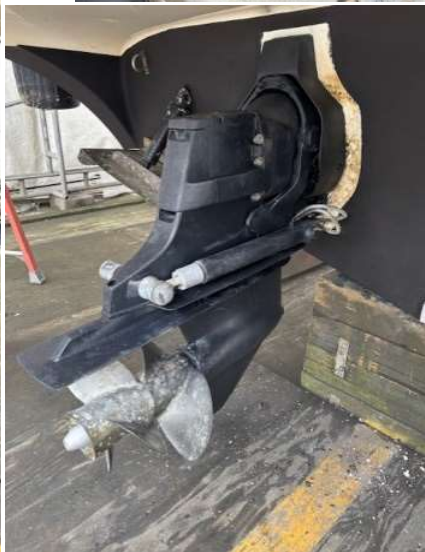
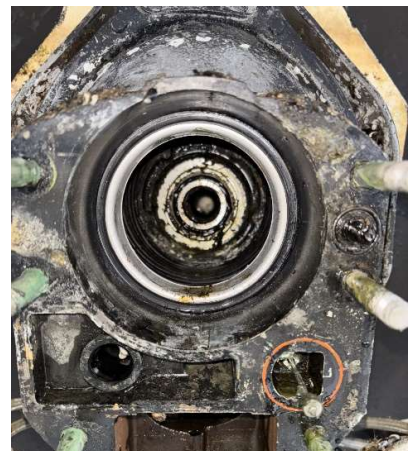
## STBD ENGINE and OUT DRIVE

- ☒ No significant water or engine fluids in the bilge
- ☒ Engine was recently serviced
- ☒ Engine was recently tuned up
- ☒ Engine cylinder compression is within allowable variance range
- ☒ No error codes when connected to the computer
- ☒ Alternator is charging properly
- ☒ Heat exchanger has recently been serviced
- ☒ Belt is in good condition
- ☒ Raw water pump impeller was replaced in February 2024
- ☒ S Suggest sanding and painting some engine surface
- ☒ Out drive has been recently serviced
- ☒ Out drive was free of water intrusion in the bellows
- ☒ Gimbal bearing, bellows and u-joints are in good condition
- ☒ Out drive has been recently painted
- ☒ Propellers are free of any significant damage

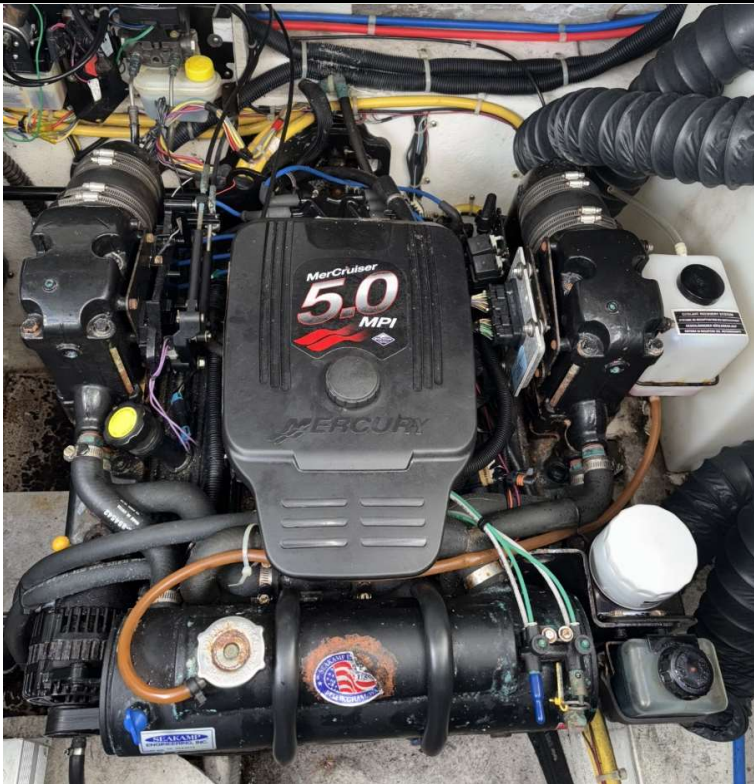
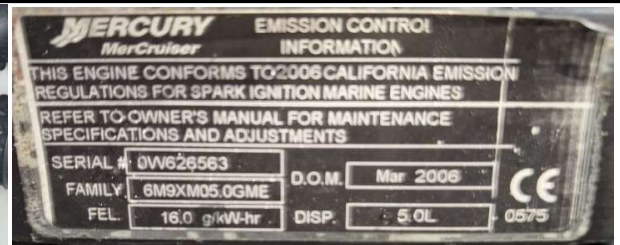
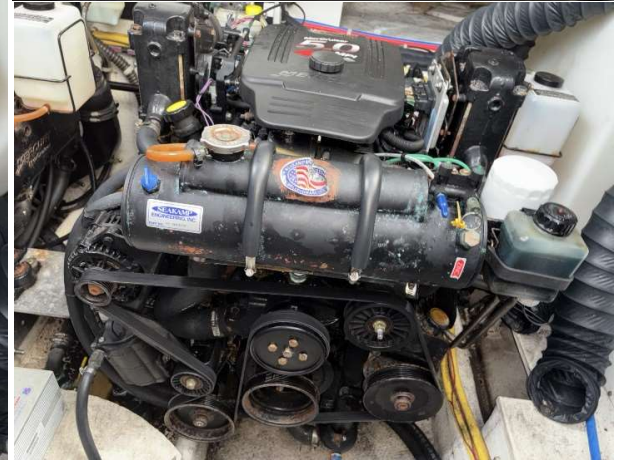
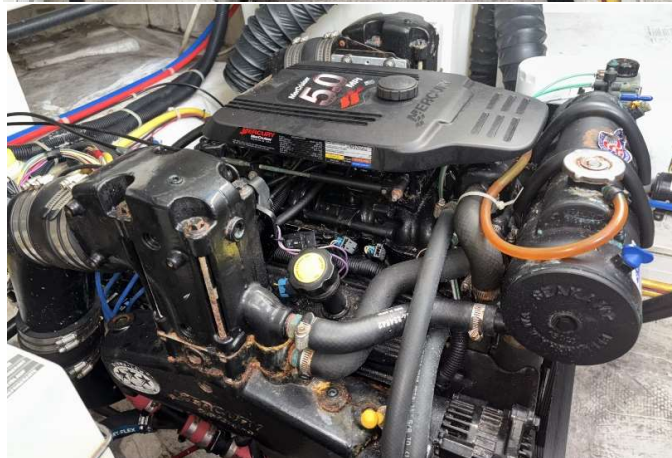
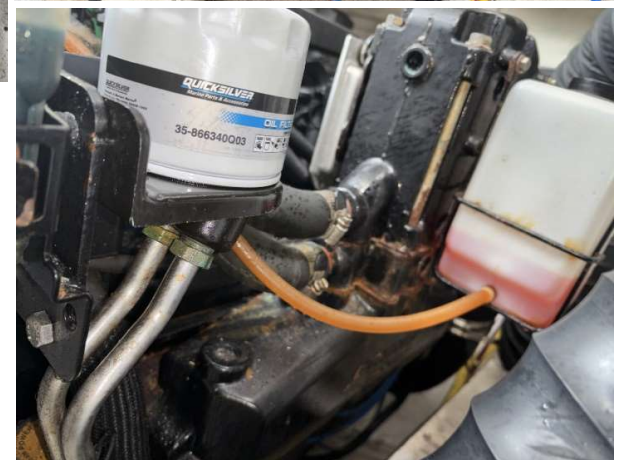
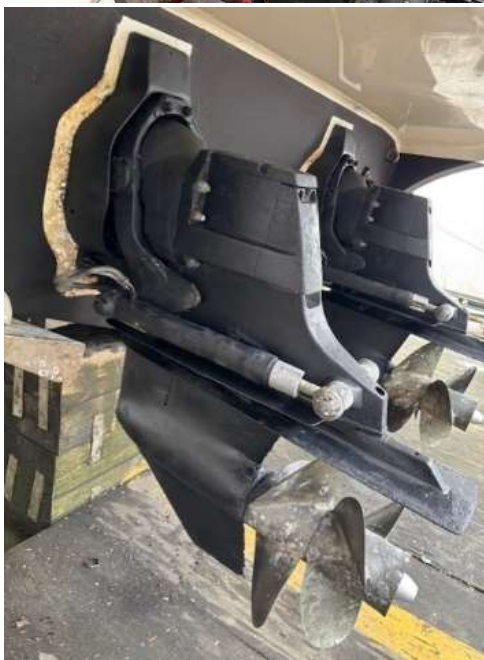
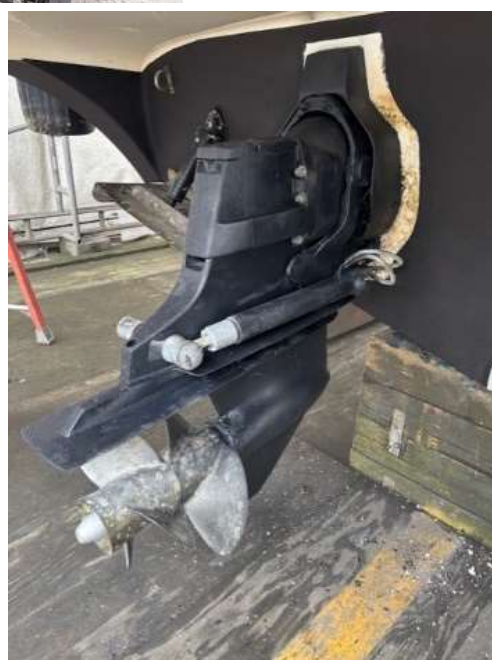
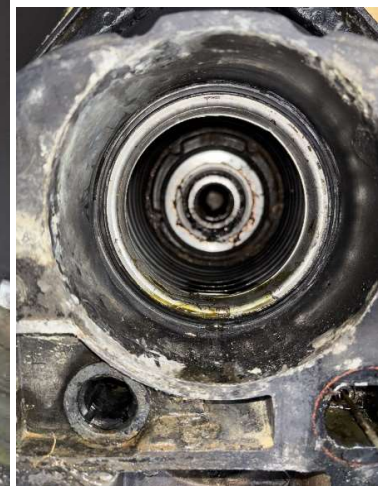
## PT ENGINE and OUT DRIVE

- ☒ No significant water or engine fluids in the bilge
- ☒ Engine were recently serviced
- ☒ Engine was recently tuned up
- ☒ Engine cylinder compression is within allowable variance range
- ☒ No error codes when connected to the computer
- ☒ Alternator is charging properly
- ☒ Newer heat exchanger
- ☒ Belt is in good condition
- ☒ Raw water pump has recently been replaced
- ☒ S Suggest sanding and painting some engine surfaces
- ☒ Out drive was free of water intrusion in the bellows
- ☒ Bellows, gimbal bearing, U-joints and U-joint shaft seal replaced in February 2024
- ☒ Out drive has been recently painted
- ☒ Propellers are free of any significant damage
