Wetland Biological Conditions EA Report

Project Name	H-600 Pipeline Spread F	A/E	124300135	Spread	H-600 Pipeline Spread F
Contractor	Price Gregory	Report #	142		
Environmental Auditor	Charles Haden			Date/Time	11/27/2023 12:50 PM
Wetland ID	W-MM20-PFO	Crossing Start Date	12/2/2023	Crossing Completion Date	1/10/2024
Milepost	171.49	Pre-Con Assessment Date	11/27/2023	Post-Con Assessment Date	1/10/2024
Station	9054+65	Cowardin Classification	PFO	Wetland Impact Area(acres)	0.2990
State	WV				
County	Summers

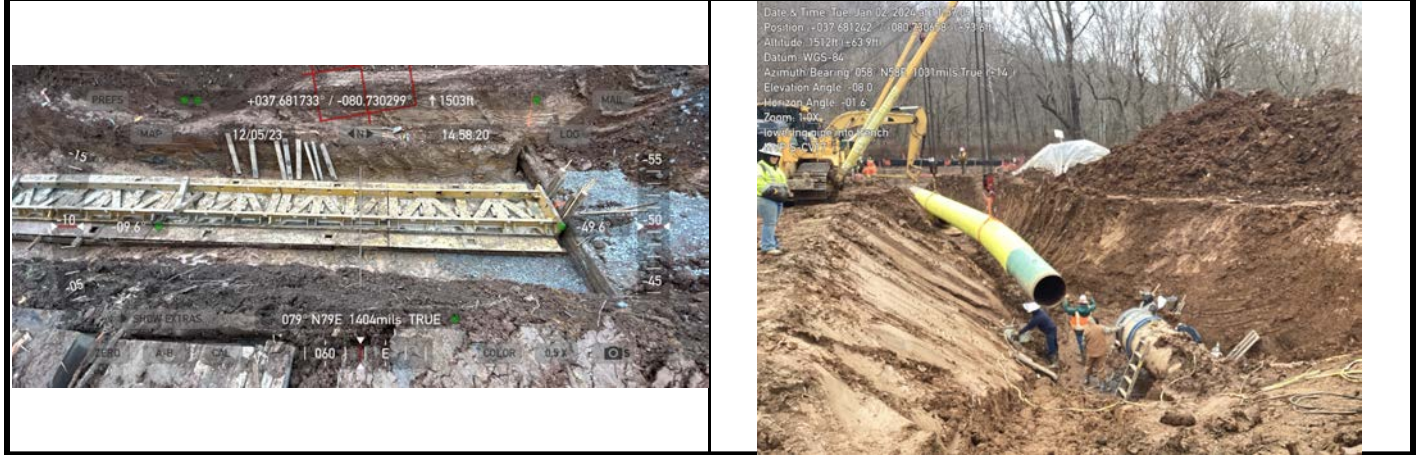
GPS Location	See Photo	GPS Location	See Photo
Description	Photo 3: Bore tracks in aquatic resource.	Description	Photo 4: Lowering pipe into trench into aquatic resource area.

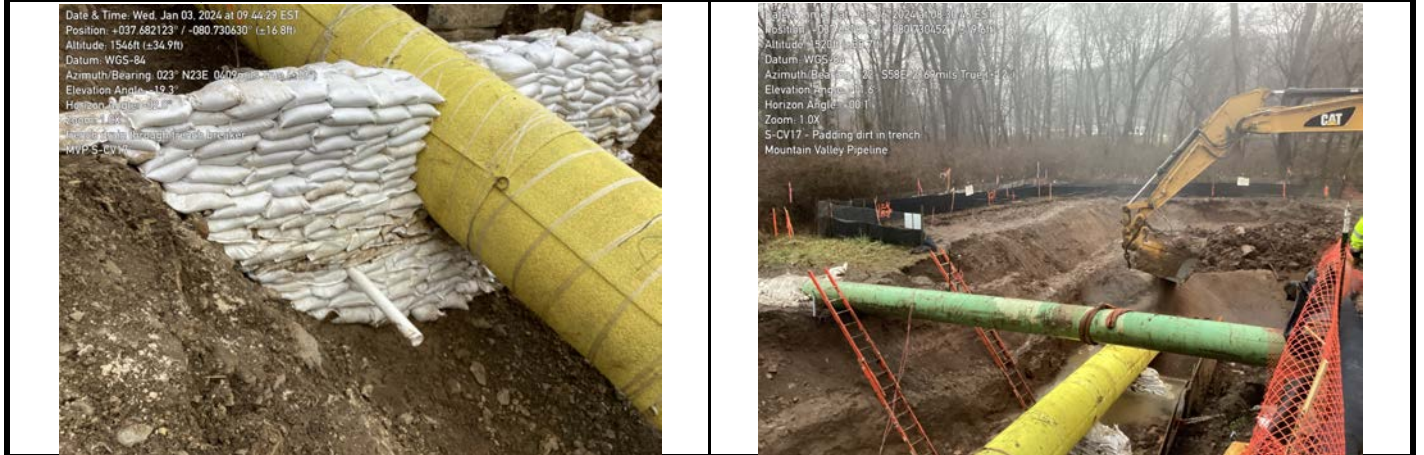
GPS Location	See Photo	GPS Location	See Photo
Description	Photo 5: Trench breaker constructed with French drain.	Description	Photo 6: Adding padding dirt and backfilling trench.

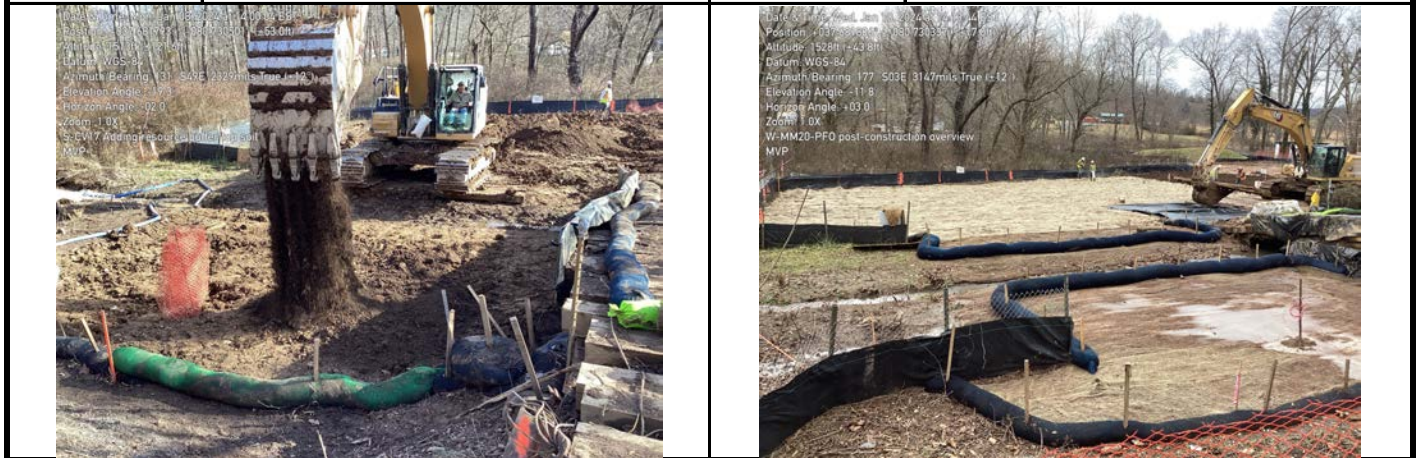
GPS Location	See Photo	GPS Location	See Photo
Description	Photo 7: Adding topsoil to aquatic resource inside S-CV17 buffer.	Description	Photo 8: Overview of wetland. Seeding ongoing.
