Stream Biological Conditions EA Report

Project Name	H-600 Pipeline Spread F	AFE	124300135	Spread	H-600 Pipeline Spread F
Contractor	Price Gregory	Report #	425		
Environmental Auditor	Mathew Huber	Date/Time	12/4/2023 7:56 AM		
Stream ID	S-C41	Crossing Start Date	12/6/2023	Crossing Completion Date	12/22/2023
Milepost	194.78	Pre-Con Assessment Date	12/4/2023	Post-Con Assessment Date	12/22/2023
Station	10284+12	Bankfull Width (ft.)	3.0	Riffle:Pool Complexes Present?	No
State	WV	Stream Classification	Intermittent		
County	Monroe	303(d) Impairment Listing	No

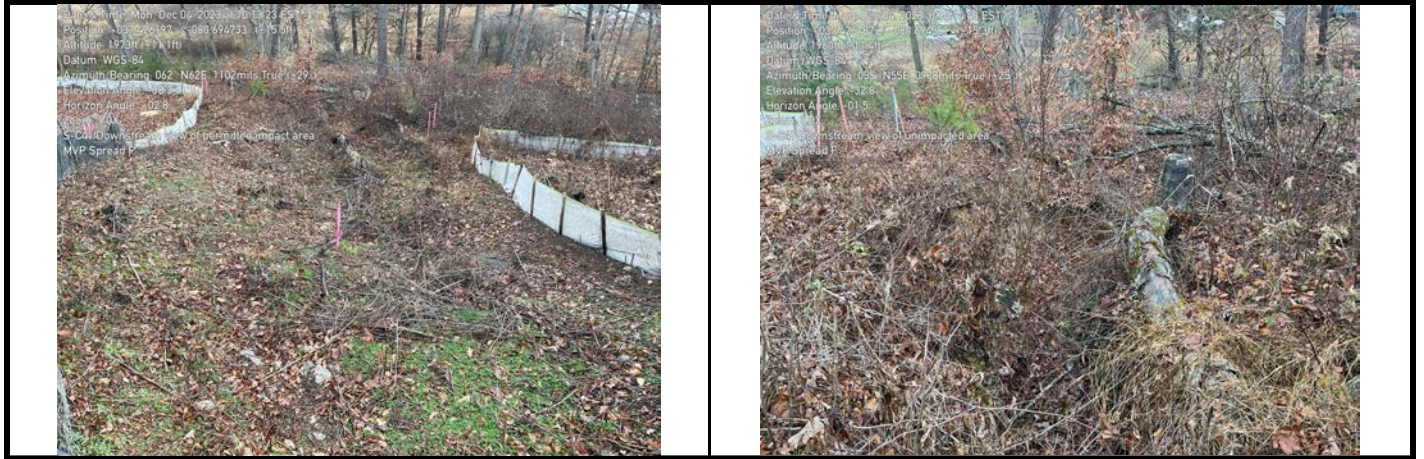
GPS Location	See Photo	GPS Location	See Photo
Description	Downstream view of permitted impact area during pre-construction assessment.	Description	Downstream view of unimpacted area during pre-construction assessment.

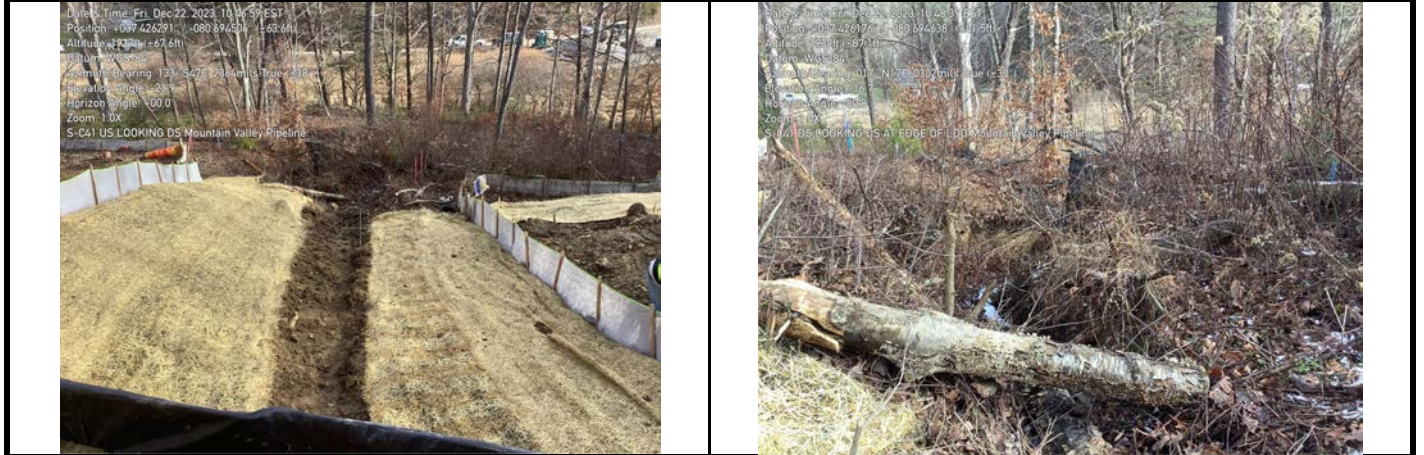
GPS Location	See Photo	GPS Location	See Photo
Description	Downstream view of permitted impact area during post-construction assessment.	Description	Downstream view of unimpacted area during post-construction assessment.

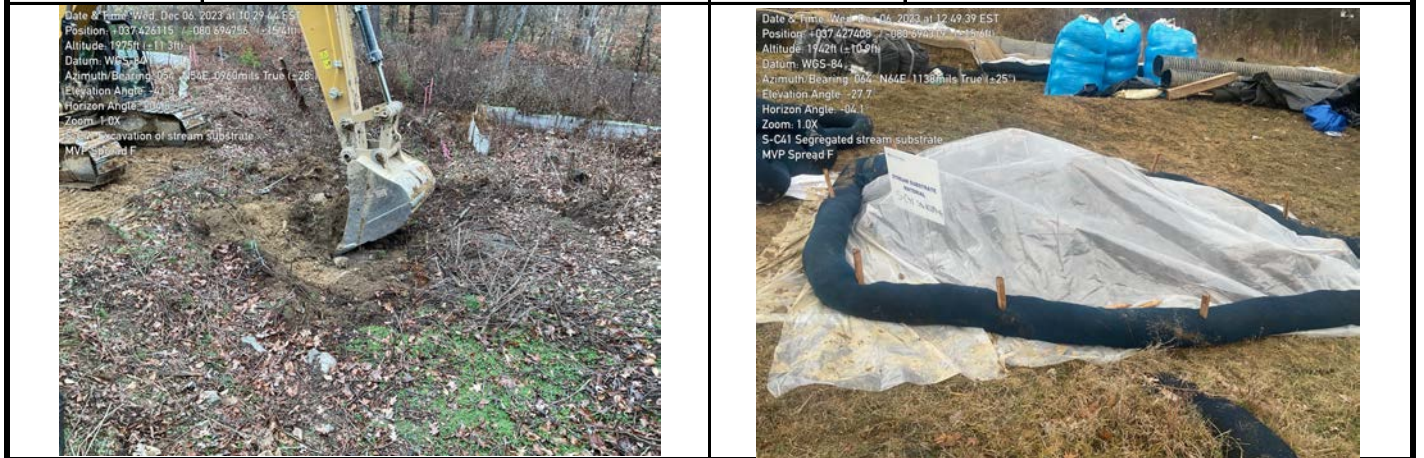
GPS Location	See Photo	GPS Location	See Photo
Description	Photo 1: Excavating top 12 inches of substrate.	Description	Photo 2: Substrate segregated and stored in upland area.
