# Wetland Biological Conditions EA Report

| <b>Project Name</b> | H-600 Pipeline Spread E | <b>A/E</b> | 124300134 | <b>Spread</b> | H-600 Pipeline Spread E |
| <b>Wetland ID</b> | W-M23 | <b>Crossing Start Date</b> | 10/7/2023 | <b>Crossing Completion Date</b> | 10/19/2023 |

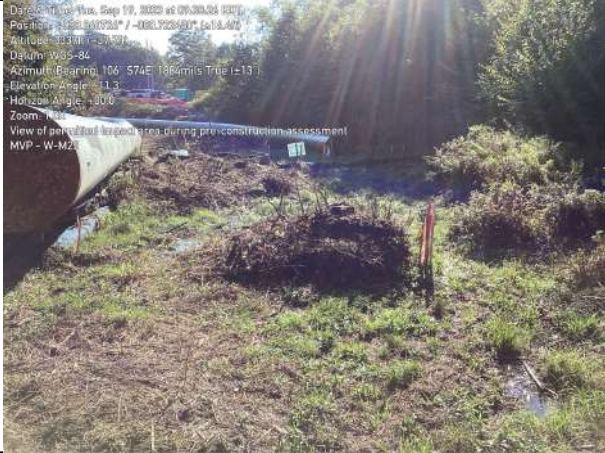
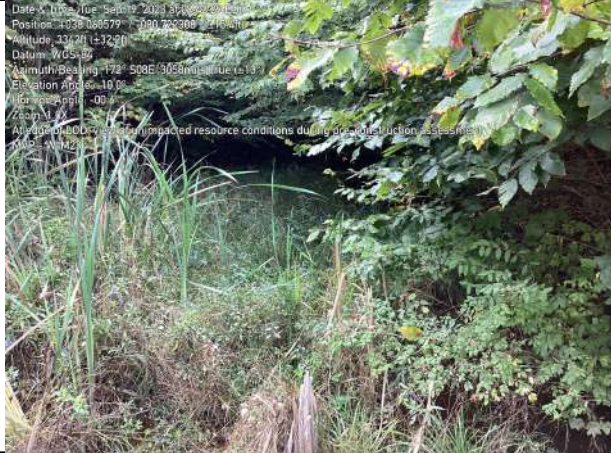
| Description | View of permitted resource impact area during pre-construction assessment. | Description | At edge of LOD, view of unimpacted resource area conditions during pre-construction assessment. | | |

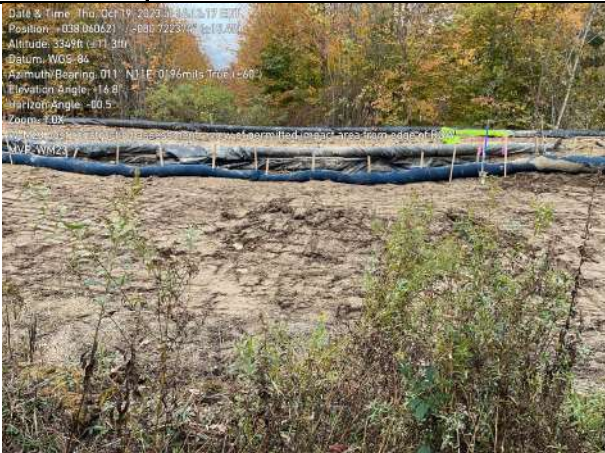
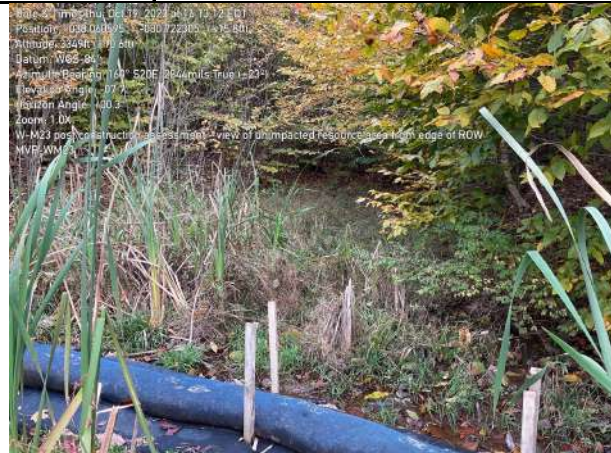
| Description | View of permitted resource impact area during post-construction assessment. | Description | At edge of LOD, view of unimpacted resource area conditions during post-construction assessment. | | |

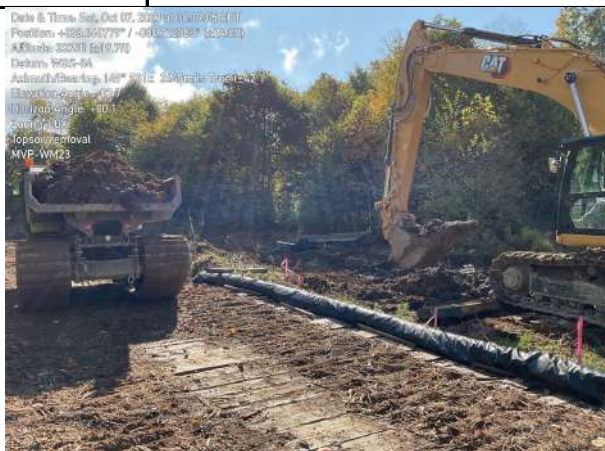
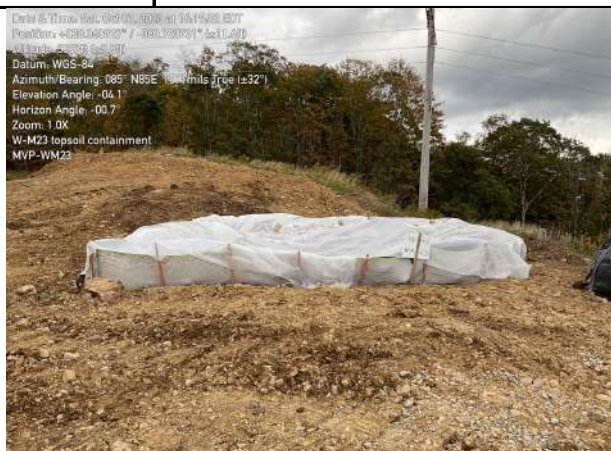
| Description | Photo 1: Wetland topsoil removal. | Description | Photo 2: Topsoil segregated and stored in an upland area. | | |

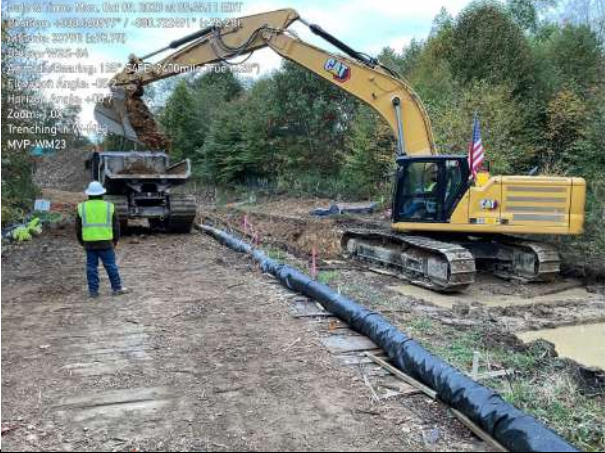
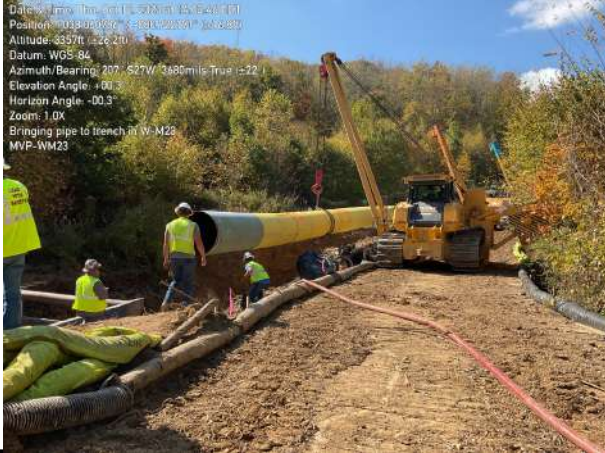
| <b>Description</b> | Photo 3: Trenching in aquatic resource. | <b>Description</b> | Photo 4: Pipe lowered into aquatic resource. | | |

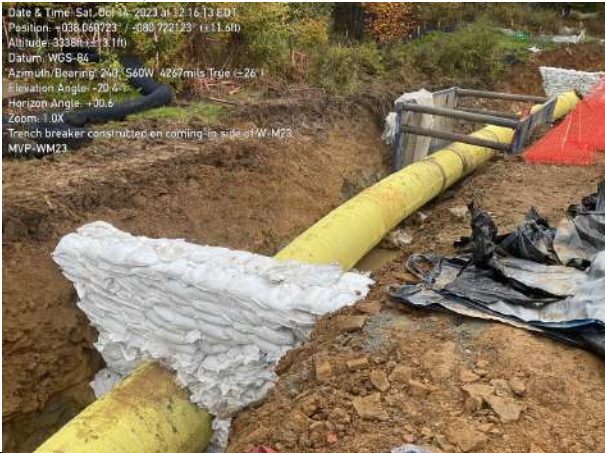
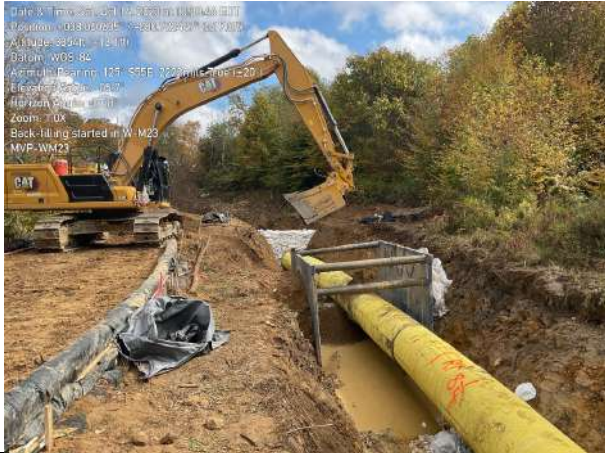
| <b>Description</b> | Photo 5: Trench breakers being installed on both sides of aquatic resource. | <b>Description</b> | Photo 6: Backfilling of aquatic resource. | | |

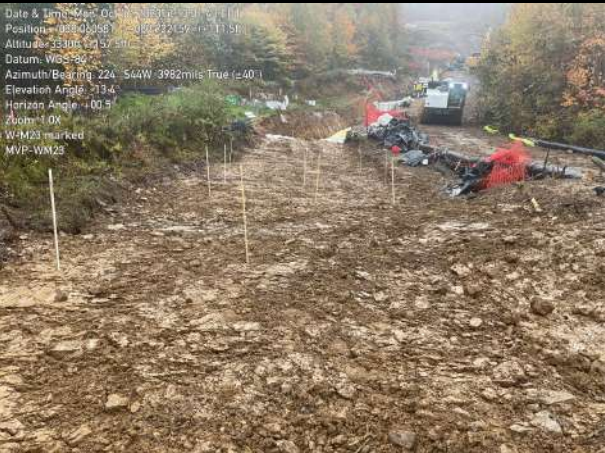
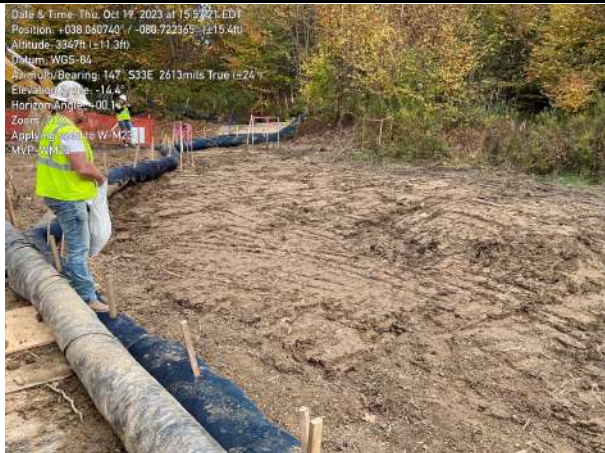
| <b>Description</b> | Photo 7: Subsoil replaced and resource marked by survey. | <b>Description</b> | Photo 8: Topsoil restored and seed applied to resource. | | |
