STREAM BIOLOGICAL CONDITIONS ENVIRONMENTAL AUDITOR REPORT

Stream ID: S-IJ16-a	Crossing Start Date: 06/12/2025	Crossing Completion Date: 06/13/2025
Milepost: 209.4	Pre-Con Assessment Date: 06/12/2025	Post-Con Assessment Date: 06/13/2025
Station: 11061+21	Stream Classification: Ephemeral (Perennial, Intermittent, Ephemeral)	Bankfull Width (ft.): 4
County: Giles	303(d) Impairment Listing: Not Impaired	Riffle:Pool Complexes Present? No

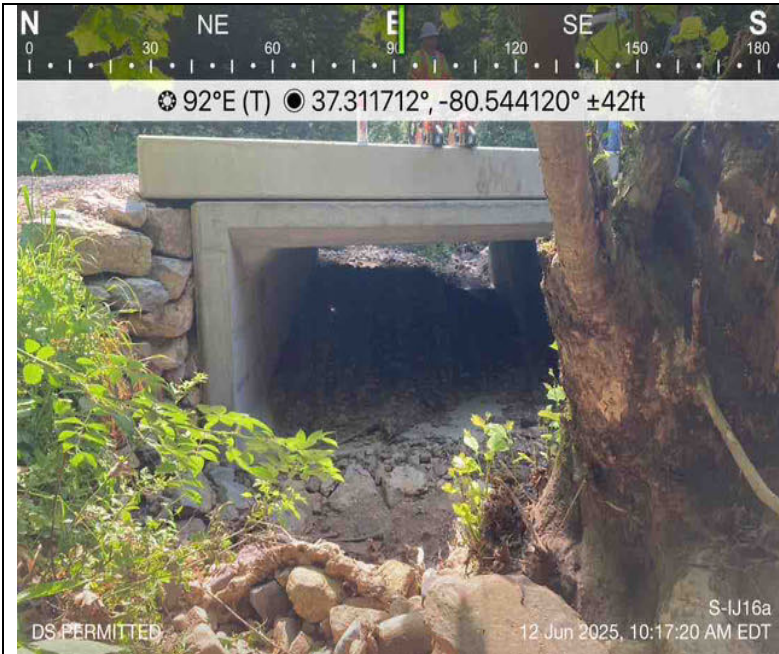
Photo Description: Downstream view of permitted impact area during pre-construction assessment.

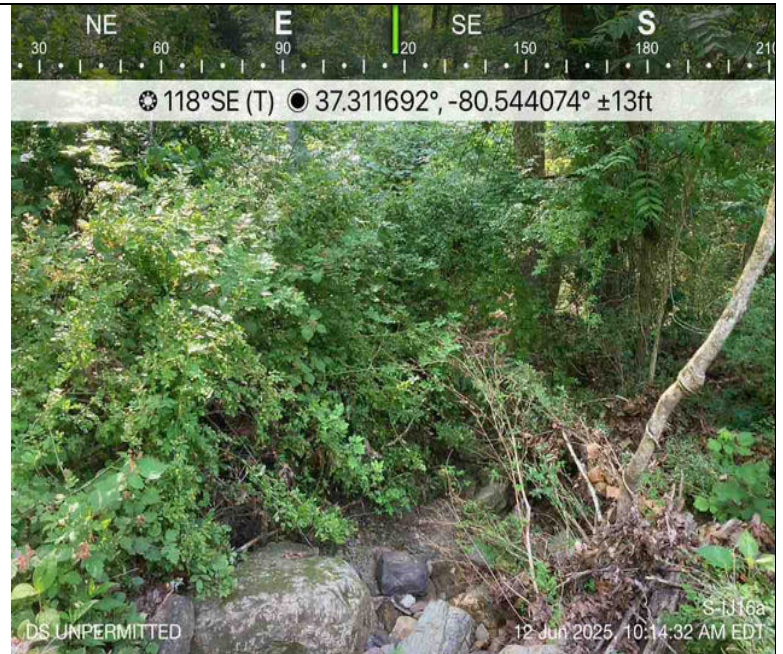
Photo Description: Conditions of the downstream area outside the ROW during pre-construction assessment.

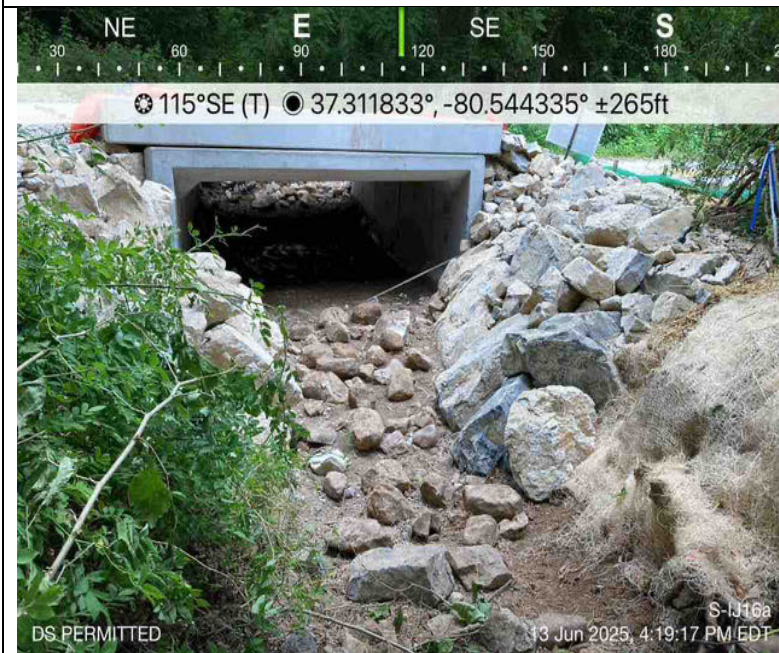
Photo Description: Downstream view of permitted impact area during post-construction assessment.

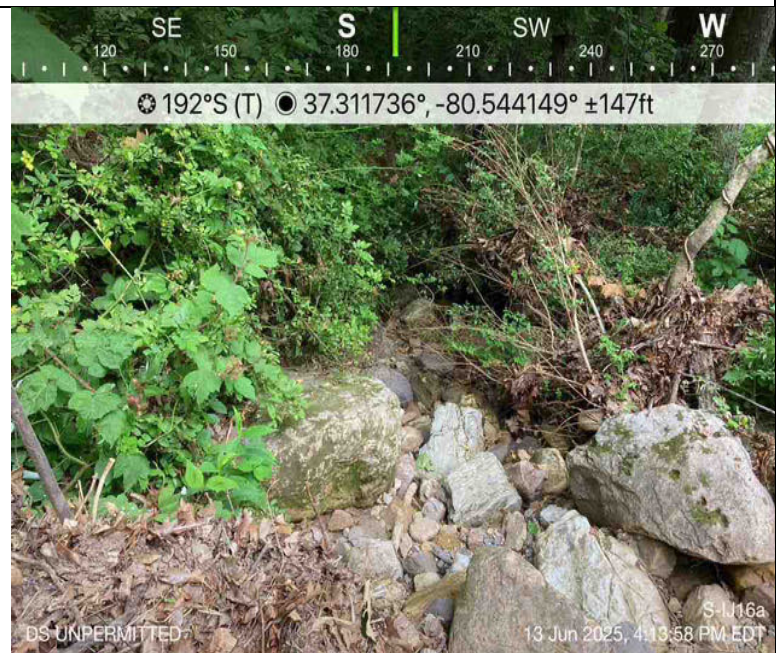
Photo Description: Conditions of the downstream area outside the ROW during post-construction assessment.

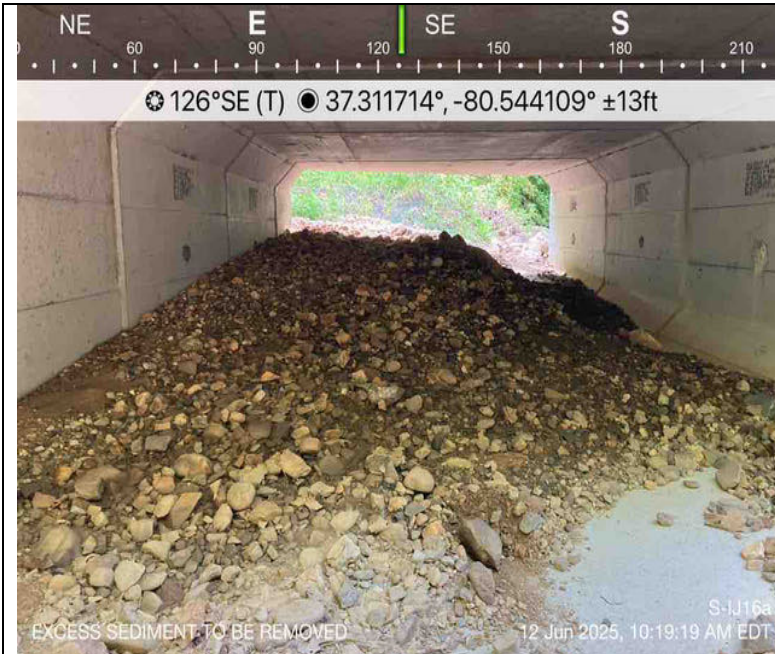
Photo Description: Culvert full of excess substrate inhibiting flow.

06/13/2025: Substrate build up within the culvert and on the downstream portion of the left bank of the stream was manually removed and dispersed evenly throughout the stream with excess sediment hauled off. The dam and pump were removed and no impacts to the biological conditions or unauthorized discharges were observed during the work activity. -K. Ball

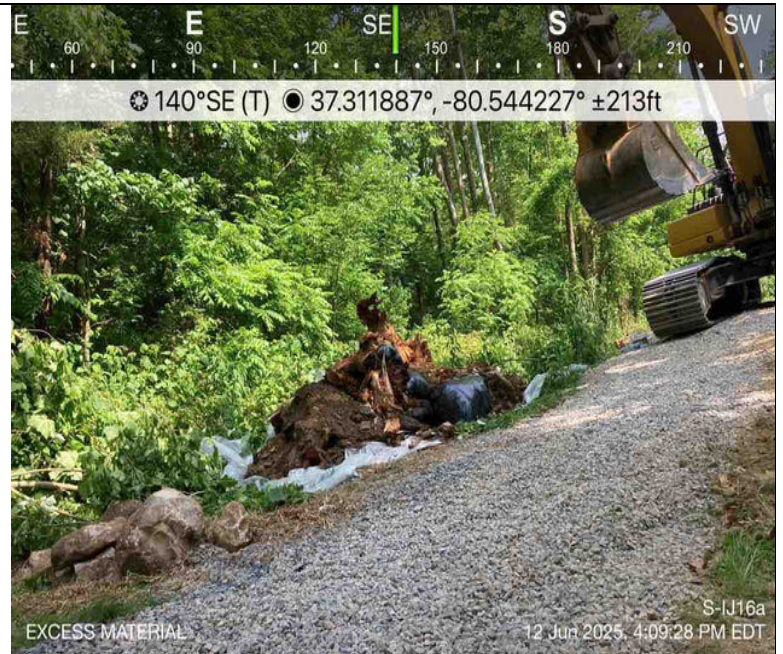
Item #8: Marked yes due to large stump removal.

Photo Description: Stump and root system removed from bank.

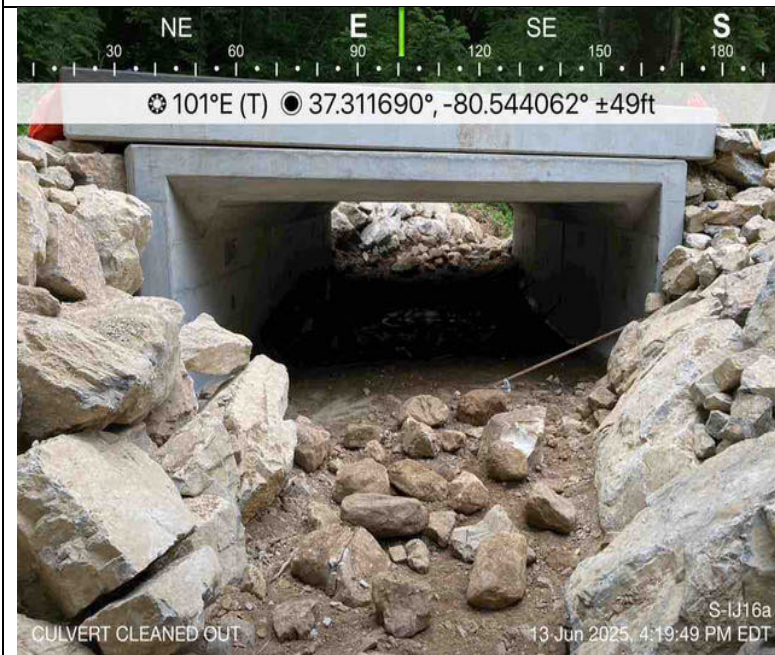
Photo Description: Culvert cleaned out of excess substrate.

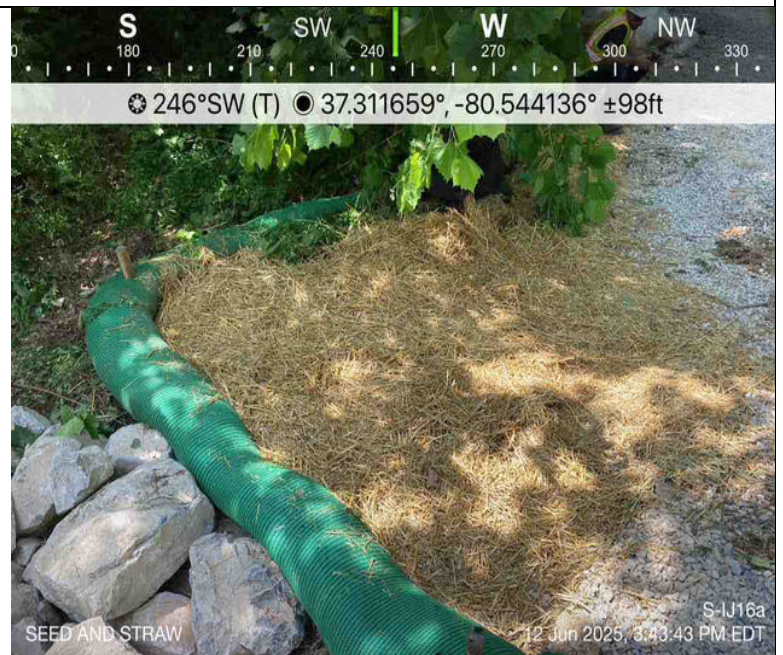
Photo Description: Stabilization applied to disturbed areas.
