# STREAM BIOLOGICAL CONDITIONS ENVIRONMENTAL AUDITOR REPORT

<b>Stream ID:</b> S-B6	<b>Crossing Start Date:</b> 04/15/2025	<b>Crossing Completion Date:</b> 04/15/2025
<b>Milepost:</b> 297.2	<b>Pre-Con Assessment Date:</b> 04/15/2025	<b>Post-Con Assessment Date:</b> 04/15/2025
<b>Station:</b> 15700+40	<b>Stream Classification:</b> Ephemeral (Perennial, Intermittent, Ephemeral)	<b>Bankfull Width (ft.):</b> 10
<b>County:</b> Pittsylvania	<b>303(d) Impairment Listing:</b> Not Impaired	<b>Riffle:Pool Complexes Present?</b> No

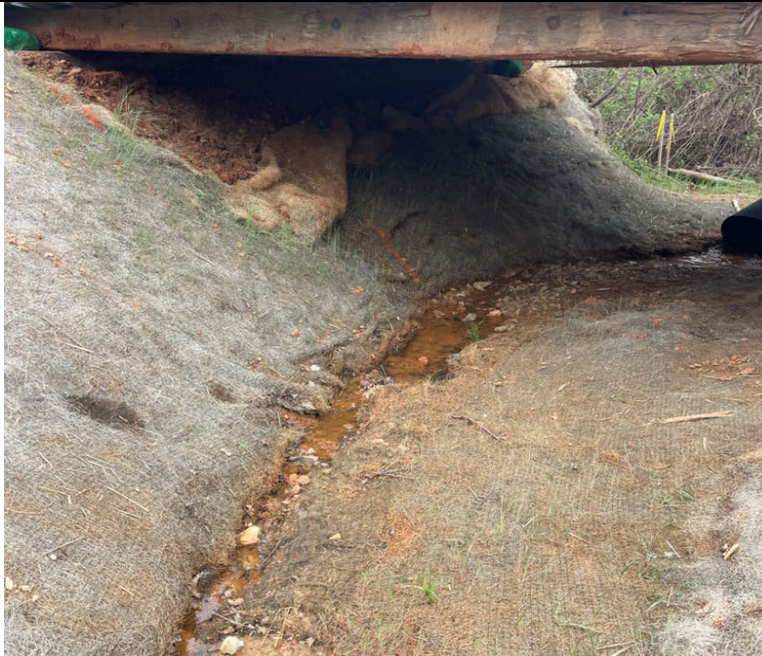
**Photo Description:** Downstream view of permitted impact area during pre-construction assessment. No GPS data available.

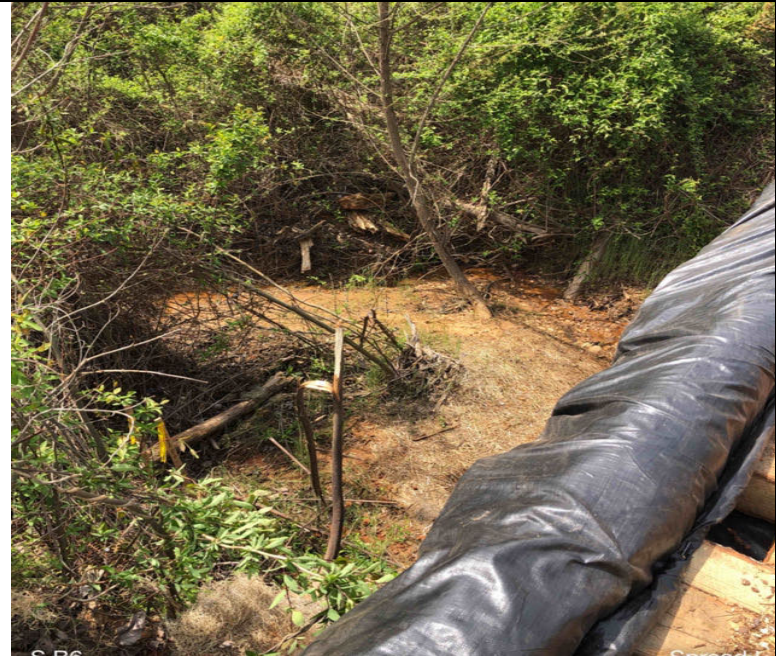
**Photo Description:** Conditions of the downstream area outside the ROW during pre-construction assessment. No GPS data available.

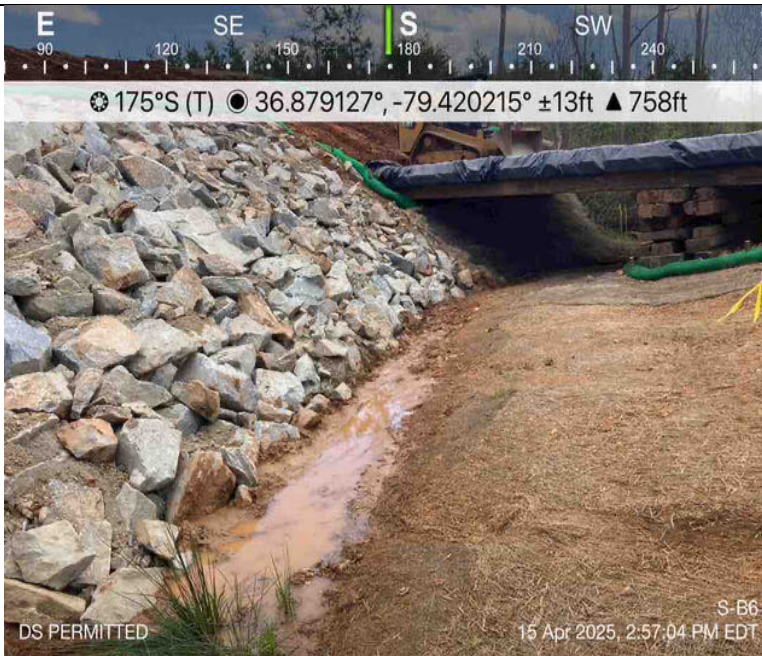
**Photo Description:** Downstream view of permitted impact area during post-construction assessment.

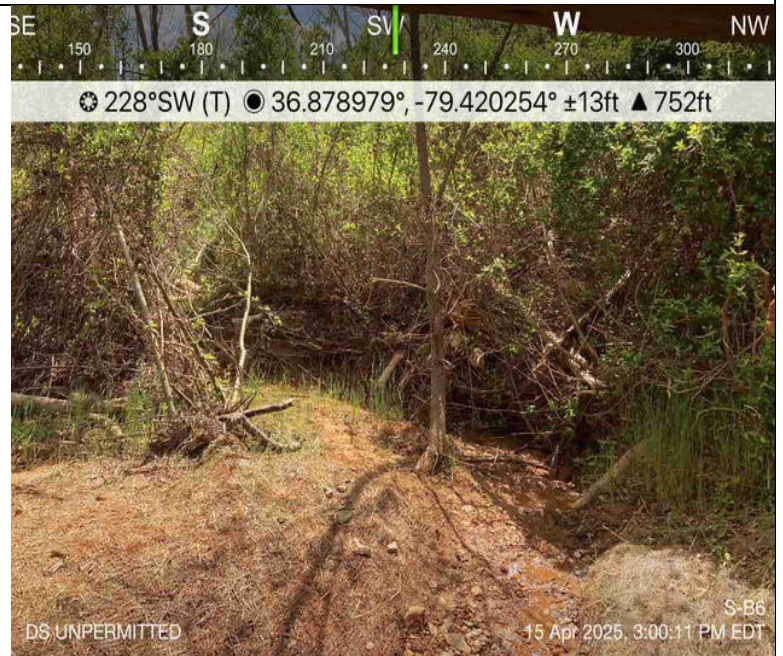
**Photo Description:** Conditions of the downstream area outside the ROW during post-construction assessment.

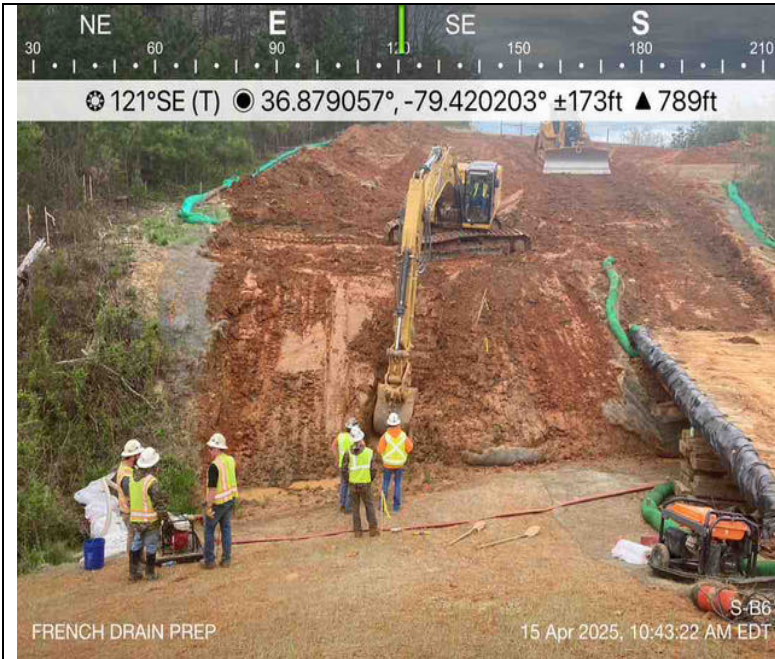
**Photo Description:** Laying back banks for French drain and rock armoring.

Item #8: This bank restoration included placing riprap on a failed stream bank in order to armor and protect the slope against future erosion, as well as, installing a French drain in the upland area to address drainage issues.

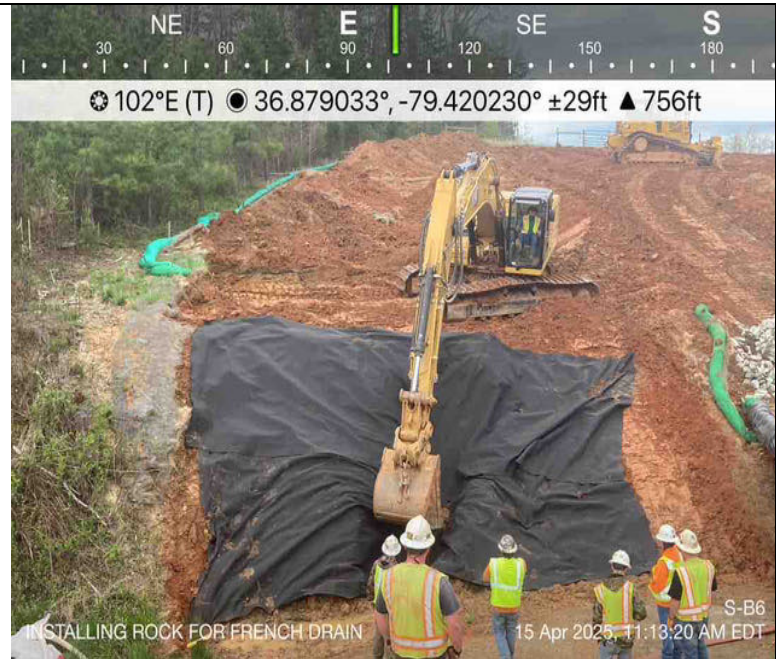
**Photo Description:** Installing geotech for French drain and rock armoring.

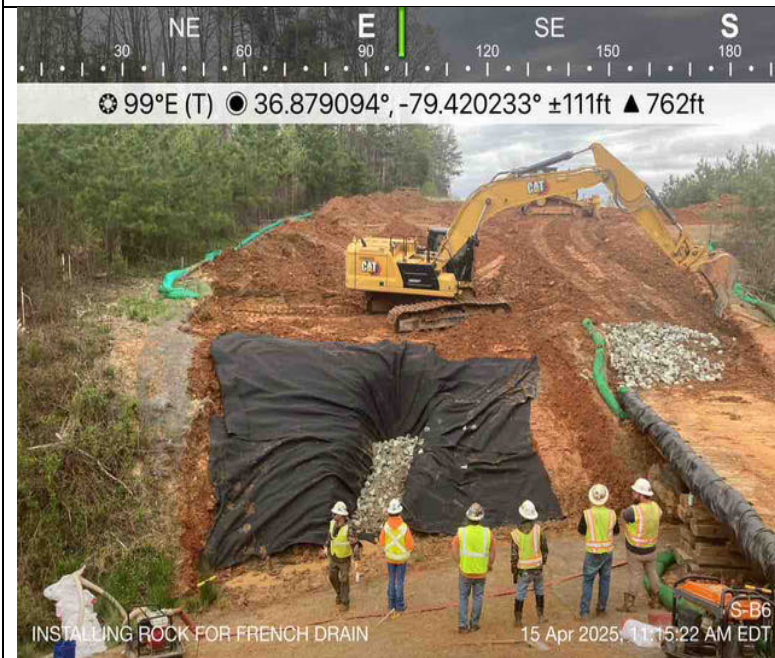
**Photo Description:** Rock installed for French drain.

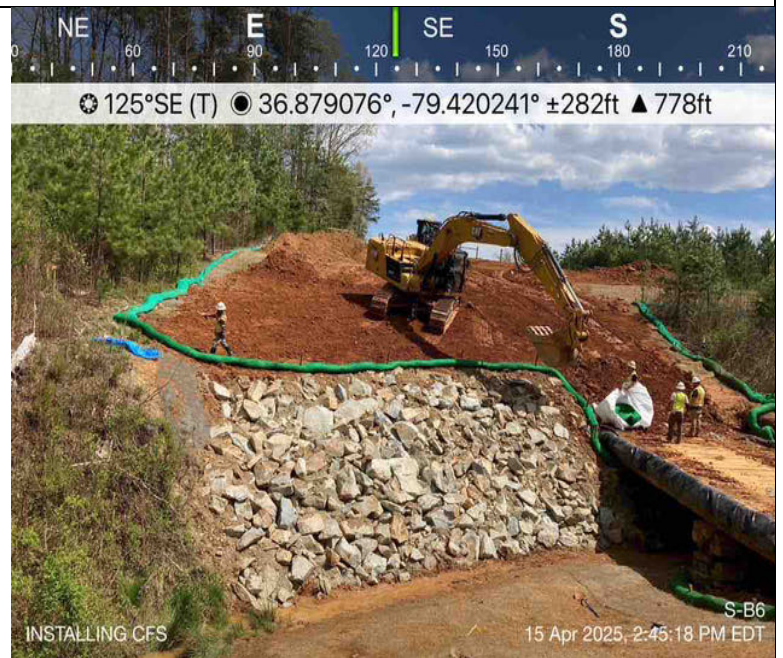
**Photo Description:** VDOT #2 installed over French drain for bank stabilization.
