# STREAM BIOLOGICAL CONDITIONS ENVIRONMENTAL AUDITOR REPORT

<b>Stream ID:</b> S-MM13	<b>Crossing Start Date:</b> 10/23/2024	<b>Crossing Completion Date:</b> 11/01/2024
<b>Milepost:</b> 229	<b>Pre-Con Assessment Date:</b> 10/21/2024	<b>Post-Con Assessment Date:</b> 11/01/2024
<b>Station:</b> 12098+44	<b>Stream Classification:</b> Ephemeral (Perennial, Intermittent, Ephemeral)	<b>Bankfull Width (ft.):</b> 5
<b>County:</b> Montgomery	<b>303(d) Impairment Listing:</b> Not Impaired	<b>Riffle:Pool Complexes Present?</b> No

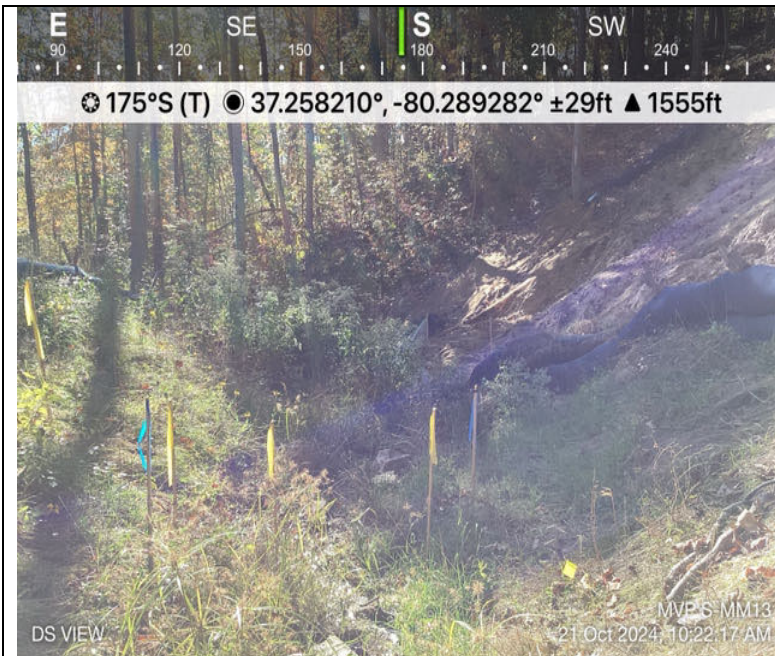
**Photo Description:** Downstream view of permitted impact area during pre-construction assessment.

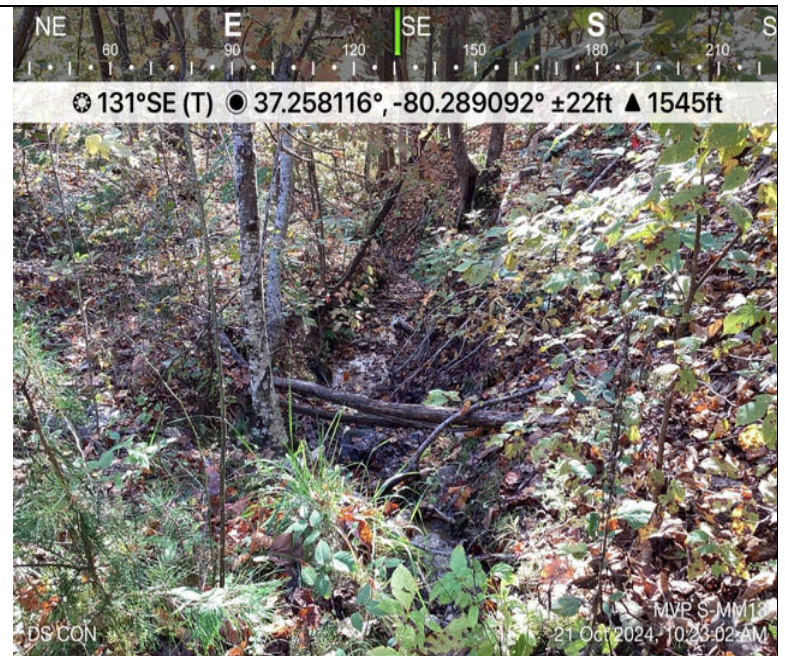
**Photo Description:** Conditions of the downstream area outside the ROW during pre-construction assessment.

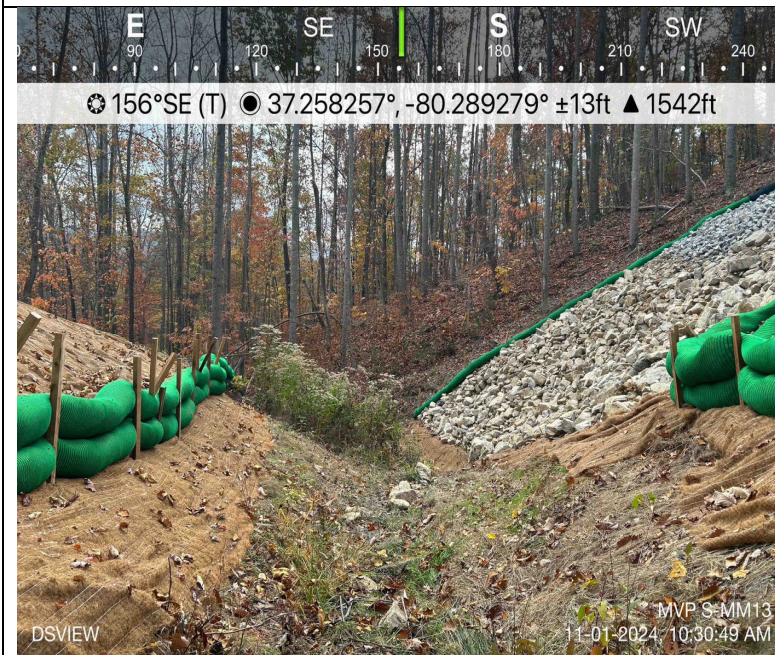
**Photo Description:** Downstream view of permitted impact area during post-construction assessment.

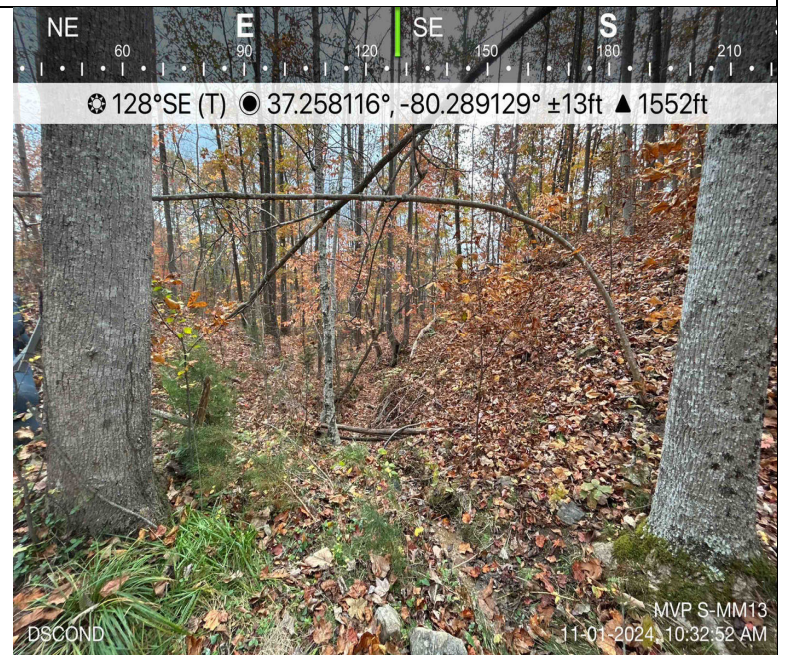
**Photo Description:** Conditions of the downstream area outside the ROW during post-construction assessment.

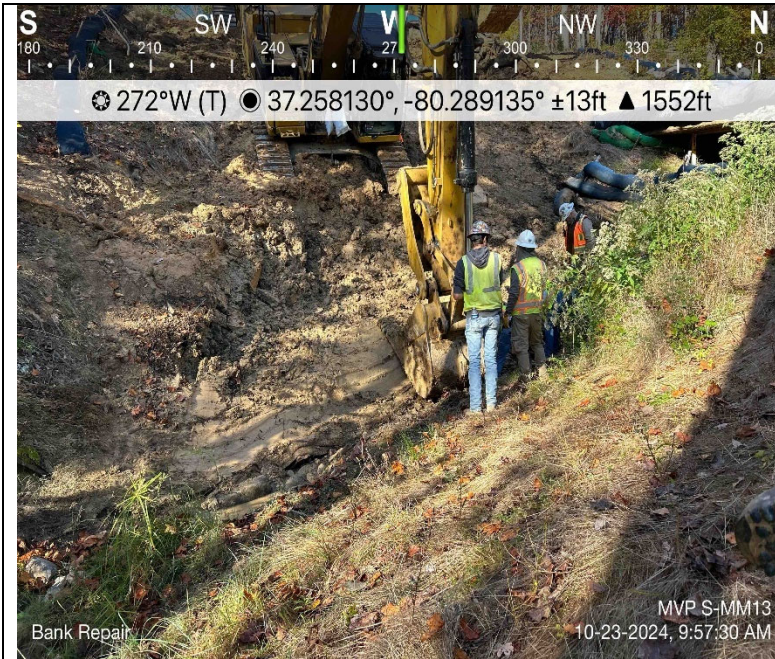
10/23/2024: Before beginning the bank repair it was established that work would have to be done within the OHWM. The crew established a dam and pump to ensure no material ended up moving off site. Once the dam and pump was established the crew removed the upland material from the bank and the stream substrate was re-established. After completing the repairs within the OHWM, the dam and pump was removed and flow was restored. SSF was placed just above the OHWM to ensure that any loose material from upslope work did not make its way into the resource. -N. Fillip

**Photo Description:** Bank repair underway within resource.

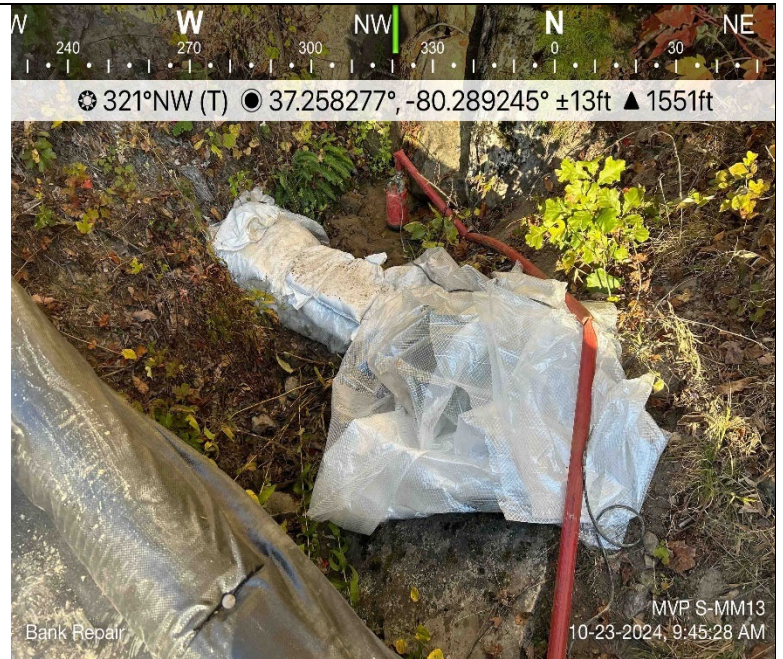
**Photo Description:** Upstream dam installed for bank repair

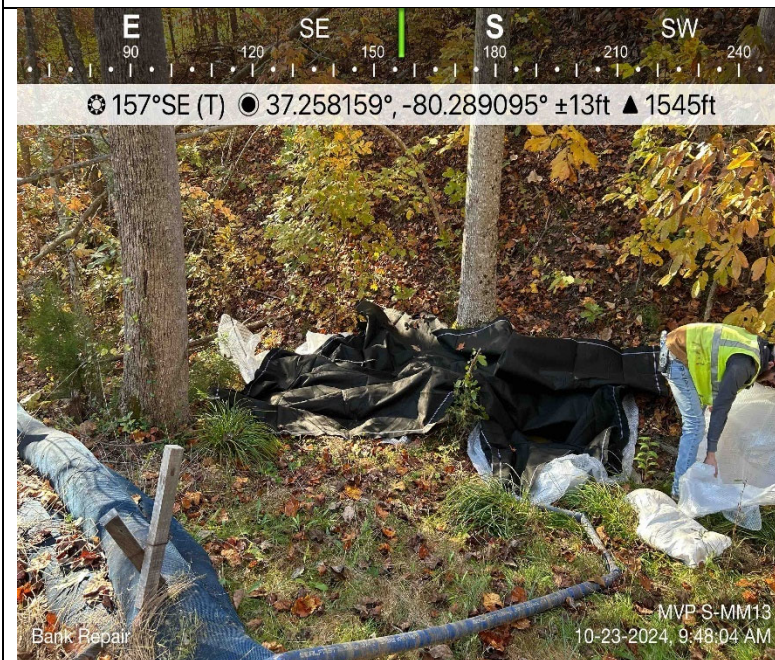
**Photo Description:** Downstream dam installed for bank repair.

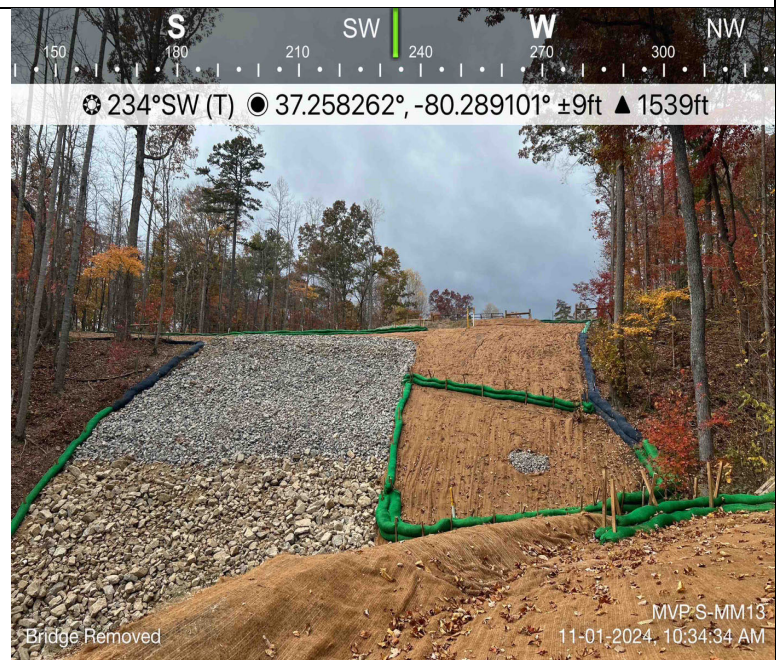
**Photo Description:** Overview of repaired slope.

Item #8: Bank modification with riprap was installed along the repaired bank to ensure long-term stability of the resource.
