WETLAND BIOLOGICAL CONDITIONS ENVIRONMENTAL AUDITOR REPORT

Wetland ID: W-Q2	Crossing Start Date: 01/26/2024	Crossing Completion Date: 03/08/2024
Milepost: 296.2	Pre-Con Assessment Date: 11/08/2023	Post-Con Assessment Date: 03/08/2024
Station: 15667+95	Cowardin Classification: PFO (PEM, PFO, PSS, POW)	Wetland Impact Area (sq ft.): 16422.12
County: Pittsylvania

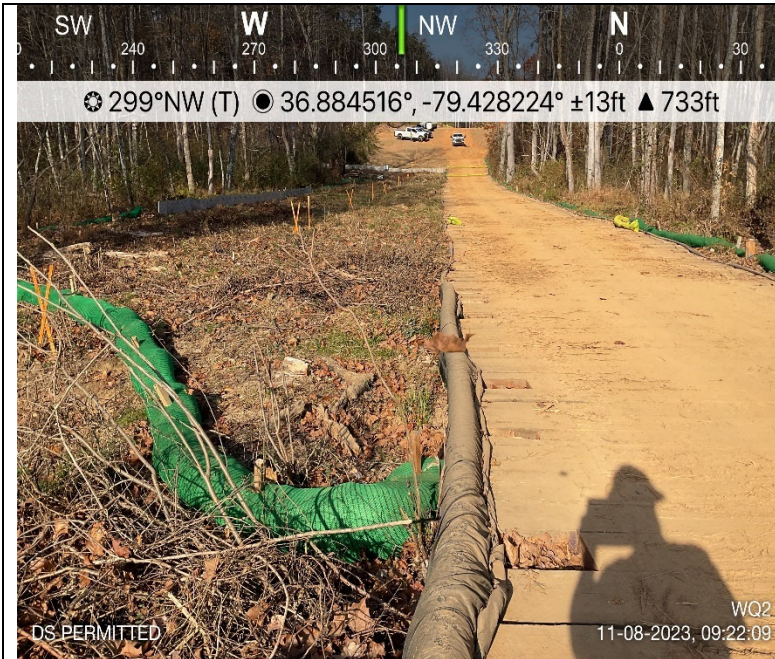
Photo Description: View of permitted resource impact area during pre-construction assessment.

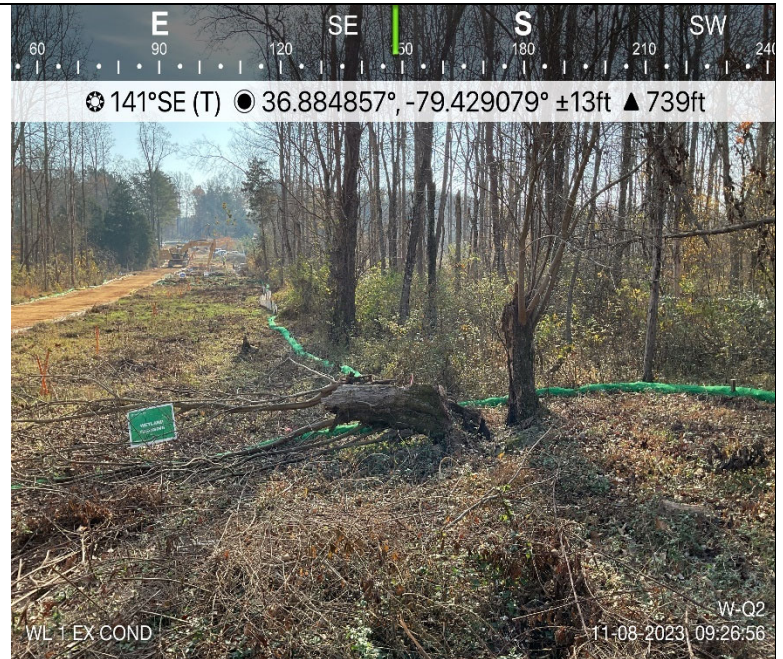
Photo Description: At edge of LOD, view of unpermitted resource area conditions during pre-construction assessment.

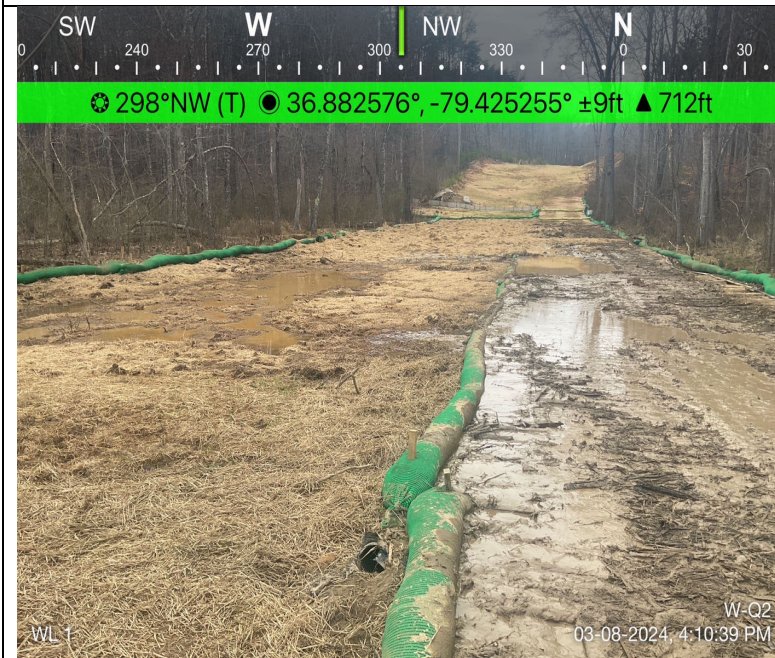
Photo Description: View of permitted resource impact area during post-construction assessment.

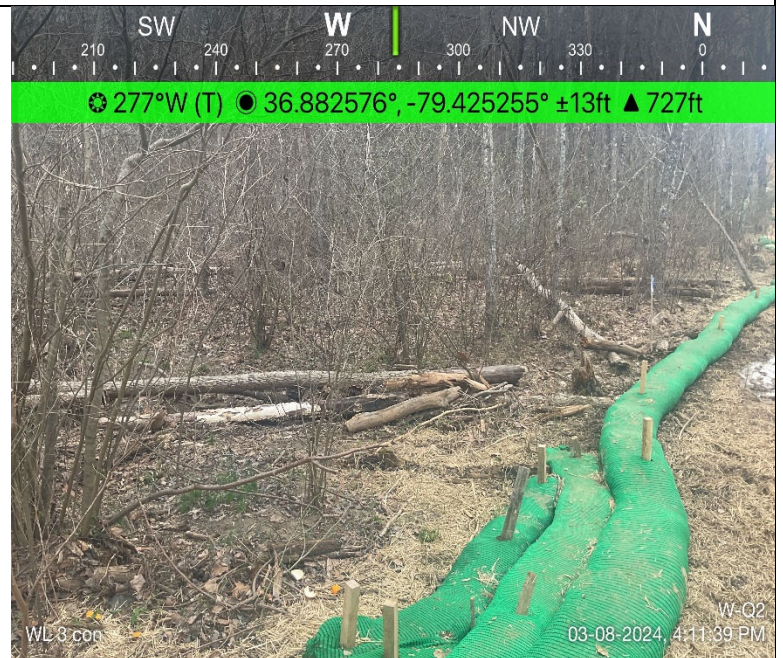
Photo Description: At edge of LOD, view of unpermitted resource area conditions during post-construction assessment.

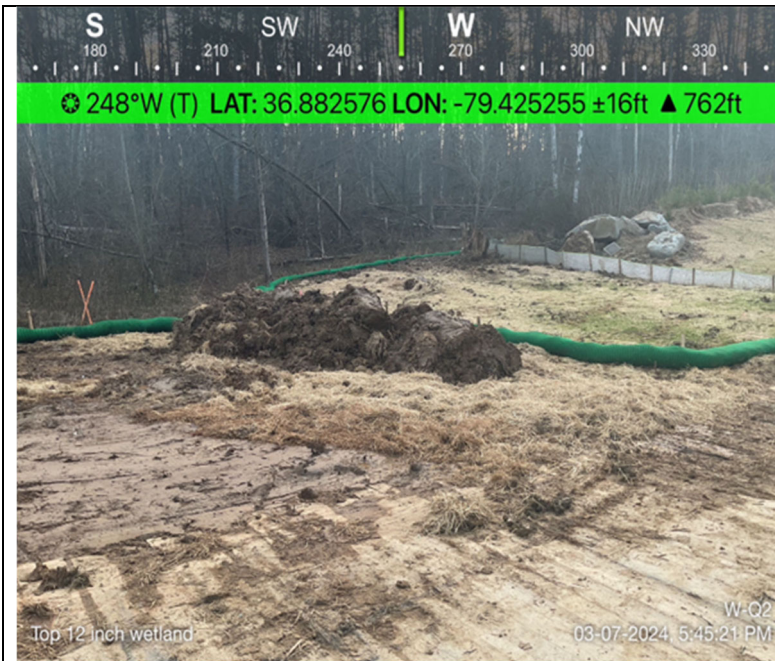
Photo Description: The topsoil was segregated and stockpiled on a bed of straw for separation.

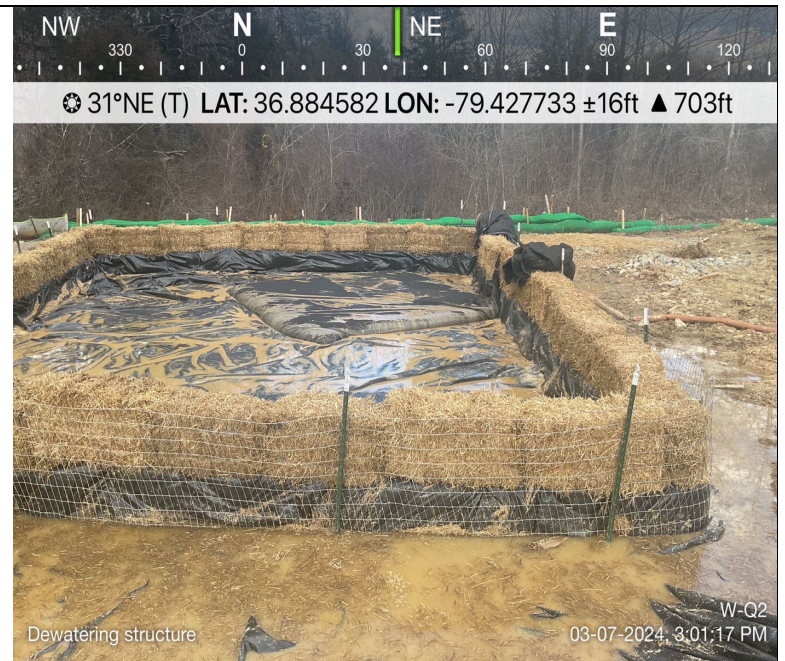
Photo Description: A dewatering structure was constructed and functioning as designed.

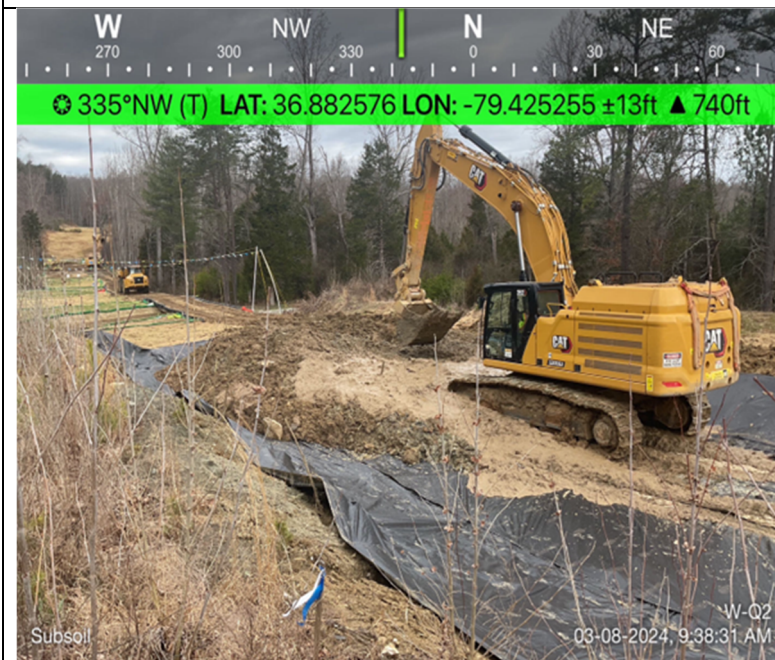
Photo Description: The subsoil was removed stockpiled properly on fabric, and backfilled to the wetland in the proper sequence during pipe integrity investigation.

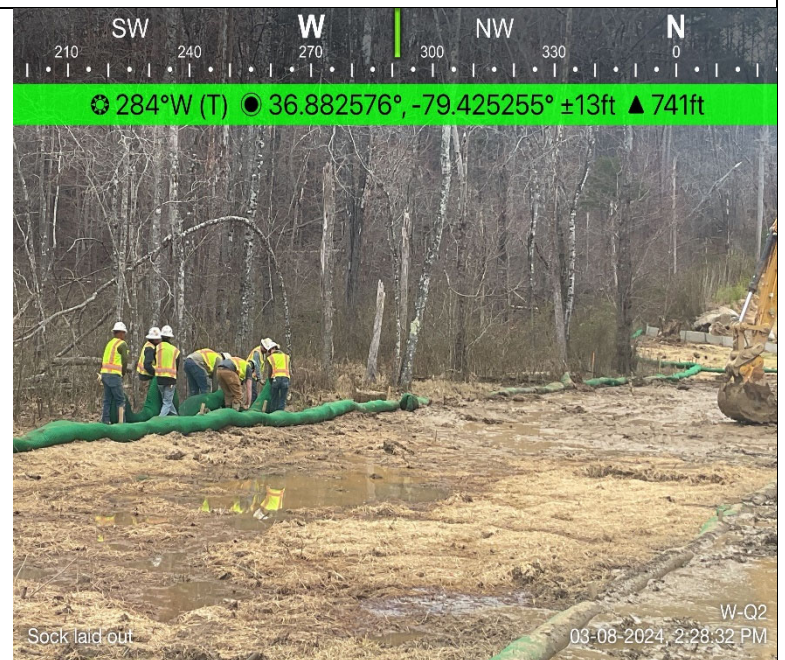
Photo Description: Filter sock was replaced along the wetland's boundaries.
