WETLAND BIOLOGICAL CONDITIONS ENVIRONMENTAL AUDITOR REPORT

Wetland ID: W-Z11	Crossing Start Date: 02/03/2024	Crossing Completion Date: 02/06/2024
Milepost: 203.1	Pre-Con Assessment Date: 02/01/2024	Post-Con Assessment Date: 02/06/2024
Station: 10733+00	Cowardin Classification: PEM (PEM, PFO, PSS, POW)	Wetland Impact Area (sq ft.): 1141.27
County: Giles

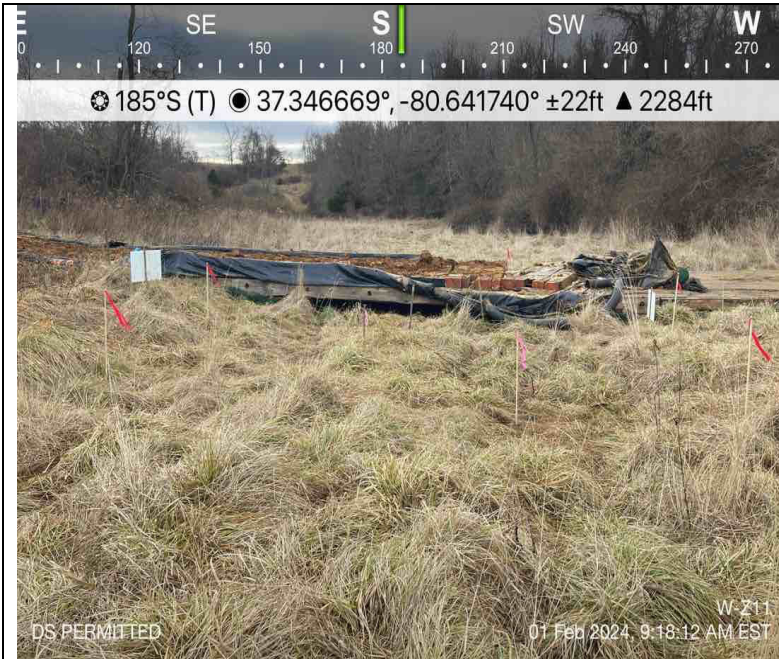
Photo Description: View of permitted resource impact area during pre-construction assessment.

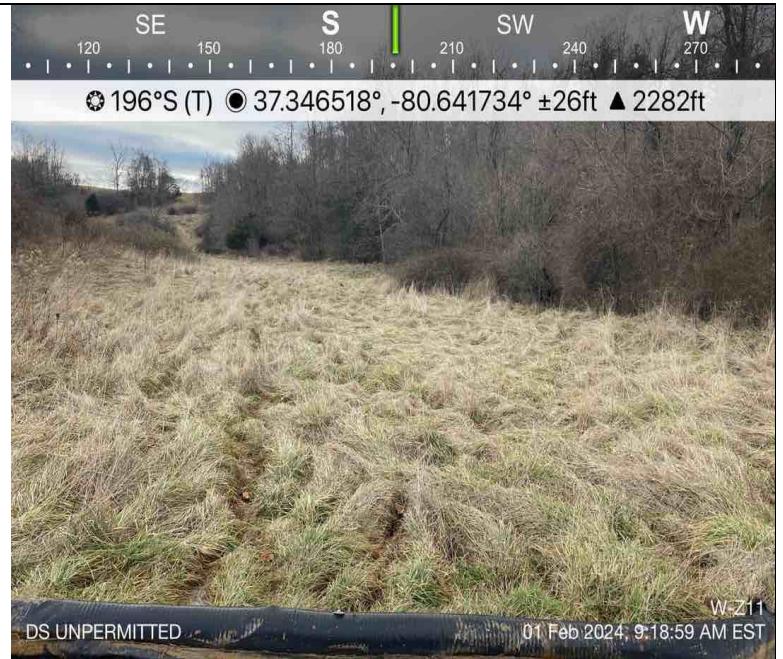
Photo Description: At edge of LOD, view of unpermitted resource area conditions during pre-construction assessment.

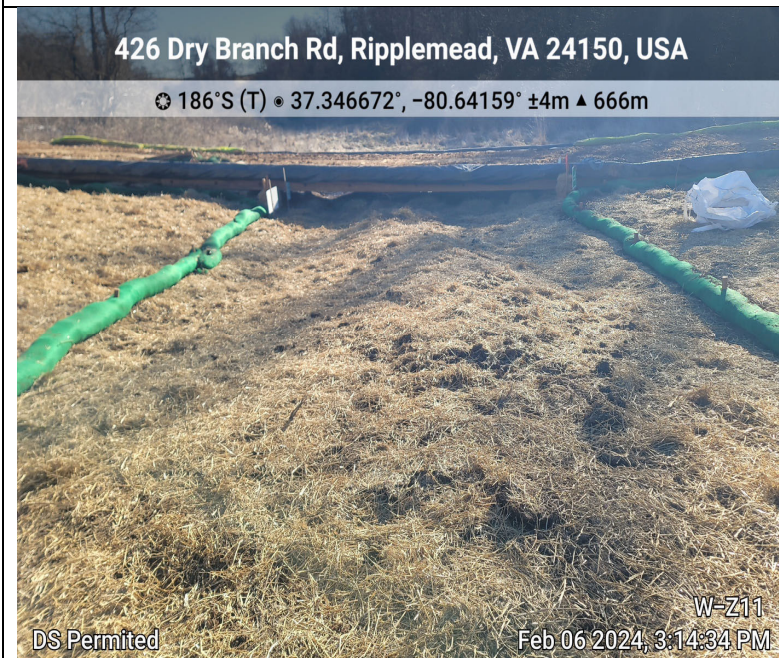
Photo Description: View of permitted resource impact area during post-construction assessment.

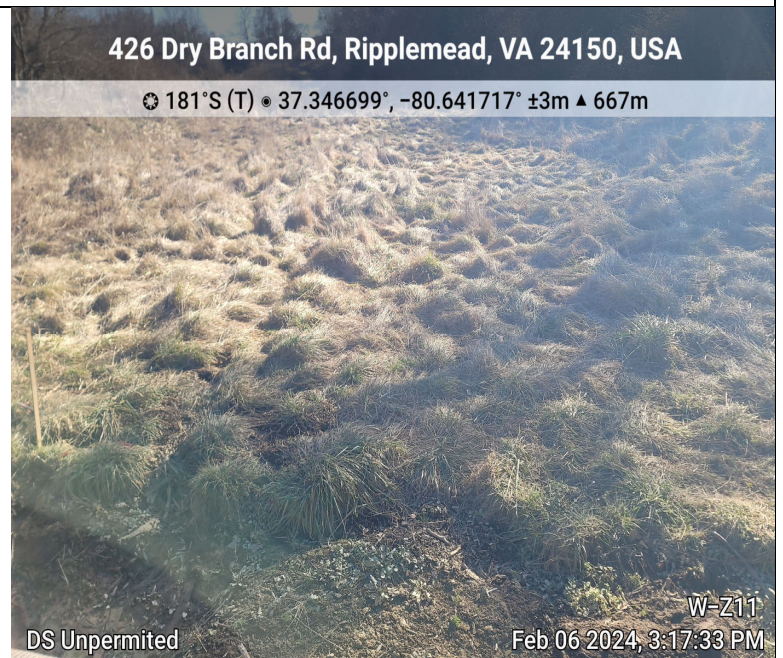
Photo Description: At edge of LOD, view of unpermitted resource area conditions during post-construction assessment.

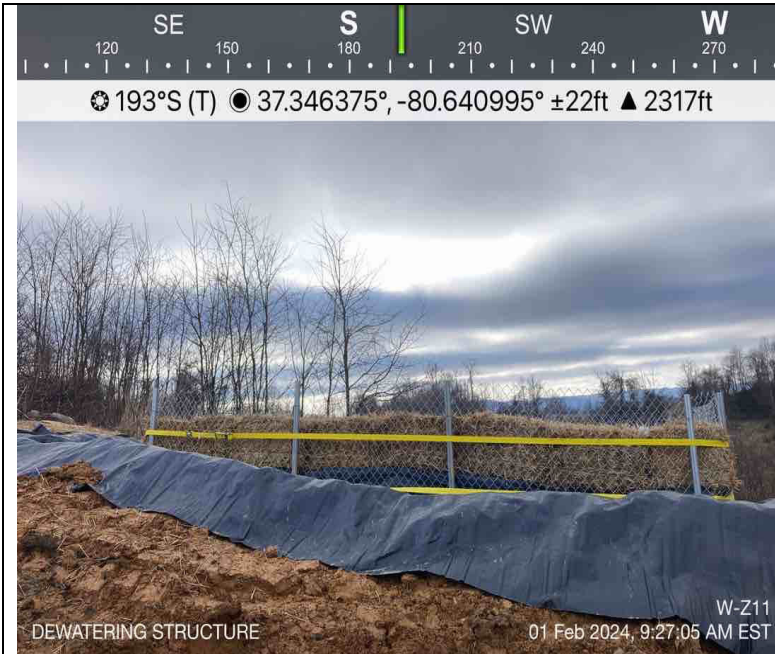
Photo Description: Dewatering structure installed for resource crossing.

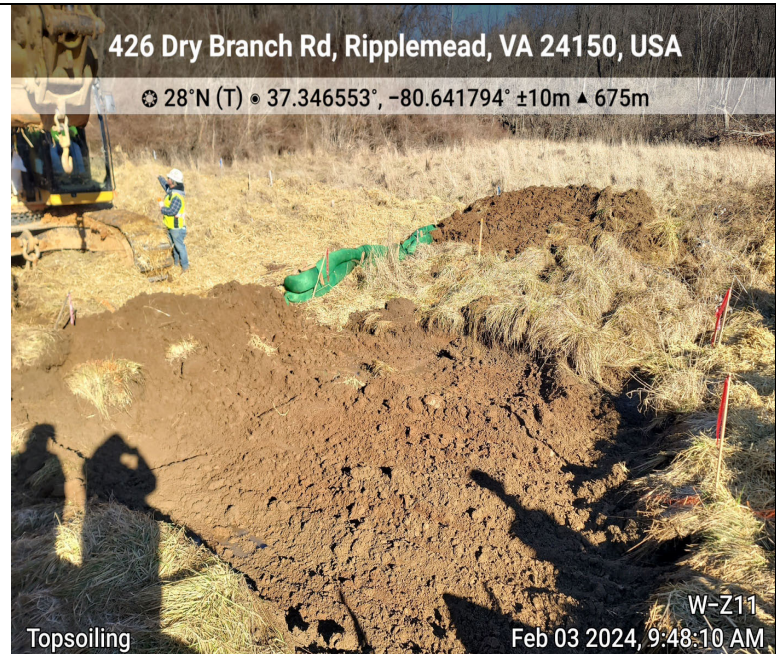
Photo Description: Topsoil removal and stockpiled separately from other soils.

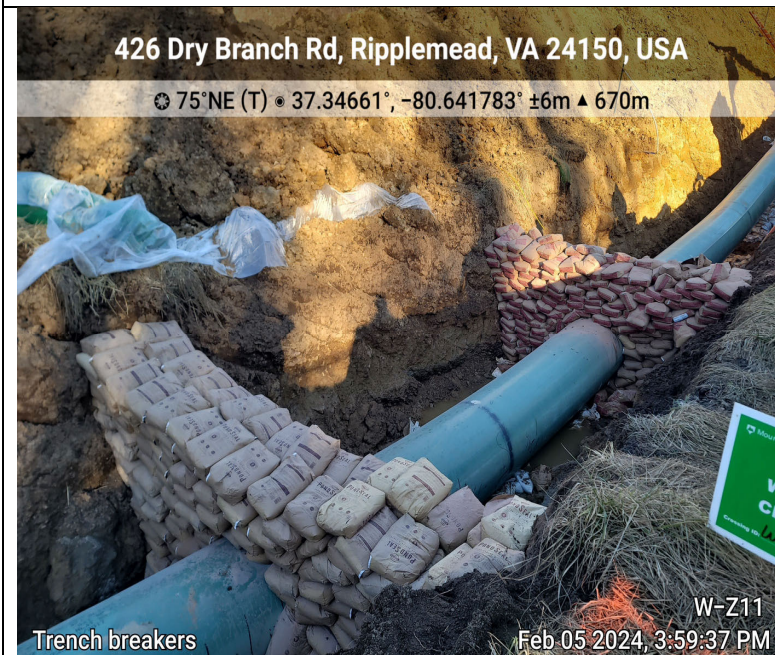
Photo Description: Trench breakers installed on both sides of resource.

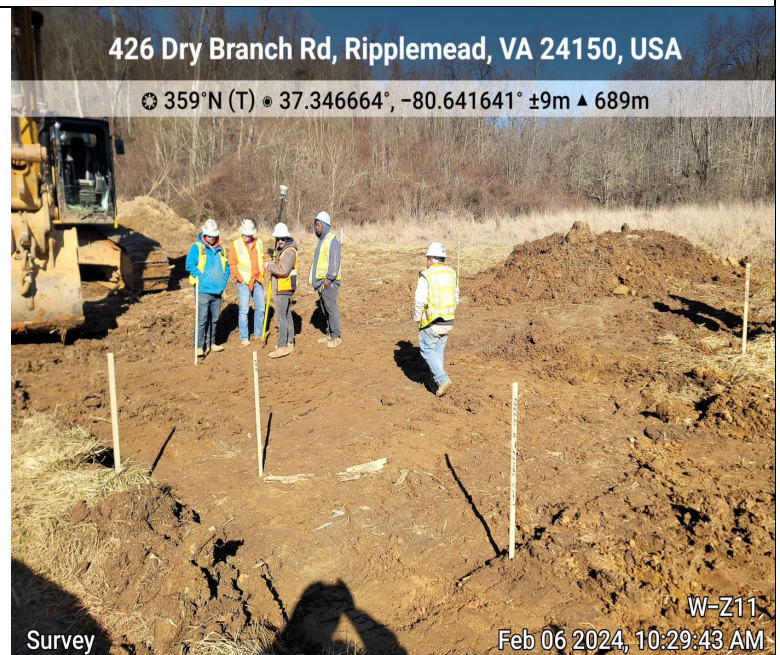
Photo Description: Survey team on site to assist with final contouring of resource.
