STREAM BIOLOGICAL CONDITIONS ENVIRONMENTAL AUDITOR REPORT

Stream ID: S-D14	Crossing Start Date: 01/11/2024	Crossing Completion Date: 01/20/2024
Milepost: 248.6	Pre-Con Assessment Date: 12/29/2023	Post-Con Assessment Date: 01/20/2024
Station: 13138+50	Stream Classification: Intermittent (Perennial, Intermittent, Ephemeral)	Bankfull Width (ft.): 7
County: Franklin	303(d) Impairment Listing: Not Impaired	Riffle:Pool Complexes Present? No

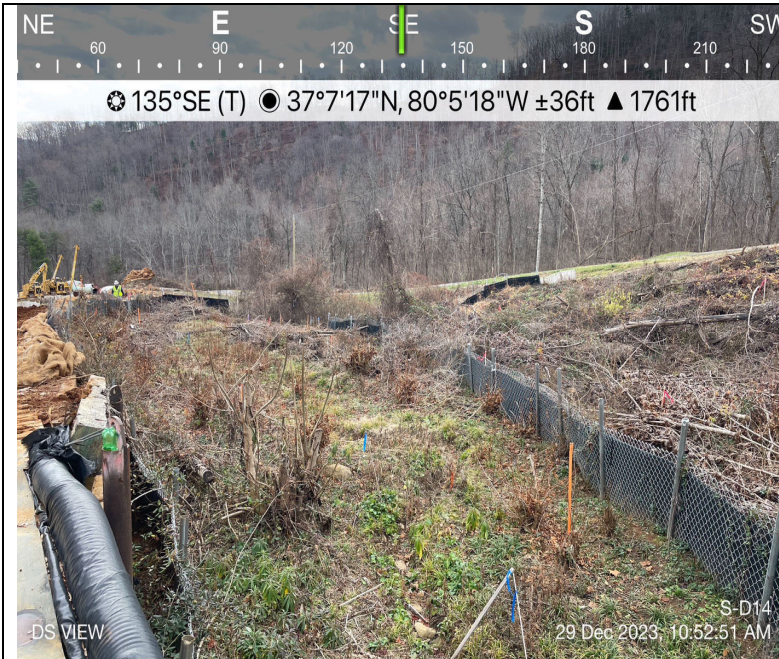
Photo Description: Downstream view of permitted impact area during pre-construction assessment.

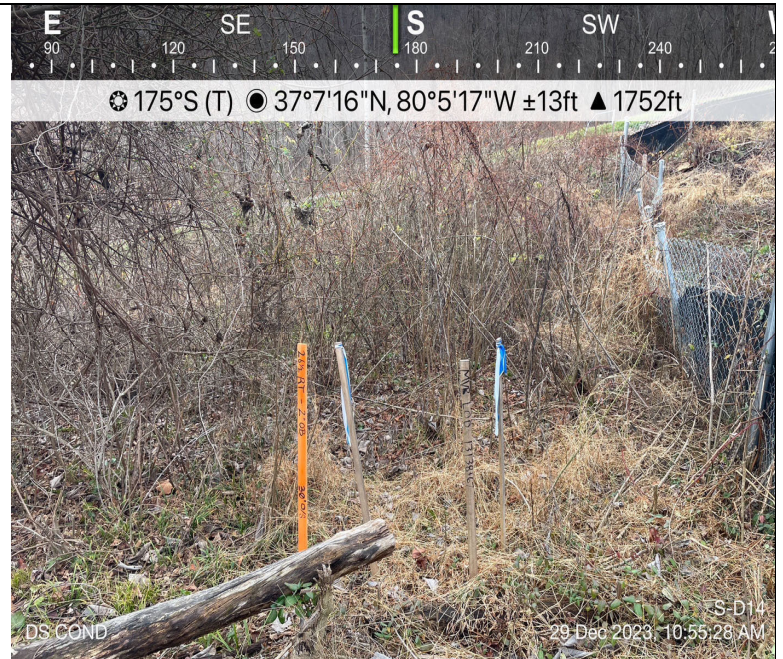
Photo Description: Conditions of the downstream area outside the ROW during pre-construction assessment.

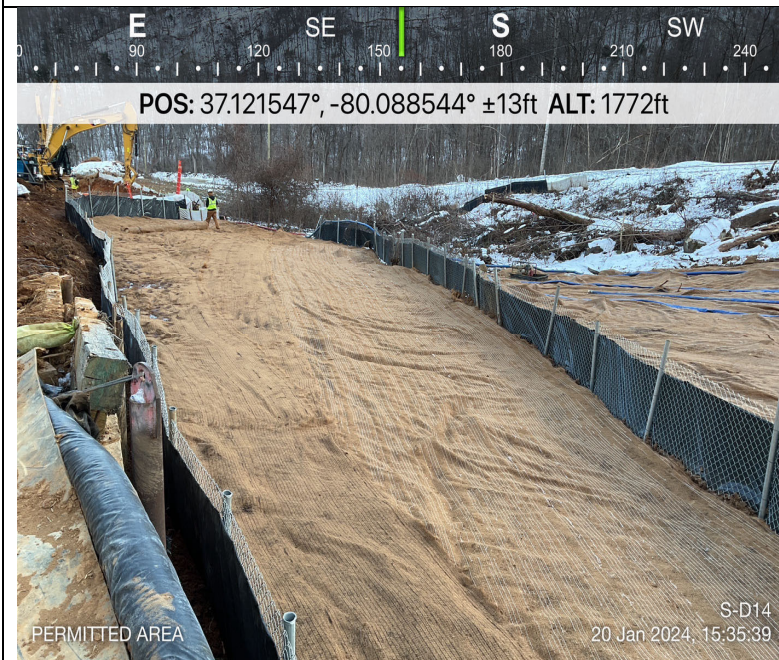
Photo Description: Downstream view of permitted impact area during post-construction assessment.

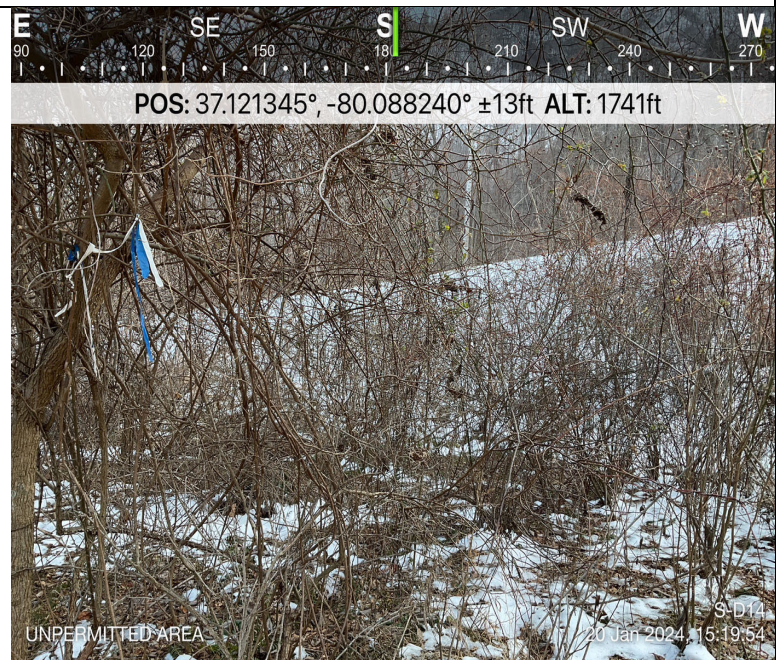
Photo Description: Conditions of the downstream area outside the ROW during post-construction assessment.

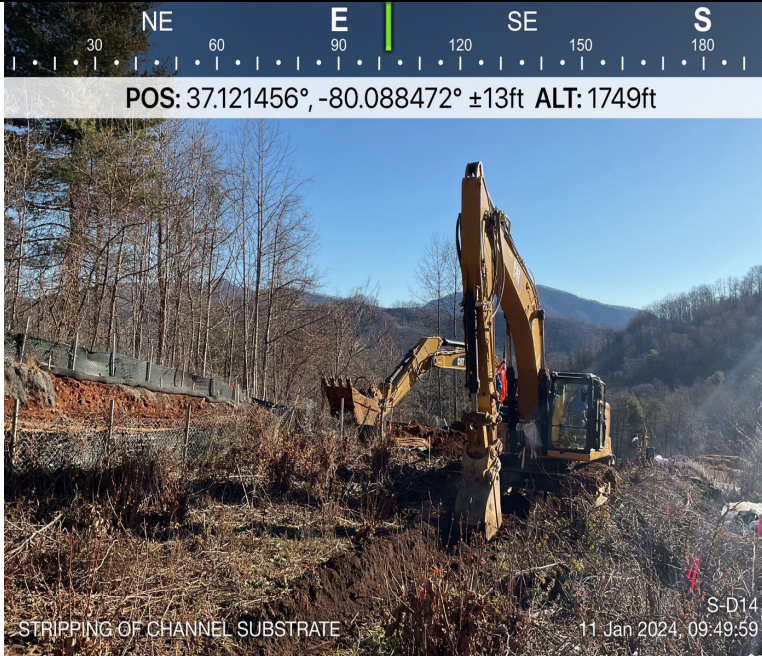
Photo Description: The channel substrate was stripped from the site.

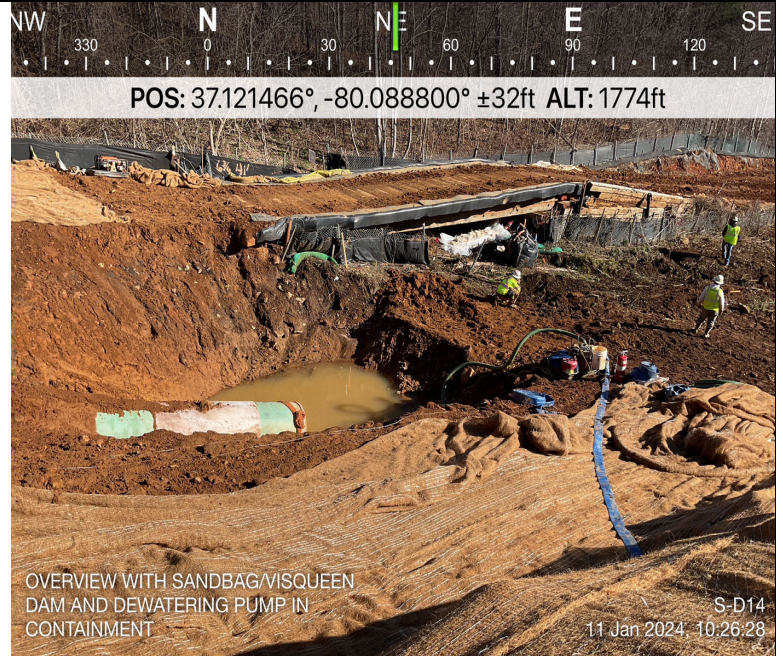
Photo Description: An overview of the sandbag and Visqueen dam.

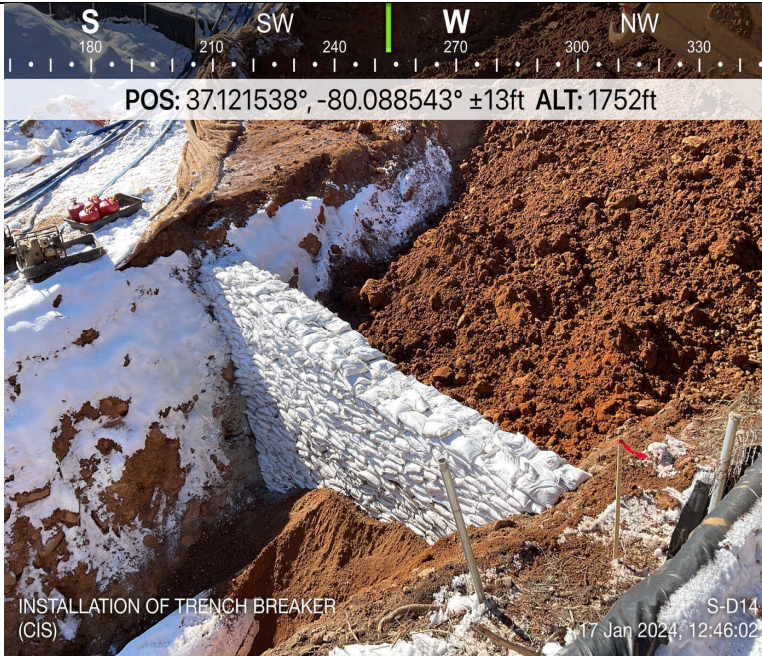
Photo Description: Installation of the impervious bentonite trench breaker (CIS).

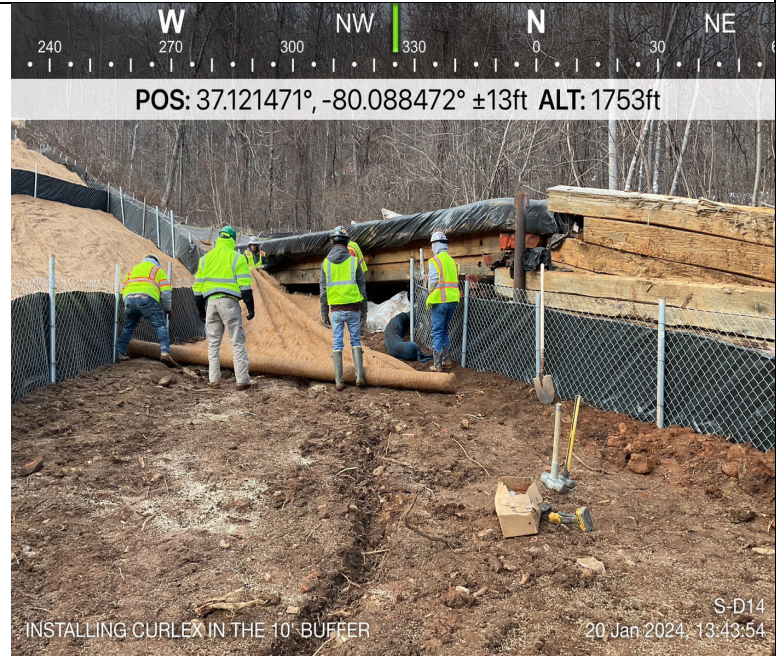
Photo Description: Curlex matting was installed within the 10-foot buffer zone.
