STREAM BIOLOGICAL CONDITIONS ENVIRONMENTAL AUDITOR REPORT

Stream ID: S-D11	Crossing Start Date: 01/15/2024	Crossing Completion Date: 01/19/2024
Milepost: 249	Pre-Con Assessment Date: 12/29/2024	Post-Con Assessment Date: 01/19/2024
Station: 13157+22	Stream Classification: Perennial (Perennial, Intermittent, Ephemeral)	Bankfull Width (ft.): 10
County: Franklin	303(d) Impairment Listing: Not Impaired	Riffle:Pool Complexes Present? No

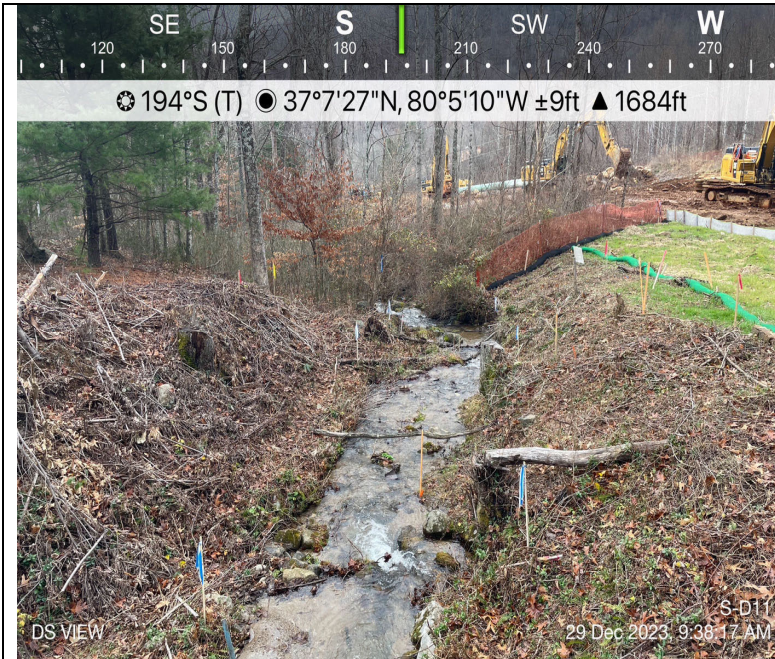
Photo Description: Downstream view of permitted impact area during pre-construction assessment.

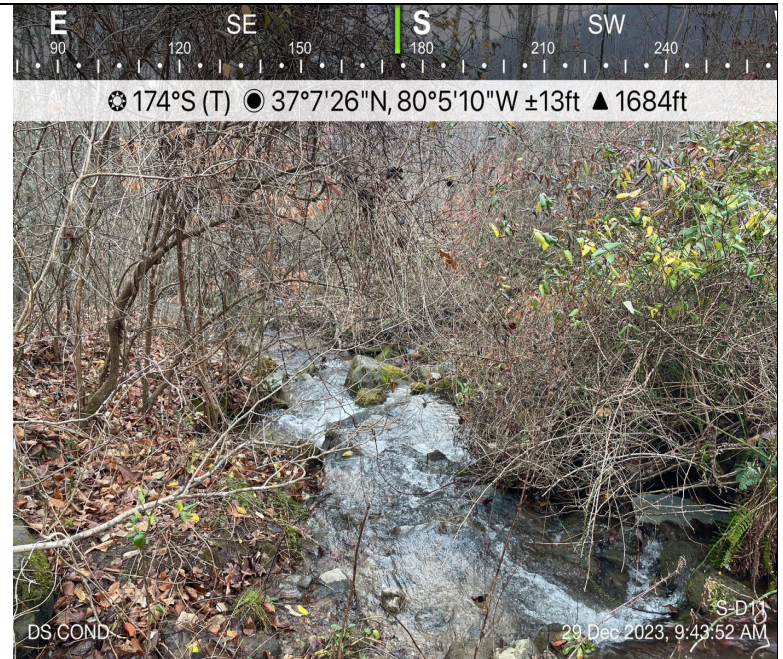
Photo Description: Conditions of the downstream area outside the ROW during pre-construction assessment.

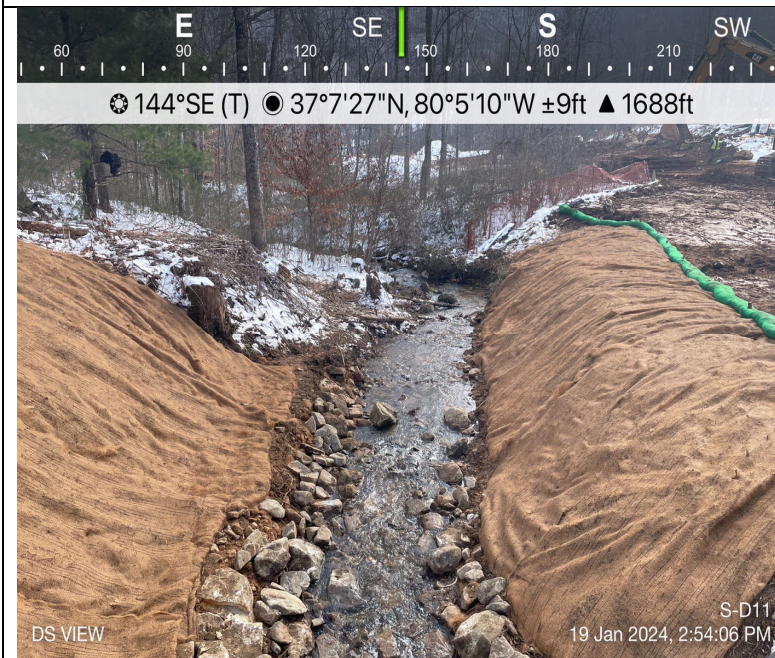
No impacts to biological conditions or unauthorized discharge, were observed during the crossing activities.

Photo Description: Downstream view of permitted impact area during post-construction assessment.

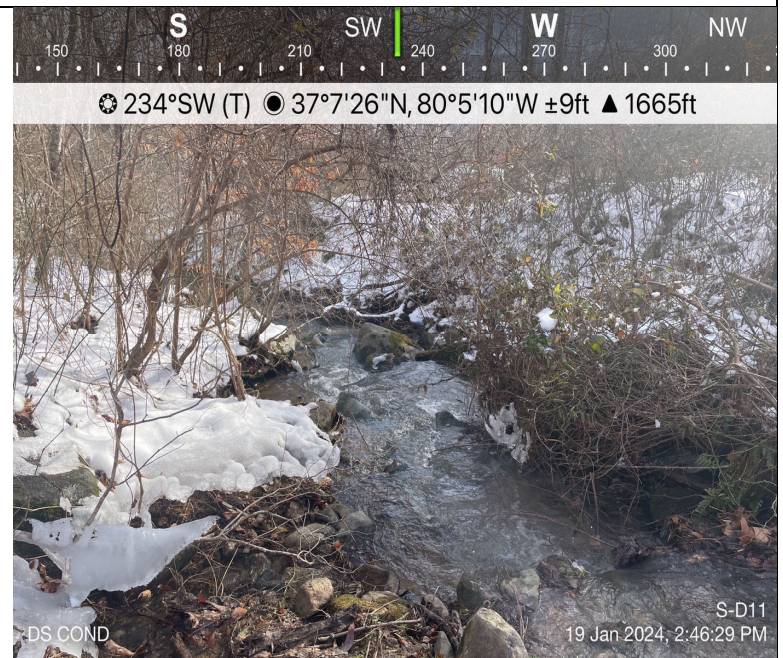
Photo Description: Conditions of the downstream area outside the ROW during post-construction assessment.

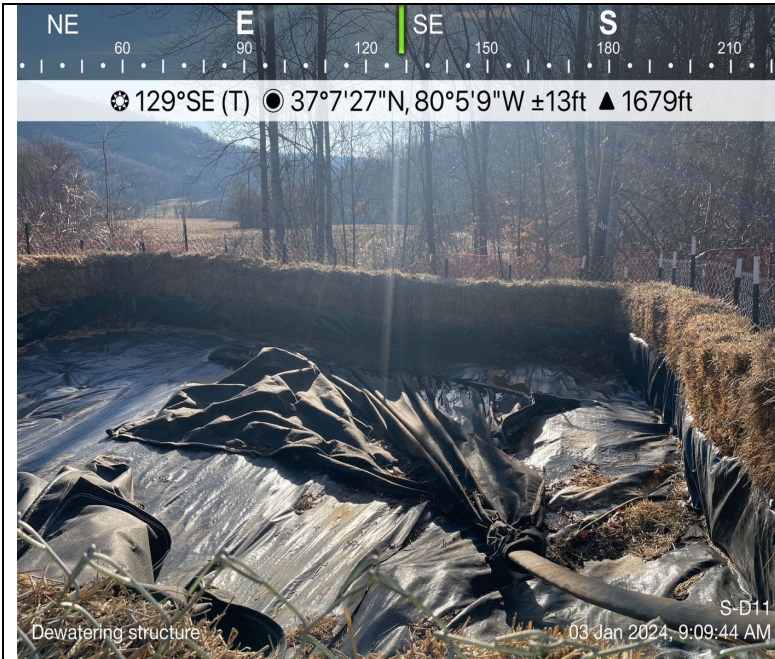
Photo Description: An overview of the dewatering structure.

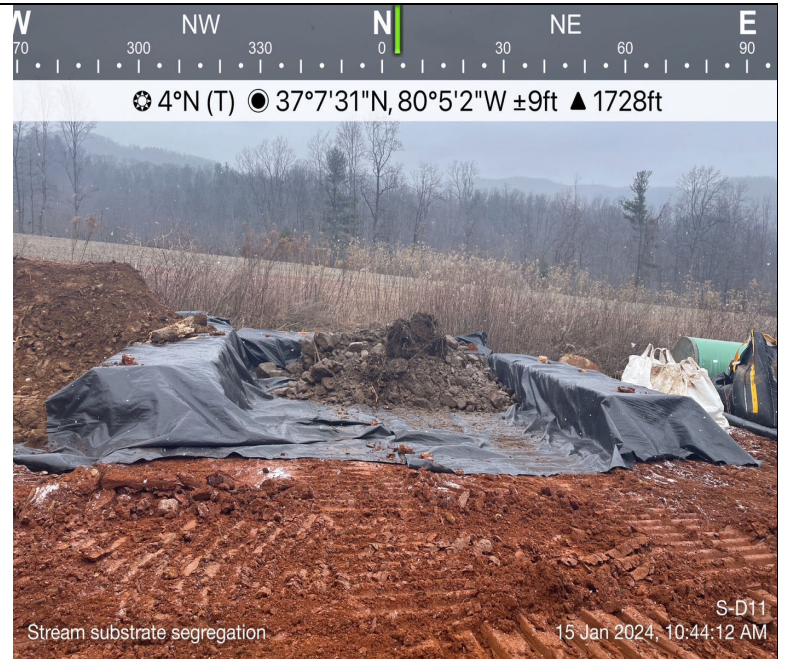
01/15/24- Topsoil and stream substrate was excavated, segregated, and stabilized in an upland area on timber mats and geotech. Downstream flow remains consistent and biological conditions remain stable. - S. Frost

Photo Description: Stream substrate segregation in an upland area on timber mats and geotech. Substrate was stabilized with Kerlex.

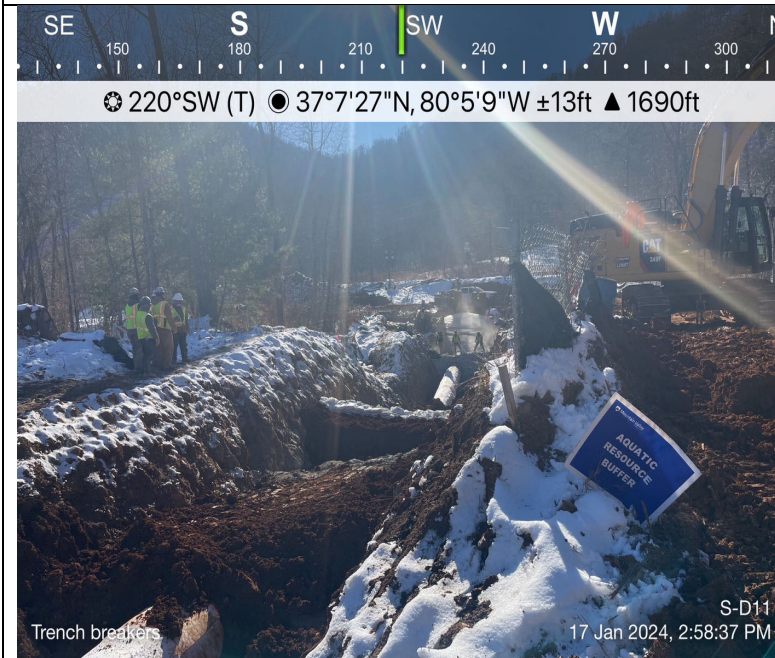
01/17/24- The second weld was completed. The weld was x-rayed and quality controlled. Trench breakers were installed, and the subsoil was partially backfilled. Downstream flow remains consistent and biological conditions remain stable. -S. Frost

Photo Description: Trench breakers installed on both sides of the resource.

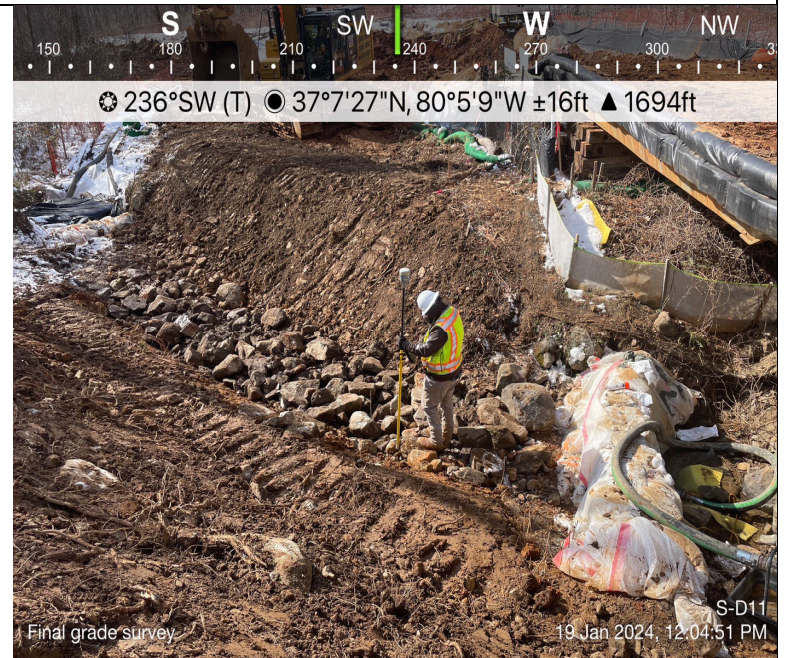
01/19/24- Subsoil backfill was completed. Survey shot grade for topsoil and substrate restoration. The stream banks were restored, and 12-inches of topsoil was added. Stream substrate was restored with 12-inches of boulder/cobble mix. Survey shot final grade. Seed was applied. Stabilization matting and erosion control devices were installed. The upstream and downstream dams, pumps, and energy dissipater were removed, and flow was restored. The post-construction assessment was completed. No unauthorized discharges were observed or reported during construction. - S. Frost

Photo Description: Survey shooting final grade after restoration of the stream substrate.
