WETLAND BIOLOGICAL CONDITIONS ENVIRONMENTAL AUDITOR REPORT

Wetland ID: W-B24-PEM	Crossing Start Date: 12/14/2023	Crossing Completion Date: 01/02/2024
Milepost: 245.9	Pre-Con Assessment Date: 11/24/2023	Post-Con Assessment Date: 01/02/2024
Station: 12992+93	Cowardin Classification: PEM (PEM, PFO, PSS, POW)	Wetland Impact Area (sq ft.): 4491.04
County: Roanoke

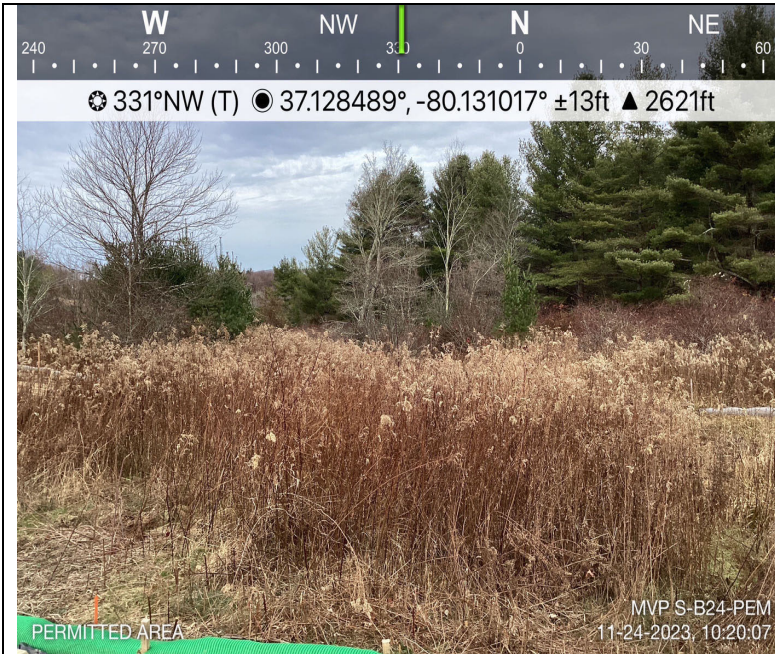
Photo Description: View of permitted resource impact area during pre-construction assessment.

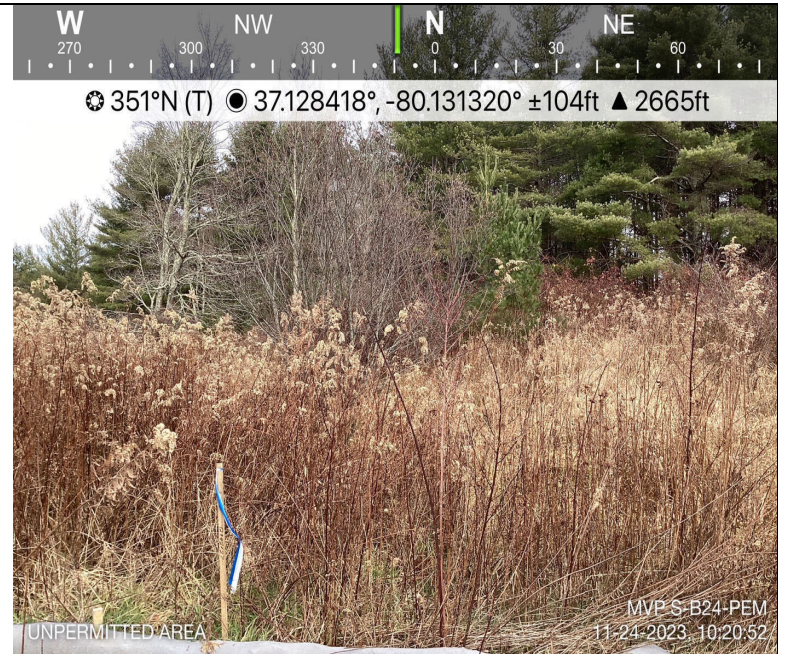
Photo Description: At edge of LOD, view of unpermitted resource area conditions during pre-construction assessment.

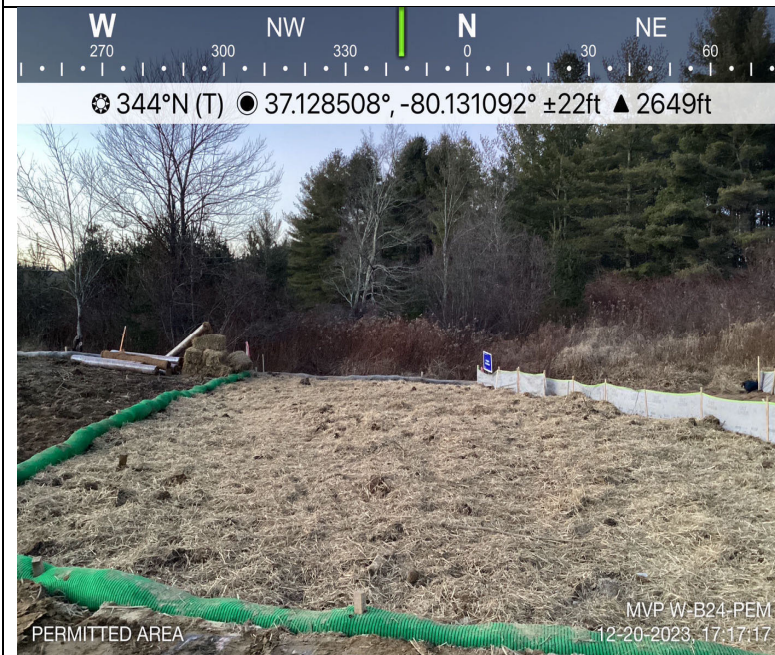
Photo Description: View of permitted resource impact area during post-construction assessment.

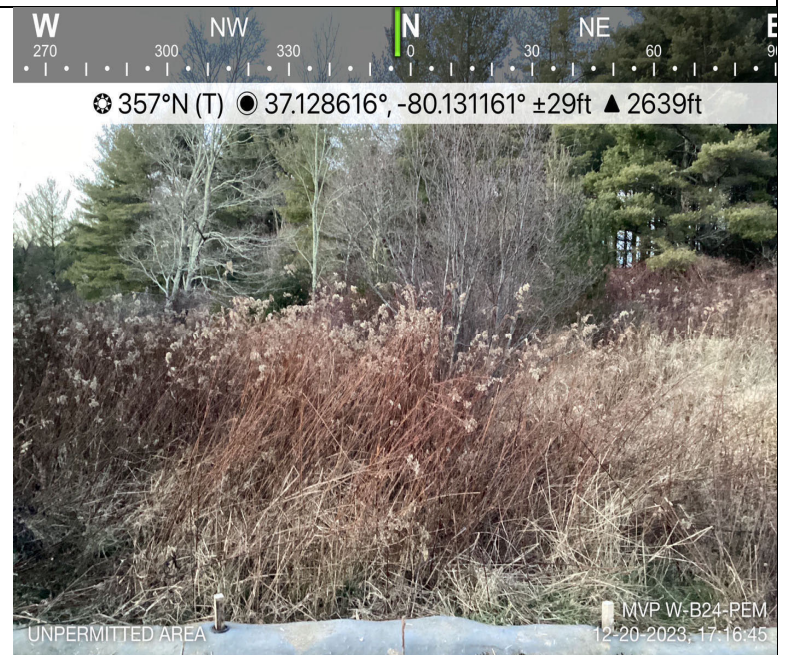
Photo Description: At edge of LOD, view of unpermitted resource area conditions during post-construction assessment.

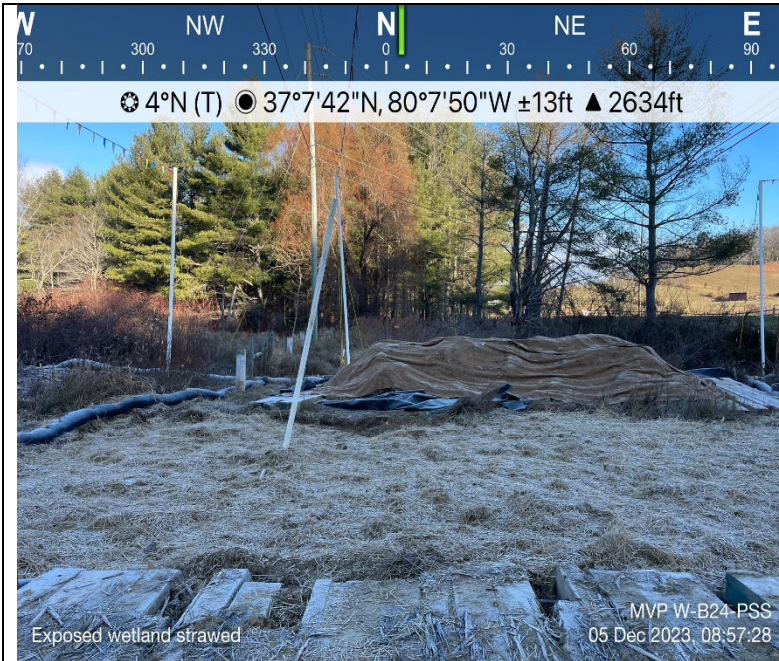
Photo Description: Wetland topsoil stockpiles stabilized with straw matting.

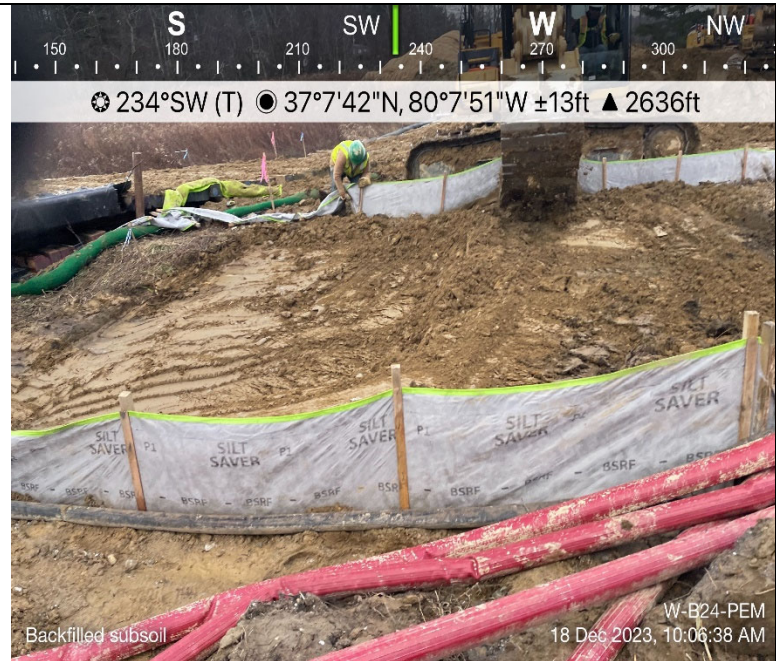
Photo Description: Subsoil backfill in wetland impact area.

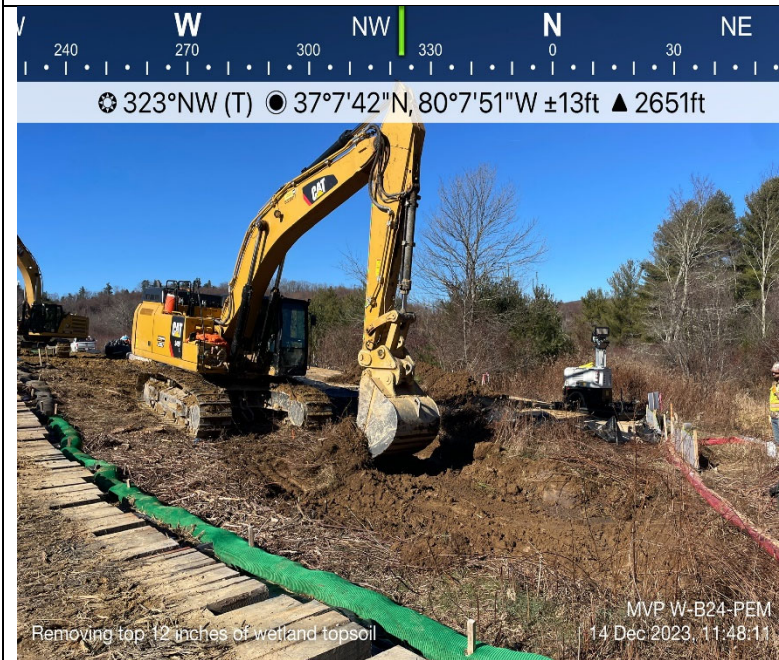
Photo Description: Removal of top 12-inches of wetland topsoil from within impact area.

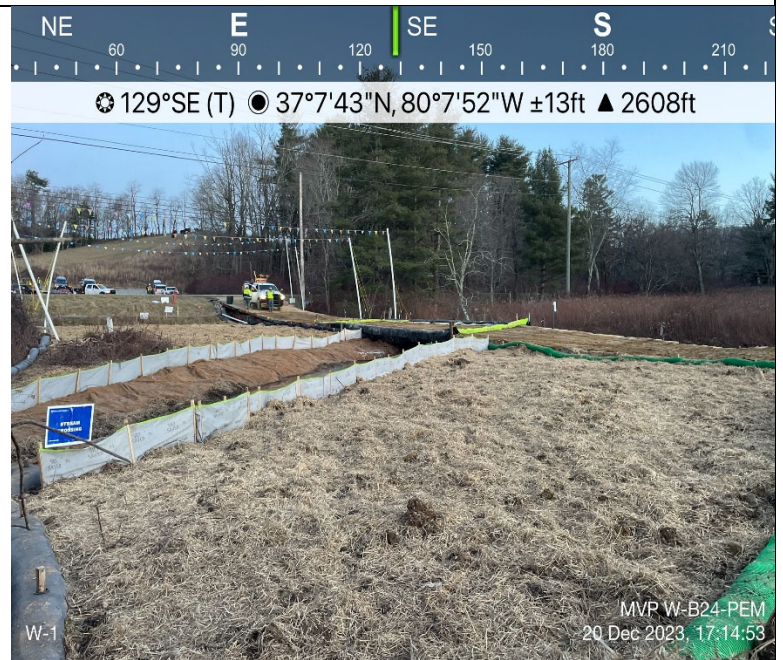
Photo Description: Restored wetland impact area.
