# STREAM BIOLOGICAL CONDITIONS ENVIRONMENTAL AUDITOR REPORT

Version 2.3

<b>Stream ID:</b> S-G30	<b>Crossing Start Date:</b> 12/09/2023	<b>Crossing Completion Date:</b> 12/22/2023
<b>Milepost:</b> 202.1	<b>Pre-Con Assessment Date:</b> 12/07/2023	<b>Post-Con Assessment Date:</b> 12/22/2023
<b>Station:</b> 10679+39	<b>Stream Classification:</b> Ephemeral (Perennial, Intermittent, Ephemeral)	<b>Bankfull Width (ft.):</b> 8
<b>County:</b> Giles	<b>303(d) Impairment Listing:</b> Not Impaired	<b>Riffle:Pool Complexes Present?</b> No

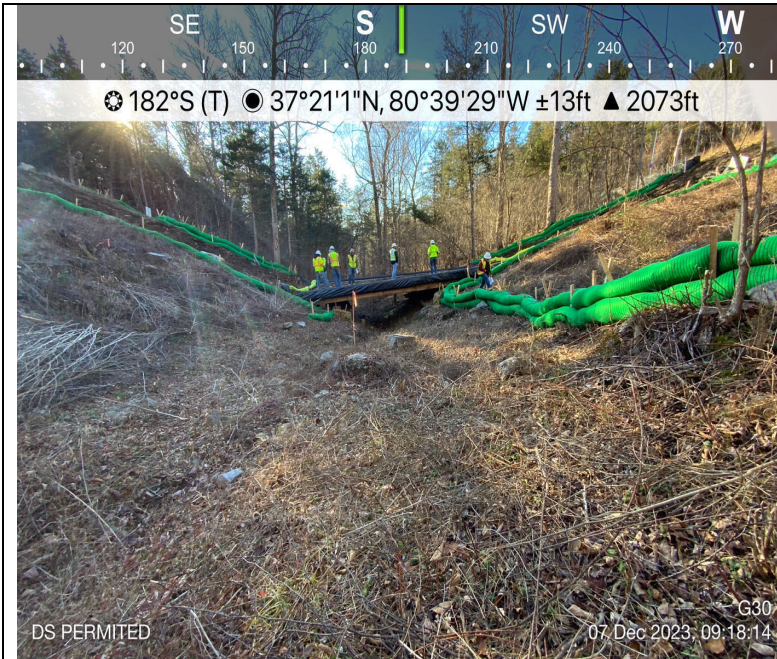
**Photo Description:** Downstream view of permitted impact area during pre-construction assessment.

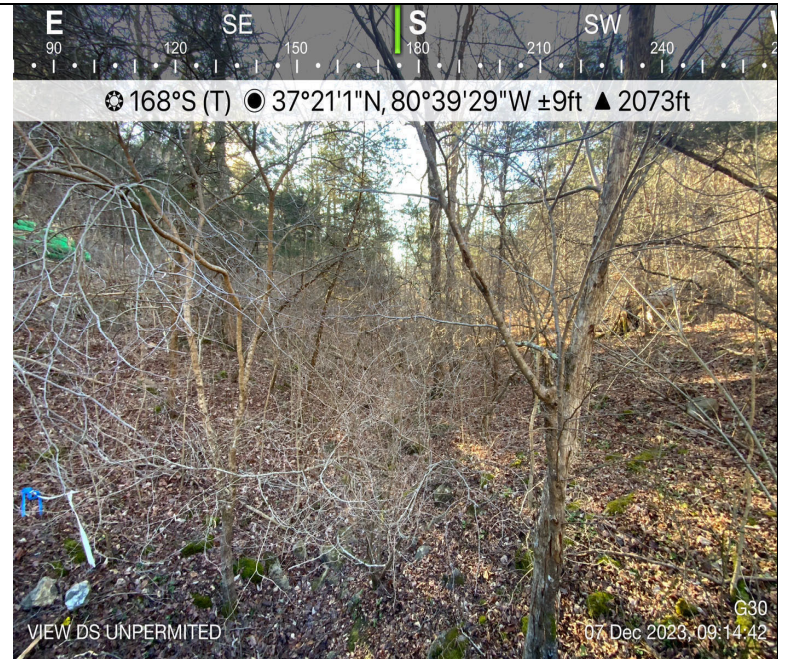
**Photo Description:** Conditions of the downstream area outside the ROW during pre-construction assessment.

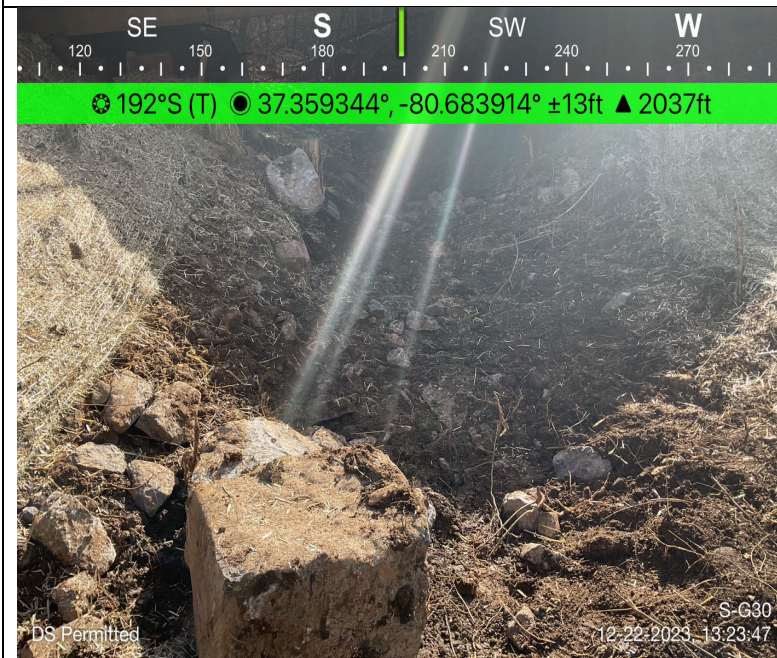
**Photo Description:** Downstream view of permitted impact area during post-construction assessment.

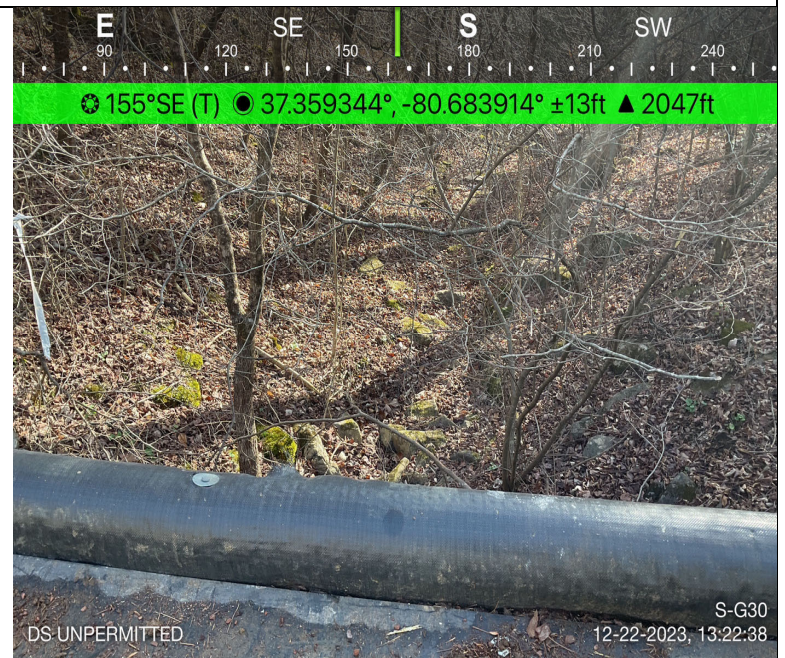
**Photo Description:** Conditions of the downstream area outside the ROW during post-construction assessment.

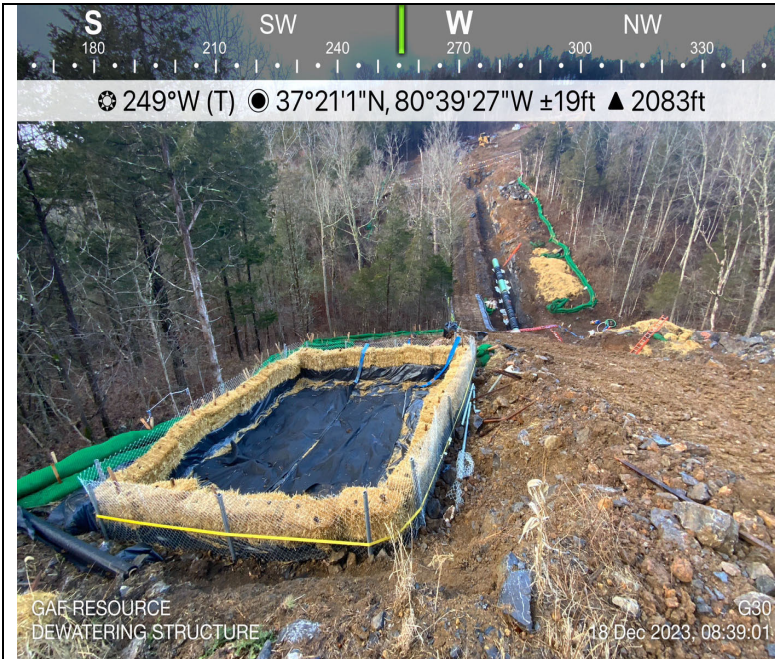
**Photo Description:** Dewatering structure located onsite.

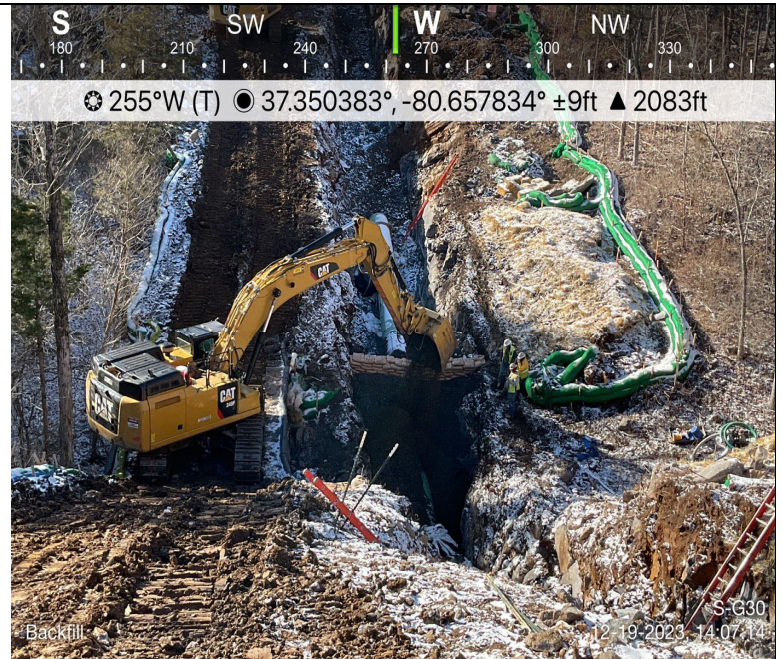
**Photo Description:** Trench breakers installed and padding and backfill begin.

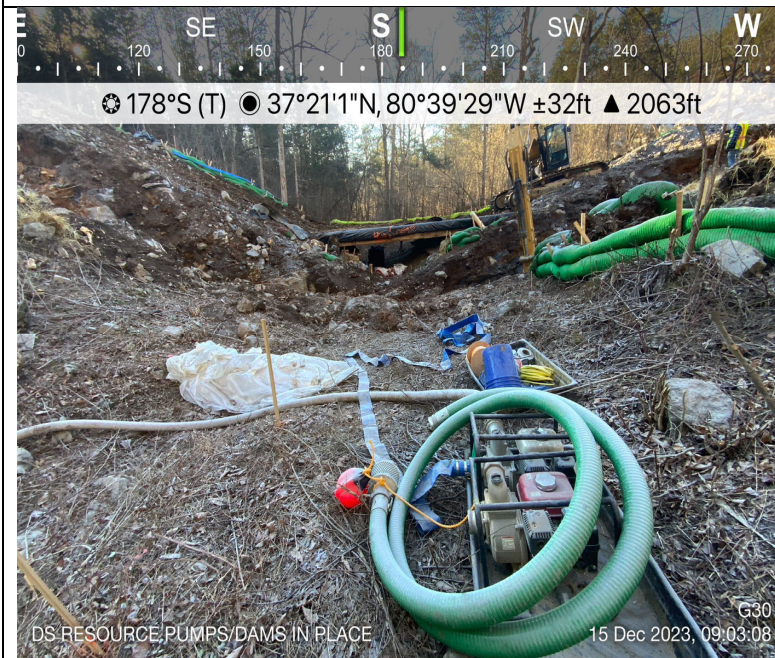
**Photo Description:** Dam and pumps in place.

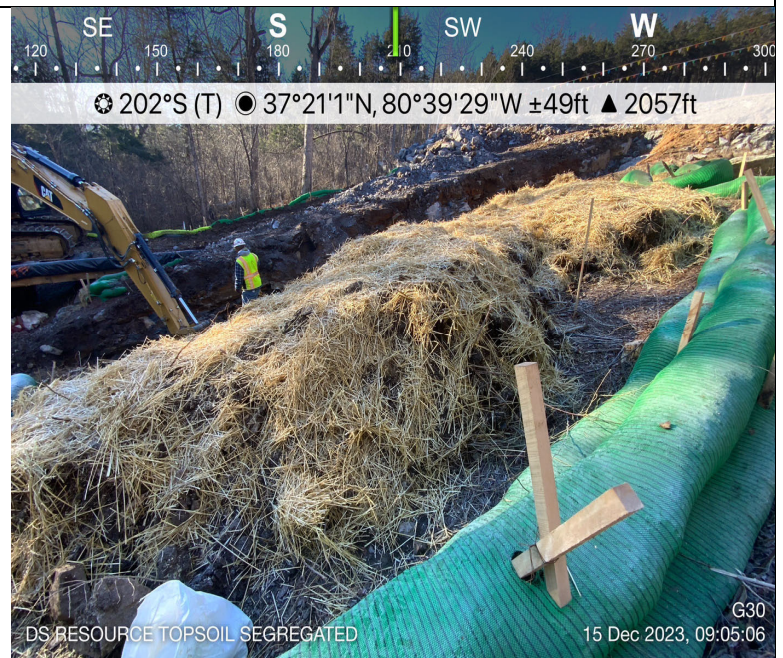
**Photo Description:** Topsoil segregated and stabilized.
