STREAM BIOLOGICAL CONDITIONS ENVIRONMENTAL AUDITOR REPORT

Stream ID: S-PP3	Crossing Start Date: 08/11/2023	Crossing Completion Date: 08/15/2023
Milepost: 217.8	Pre-Con Assessment Date: 08/11/2023	Post-Con Assessment Date: 08/15/2023
Station: 11507+78	Stream Classification: Perennial (Perennial, Intermittent, Ephemeral)	Bankfull Width (ft.): 3
County: Craig	303(d) Impairment Listing: Not Impaired	Riffle:Pool Complexes Present? No

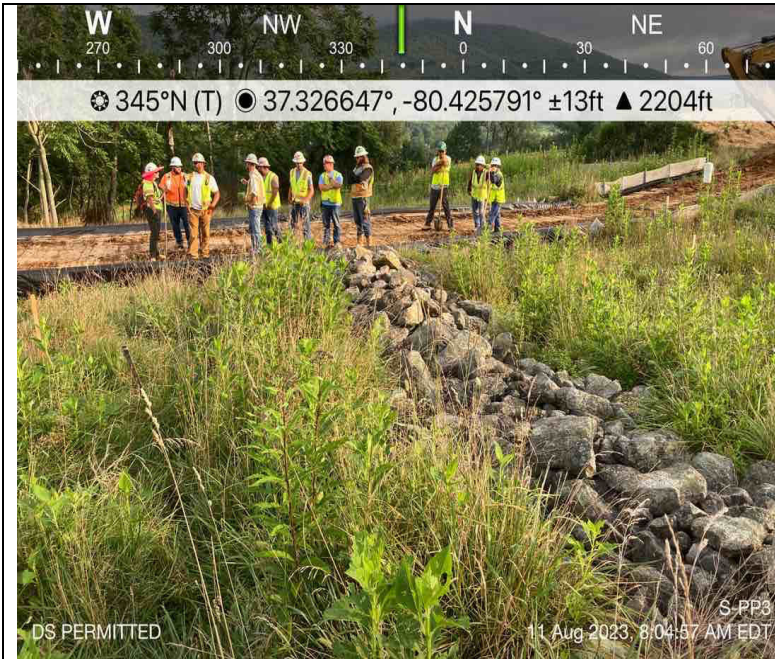
08/11/2023: Pre- construction meeting held. Stream is lined with rip rap. Rip rap will be removed and stockpiled for restoration post construction per landowner. Encompass will survey stream once rip rap is removed and those shots will be utilized in the restoration efforts of the stream. Once survey is complete post construction, riprap will be placed back over streambed. Mindy Metcalf is MVP EI on-site.

Photo Description: Downstream view of permitted impact area during pre-construction assessment.

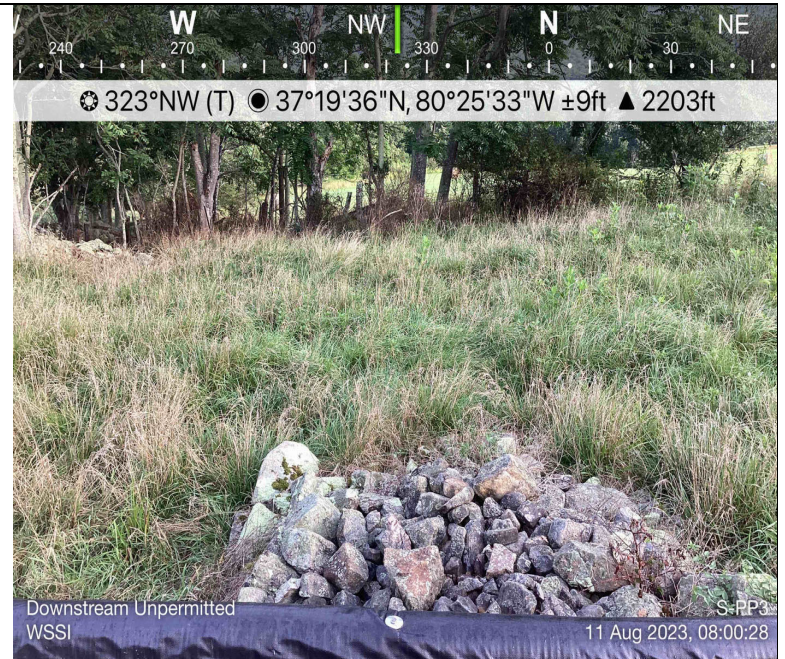
Photo Description: Downstream view of unpermitted area during pre-construction assessment.

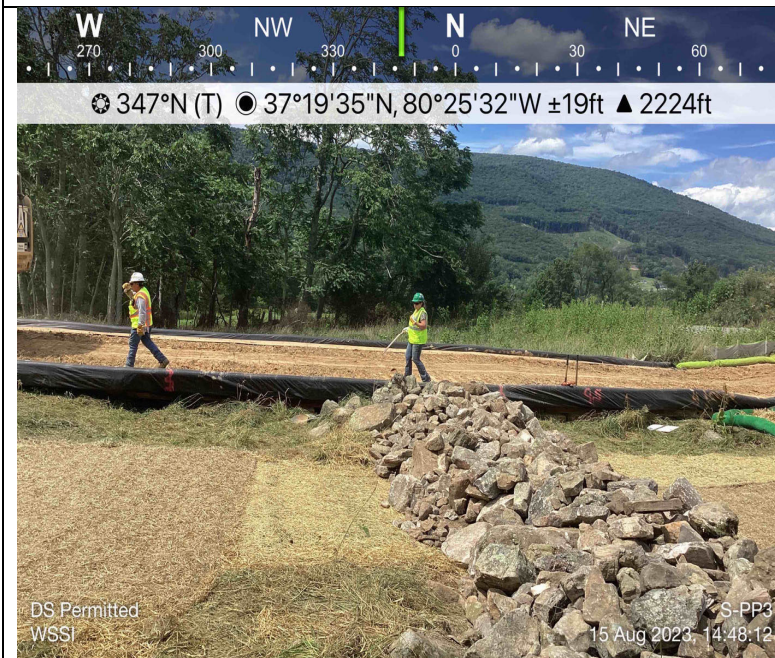
Item #19: Rated severe due to landowner installed rip rap across the resource impact area. Rip rap reinstalled post-construction per landowner request.

Photo Description: Downstream view of permitted impact area during post-construction assessment.

8/15/2023: Survey staked out contours for restoration efforts. Substrate restored and topsoiling complete. Rip rap channel restored per landowner agreement. ECM installed and seed and straw applied. Stream restoration complete.

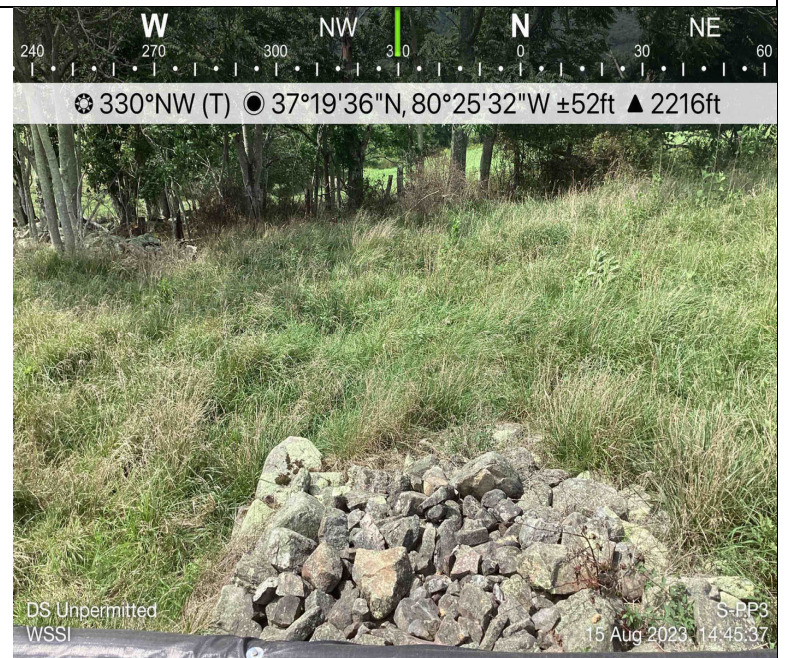
Photo Description: Downstream view of unpermitted area during post-construction assessment.

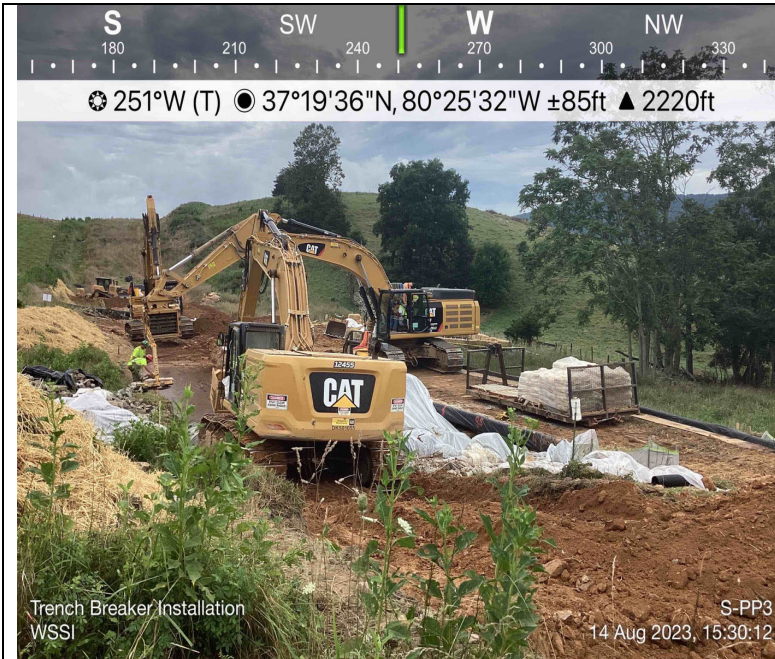
Photo Description: Trench breakers being installed.

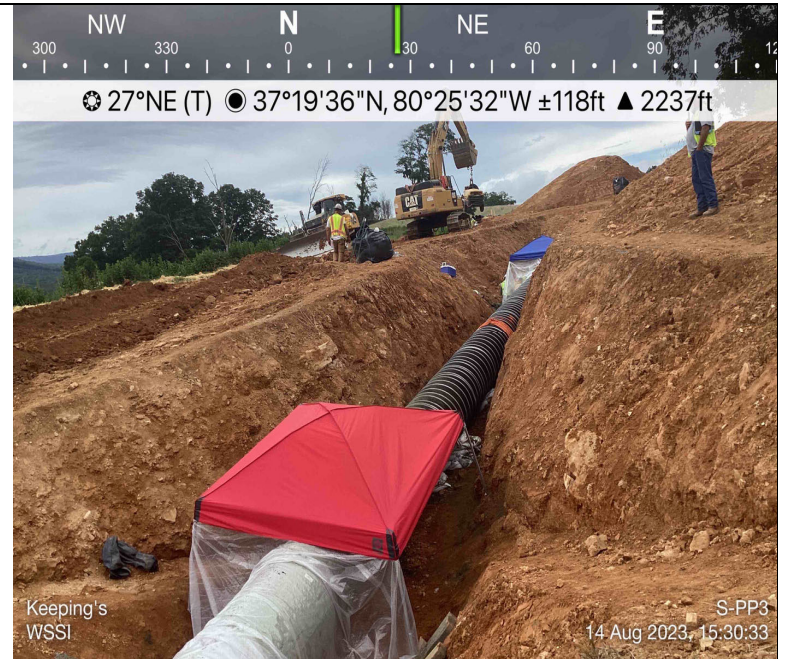
Photo Description: Keeping and coating at welds 2 and 3.

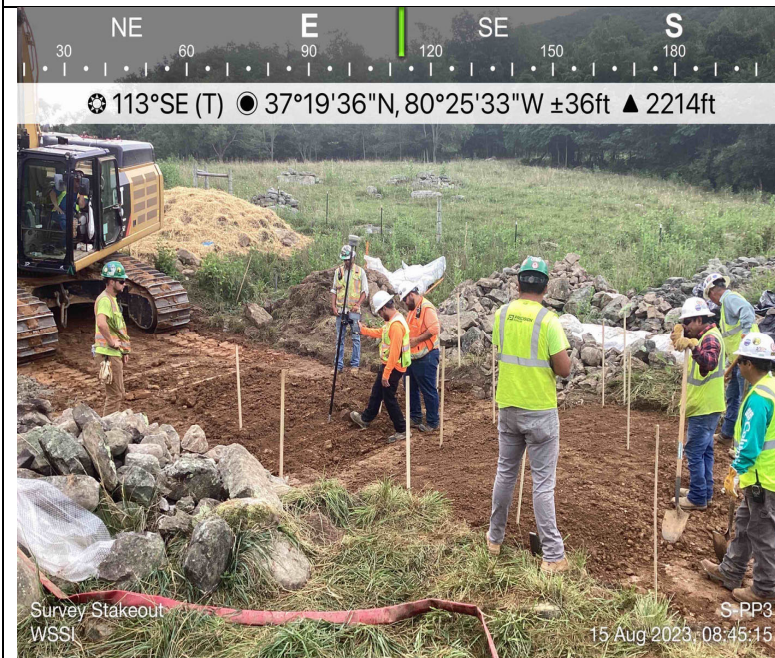
Photo Description: Survey Stakeout

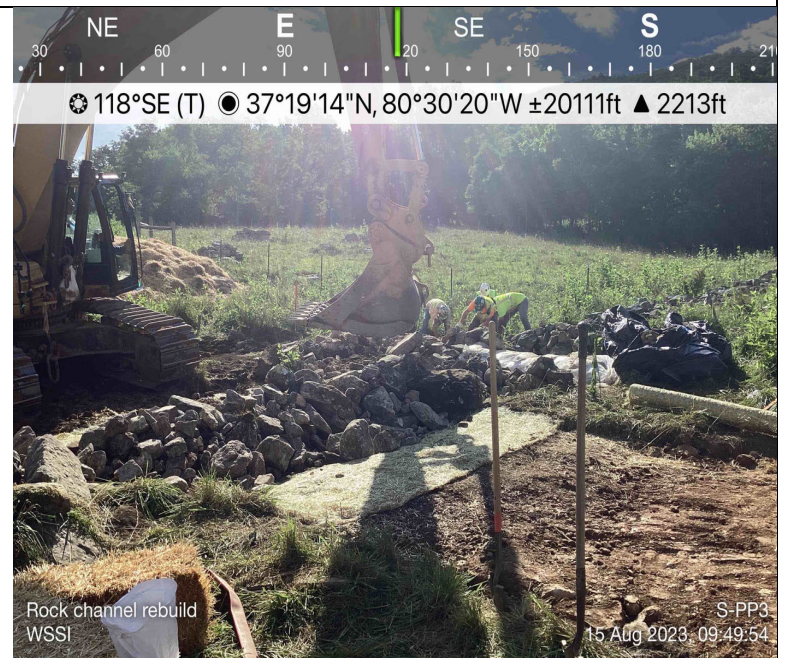
Photo Description: Rock channel being rebuilt.
