## Baseline Assessment – Stream Attributes

### Reach S-G15 (Pipeline ROW) Intermittent Spread I Franklin County, Virginia

## Spread I Stream S-G15 (ROW) Franklin County

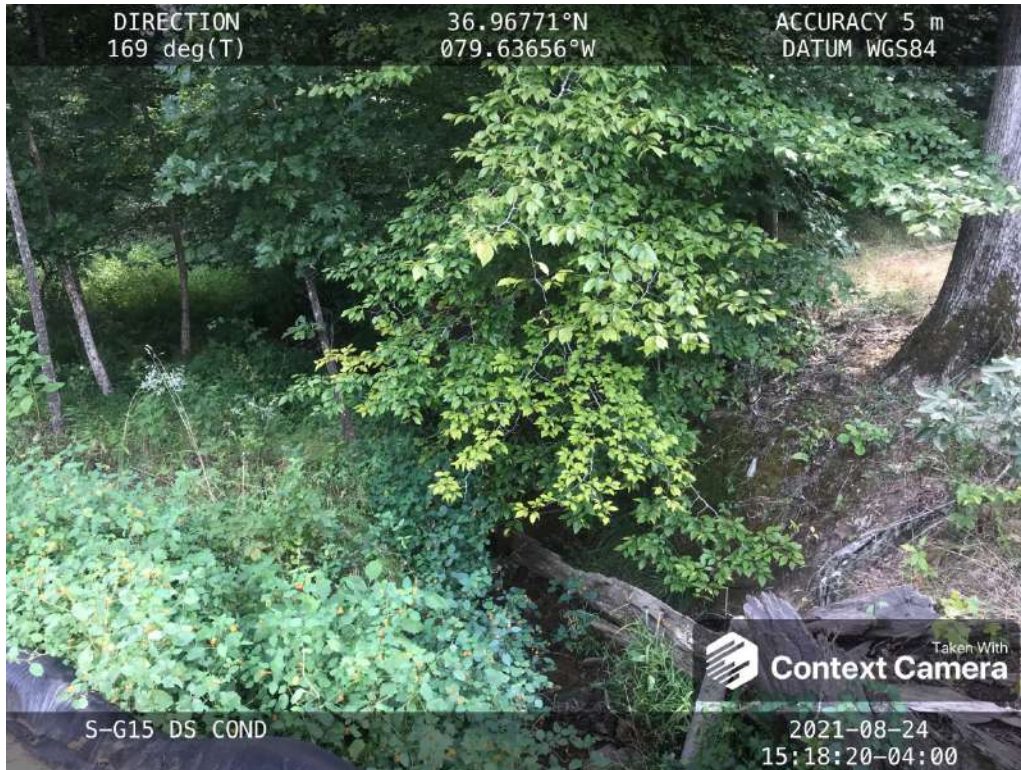
Photo Type: DS COND

Location, Orientation, Photographer Initials: Downstream at LOW looking S downstream, RAH

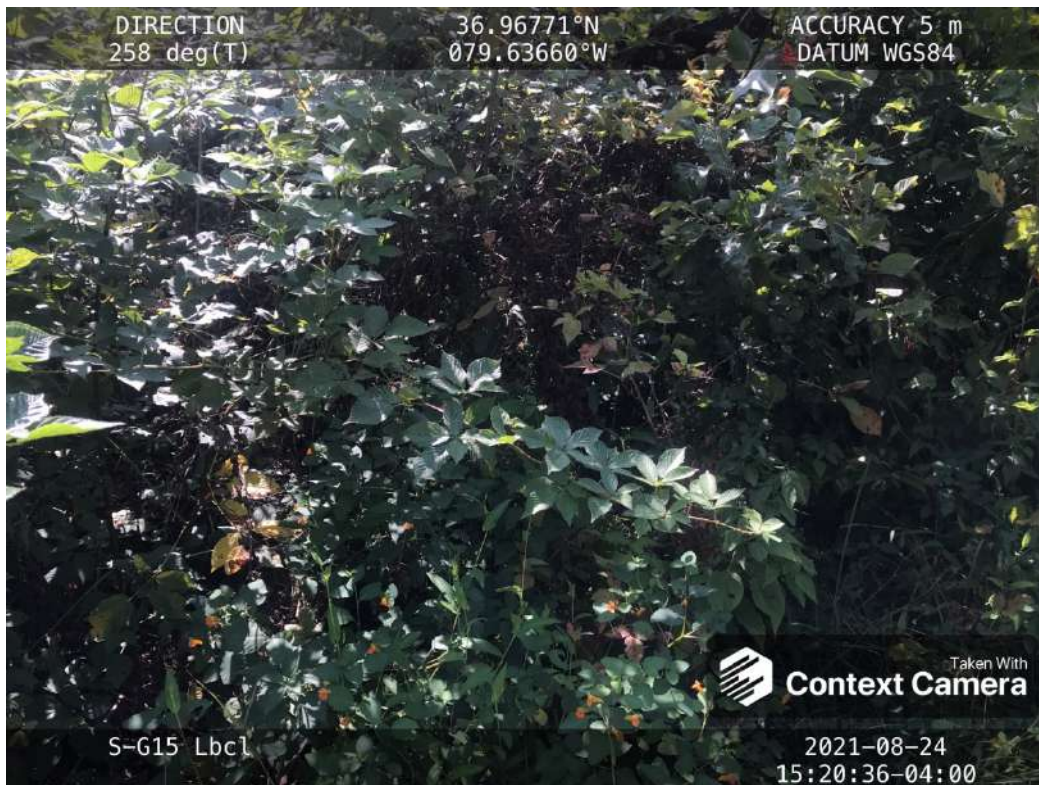
Photo Type: LB CL

Location, Orientation, Photographer Initials: On thalweg at pipe centerline looking W at left streambank, RAH

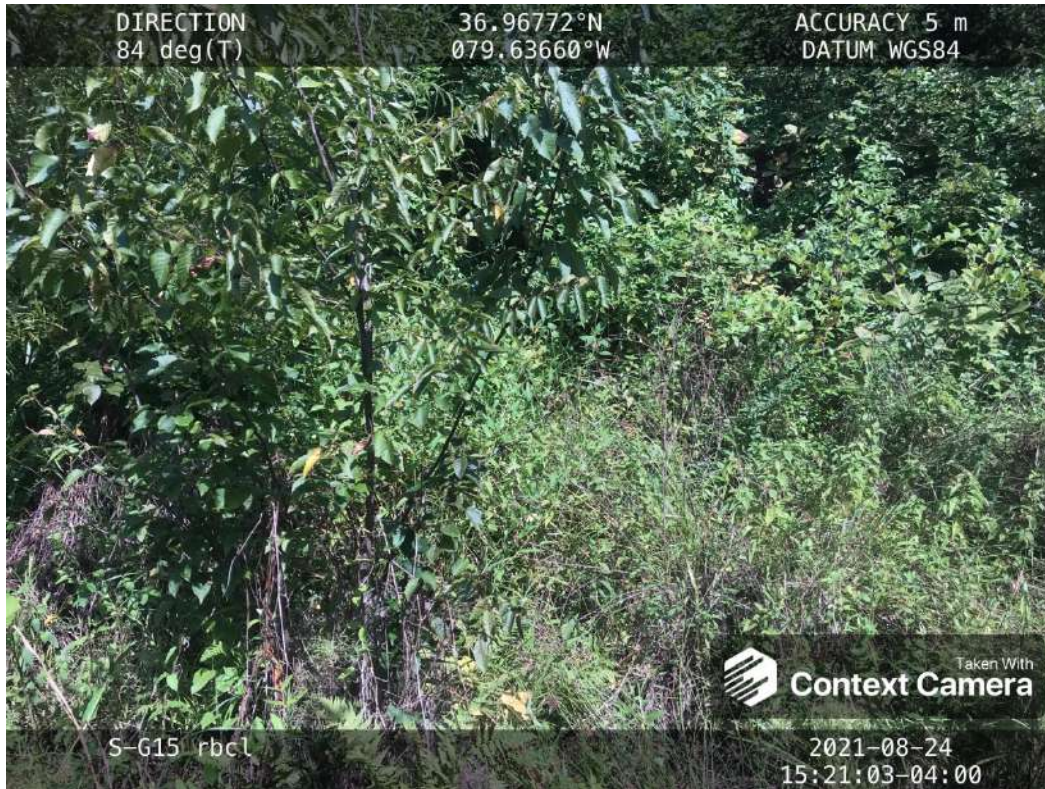
Photo Type: RB CL

Location, Orientation, Photographer Initials: On thalweg at pipe centerline looking S at right streambank, RAH

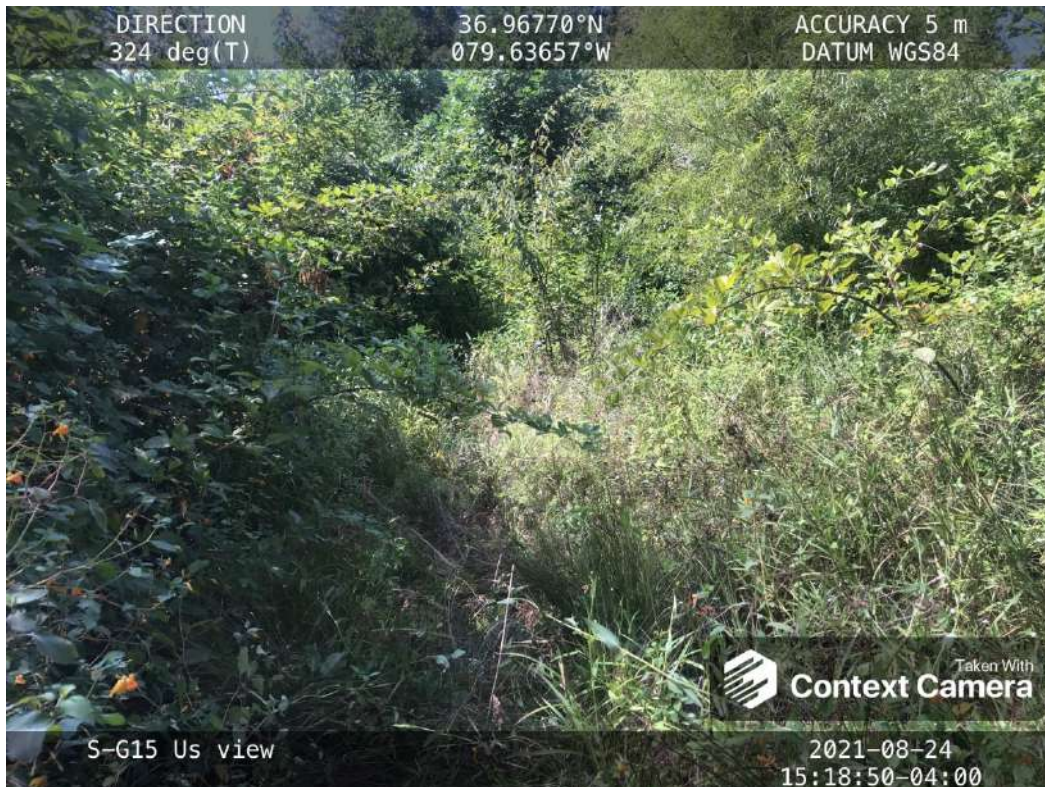
Photo Type: US VIEW

Location, Orientation, Photographer Initials: Downstream at ROW looking NW upstream, RAH

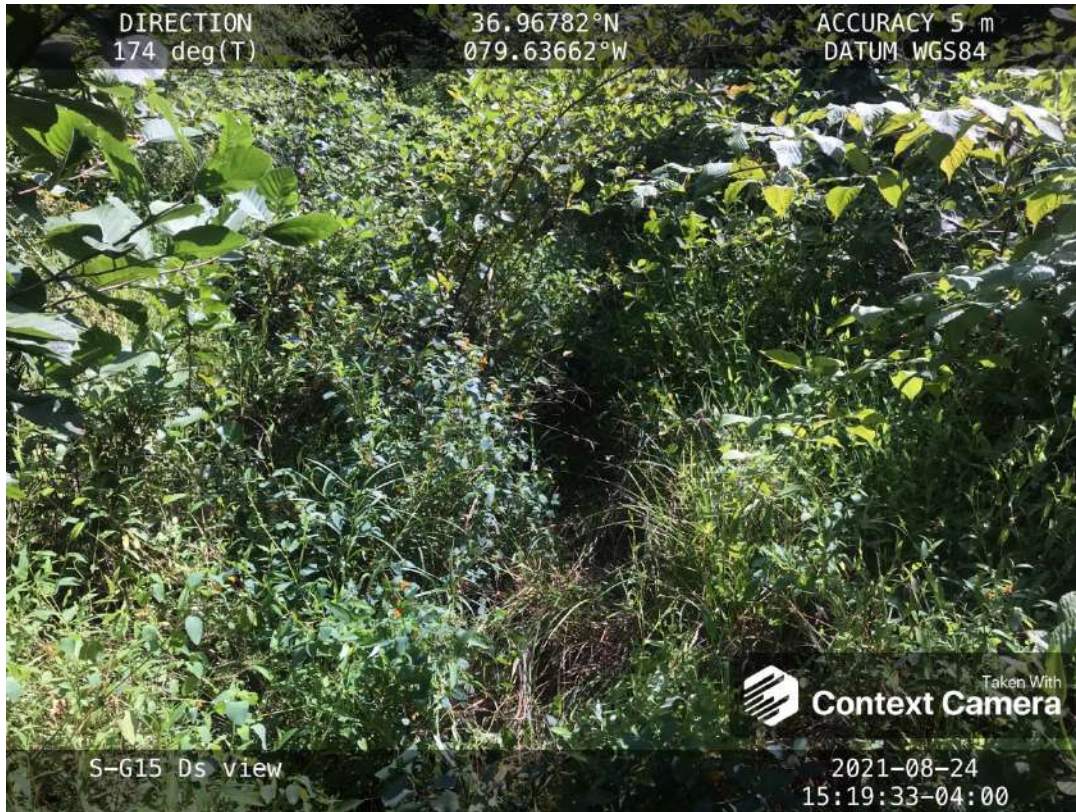
Photo Type: DS VIEW

Location, Orientation, Photographer Initials: Upstream at LOC looking S downstream, RAH
