## Baseline Assessment – Stream Attributes

### Reach S-KL35 (Timber Mat Crossing) Perennial Spread I Franklin County, Virginia

## Stream S-KL35 (Timber Mat) Franklin County

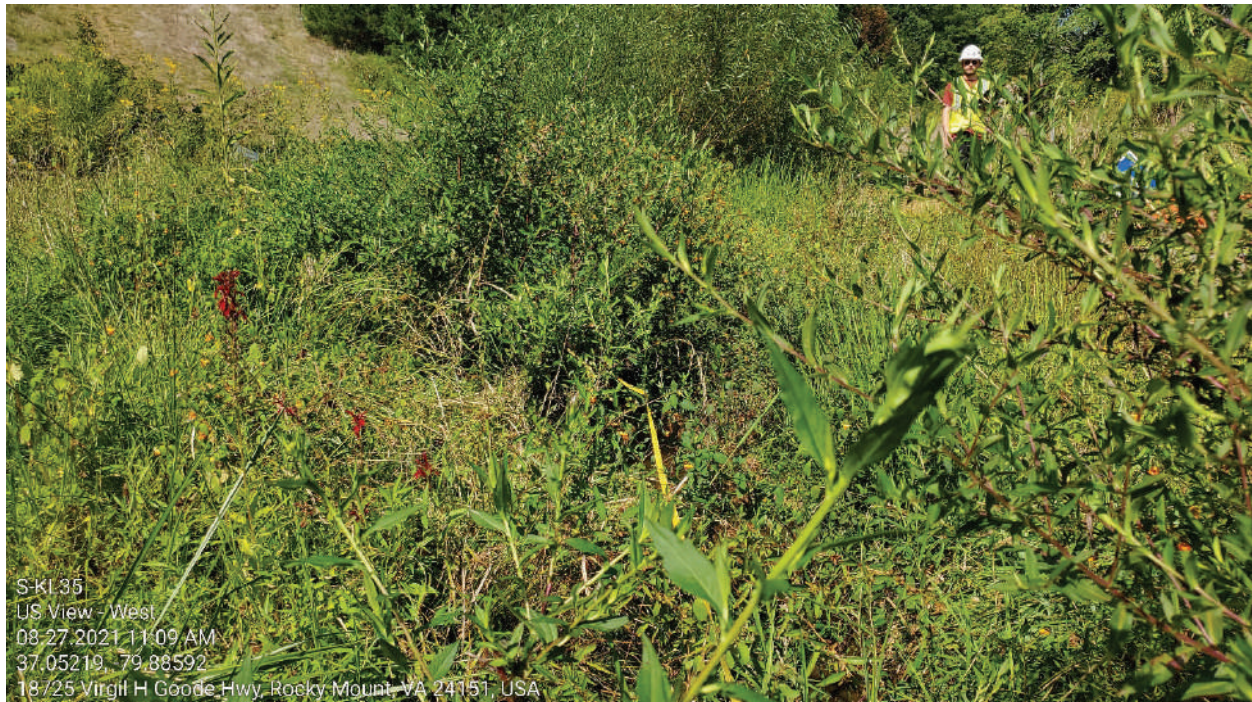
Photo Type: US VIEW

Location, Orientation, Photographer Initials: Downstream at ROW/LOD looking W upstream, DW

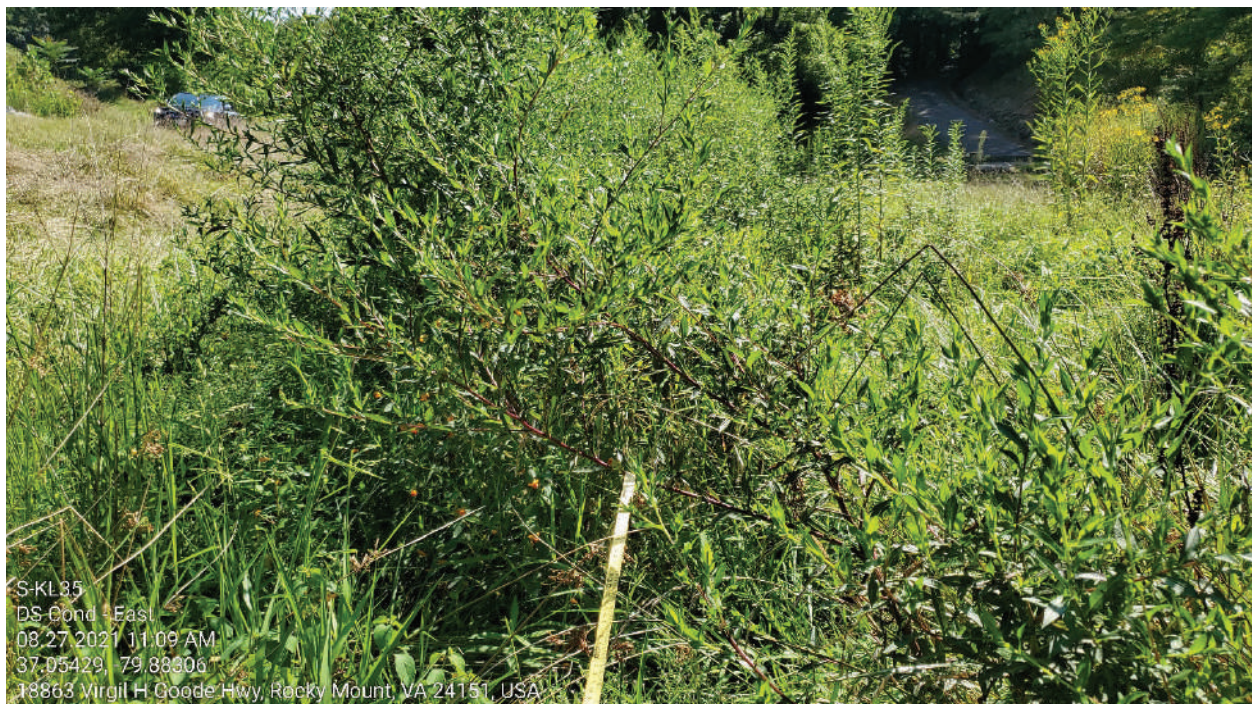
Photo Type: DS COND

Location, Orientation, Photographer Initials: Downstream at ROW/LOD looking E downstream, DW

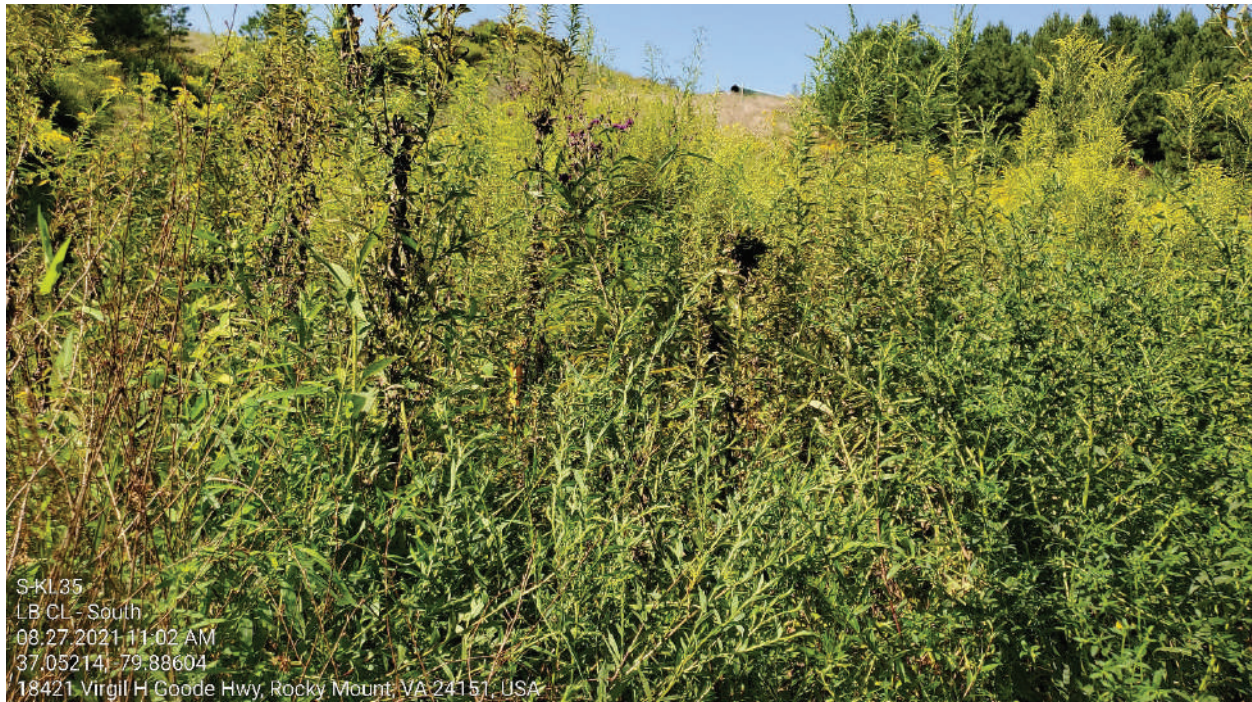
Photo Type: LB CL

Location, Orientation, Photographer Initials: On thalweg at pipe centerline looking S at right streambank, DW

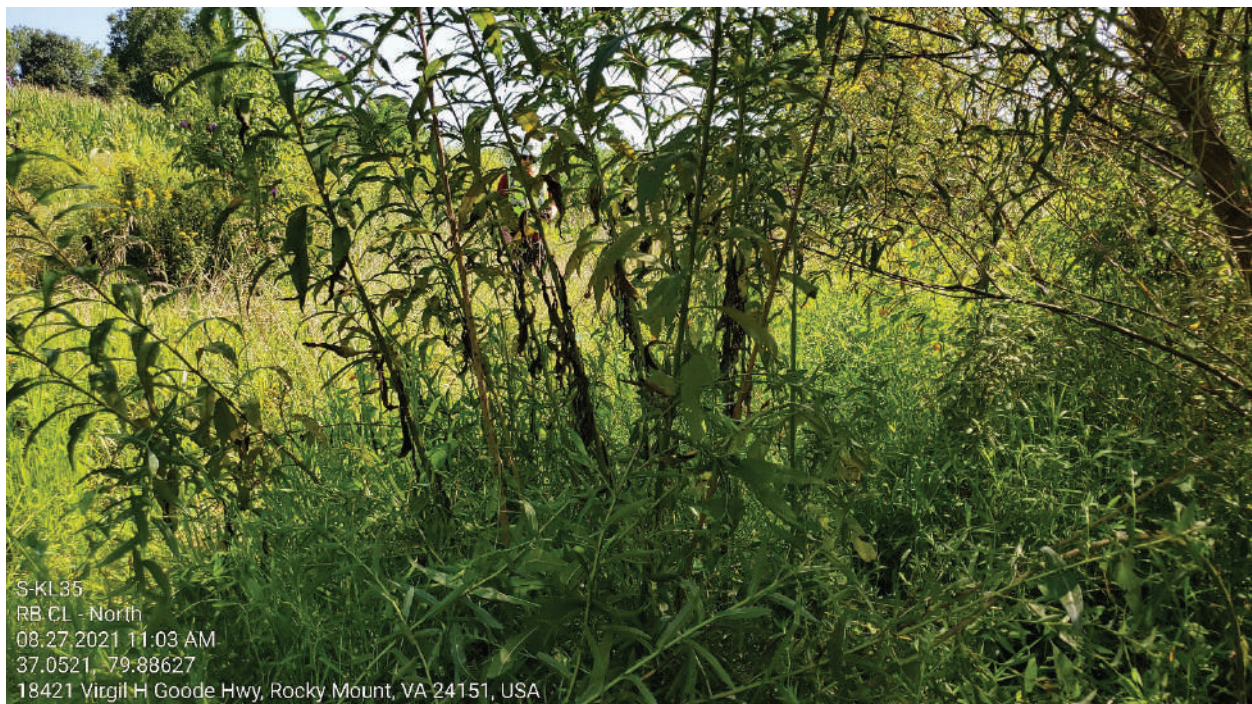
Photo Type: RB CL

Location, Orientation, Photographer Initials: On thalweg at pipe centerline looking N at left streambank, DW

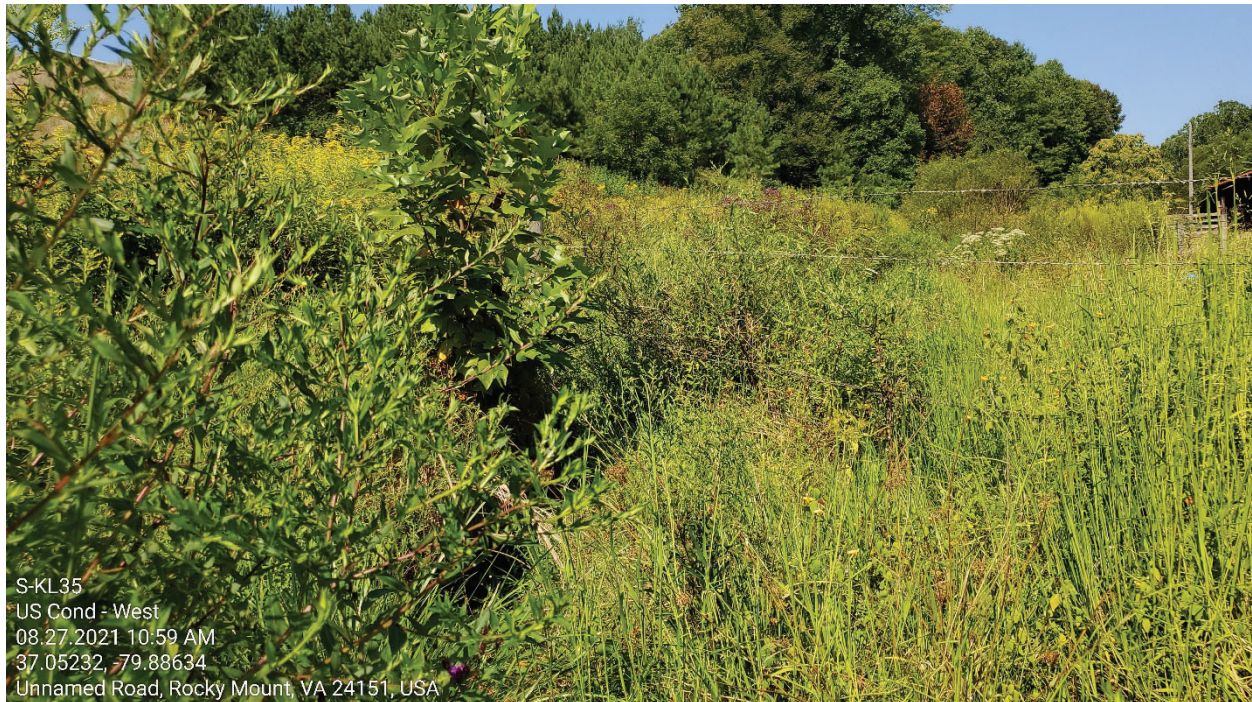
Photo Type: US COND

Location, Orientation, Photographer Initials: Upstream at ROW/LOD looking W upstream, DW

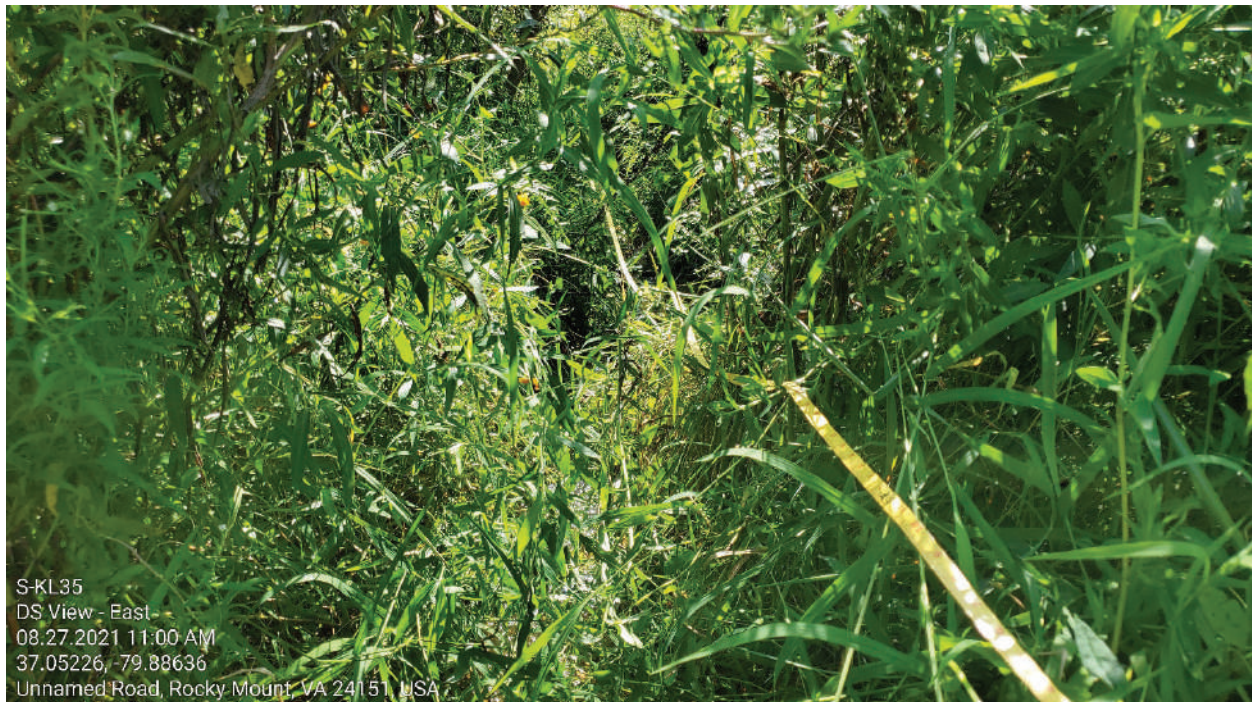
Photo Type: DS VIEW

Location, Orientation, Photographer Initials: Upstream at ROW/LOD looking E downstream, DW
