## Baseline Assessment – Stream Attributes

### Reach S-MM44 (Timber Mat Crossing) Perennial Spread I Franklin County, Virginia

## Spread I Stream S-MM44 (Timber Mat Crossing) Franklin County

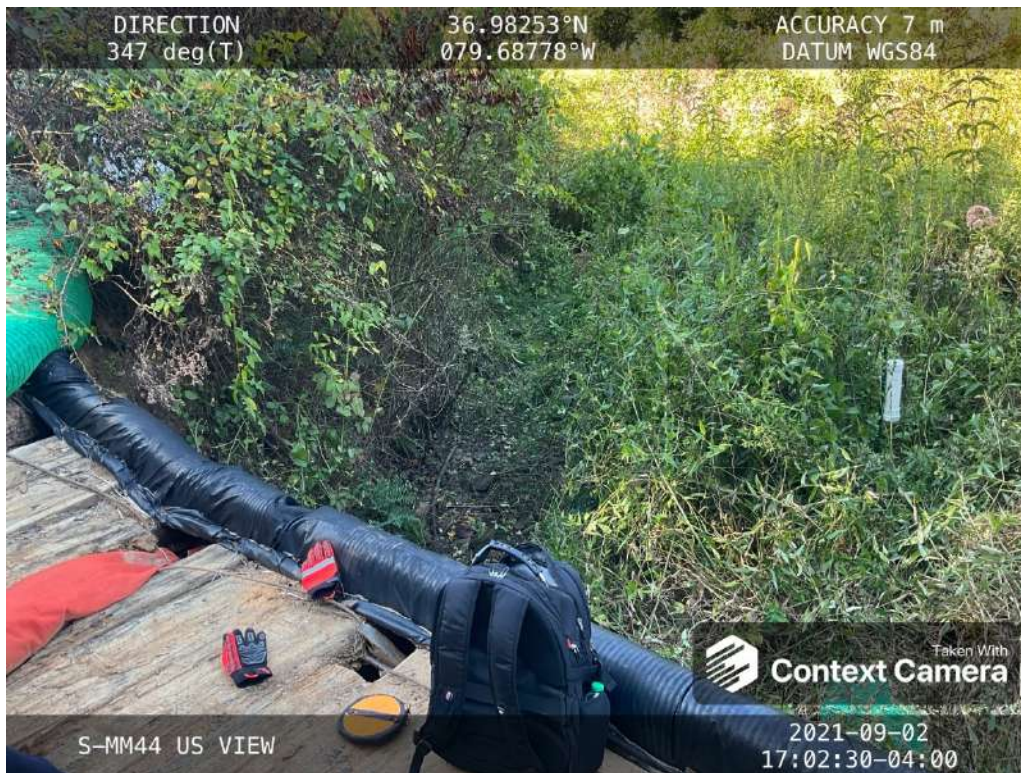
Photo Type: US VIEW

Location, Orientation, Photographer Initials: Downstream at ROW/LOD looking NW upstream, RAH

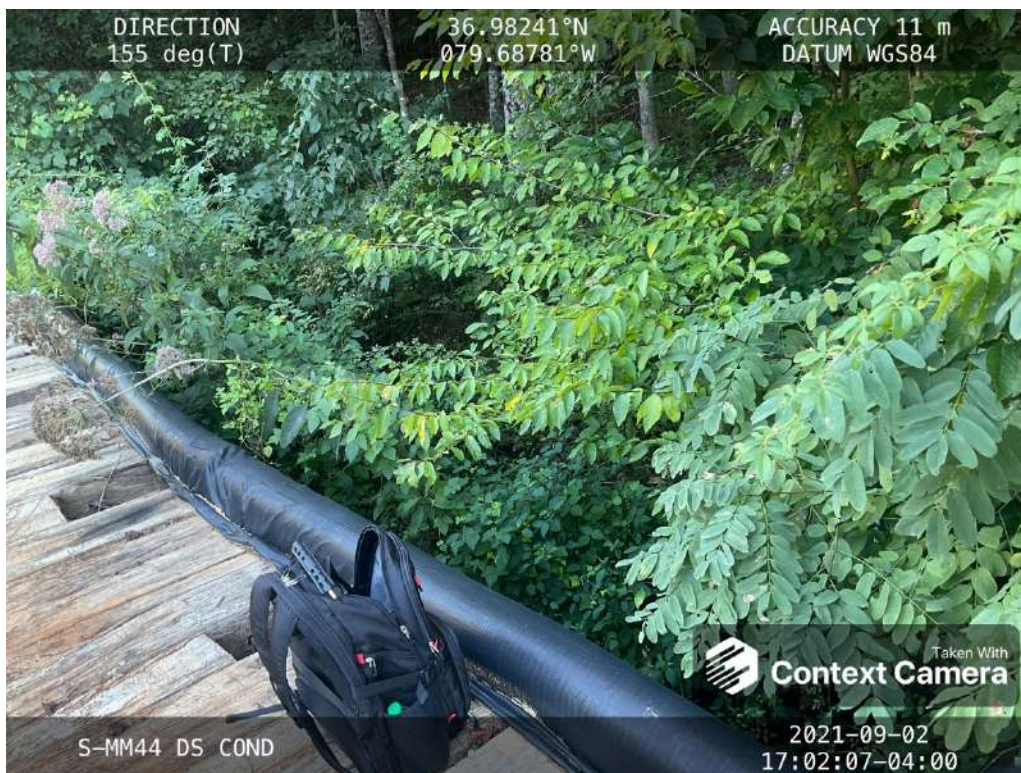
Photo Type: DS COND

Location, Orientation, Photographer Initials: Downstream at ROW/LOD looking SE downstream, RAH

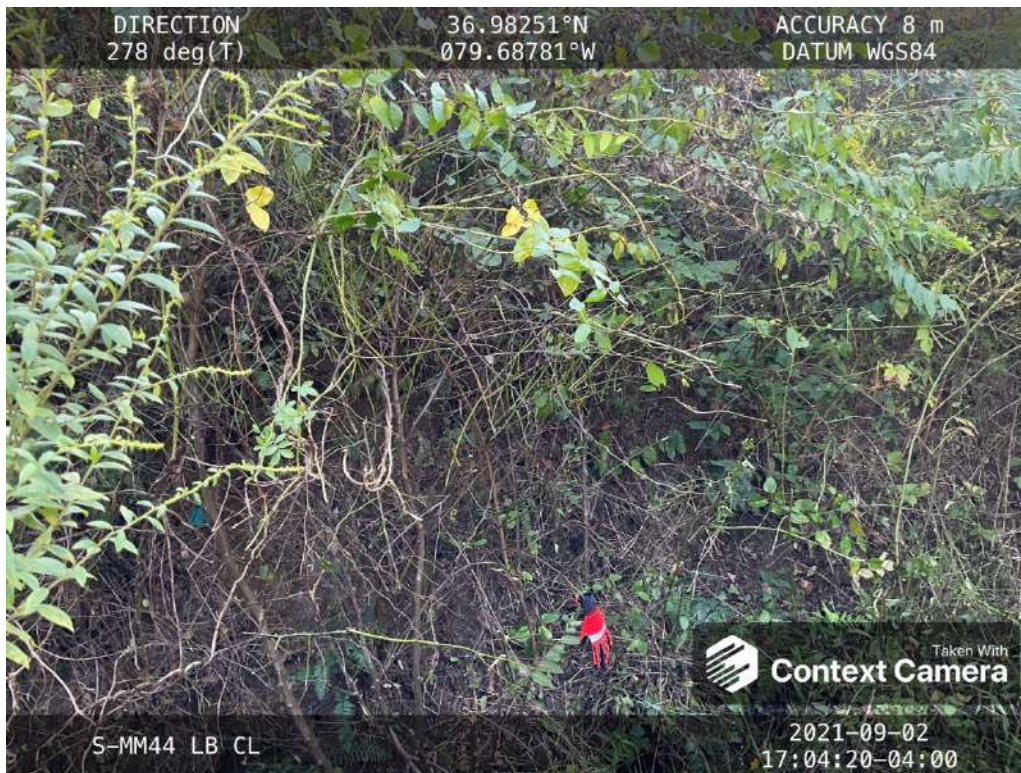
Photo Type: LB CL

Location, Orientation, Photographer Initials: On thalweg at pipe centerline looking SW at right streambank, RAH

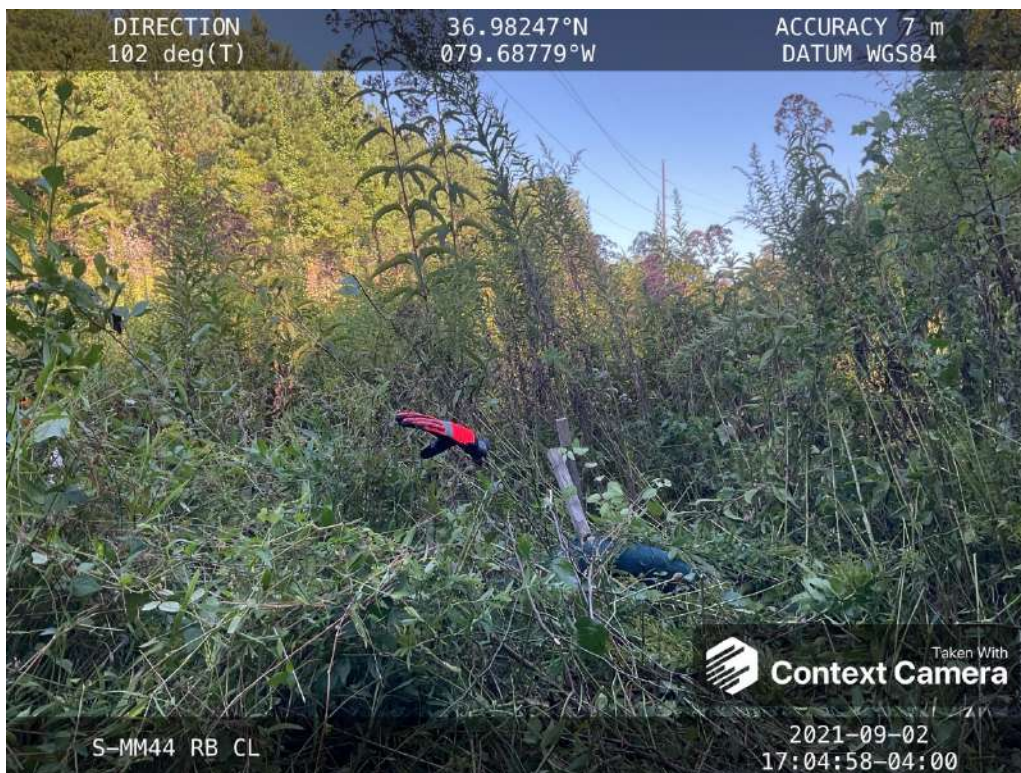
Photo Type: RB CL

Location, Orientation, Photographer Initials: On thalweg at pipe centerline looking SE at left streambank, RAH

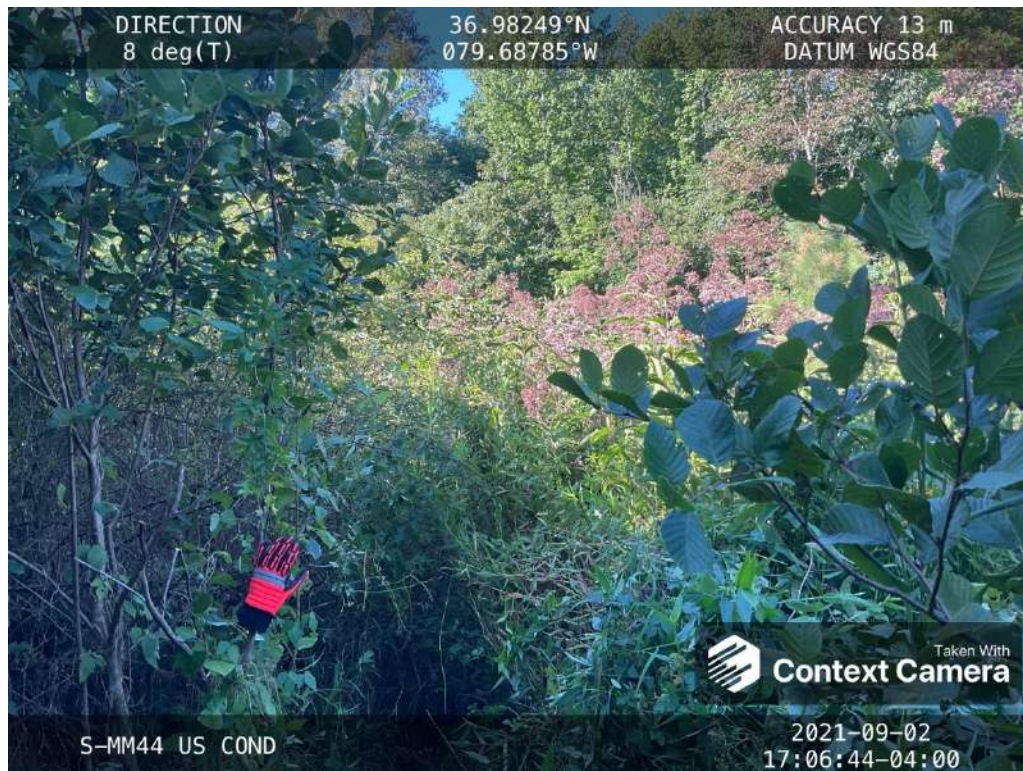
Photo Type: US COND

Location, Orientation, Photographer Initials: Upstream at ROW/LOD looking N upstream, RAH

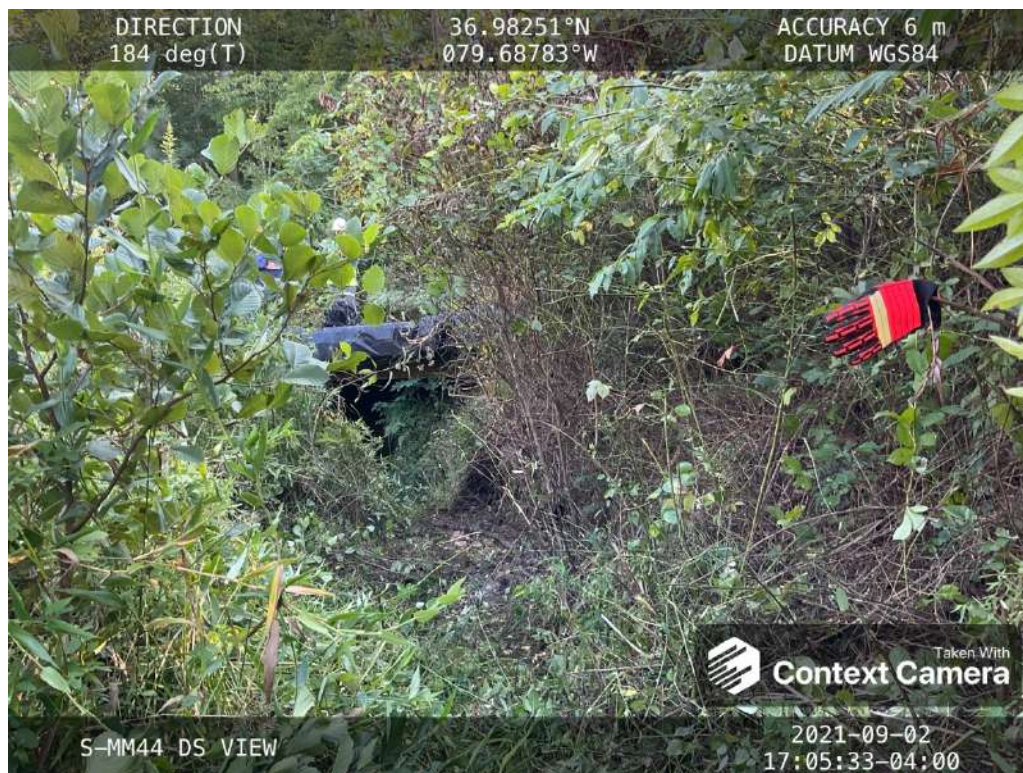
Photo Type: DS VIEW

Location, Orientation, Photographer Initials: Upstream at ROW/LOD looking S downstream, RAH
