## Baseline Assessment – Stream Attributes

### Reach S-SS8 (Timber Mat Crossing) Perennial Spread I Franklin County County, Virginia

| Project # | Project Name (Applicant) | Locality | Cowardin Class. | HUC | Date | SAR # | Impact Length | Impact Factor |
|---|---|---|---|---|---|---|---|---|
| 22865.06 | Mountain Valley Pipeline (Mountain Valley Pipeline, LLC) | Franklin County | R3 or R4 | 03010101 | 8/24/2021 | S-SS8 | 20 | 1 |

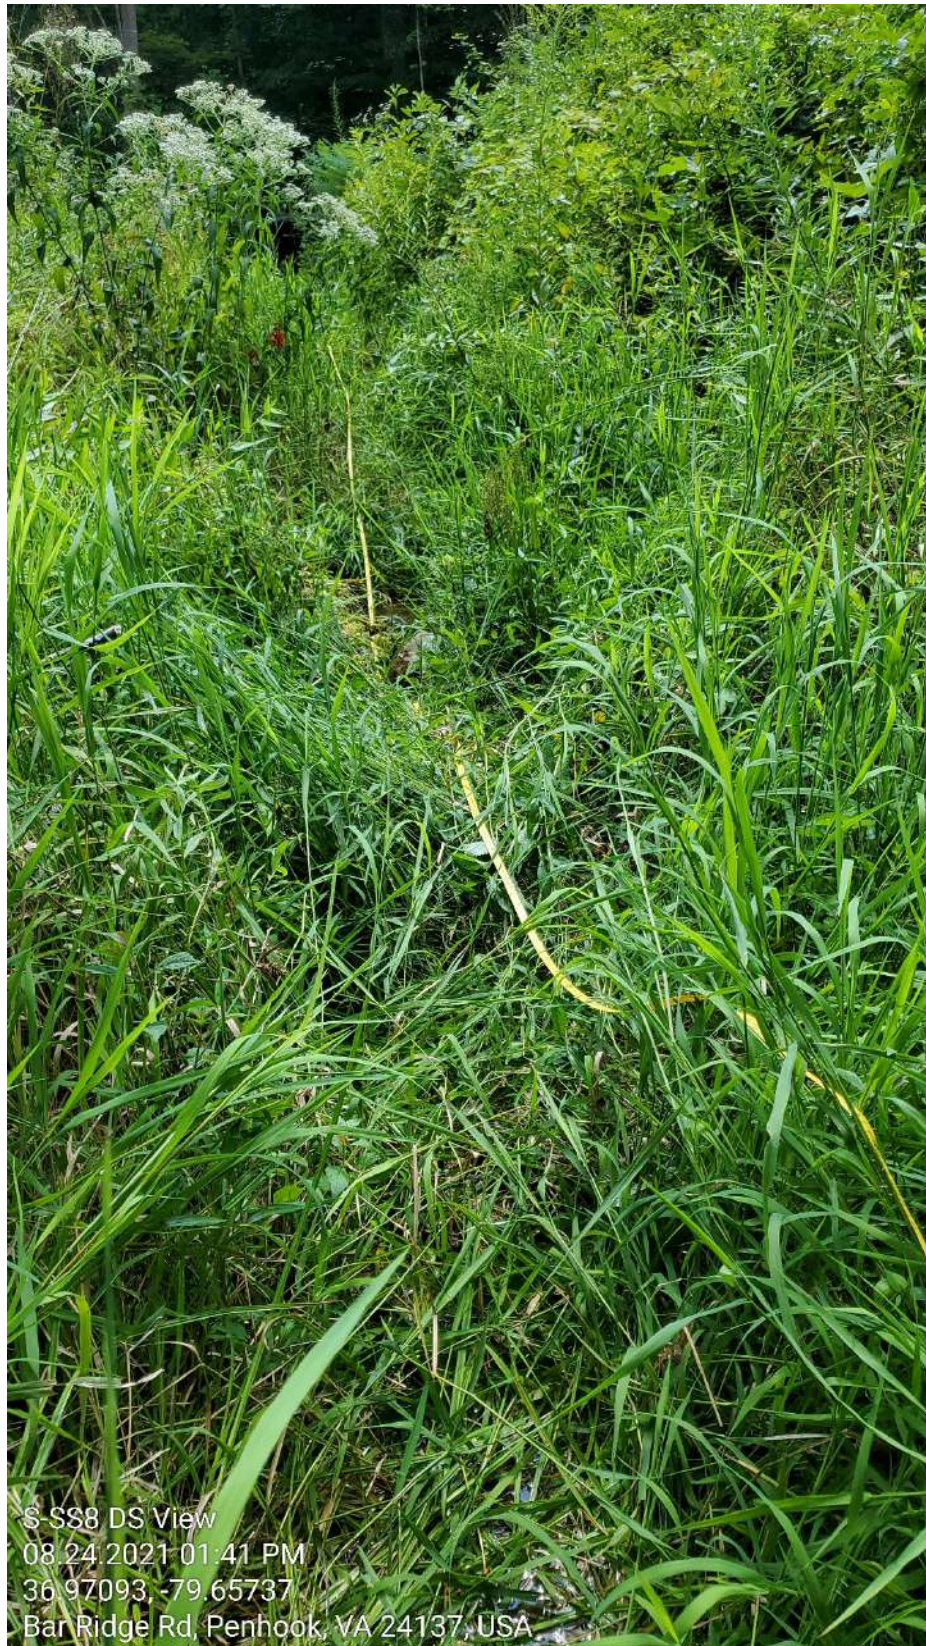
Photo Type: DS VIEW

Location, Orientation, Photographer Initials: Downstream view of ROW/LOD looking S, DW

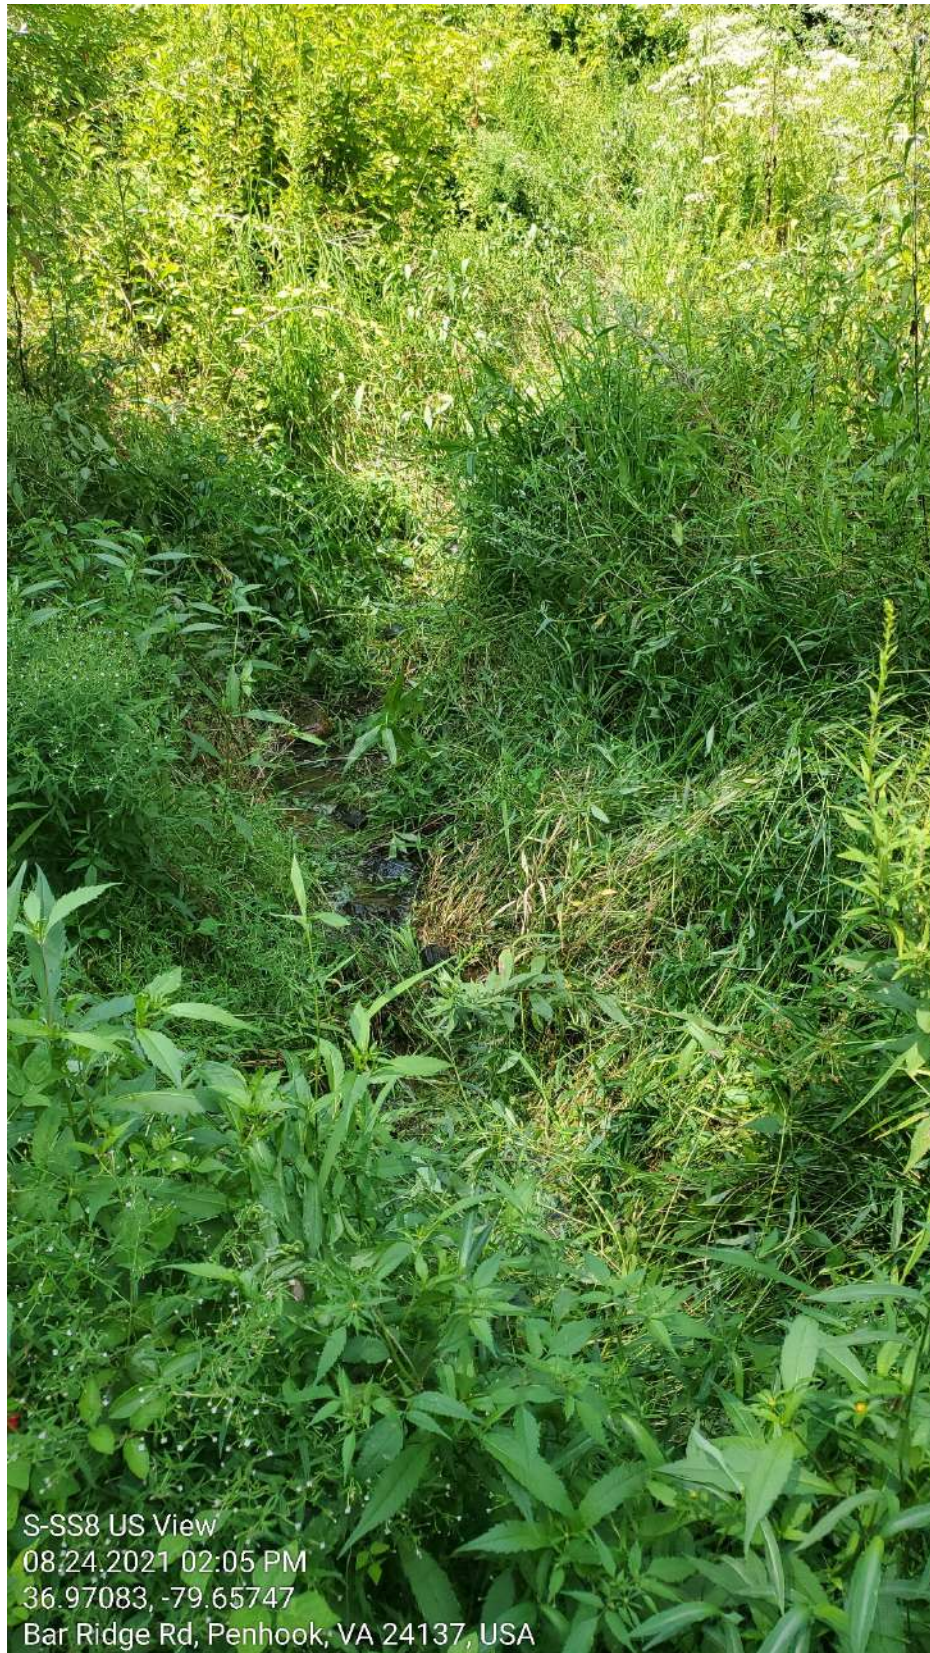
Photo Type: US VIEW

S-SS8 US View  
08/24/2021 02:05 PM  
36.97083, -79.65747  
Bar Ridge Rd, Penhook, VA 24137, USA

Location, Orientation, Photographer Initials: Upstream view of ROW/LOD looking N, Photographer Initials

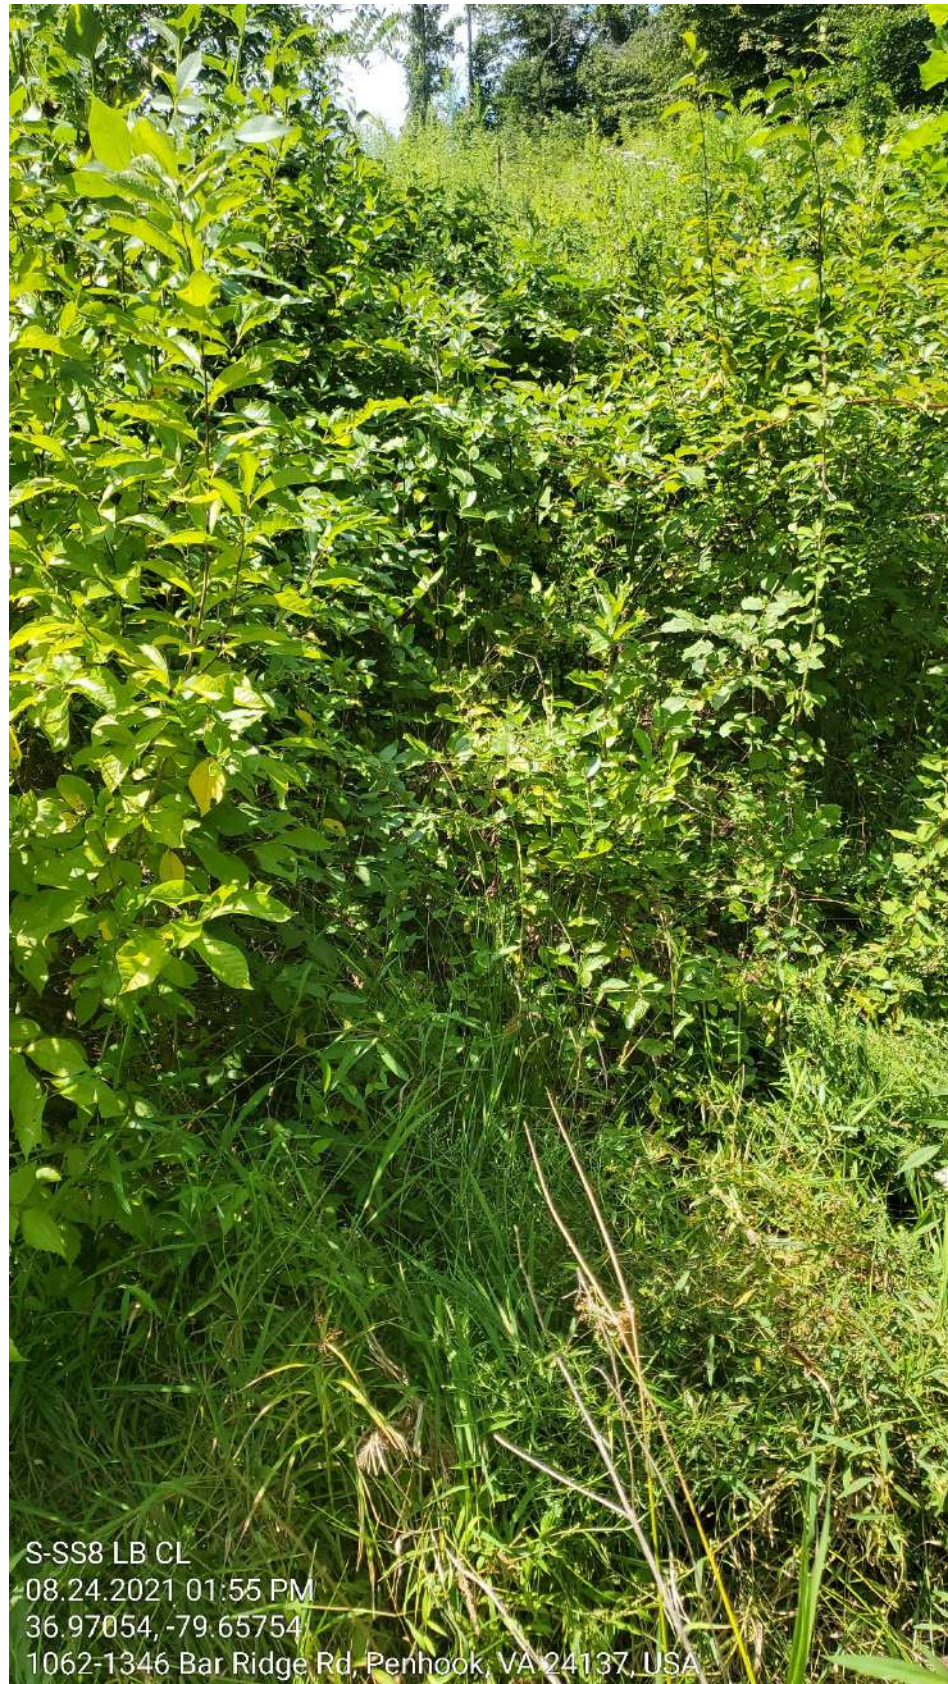
Photo Type: LB CL

Location, Orientation, Photographer Initials: Standing on LB looking at RB along pipe centerline looking W, DW

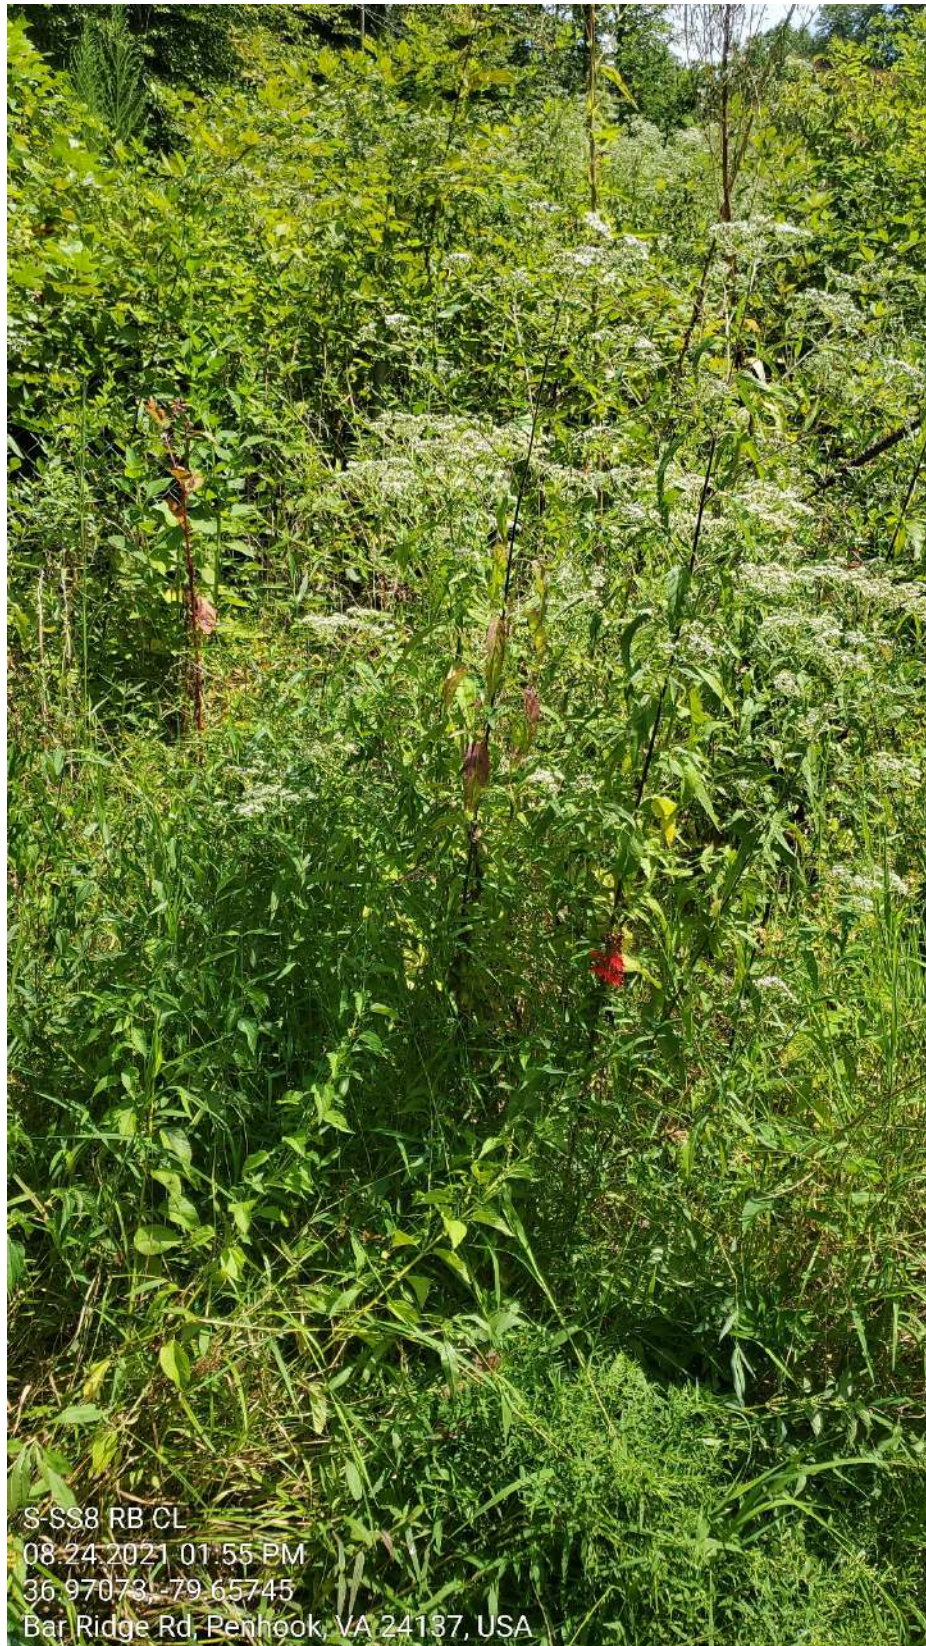
Photo Type: RB CL

Location, Orientation, Photographer Initials: Standing on RB looking at LB along pipe centerline looking E, DW

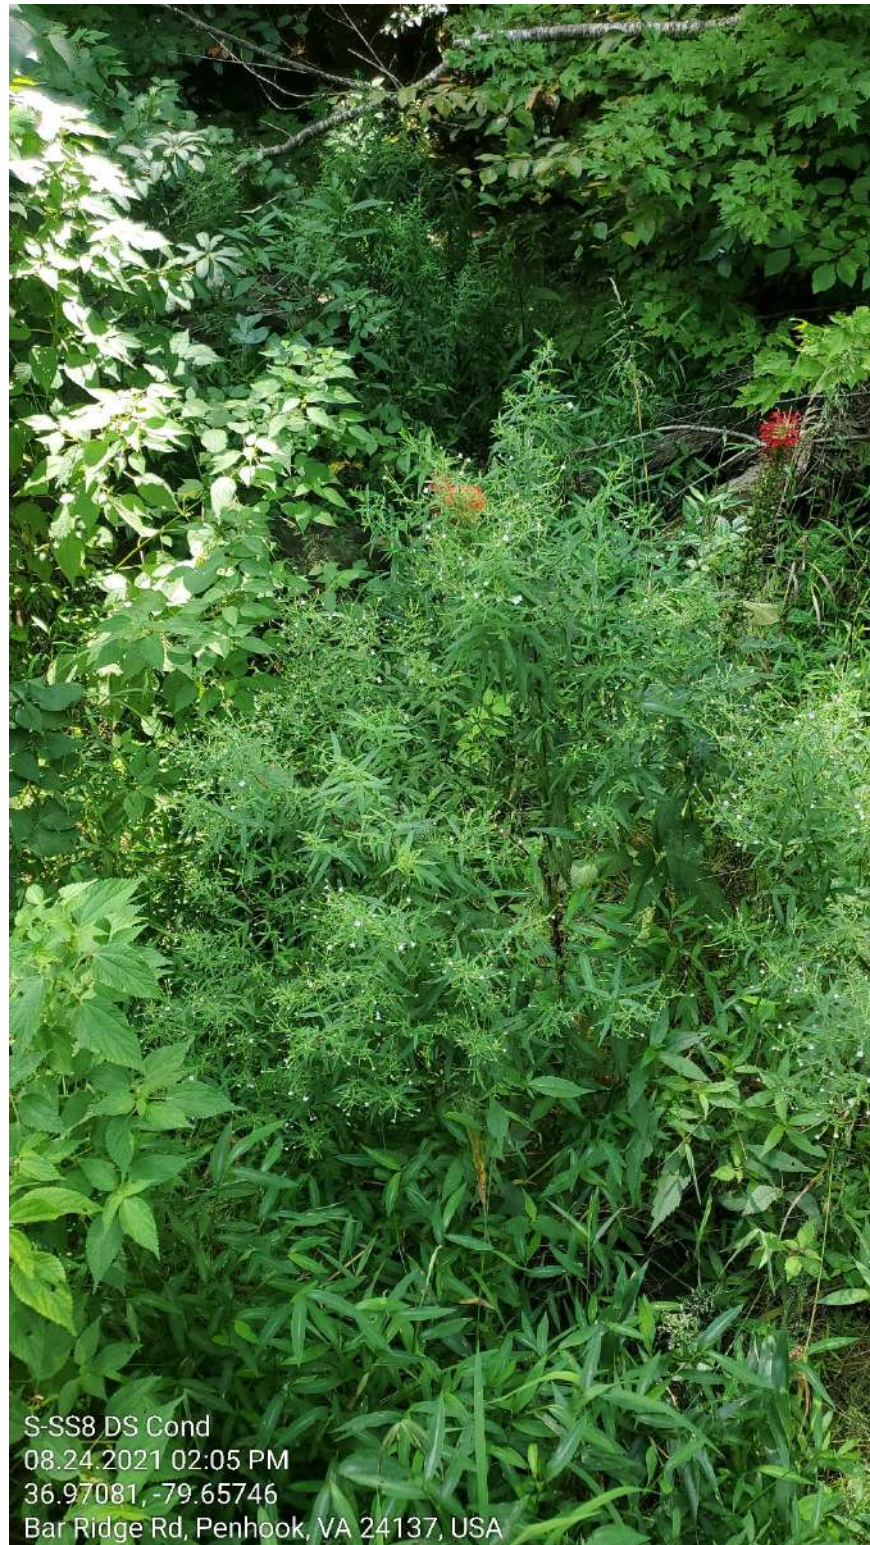
Photo Type: DS COND

Location, Orientation, Photographer Initials: Downstream conditions outside of ROW/LOD looking S, DW

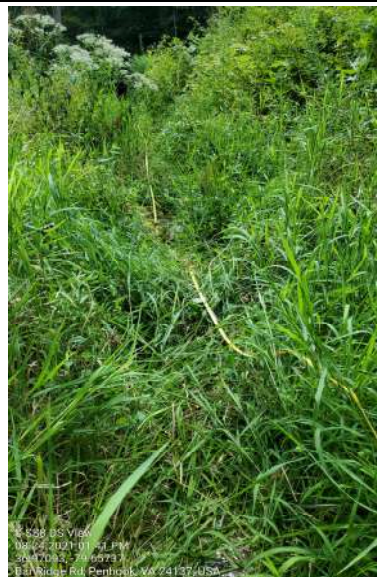
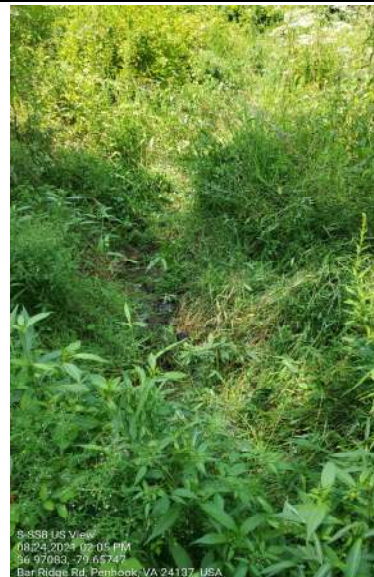
CAPTION. Assessment is limited to areas within the temporary ROW.
